East West Rail Phase 2

Development Stage 2A2: Compound 2A2 and Access at Land East of Station Road, Oxfordshire

Post-Excavation Assessment

EWR Alliance

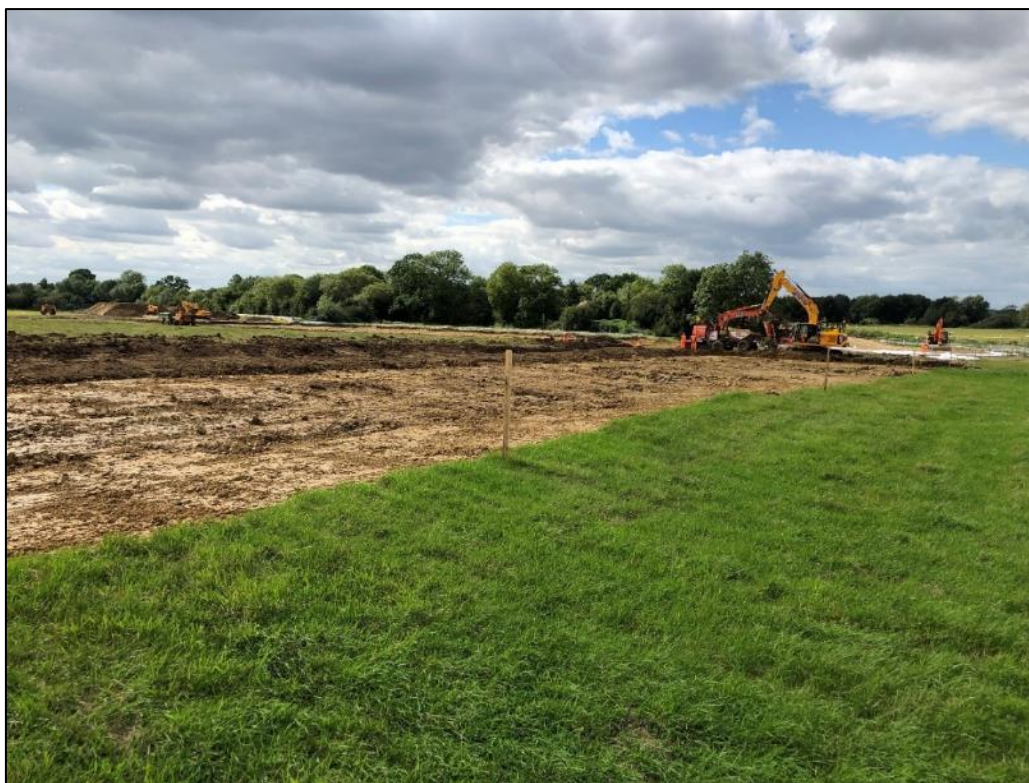
Plate 1: Working shot, showing the stratigraphy of the Site; natural geology (1003), subsoil (1002) and topsoil (1001)

Across the Site the natural geology (1002) comprised a very firm clay with occasional small angular natural flint inclusions, which varied in colour from blueish/grey to a yellow/orange. The natural geology was observed at heights across the Site from 66.39m aOD in the south, to 67.95m aOD in the north (Figures 3.1-3.2; Plate 1).

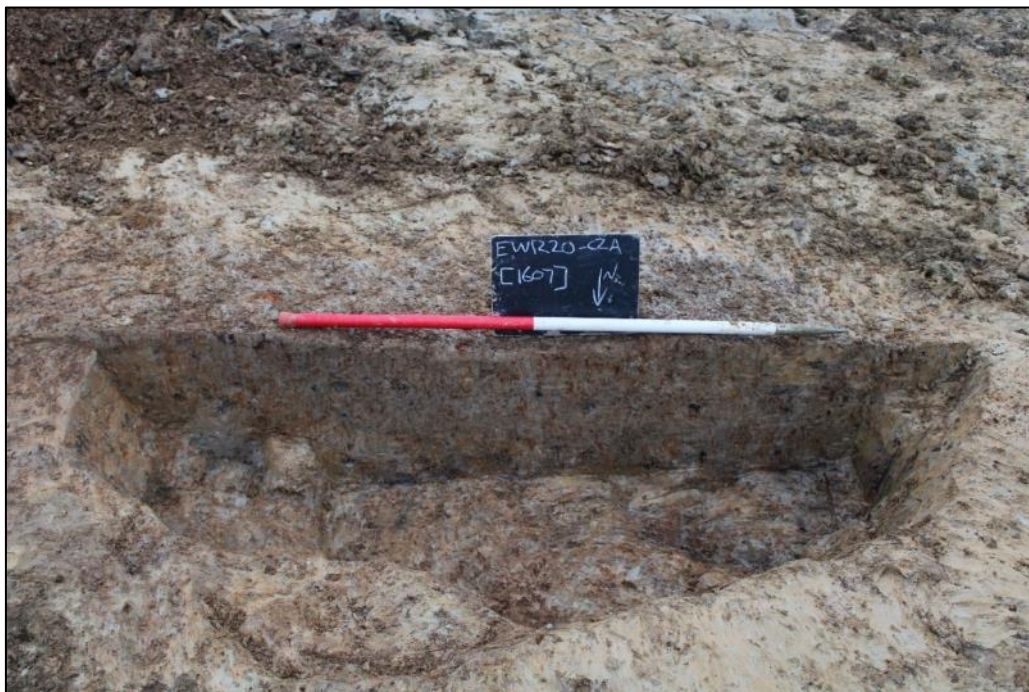
Plate 2: North facing section of pit [1607], looking south

Pit [1607] was observed at a height of 65.84m aOD, taking the form of a well-defined oval shaped pit situated between drainage ditches [1294] and [1589] at the southern end of the Site (Figure 4.9, 5.9; Section 68.1; Plate 2). It was orientated on an east-west alignment, measuring 0.85m by 0.60m with a depth of 0.27m. The profile had uneven concave sides and an undulating base which held a single fill (1606) comprising silty grey clay with inclusions of angular stones, charcoal remnants and 10 small sherds of pottery. The small amount of charcoal was brittle and iron pan damaged due to waterlogging, but could be identified as oak and seen as fuel waste (Appendix E). The pottery was identified as Late Bronze Age to Early Iron Age in date, probably having derived from a single vessel. The assemblage comprised sherds in a fabric that contained common-abundant calcined flint temper which is characteristic of the medium-coarse fabrics used for a wide range of post-Deverel-Rimbury bowls and jars in the continuum of a ceramic style that spans the late Bronze Age and Early Iron Age (Appendix C).

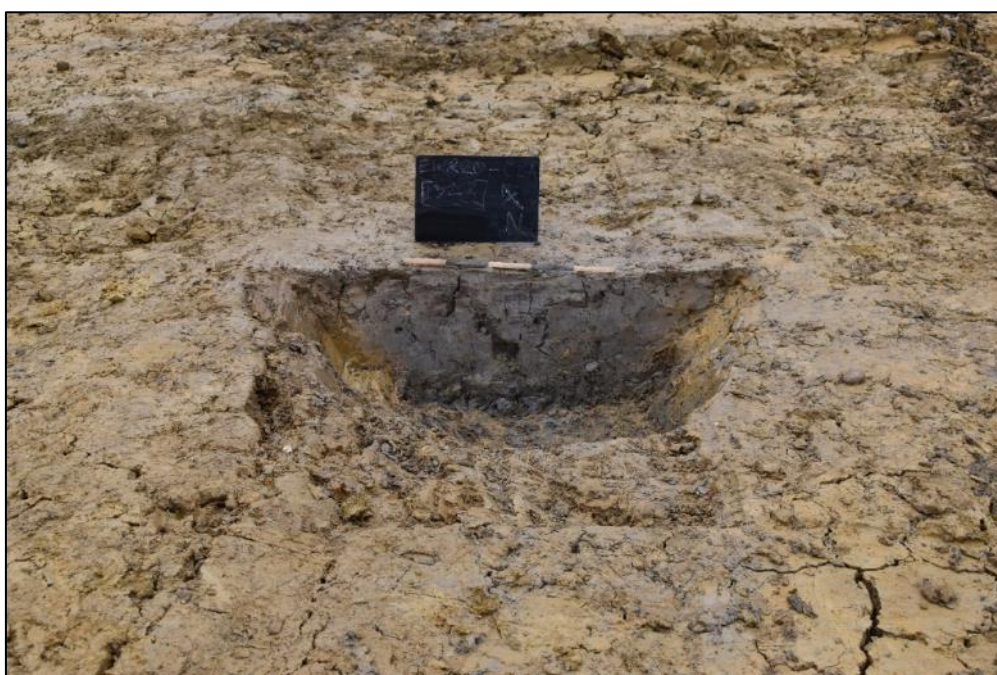
Plate 3: North-west facing section of pit [1323], looking south-east

Pit [1323], observed on the south-eastern edge of the Site at a height of 69.45m aOD, was subcircular in plan measuring 0.65m by 0.55m by 0.25m deep (Figure 4.12, 5.4; Sections 31.3, 31.4; Plate 3). The single fill was mid-blueish grey silty clay (1322) with moderate inclusions of small angular stones, some oak charcoal and numerous sheep/goat tooth fragments (Appendix E, F). The single body sherd recovered from this feature is typical of Middle to Late Iron Age pottery in the region, which is largely characterised by a range of sand-tempered fabrics, used to make ovoid/slack-bodied jars and bowls (Appendix C). Pit [1323] can be interpreted as a Middle to Late Iron Age feature, the upper reaches of which had probably been lost to post-depositional processes such as later agricultural activity.

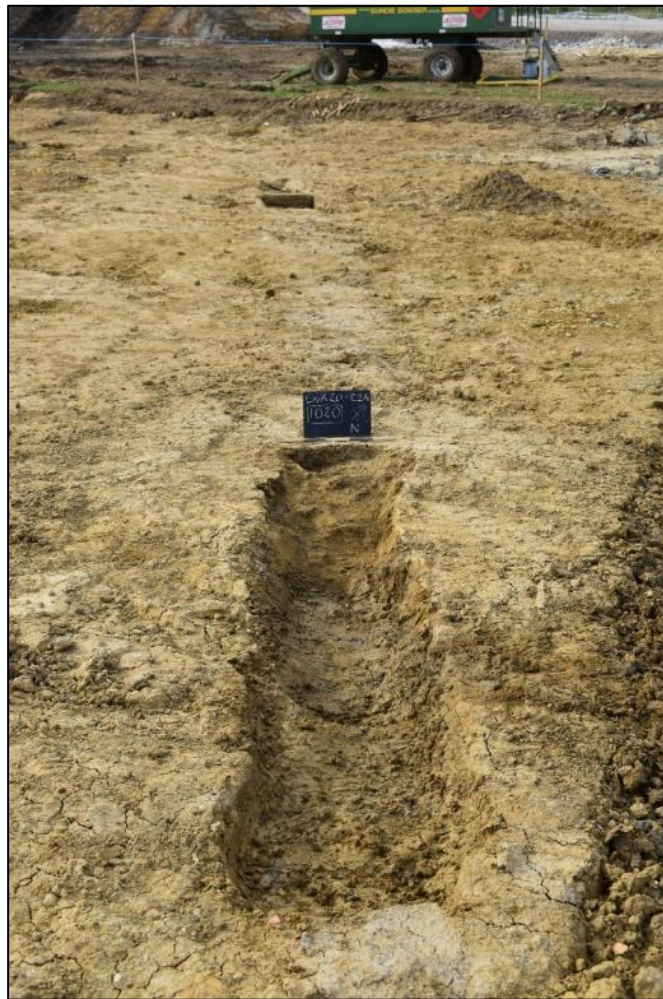
Plate 4: Ditch [1020], Slot [1059], looking north-west

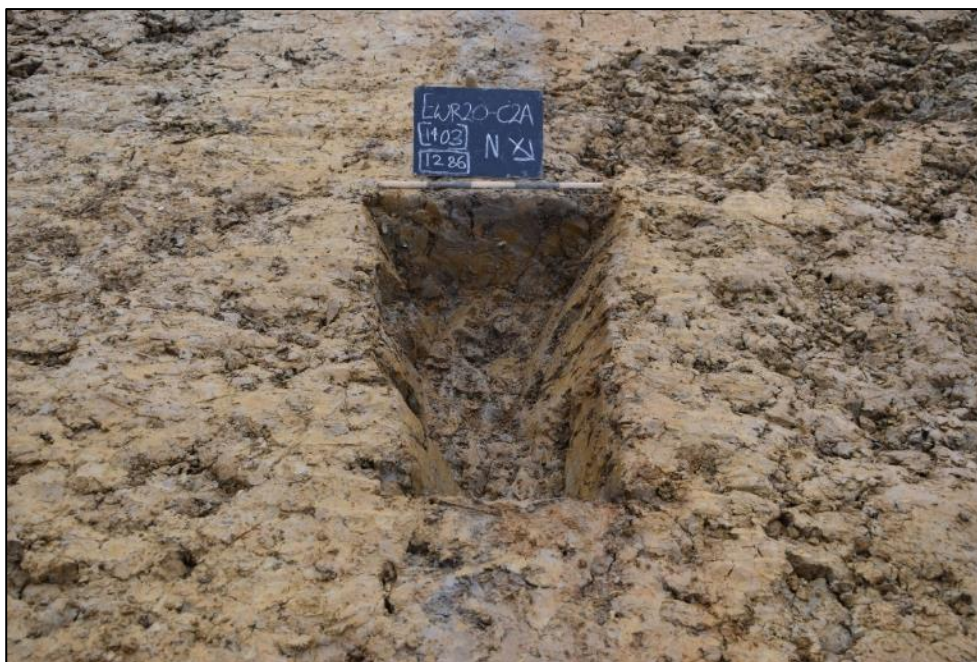
Plate 5: Ditch [1286], slot [1403], looking south-west

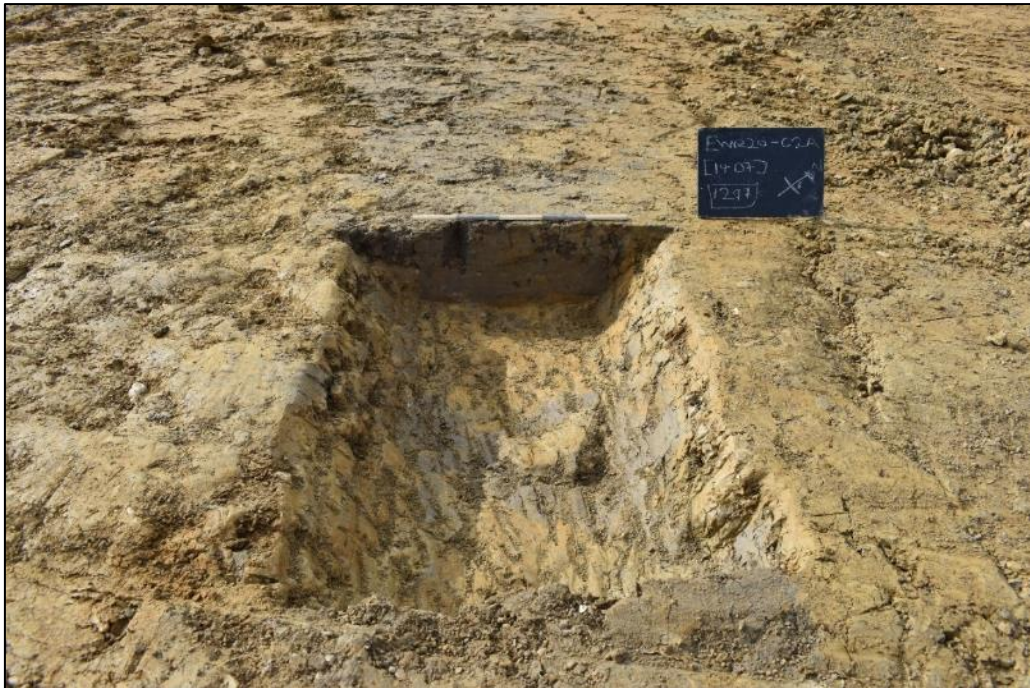
Plate 6: Ditch [1297], slot [1407], looking north-west

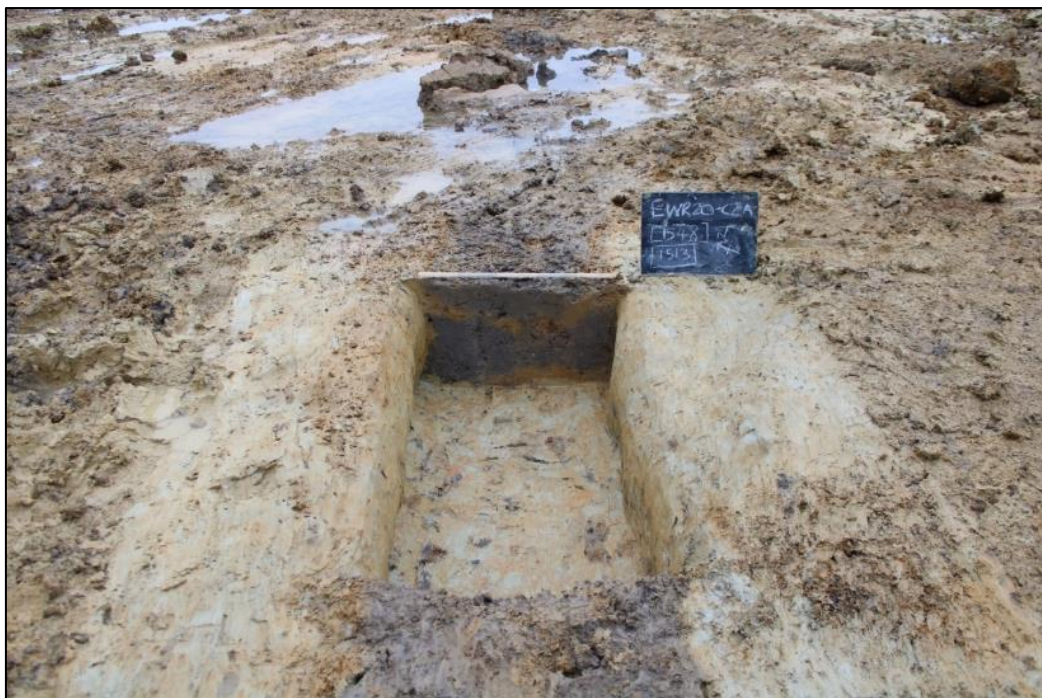
Plate 7: Ditch [1513], slot [1548], looking north-east

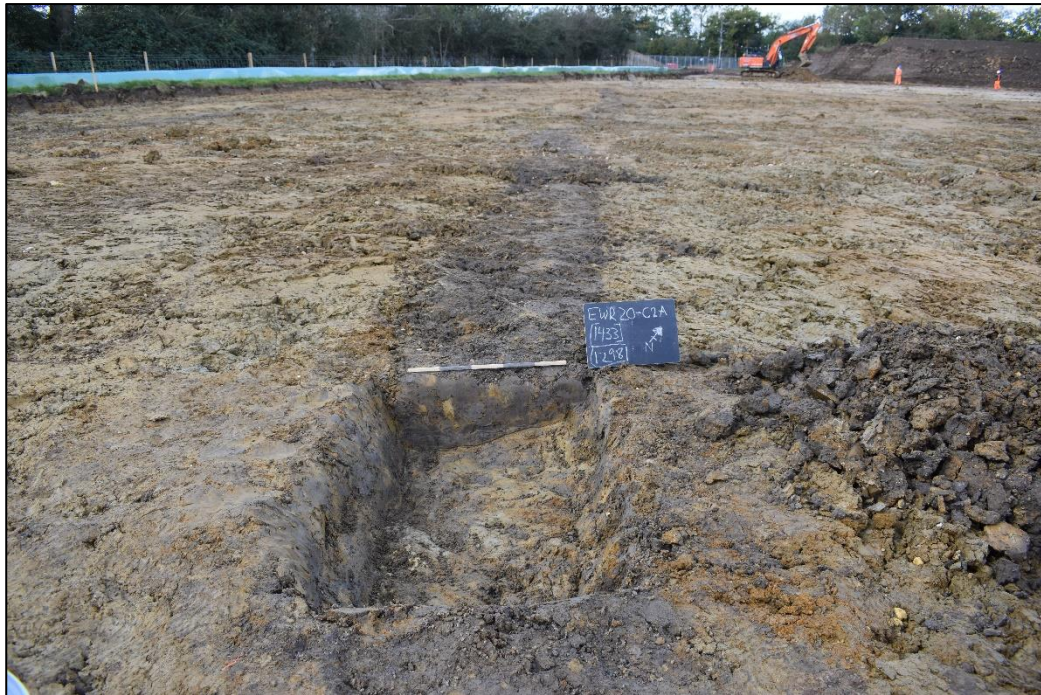
Plate 8: Ditch [1298], slot [1433], looking north-east

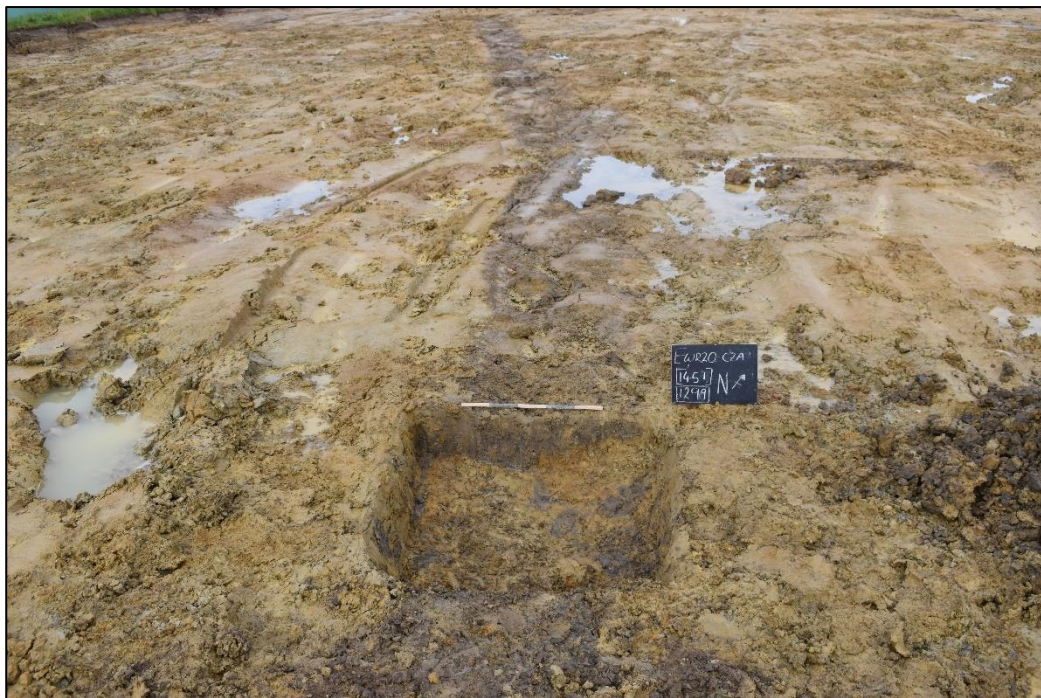
Plate 9: Ditch [1299], slot [1451], looking north-east

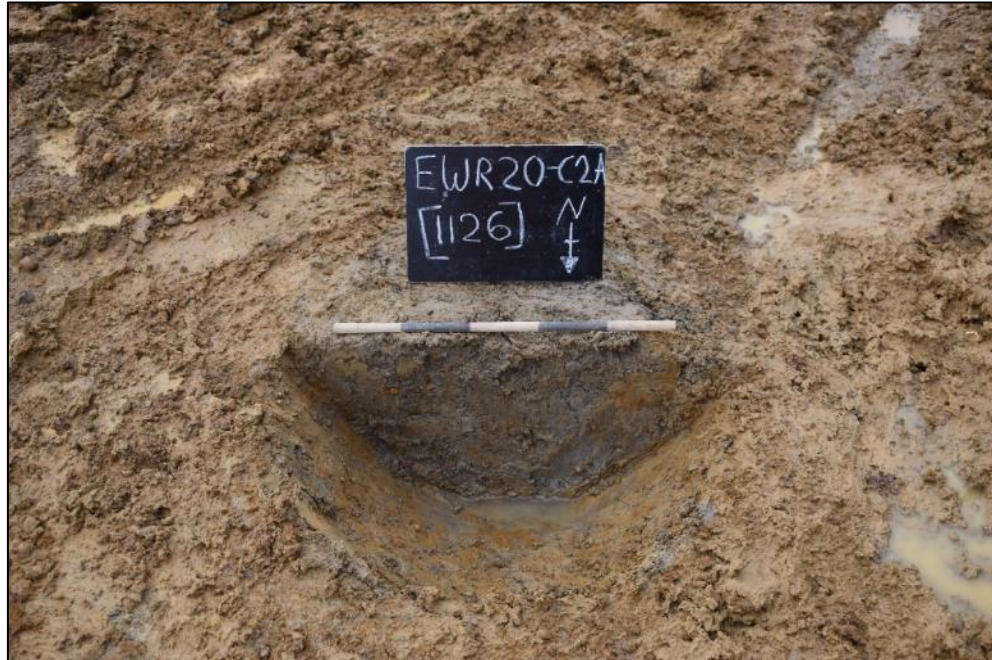
Plate 10: North facing section of posthole [1126], looking south

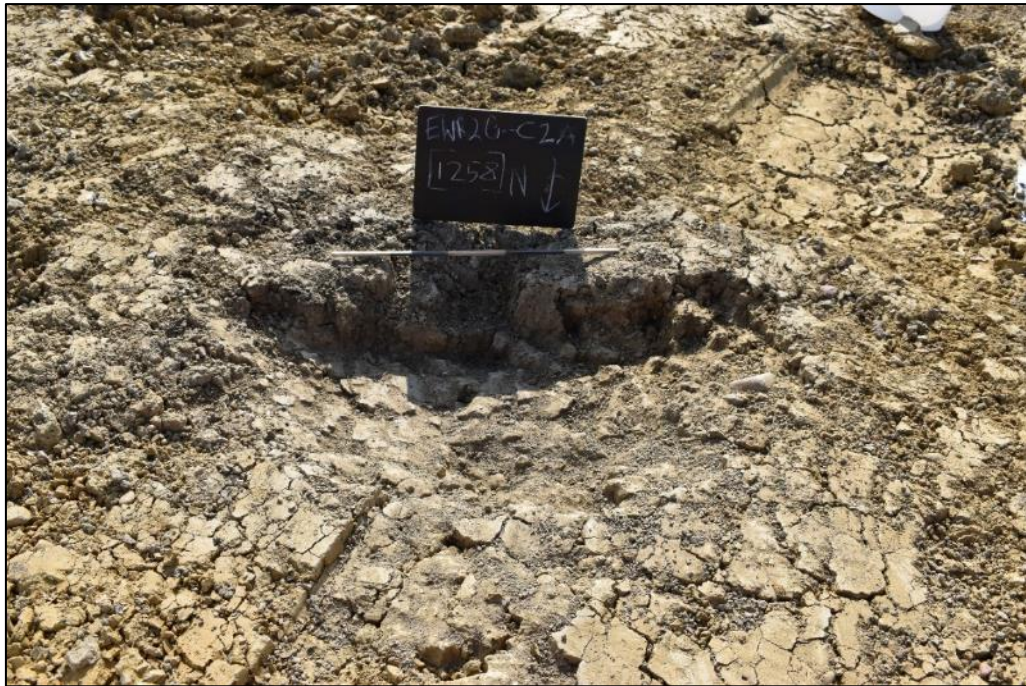
Plate 11: South facing section of posthole [1258], looking south

The only diagnostic finds recovered from any of the features in the alignment came in the form of 12 small sherds of medieval sandy grey ware that may date to the 11th to 14th century (Appendix C). The pottery was retrieved from posthole [1258] which lies just east of drainage ditch [1201] on the eastern side of the Site (Figure 4.6) at a height of 70.06m aOD. This posthole was one of the larger features in the alignment; subcircular in plan measuring 1.00m by 0.80m. It was clearly defined with a sharp break of slope onto sloping sides and a sloping flat base, with a depth of 0.13m (Figure 4.2; Section 25.2; Plate 11). The charcoal retrieved from the fill deposit (1257) was identifiable as oak (Appendix E).

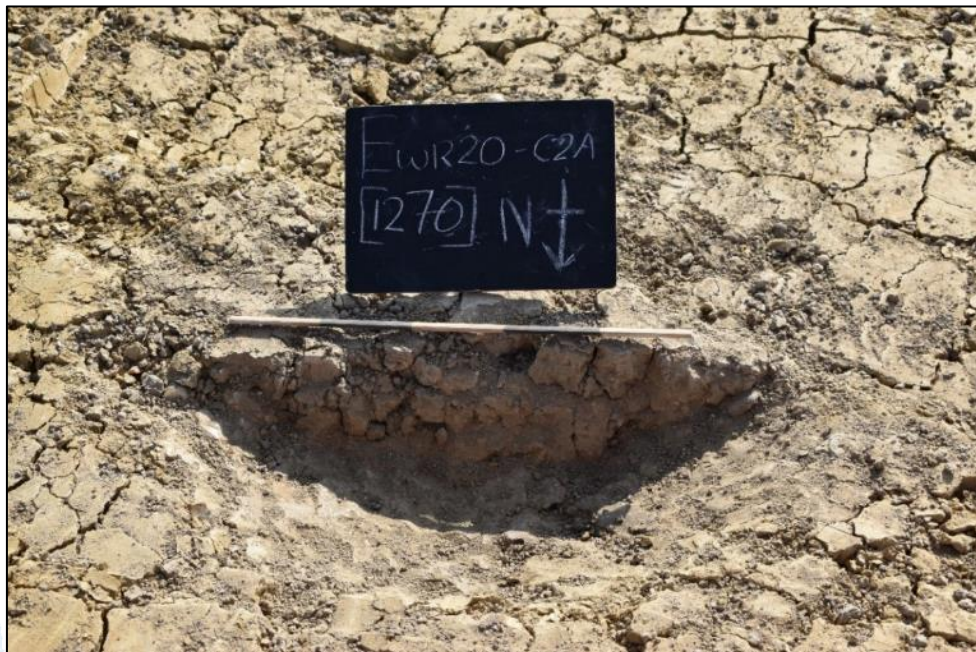
Plate 12: North facing section of posthole [1270], looking south

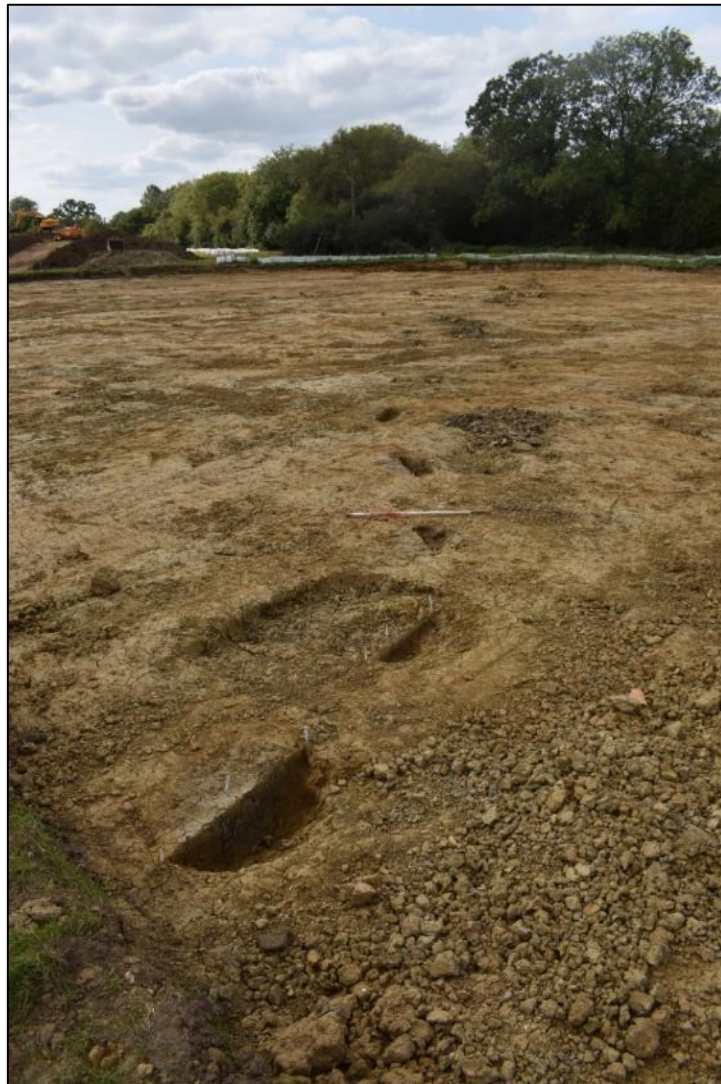
Plate 15: Western end of posthole alignment, looking east

Overall, the postholes or pits were relatively regularly spaced along the length of the alignment with gaps of between 0.8m and 1.4m between adjacent features. However, there are a couple of more significant gaps, such as between [1136] and [1138], or [1164] and [1166], with gaps of 3.2 m and 5.1 m respectively, which is suggestive of a single missing posthole; or between [1150] and [1154], or [1174] and [1176], which had gaps of 5.1m and 7.7m respectively, which would suggest more than one missing feature. The largest gap was to the east between features [1230] and [1232] which was 18.4 m. Whilst potential missing posts may be the result of truncation or the result of modern ceramic drainage features removing postholes, there is also the possibility that these gaps were deliberate openings to allow access or easy movement from one side to the other of the boundary that the alignment presumably formed.

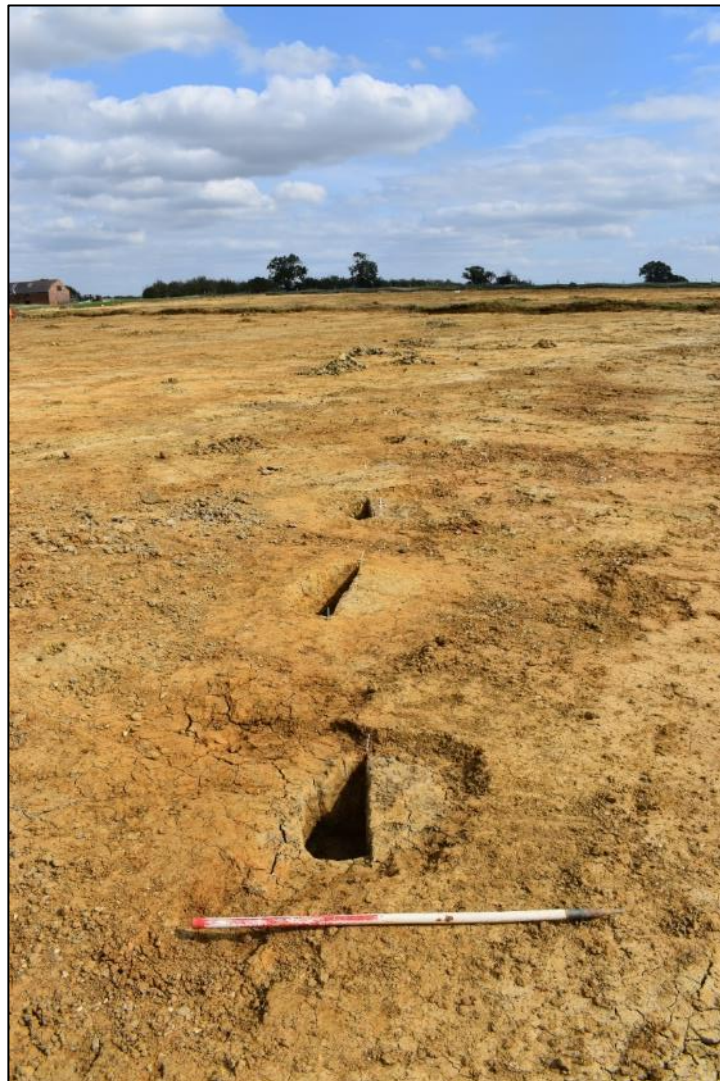
Plate 16: View of eastern end of posthole alignment, looking south-west

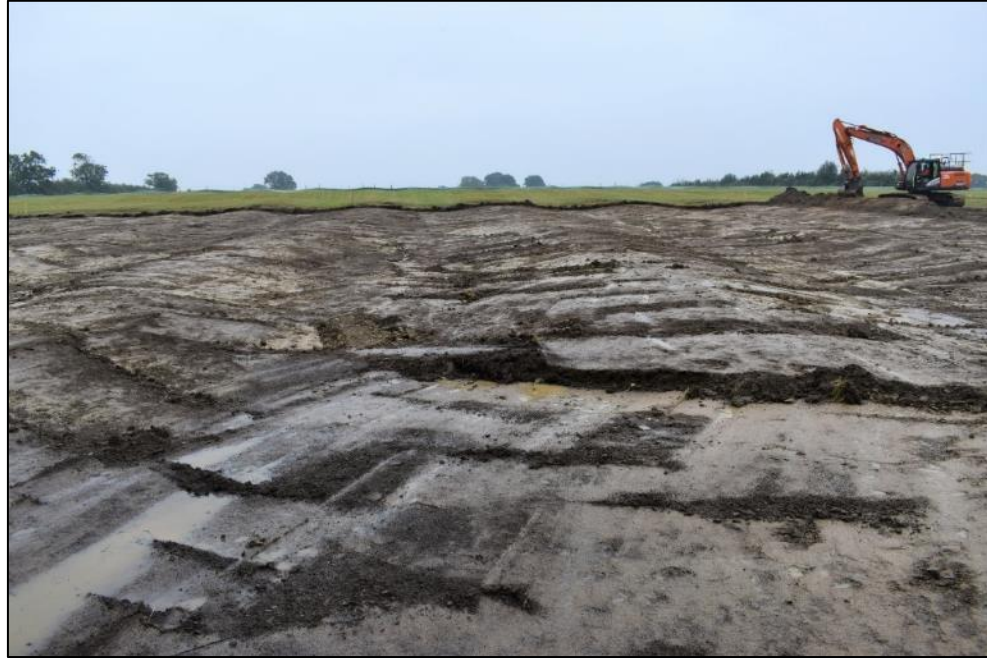
Plate 15: View of ridge and furrow during topsoil strip in northern area of the Site, looking south-east

and measured between 2m and 3m in width with the ridges wider at 4m to 5m. The furrows were on almost the same alignment as the earlier bedding trenches that were recorded across the Site, which could be taken to suggest that they were part of the same regime of cultivation, however the stratigraphy encountered appears to indicate otherwise.

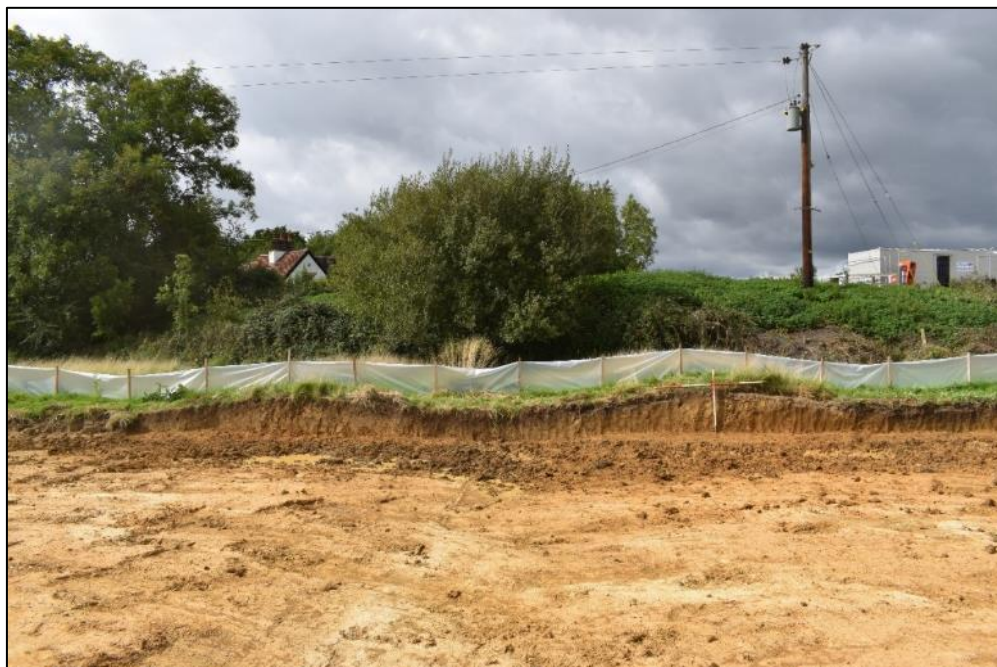
Plate 16: View of SE facing section through ridge and furrow section at north-western limit of excavation, looking north-west

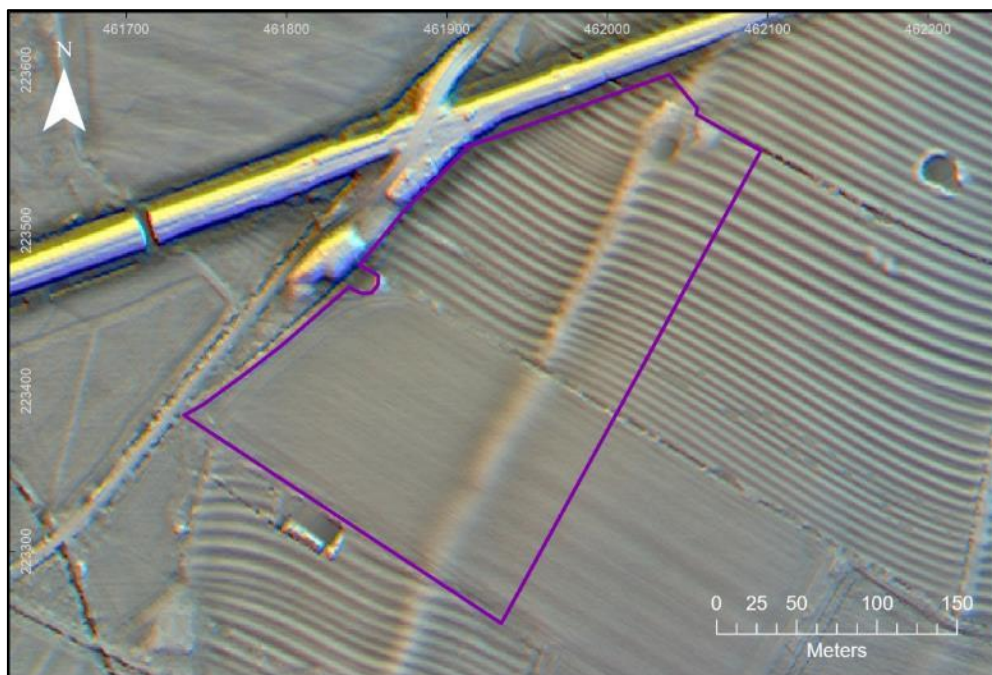
Plate 17: LiDAR showing ridge and furrow and headland

The headland was created to allow the turning of the plough at the end of the ridge, however the limit of excavation on the northeast side of Site shows the presence of some very patchy deposited gravel at the base of the topsoil where the headland exits the Site (not illustrated). The presence of the gravel may suggest the headland may have been later used as an access route to buildings depicted in the area on Ordnance Survey (OS) mapping³⁴.

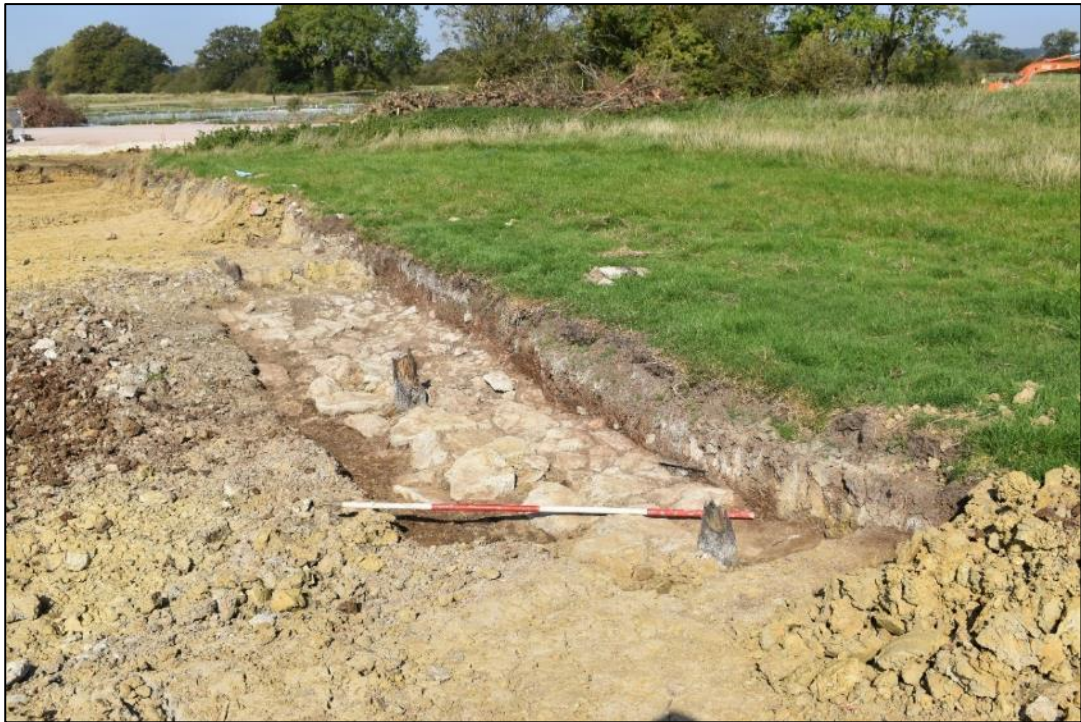
Plate 18: View of floor surface [1283], looking north-west

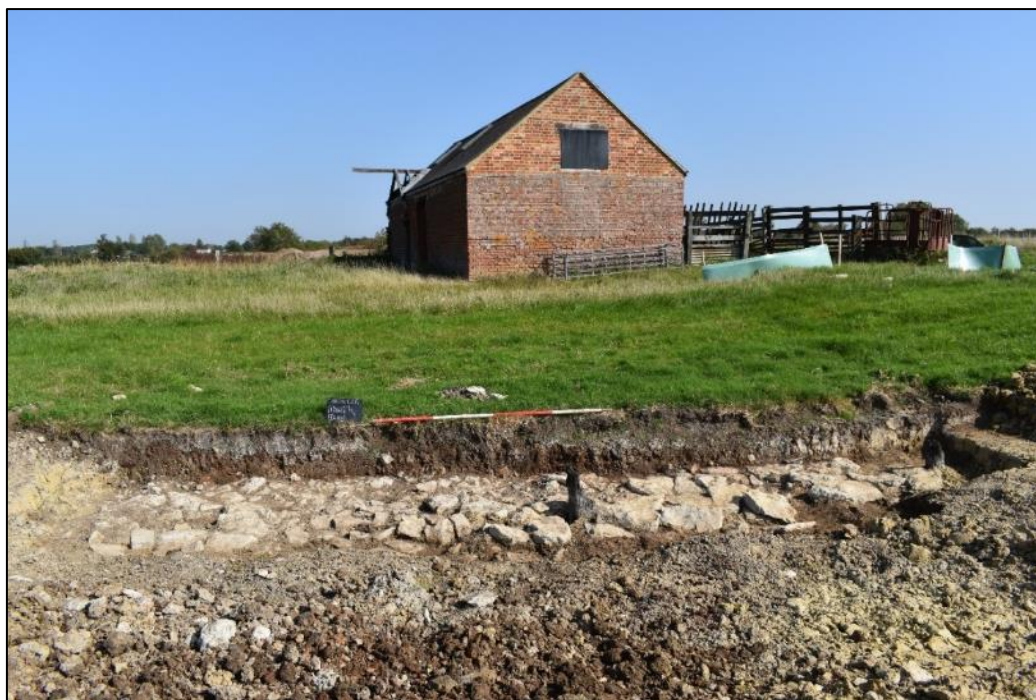
Plate 19: View of floor surface [1283] and north-eastern limit of excavation, looking north-north-east

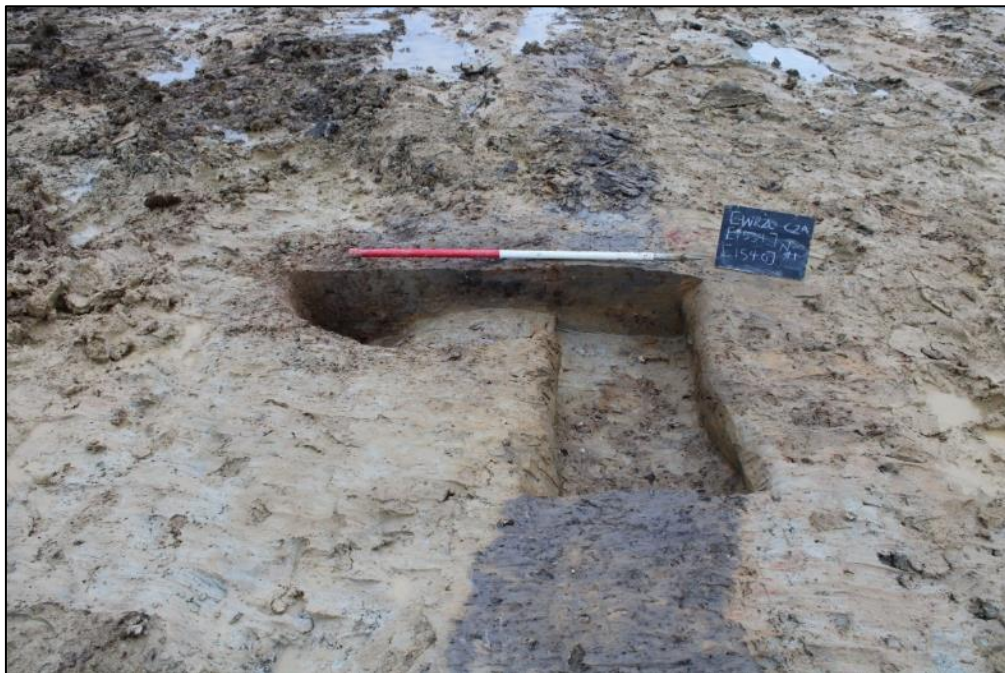
Plate 22: North-west facing section of pit [1540] and ditch [1513], looking south-east

Pit [1540] was located on the north-eastern edge of ditch [1513] and was circular in plan with a diameter of 0.95m with steep sides onto a rounded base 0.45 m deep (Figure 4.8, 5.8; Section 60.1; Plate 20). It was observed at a height of 66.25m aOD and contained a single fill of mottled silty clay (1539) with evidence of dumped burning in the form of charcoal and ashy burnt material. The pit was clearly truncated by ditch [1513] and contained no datable material.

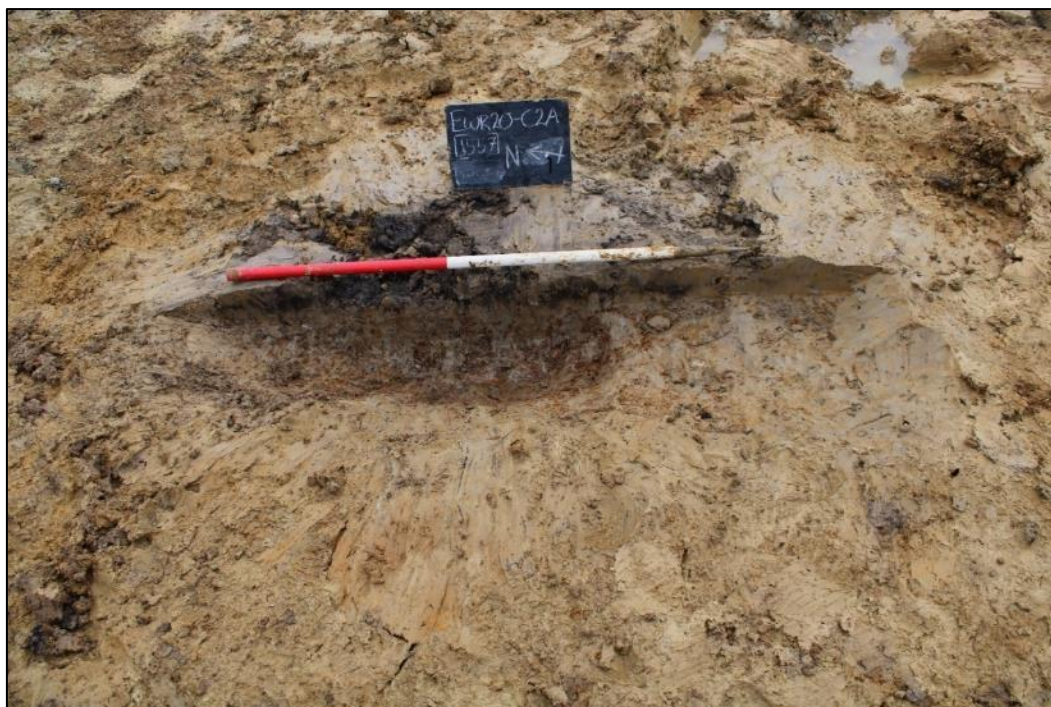
Plate 23: North-west facing section of pit [1557], looking south-east

Pit [1557] lay a few metres to the south of pit [1540] between drainage ditches [1513] and [1527] (Figure 4.8, 5.7; Section 58.6; Plate 21). Pit [1557] was observed at a height of 66.17m aOD, measured 1.63m by 1.05m with a depth of 0.31m. Its profile had gradually sloping sides onto an irregular base and contained three distinct fills. The basal fill was a light grey clay (1556) with flecks of charcoal and occasional angular stones with a depth of 0.16m. The deposit contained a single grain of barley (Appendix E). Above this was a darker clay (1555) with more charcoal flecking and a depth of 0.10m. The final fill was a thin band of dark grey clay (1554) with even more charcoal flecking and some charcoal pieces. No datable material was recovered and the charcoal and burnt material was likely dumped material and not evidence of burning *in situ*.

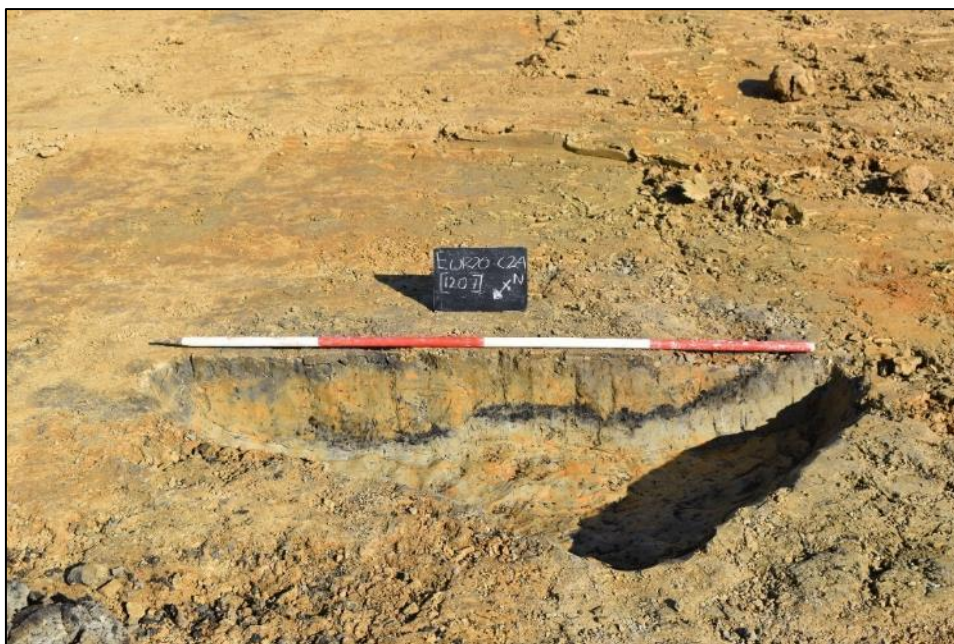
Plate 24: North-west facing section of pit [1207], looking south-east

Pit [1207] was located towards the middle of the Site and was observed at a height of 68.05m aOD (Figure 4.7, 5.3; Section 19.1; Plate 22). It was sub-circular in plan, measuring 2.00m by 1.60m with moderately steep sides onto a flat base 0.35 m deep. The basal fill was a firm light bluish grey clay (1208) with a charcoal rich lens along the top. There was no evidence of the pit being heat affected so this charcoal was likely a deliberate deposit rather than representing *in situ* burning. Identification of the charcoal where possible revealed it to be entirely oak and it was the largest charcoal assemblage from the excavations and was indicative of fuel waste (Appendix E). This was overlain by an upper fill which comprised light greyish brown clay (1206) with occasional charcoal flecks. The pit was partially truncated by a ceramic field drain cut along its southern edge.
