Himley Village, Bicester

Ground Investigation Report

Date: 21 July 2023

Doc ref: 27141-HYD-XX-XX-RP-GE-1002-S0-P01

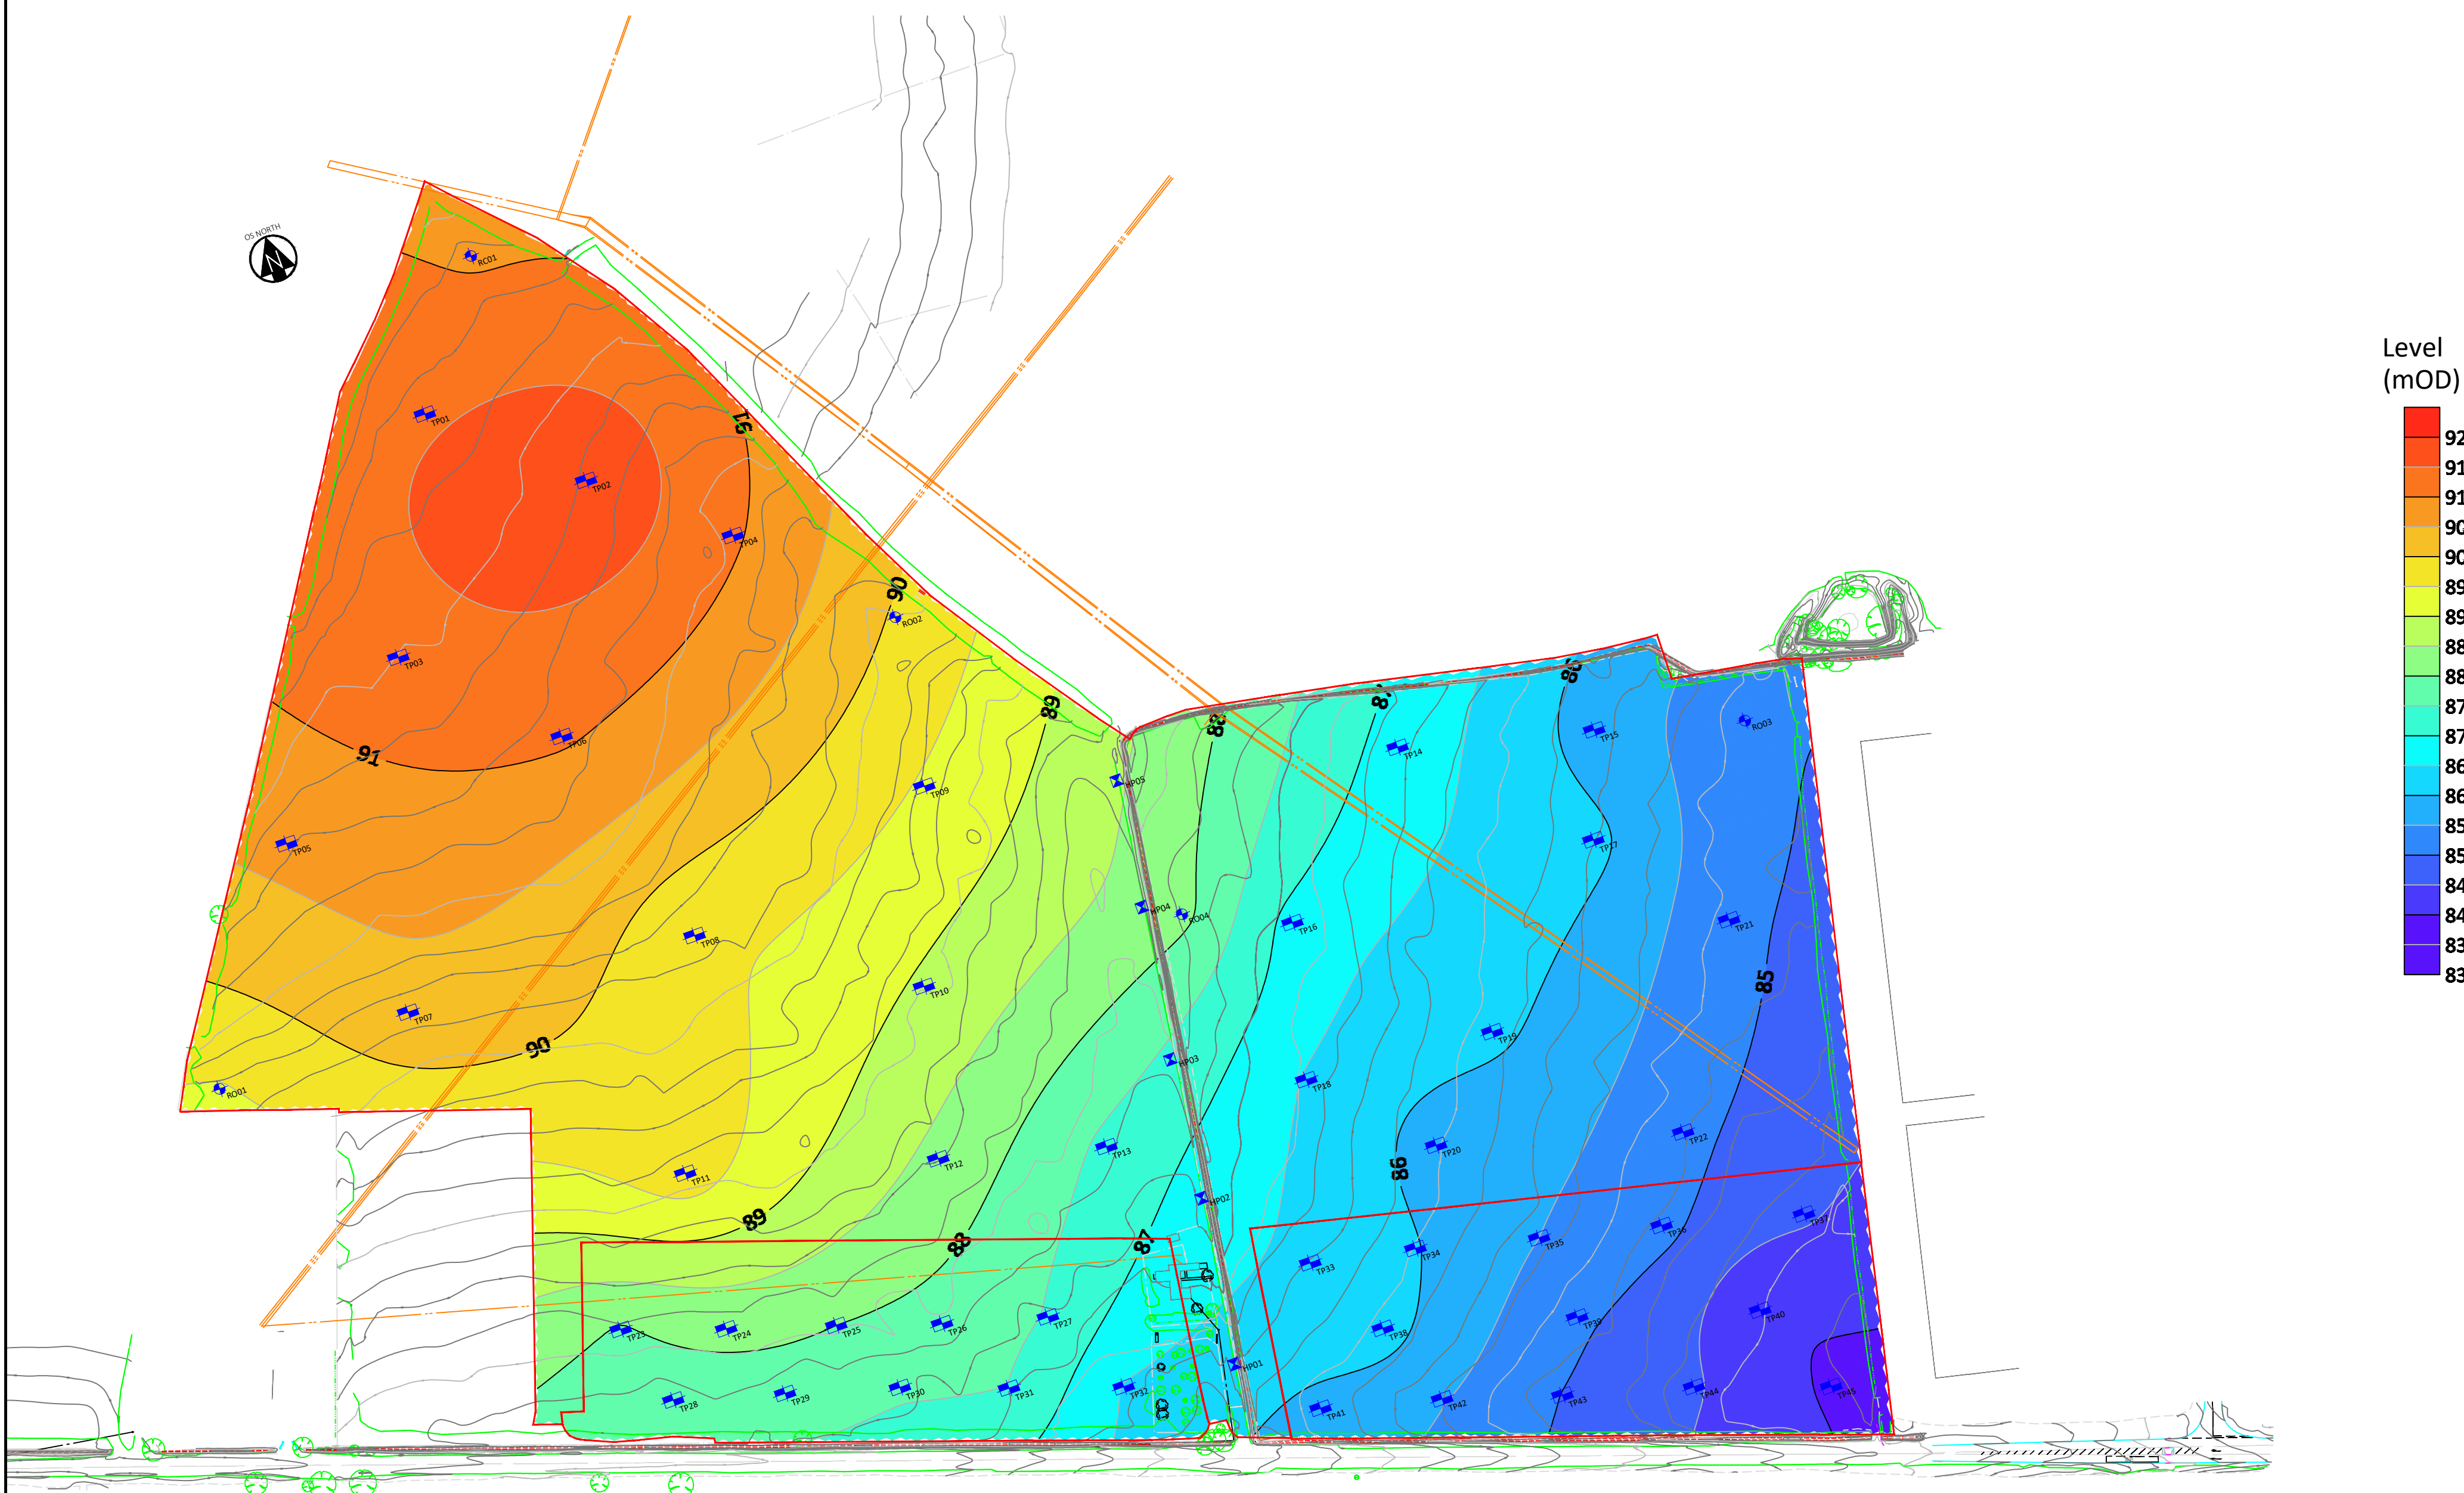
Level of Base of Cornbrash Formation (mOD)

Depth to Base of Cornbrash Formation (mbgl)

KEY Hydrock SI (May/June 2023) Rotary Borehole Trial Pit Hand Pit Redline Boundary Overhead cables	NOTES 1. All dimensions are to be checked on site before the commencement of works. Any discrepancies are to be reported to the Architect & Engineer for verification. Figured dimensions only are to be taken from this drawing. 2. This drawing is to be read in conjunction with all relevant Engineers' and Service Engineers' drawings and specifications. 3. This drawing has been based on the following drawings and information: 27141-HYD-XX-XX-M2-C-0021 - Topo 4. Surfaces have been created using Hydrock Site Investigation data (May/June 2023). Levels and depths are accurate at investigation locations. Between investigation locations, levels and depths have been extrapolated and are indicative only.	 Hawthorn Park Holdenby Road Spratton Northampton NN6 8LD TEL: 01604 842 888 E-Mail: northampton@hydrock.com or visit www.hydrock.com	TITLE Base of Cornbrash (mOD and mbgl)

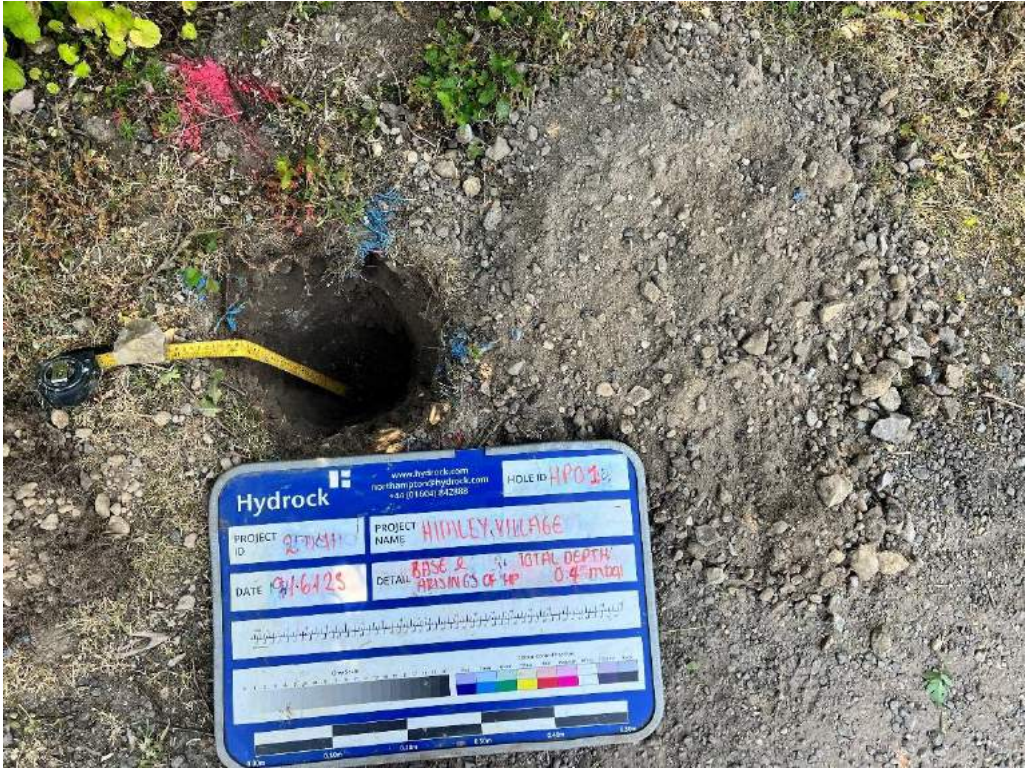
Site Investigation Photograph 1
Date: 09/06/2023
Direction Photograph Taken: N/A.
Description: HP01 showing Made Ground over Cornbrash Formation.

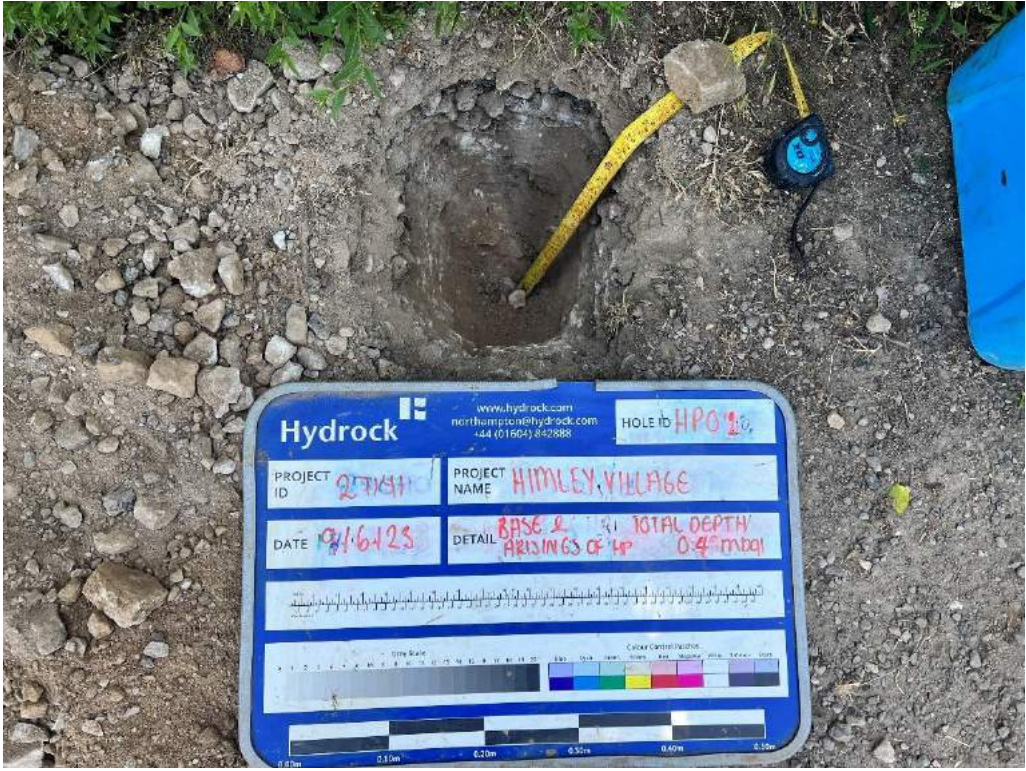
Site Investigation Photograph 2
Date: 09/06/2023
Direction Photograph Taken: n/a.
Description: HP02 showing Made Ground over Cornbrash Formation.

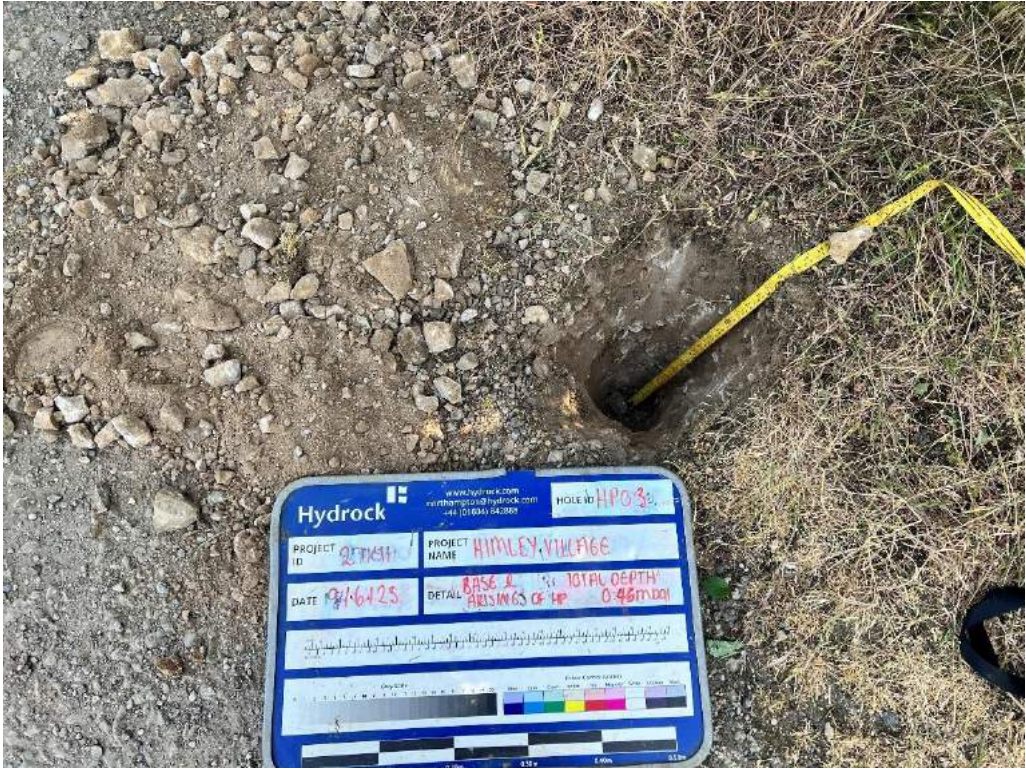
Site Investigation Photograph 3

Description: HP03 showing Made Ground over Cornbrash Formation.

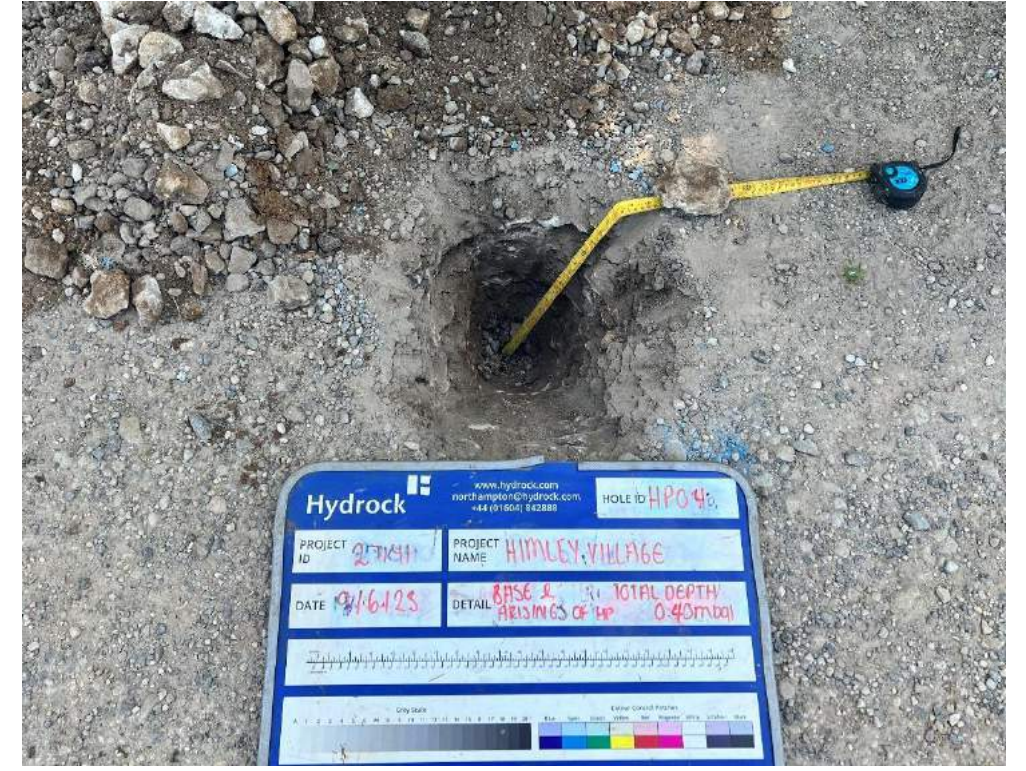
Site Investigation Photograph 4

Description: HP04 showing Made Ground over Cornbrash Formation.

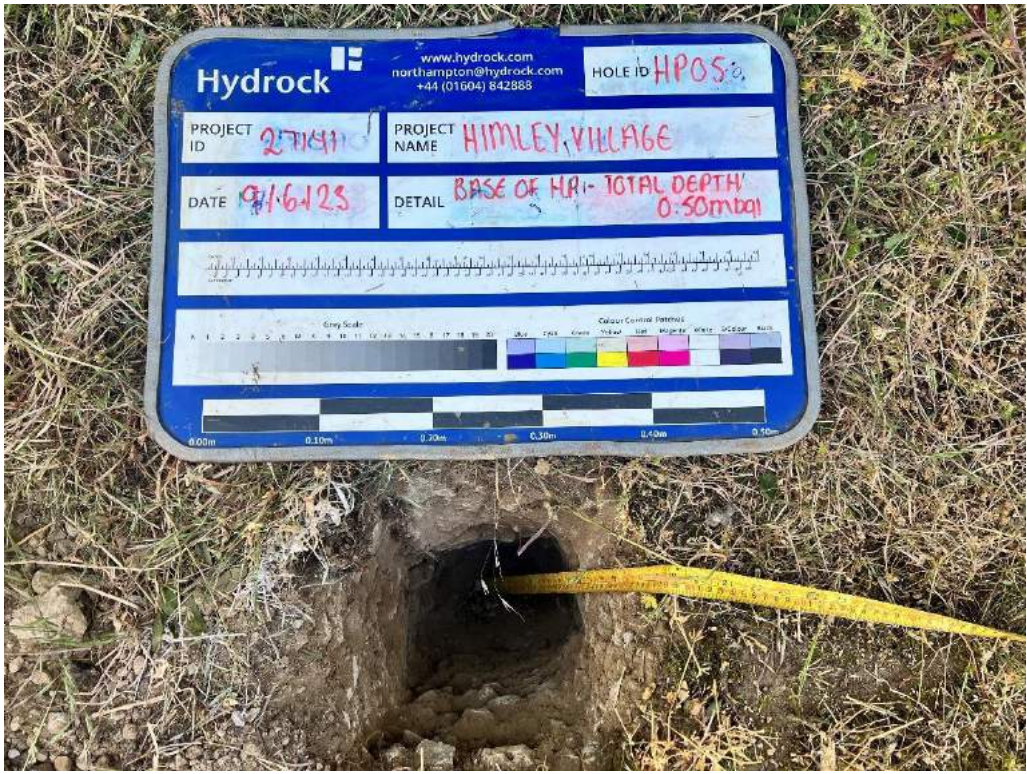
<p>Site Investigation Photograph 5</p>
<p>Date: 09/06/2023</p>
<p>Direction Photograph Taken: n/a.</p>
<p>Description: HP05 showing Made Ground over Cornbrash Formation.</p>

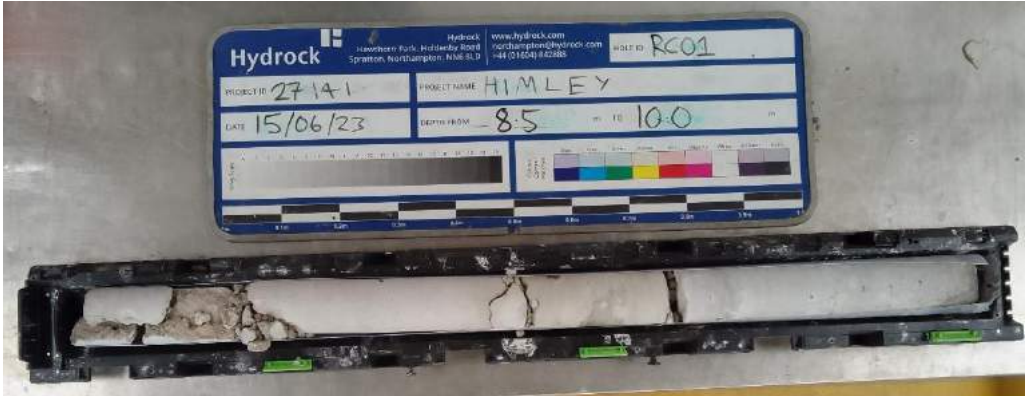
Description: RC01
8.50m to 10.00m
showing Forest
Marble Formation.

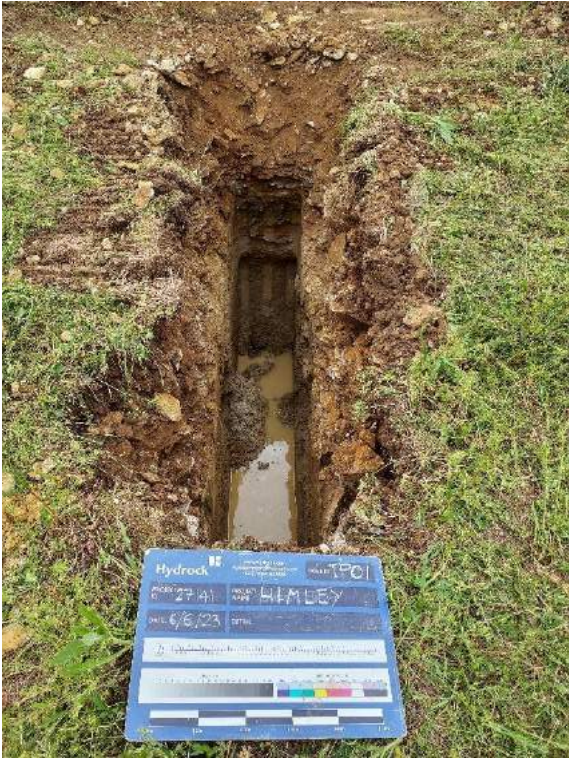
<p>Site Investigation Photograph 13</p>
<p>Date: 06/06/2023</p>
<p>Direction Photograph Taken: North.</p>
<p>Description: TP01 showing Topsoil over Cornbrash Formation.</p>

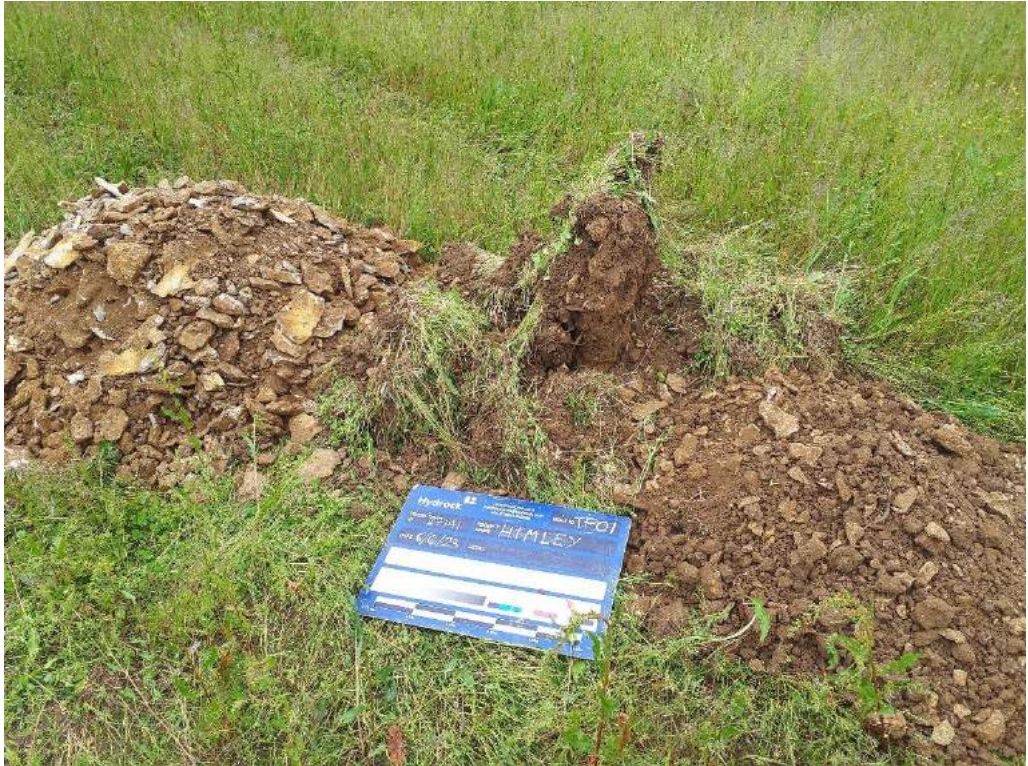
<p>Site Investigation Photograph 14</p>
<p>Date: 06/06/2023</p>
<p>Direction Photograph Taken: North.</p>
<p>Description: Spoil from TP01 showing Topsoil and Cornbrash Formation.</p>

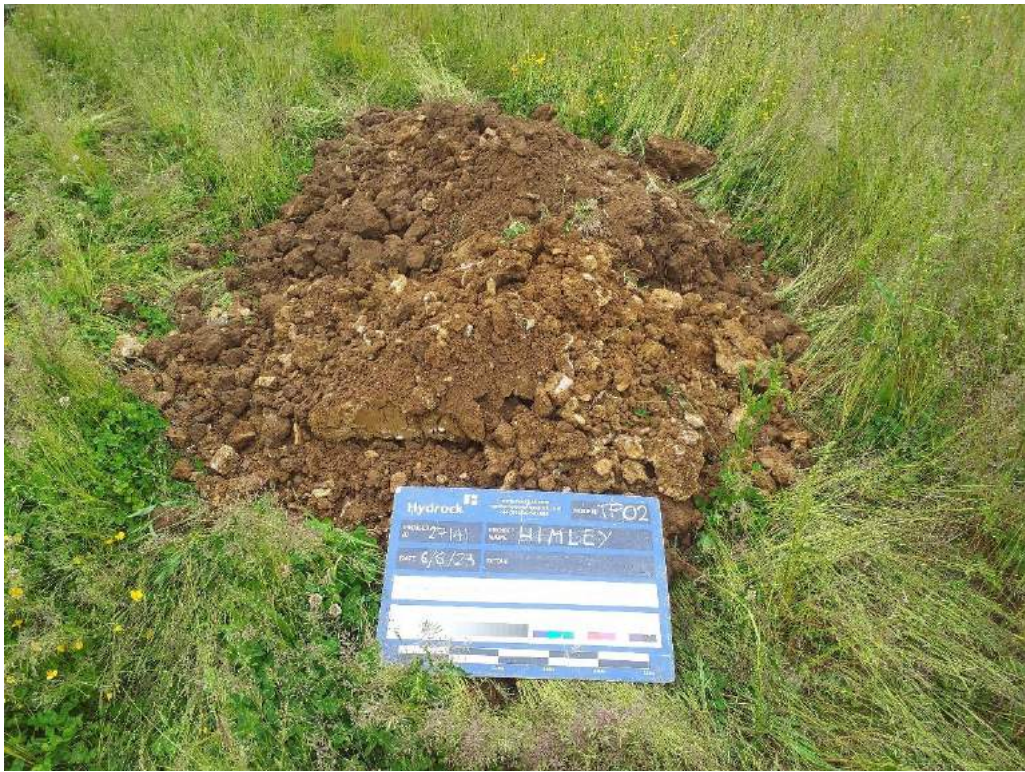
<p>Site Investigation Photograph 17</p>
<p>Date: 06/06/2023</p>
<p>Direction Photograph Taken: East.</p>
<p>Description: Spoil from TP02 showing Made Ground, Head Deposits and Cornbrash Formation.</p>

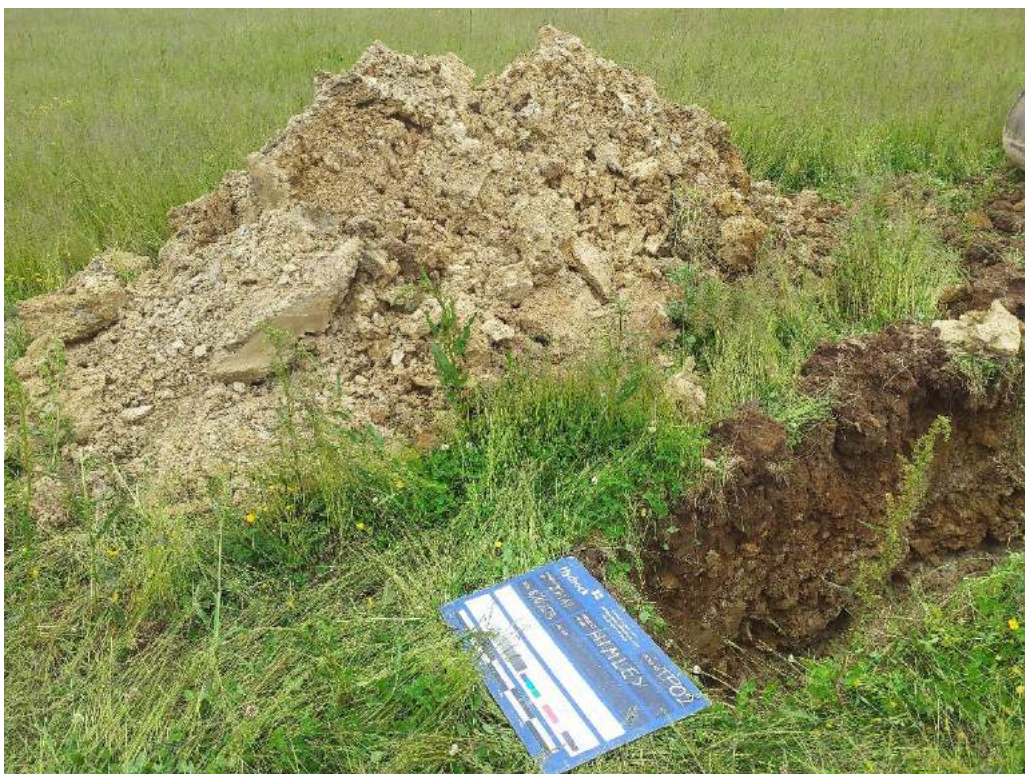
<p>Site Investigation Photograph 18</p>
<p>Date: 06/06/2023</p>
<p>Direction Photograph Taken: West.</p>
<p>Description: Spoil from TP02 showing Cornbrash Formation and Forest Marble Formation.</p>

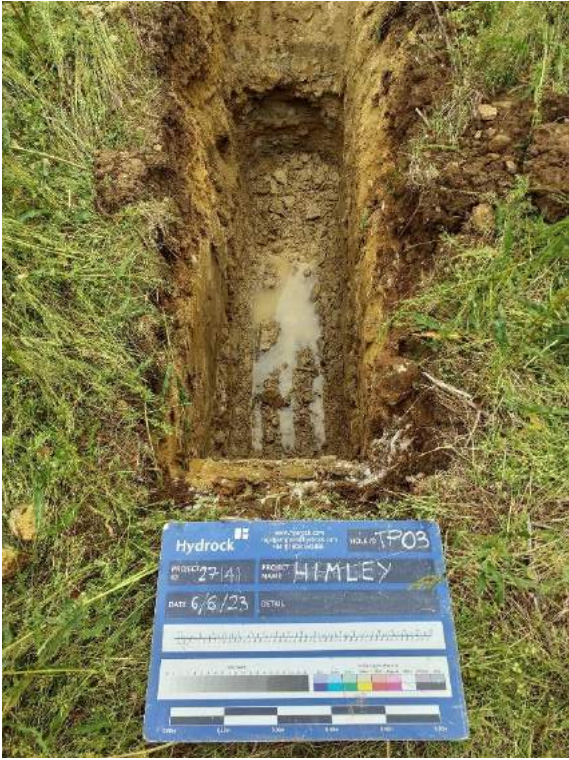
<p>Site Investigation Photograph 19</p>
<p>Date: 06/06/2023</p>
<p>Direction Photograph Taken: North.</p>
<p>Description: TP03 showing Topsoil over Head Deposits over Cornbrash Formation.</p>

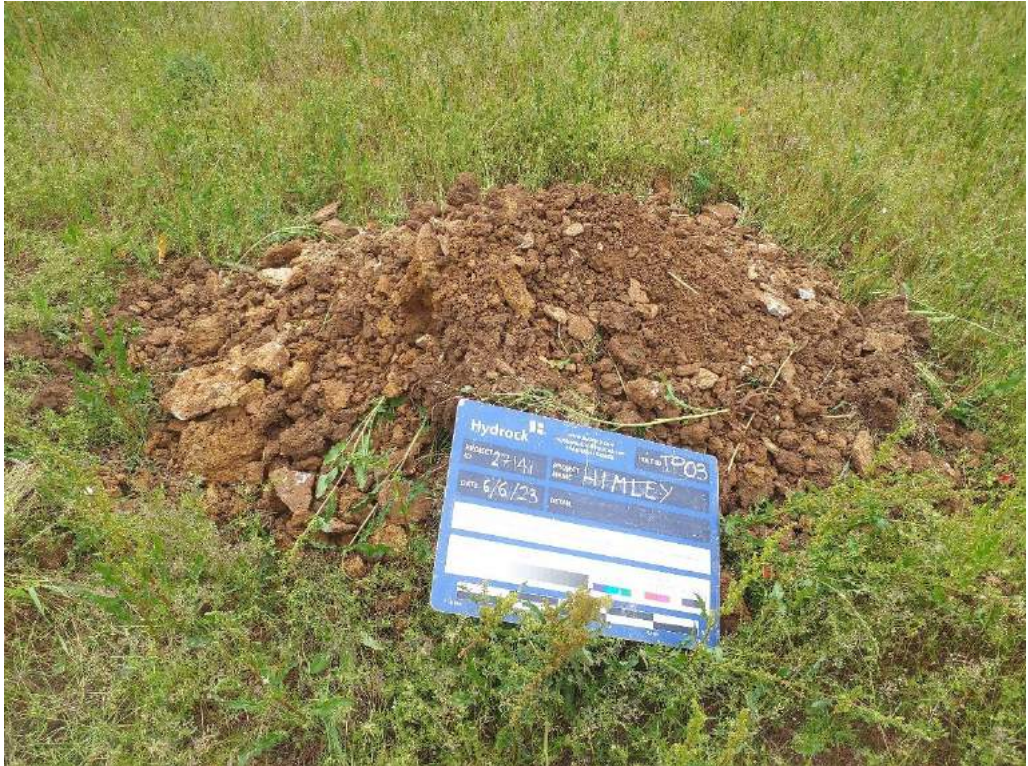
<p>Site Investigation Photograph 20</p>
<p>Date: 06/06/2023</p>
<p>Direction Photograph Taken: East.</p>
<p>Description: Spoil from TP03 showing Topsoil, Head Deposits and Cornbrash Formation.</p>

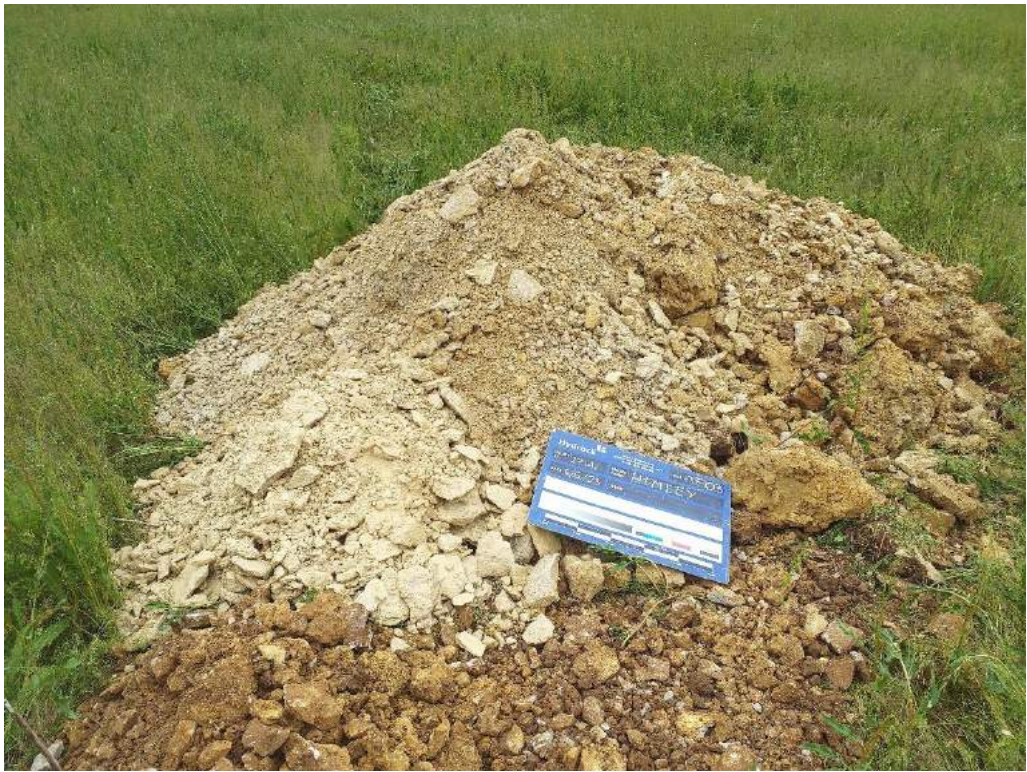
<p>Site Investigation Photograph 21</p>
<p>Date: 06/06/2023</p>
<p>Direction Photograph Taken: West.</p>
<p>Description: Spoil from TP03 showing Topsoil, Head Deposits and Cornbrash Formation.</p>

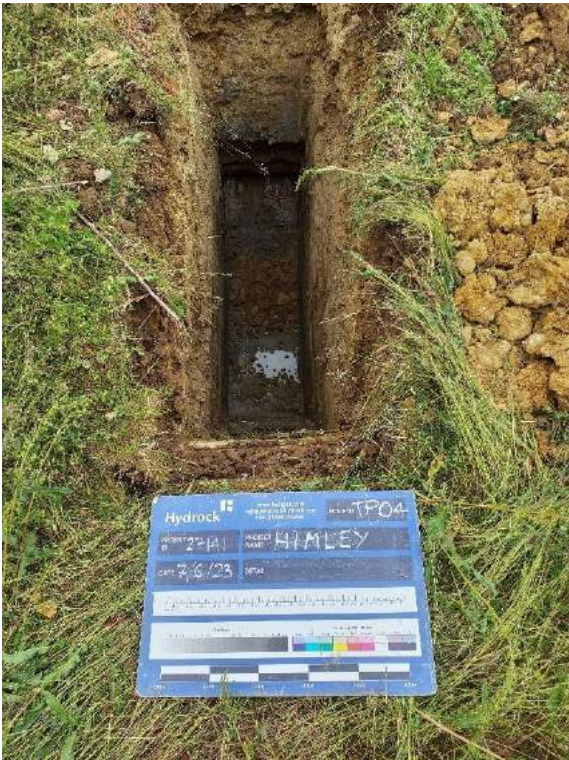
<p>Site Investigation Photograph 22</p>
<p>Date: 07/06/2023</p>
<p>Direction Photograph Taken: North.</p>
<p>Description: TP04 showing Made Ground over Head Deposits over Cornbrash Formation over Forest Marble Formation.</p>

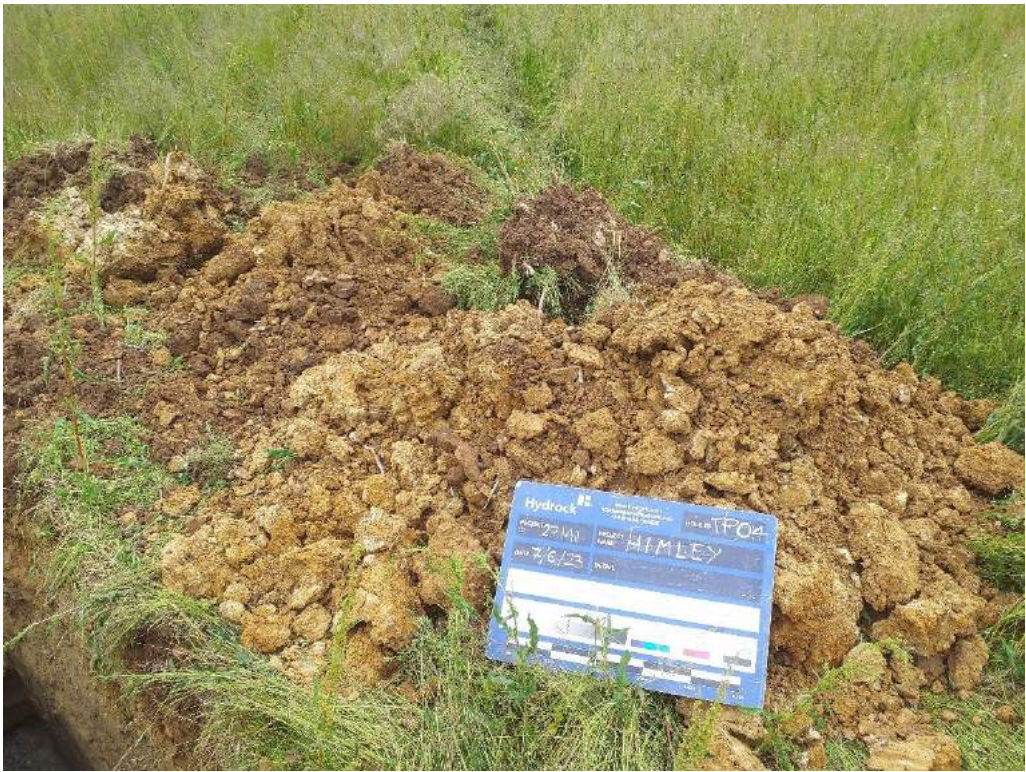
<p>Site Investigation Photograph 23</p>
<p>Date: 07/06/2023</p>
<p>Direction Photograph Taken: East.</p>
<p>Description: Spoil from TP04 showing Topsoil, Head Deposits and Cornbrash Formation.</p>

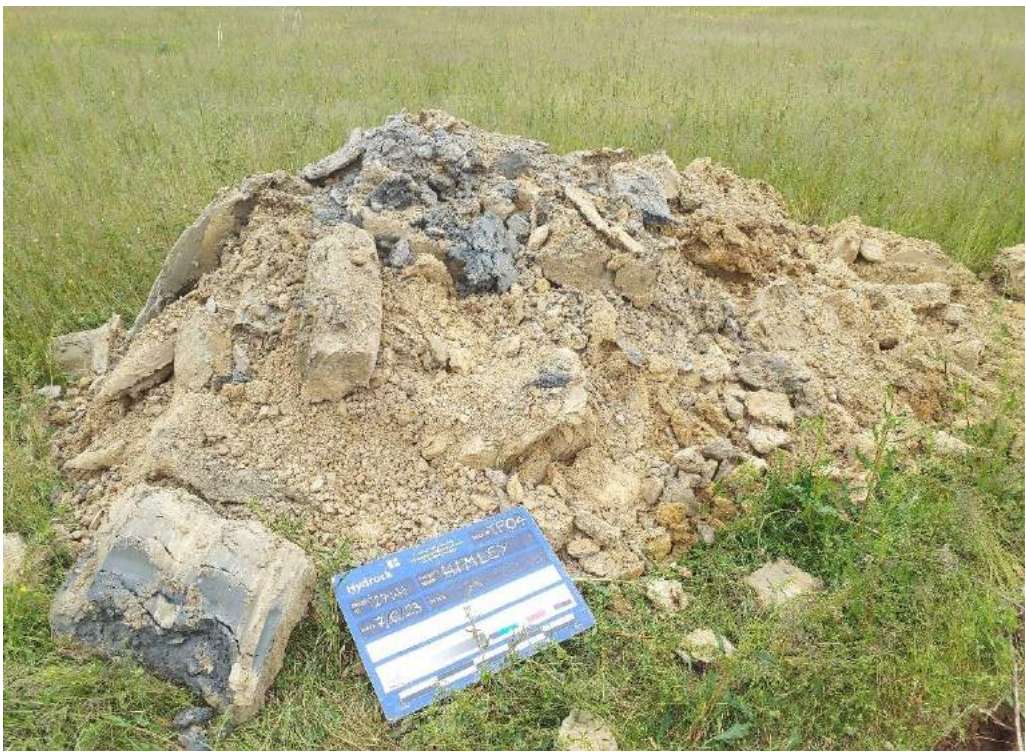
<p>Site Investigation Photograph 24</p>
<p>Date: 07/06/2023</p>
<p>Direction Photograph Taken: West.</p>
<p>Description: Spoil from TP04 showing Cornbrash Formation and Forest Marble Formation.</p>

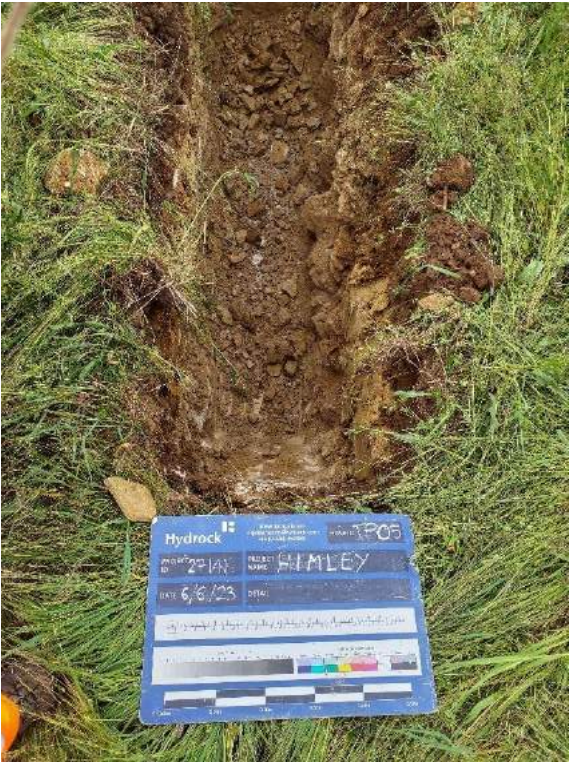
Site Investigation Photograph 25
Date: 06/06/2023
Direction Photograph Taken: North.
Description: TP05 showing Topsoil over Cornbrash Formation.

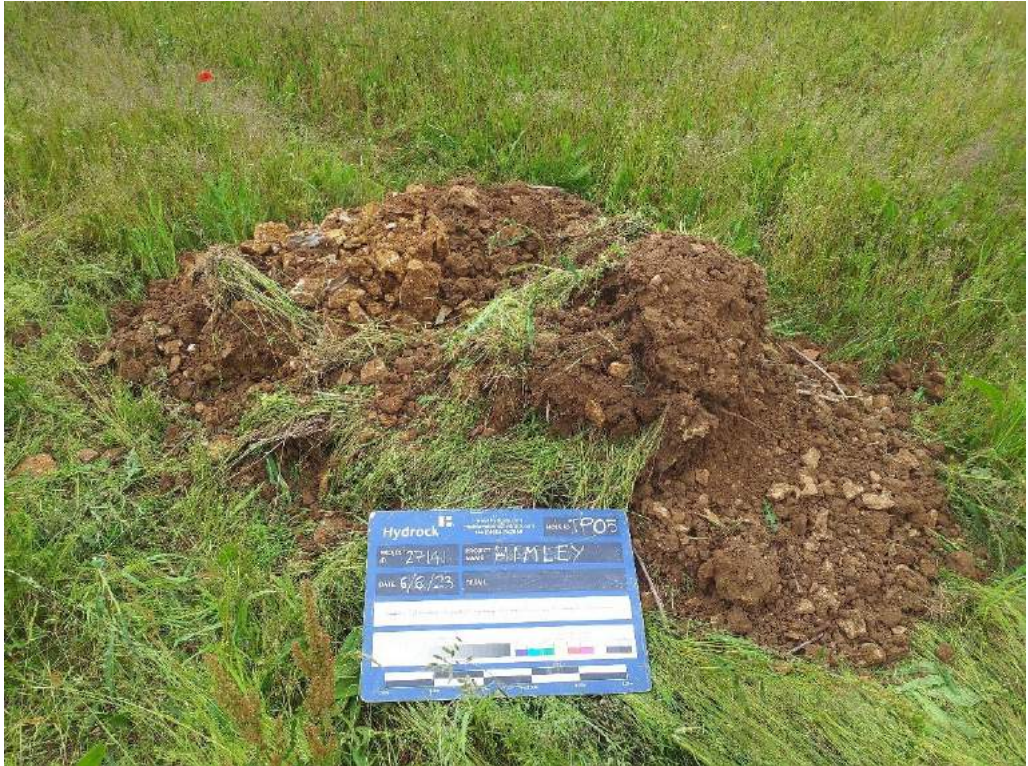
Site Investigation Photograph 26
Date: 06/06/2023
Direction Photograph Taken: East.
Description: Spoil from TP05 showing Topsoil and Cornbrash Formation.

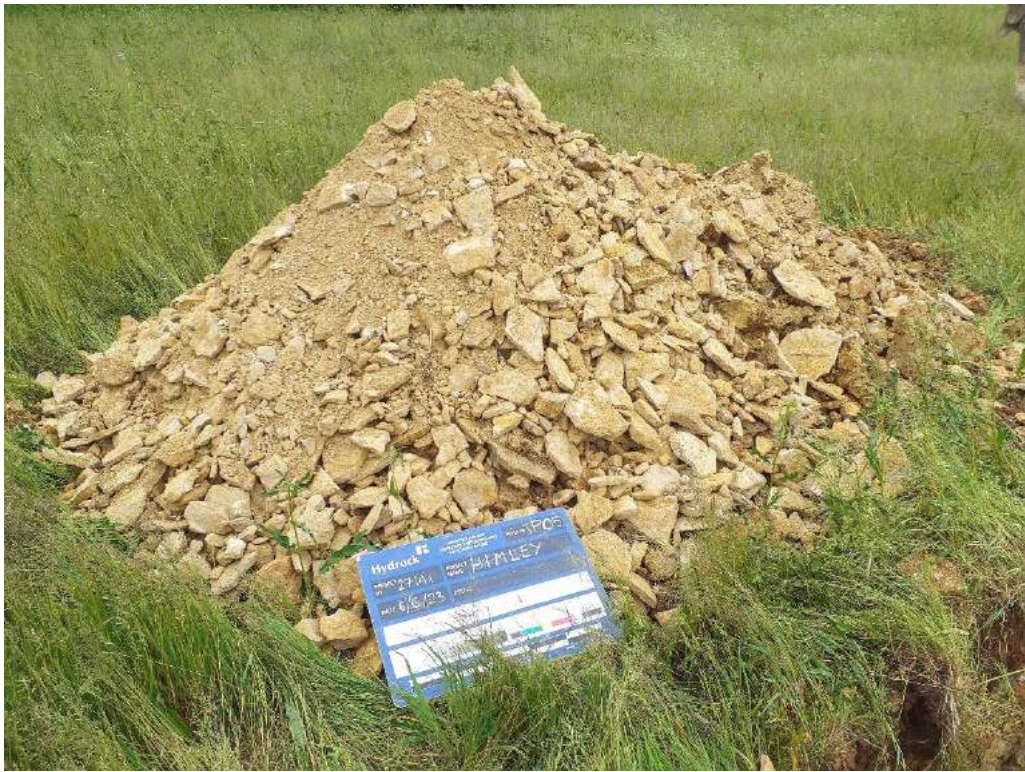
<p>Site Investigation Photograph 27</p>
<p>Date: 06/06/2023</p>
<p>Direction Photograph Taken: West.</p>
<p>Description: Spoil from TP05 showing Cornbrash Formation.</p>

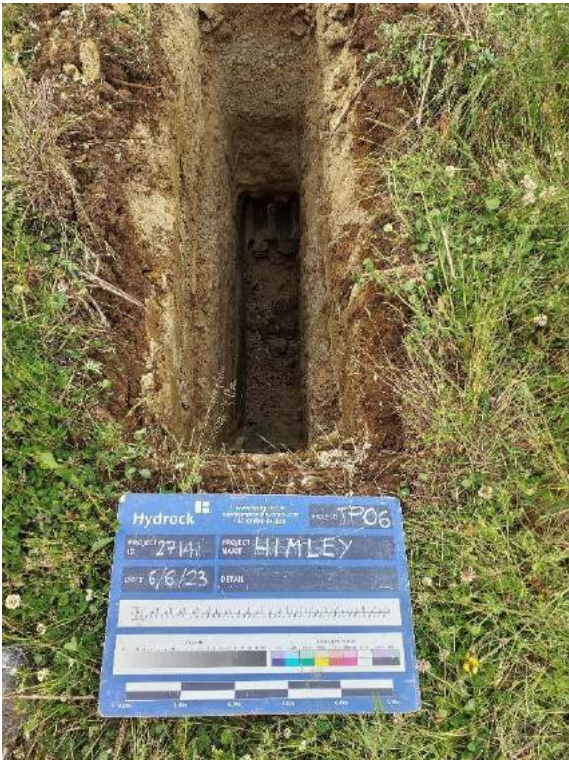
<p>Site Investigation Photograph 28</p>
<p>Date: 06/06/2023</p>
<p>Direction Photograph Taken: North.</p>
<p>Description: TP06 showing Made Ground over Cornbrash Formation over Forest Marble Formation.</p>

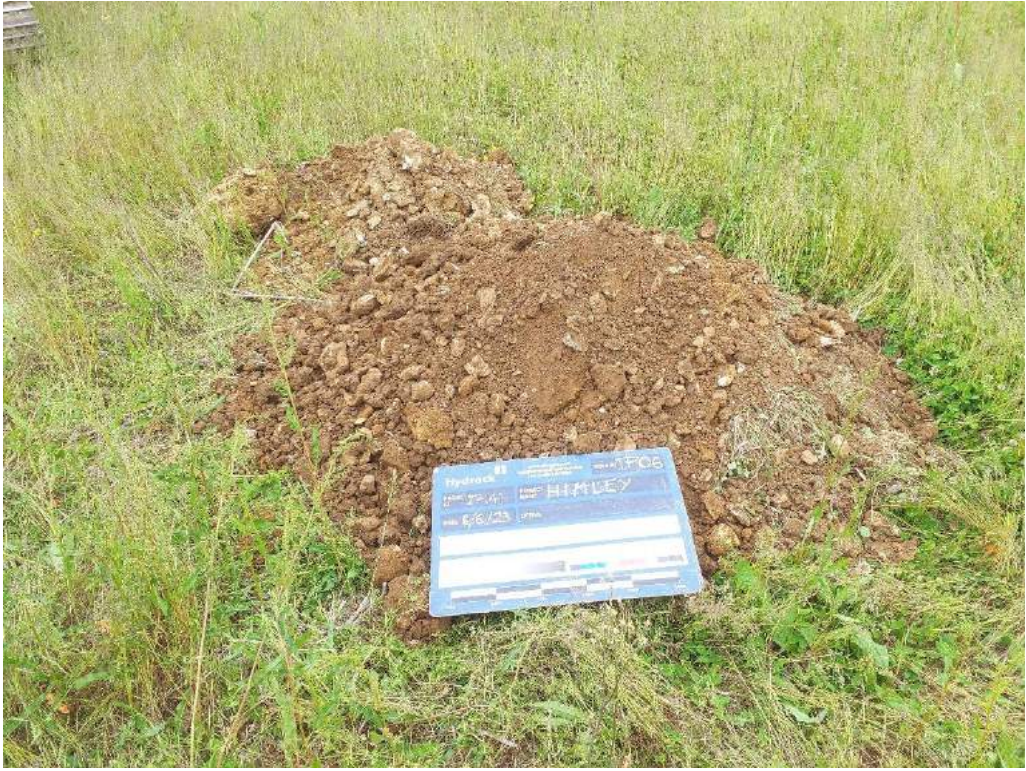
<p>Site Investigation Photograph 29</p>
<p>Date: 06/06/2023</p>
<p>Direction Photograph Taken: East.</p>
<p>Description: Spoil from TP06 showing Made Ground and Cornbrash Formation.</p>

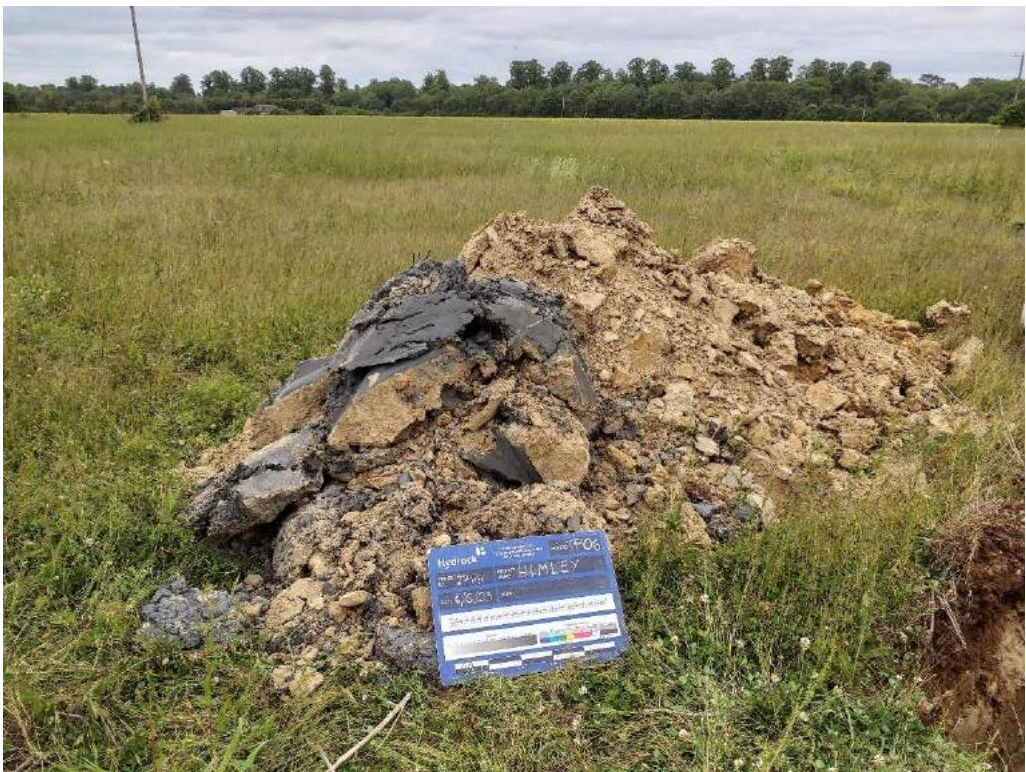
<p>Site Investigation Photograph 30</p>
<p>Date: 06/06/2023</p>
<p>Direction Photograph Taken: West.</p>
<p>Description: Spoil from TP06 showing Made Ground and Cornbrash Formation.</p>

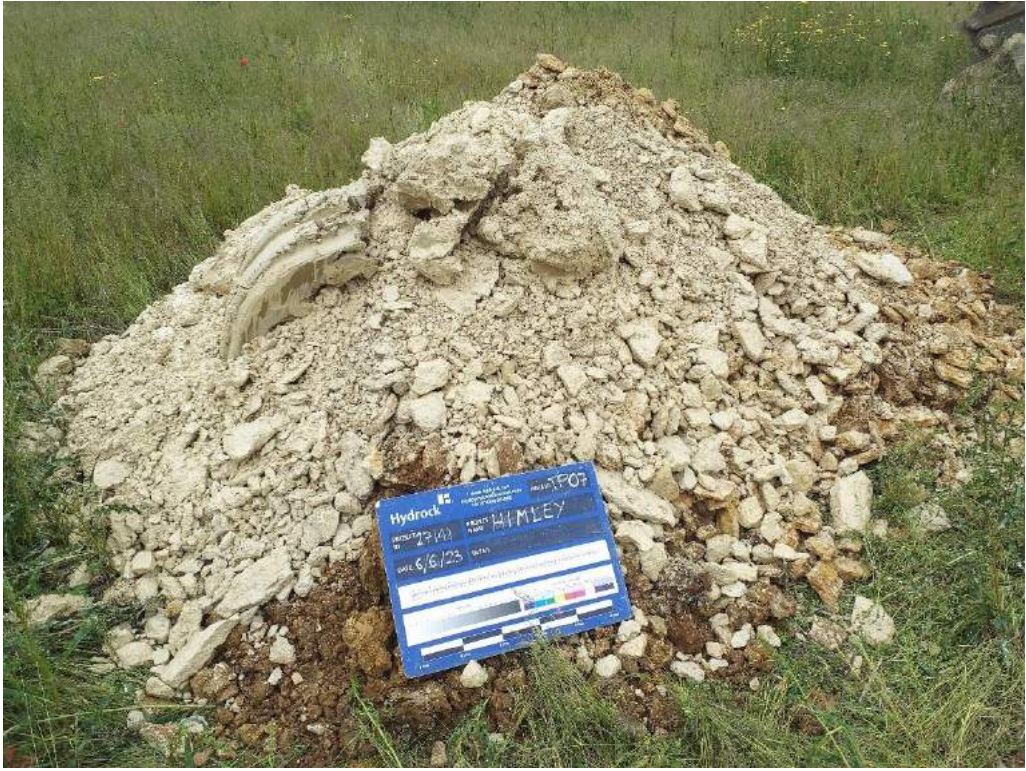
Description: Spoil from TP07 showing Made Ground, Head Deposits, Cornbrash Formation and Forest Marble Formation.

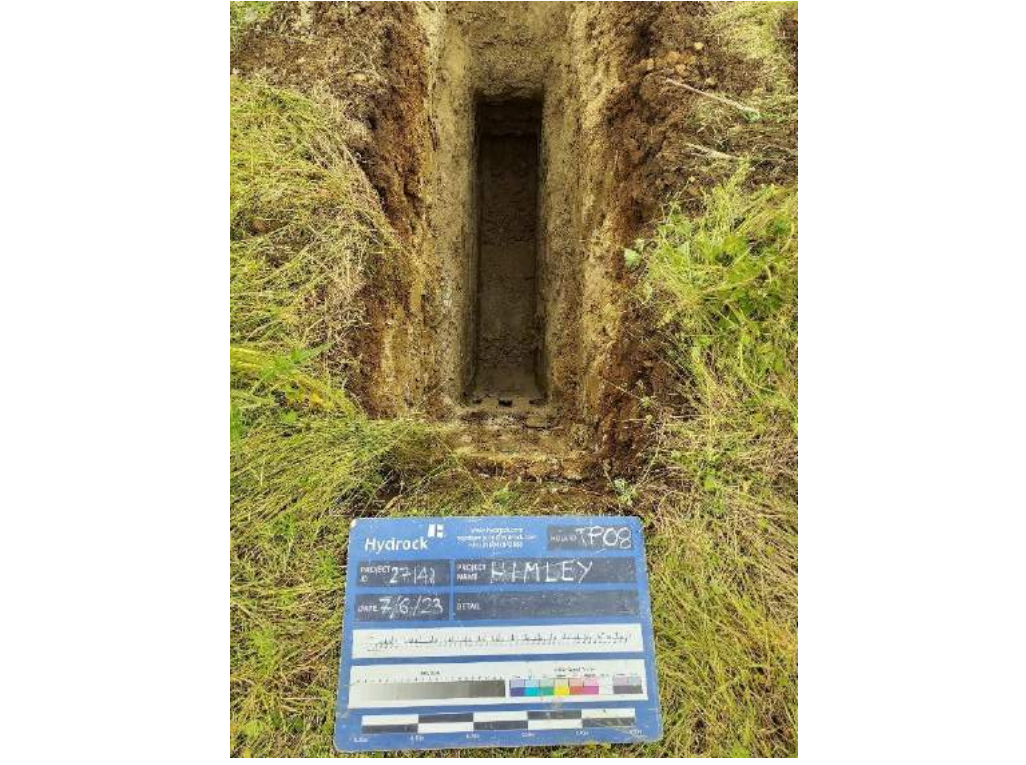
Site Investigation Photograph 34

Description: TP08 showing Made Ground over Head Deposits over Cornbrash Formation over Forest Marble Formation.

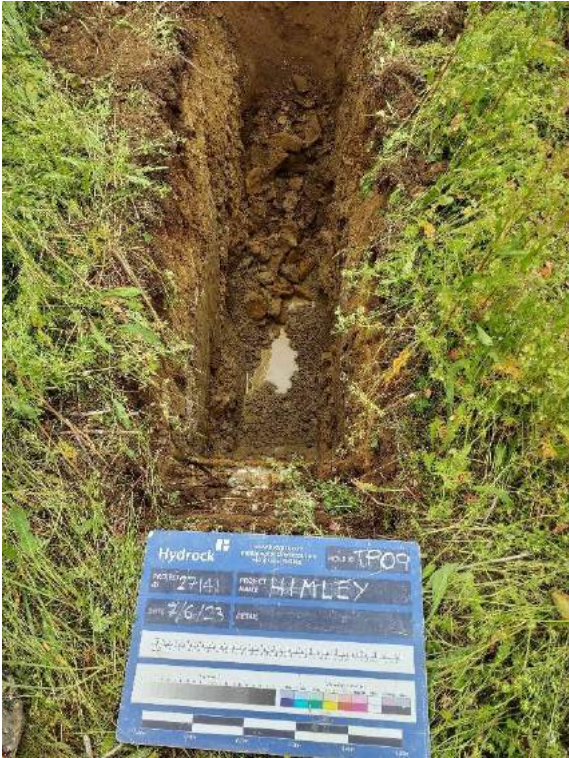
<p>Site Investigation Photograph 37</p>

<p>Date: 07/06/2023</p>	
<p>Direction Photograph Taken: North.</p>	
<p>Description: TP09 showing Topsoil over Head Deposits over Cornbrash Formation.</p>

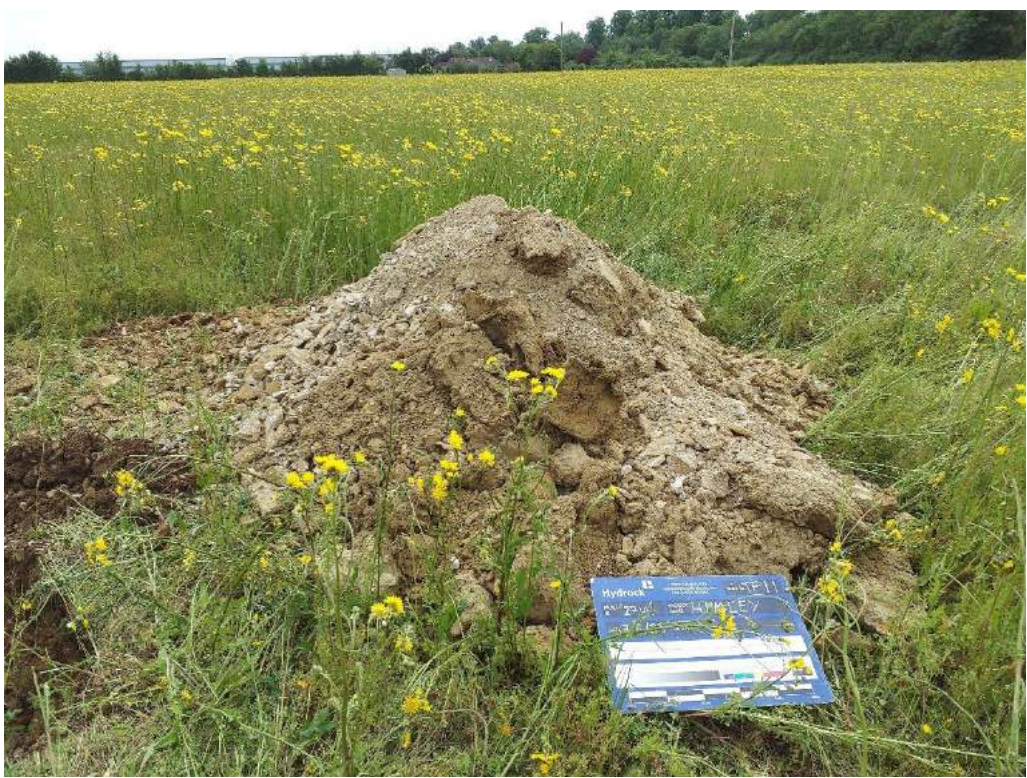
<p>Site Investigation Photograph 45</p>
<p>Date: 07/06/2023</p>
<p>Direction Photograph Taken: West.</p>
<p>Description: Spoil from TP11 showing Cornbrash Formation.</p>
