Himley Village, Bicester

Ground Investigation Report

Date: 21 July 2023

Doc ref: 27141-HYD-XX-XX-RP-GE-1002-S0-P01

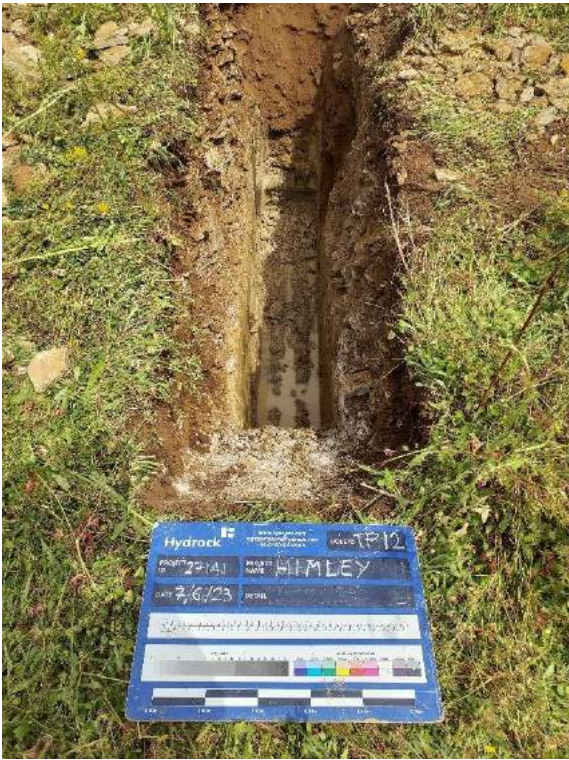
<p>Site Investigation Photograph 46</p>
<p>Date: 07/06/2023</p>
<p>Direction Photograph Taken: North.</p>
<p>Description: TP12 showing Topsoil over Head Deposits over Cornbrash Formation.</p>

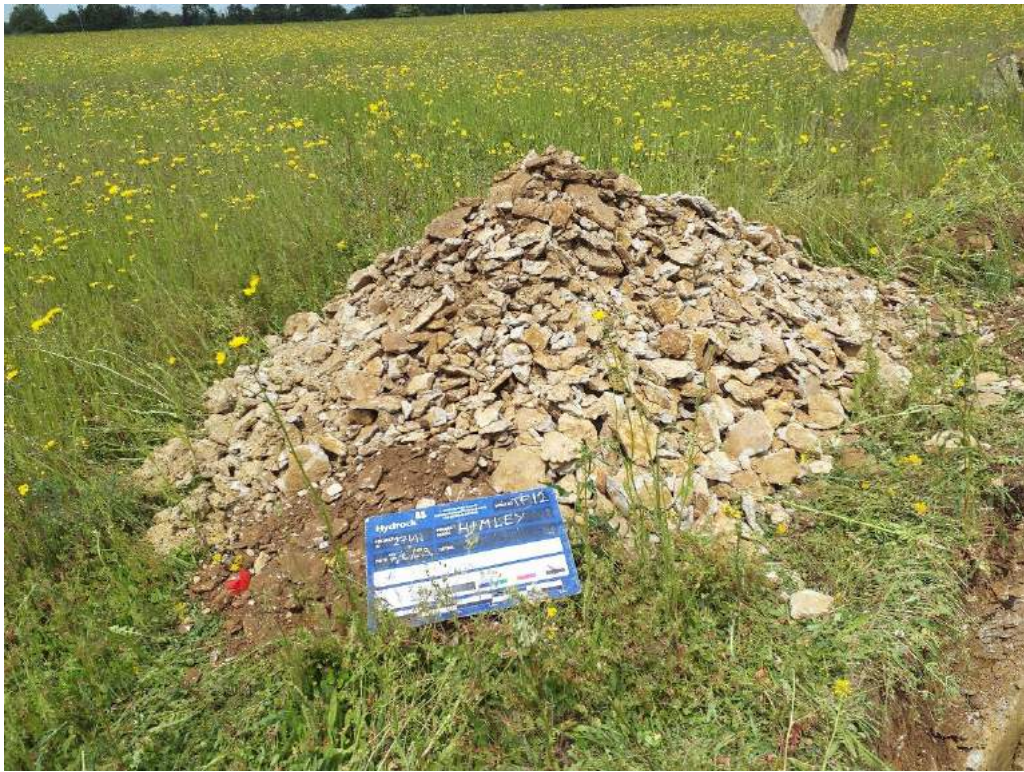
<p>Site Investigation Photograph 47</p>
<p>Date: 07/06/2023</p>
<p>Direction Photograph Taken: East.</p>
<p>Description: Spoil from TP12 showing Topsoil, Head Deposits, Cornbrash Formation.</p>

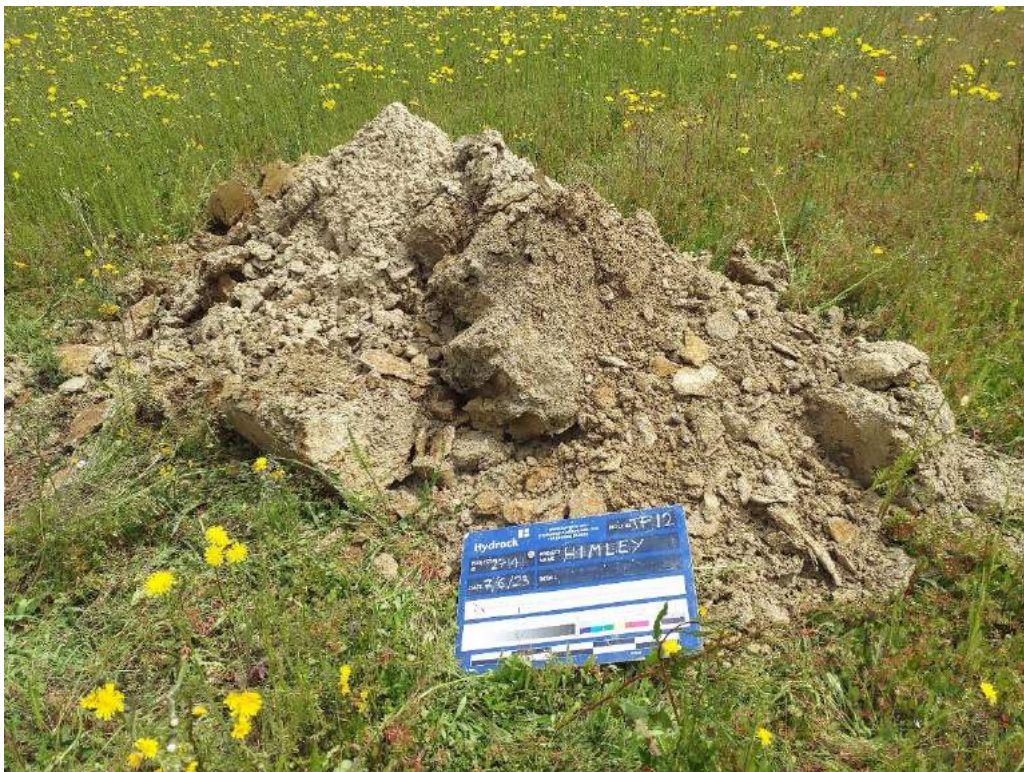
<p>Site Investigation Photograph 48</p>
<p>Date: 07/06/2023</p>
<p>Direction Photograph Taken: West.</p>
<p>Description: Spoil from TP12 showing Cornbrash Formation.</p>

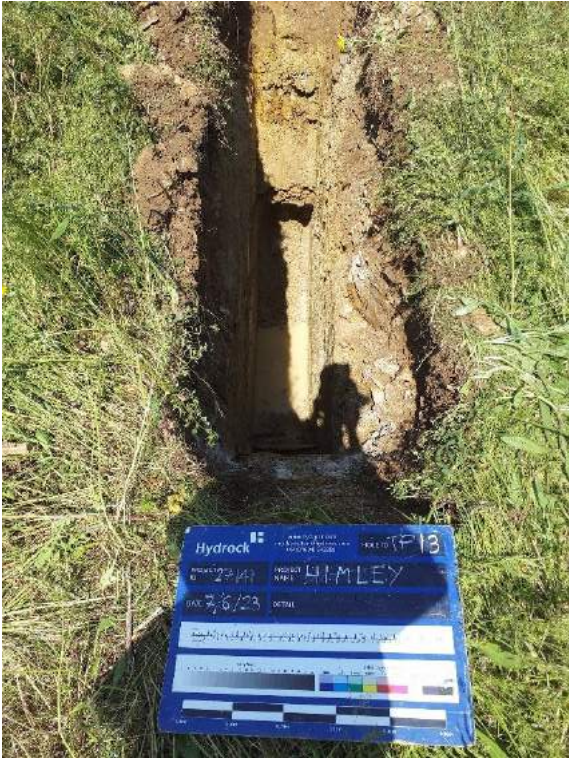
Site Investigation Photograph 49
Date: 07/06/2023
Direction Photograph Taken: North.
Description: TP13 showing Topsoil over Head Deposits over Cornbrash Formation.
