# **Wendlebury Road, Bicester**

Road Safety Audit  
Stage 1

10 March 2020

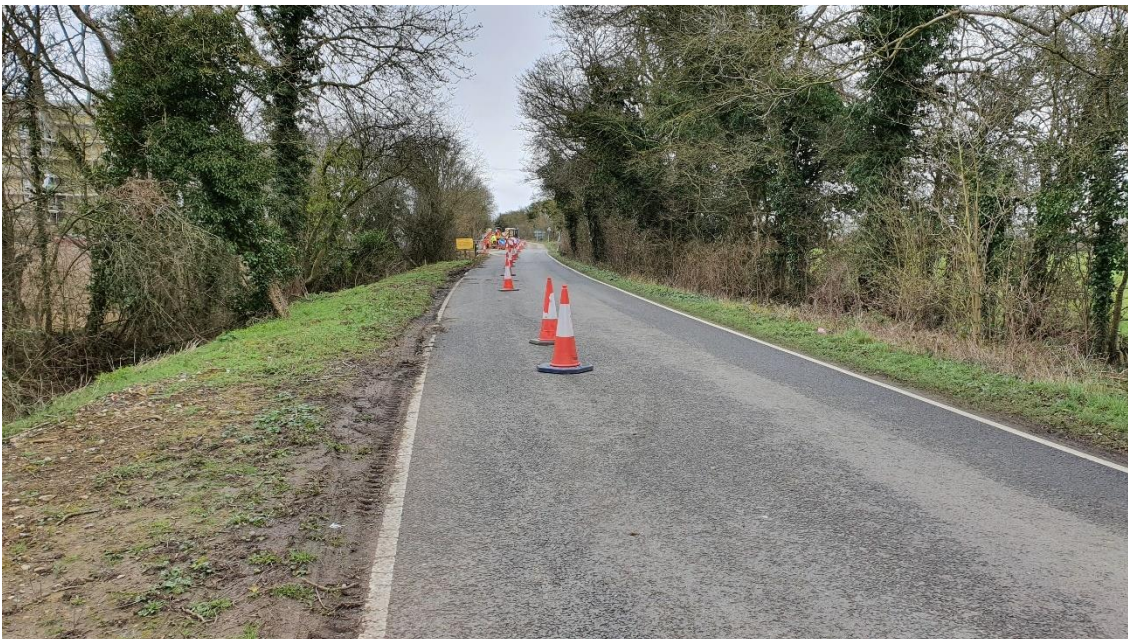
**Figure 1: Existing ditch on western side of Wendlebury Road.**

*Location: Throughout scheme.*

*Summary: Drop at back of footway may present a hazard to pedestrians.*

A new 3.0m footway / cycleway is proposed along the eastern side of Wendlebury Road, and a new 3.0m cycleway on the western side, south of the proposed roundabout. There is an overgrown ditch running the length of the eastern side of Wendlebury Road throughout the scheme, with a noticeable level difference from the carriageway level to the bottom of the ditch; this is also the case along the western side of carriageway, south of the proposed roundabout. Provision of footway / cycleways at these locations will result in drop at the back of the footway / cycleways, which may present a hazard to pedestrians or cyclists should they leave the paved surface. This may result in falls resulting in personal injury.

It is recommended that a fence or guardrail of suitable height is provided at the back of the footway wherever a drop to surrounding surface levels is present. Alternatively, ground at the edge of the footway/cycleway should be graded to avoid a steep drop.

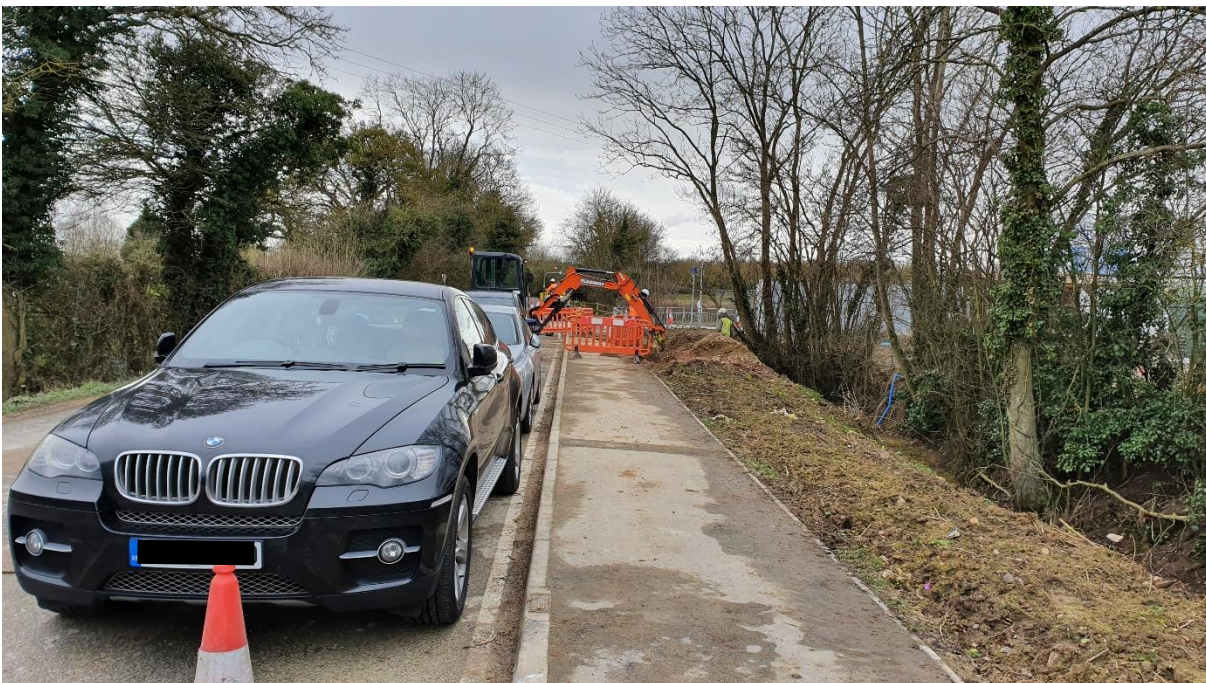
**Figure 2: Existing footway / cycleway (to become footway only) on western side of Wendlebury Road.**

*Location: Western side of proposed roundabout.*

*Summary: Unaccommodated pedestrian desire line may result in trips and falls.*

A new 3.0m cycleway is to be provided on the south-western side of the new roundabout to allow northbound cyclists to move between the Wendlebury Road carriageway and the new footway / cycleway along the eastern side via an uncontrolled crossing point across the southern arm of the roundabout. An existing footway is present on the northern side of the A41 link road and a footway / cycleway along the western side of Wendlebury Road north of the proposed roundabout that will become footway only. Pedestrians using or intending to use these facilities may attempt to cross the western arm of the roundabout away from any formal crossing facilities increasing the likelihood to trips and falls due to crossing a full height kerb or travelling over unmade ground.

It is recommended that a pedestrian crossing is provided across the western arm of the roundabout. Alternatively, appropriate landscaping and / or street furniture could be installed between the new cycleway south of the roundabout and the roundabout to deter pedestrians.

Clear cyclist directional signing should be provided to indicate the route via the southern crossing and eastern footway / cycleway.

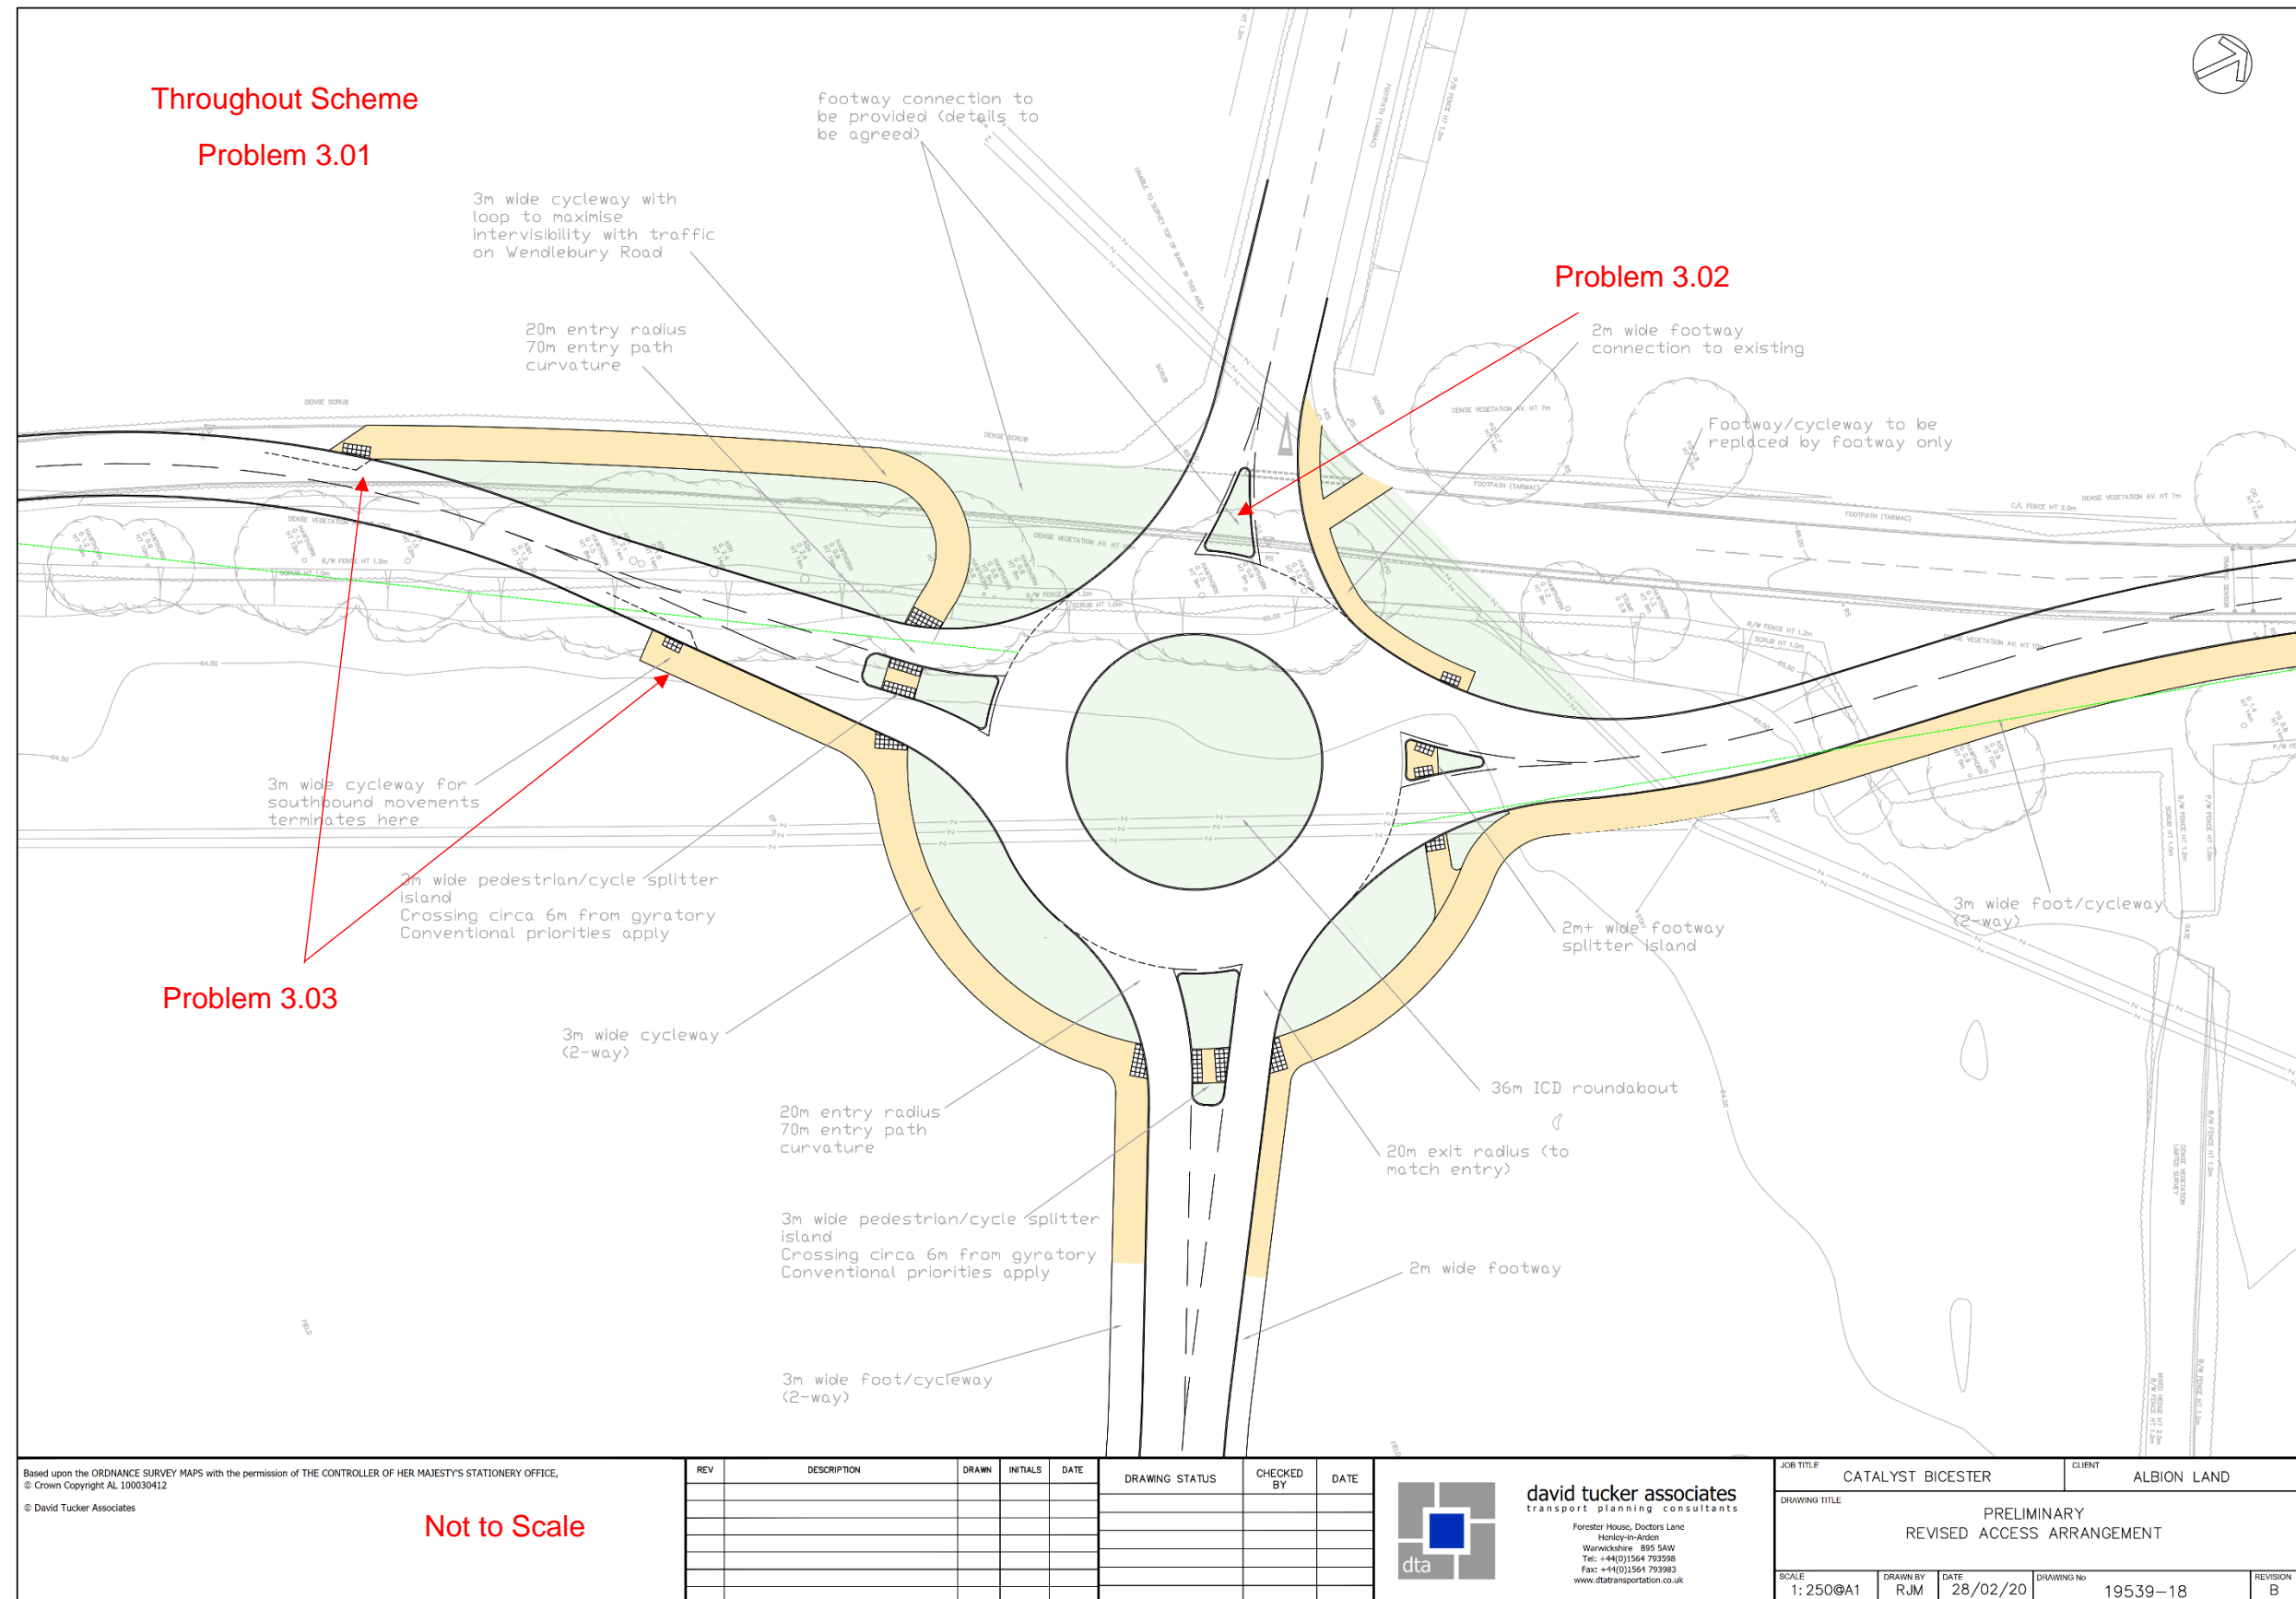
## B. Location Plan – Wendlebury Road, Bicester

A Key Plan indicating the location of any identified safety related issues is provided in **Appendix B**.

This section describes road safety related issues identified by the Audit Team associated with the scheme as presented in **Appendix A**. A reference key plan is shown in **Appendix B**.
