# **Calthorpe Street, Banbury**

Preliminary Risk Assessment

1922759-R01-00

**Title:** Preliminary Risk Assessment: Calthorpe Street, Banbury, OX16 5EX

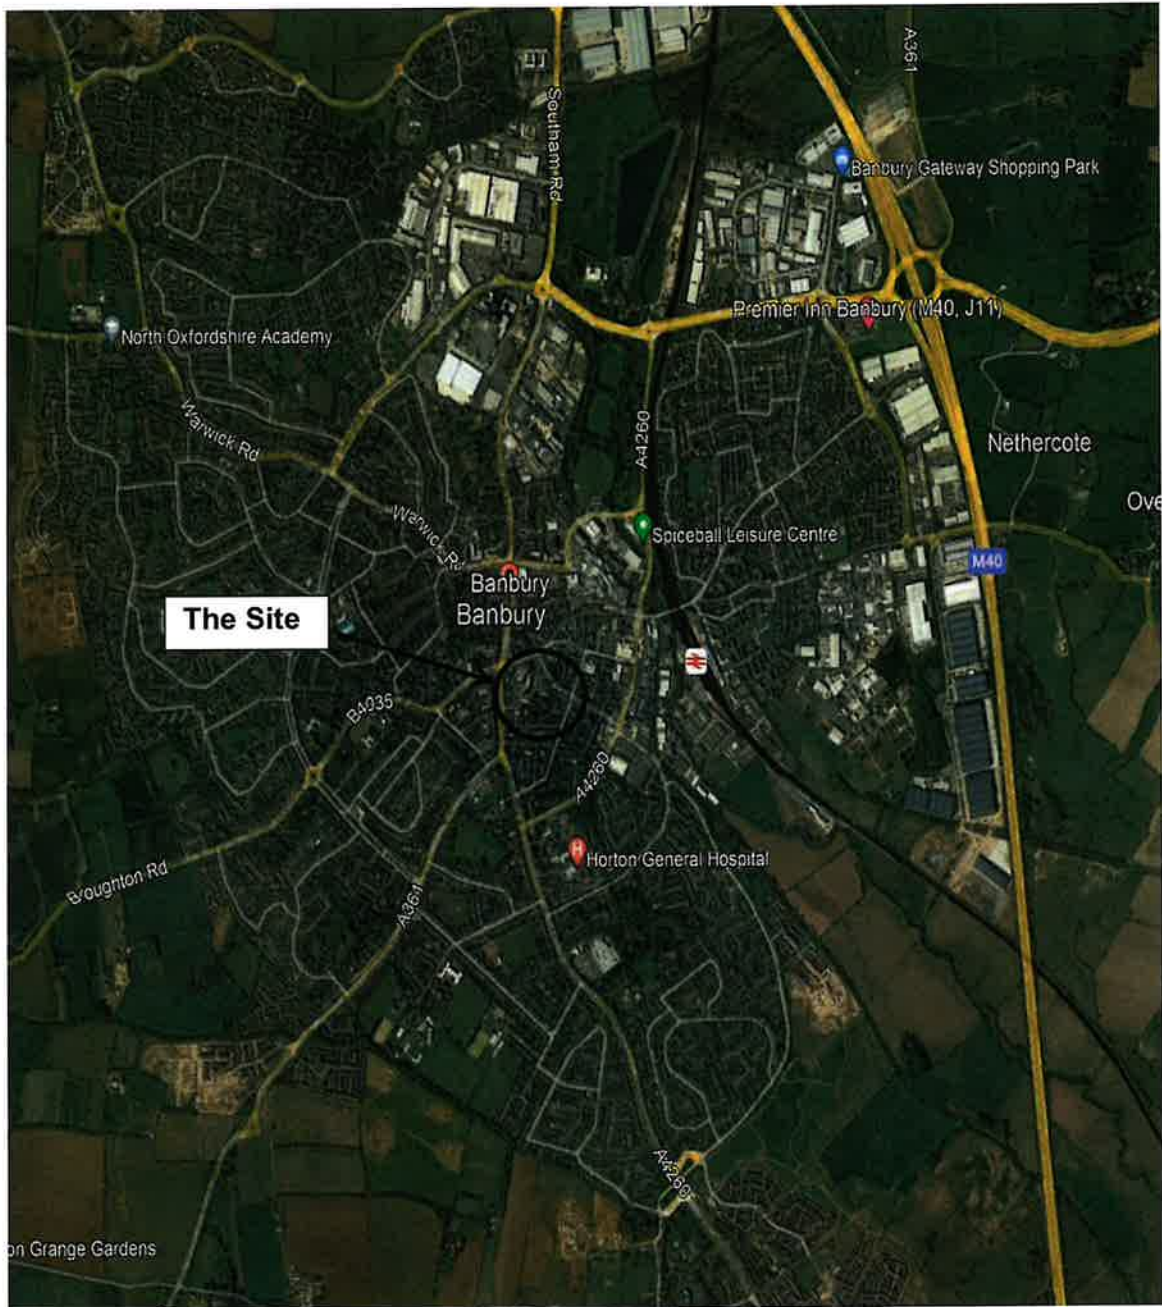
**FIGURE 1 SITE LOCATION PLAN**

<b>SITE LOCATION PLAN</b>	<b>Client: TR17 Banbury LLP</b>	<b>Figure: 1</b>
		<b>Site: Calthorpe Street, Banb</b>	<b>Report ref: 1922759</b>
		<b>Scale: NTS</b>
