**OXFORD ARCHAEOLOGY GAZETTEER DATED SEPTEMBER
2005**

FORMER RAF UPPER HEYFORD

Gazetteer
September 2005

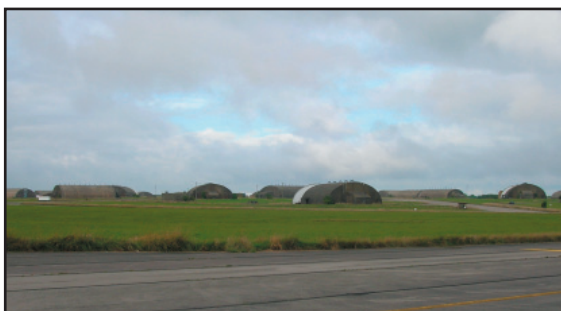
Gazetteer: OA1
Former RAF Upper Heyford

Setting and Context

The landscape setting and hardened concrete structures of former RAF Upper Heyford have the power to communicate the atmosphere of the Cold War. There is a very functional character to the airbase and this is particularly true of the airbase to the north of the runway which has greater coherence.

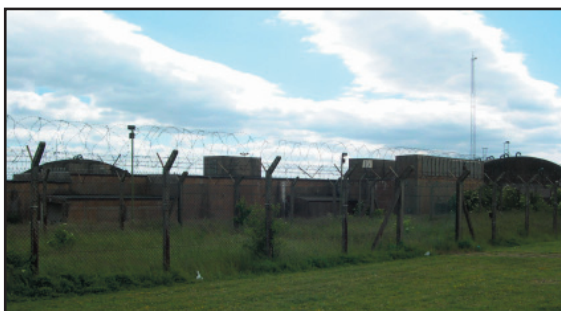
Gazetteer: OA2

The QRA area consists of nine HAS(s) used to house the F111E aircraft (**3001 - 3009**). The area is surrounded by a double fence with a running track around the perimeter. Entrance for personnel, vehicles, arms etc. was through the large turnstile gates outside the entry control point (ECP) **3100**. Aircraft would enter via the gates to the west.

The shelters were constructed by Laing, and have a simple concrete deflector to the rear. Each shelter was designed to house a single aircraft. The shelters are c.8.3m high, c.36.5m in length and c.24m wide (internal). Engines could be started inside the shelter to provide an instant response, and to the rear of the HAS is an efflux and generator room. The efflux door to the rear allows for exit of gases, and there are low-level vents and ten high level U-shaped vents to allow for movement of gases. Each HAS is constructed from corrugated galvanised steel anti-spall plates assembled in deep vertical corrugated arches for additional strength. The building was then covered with reinforced concrete. To the rear of the building is a concrete efflux tunnel and deflector. A bi-parting door leads to this tunnel.

Internally there is a reinforced concrete floor, overhead lights and two sliding efflux doors. Aircraft would enter the HAS(s) by a winch system. The sliding doors are constructed from reinforced concrete panels that are supported by steel girders. Each door weights approximately 85 tons. Weights were used to stabilise the structure as aircraft entered. The front entrance was operated by a 7.5 kilowatt motor from a control panel which has a joy stick for operating the door. The personnel entrance was through a blast-proof side door, just off the hardstanding area used for parking aircraft equipment.

These are as detailed in Section 5 of Volume 1, and sections 5.3, 5.4 and 5.6 are of particular relevance. Extant fixtures and fittings should be recorded in alignment with archaeological best practice and considered in a future management plan.

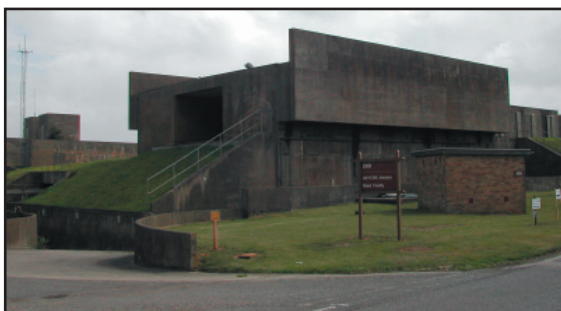
Gazetteer OA3
Former RAF Upper Heyford

299: a hardened concrete semi-sunken structure. Entry is via a blast door protected by a sunken, open walkway. There are two such blast doors. The building was designed to withstand conventional, chemical and biological attack, to maintain the F111E electronics and download and process reconnaissance data. The bunker houses a number of vast rooms mostly rectangular but one 'L' shaped.

- *Wall art*: environmental factors will result in deterioration of the internal wall art.
- *Water penetration*: this has been identified within building 299 and it is understood this is regularly pumped out.

These are as detailed in Section 5 of Volume 1 and sections 5.3, 5.4 and 5.6 are of particular relevance. The wall art should be recorded according to English Heritage guidelines.⁷ It is also important to ensure that the water is continued to be pumped out from the Avionics, or the problem rectified to prevent further deterioration. This issue should be considered in a future management plan.

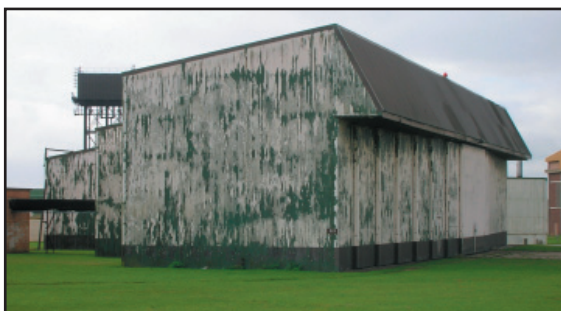
Gazetteer OA4
Former RAF Upper Heyford

There is a group of three well-preserved Nose Docking Sheds lying to the south of the site (**325, 327, 328**), and one further structure lying just to the north of this group (**335**). As the name suggests the structures were built to allow shelter for the front section of the aircraft and to make it possible to work on its nose and engines under cover.

The Nose Docking Sheds are constructed on ten aluminium girder wall frames supporting a cantilever roof framework, which support the main hanger doors (which are in 14 divisions). The innovative design with the long cantilever form was to create the opening needed to accommodate the aircraft deployed by SAC at this time. There is a close correspondence between the architectural form and the types of aircraft deployed at Upper Heyford during the 1950s, especially the B-50Ds, KB-29Ps, and later the B-47 Stratojet. Internally, the Nose Docks have a concrete floor.

- *Paint work*: building 335 is now painted a light blue.

These are as detailed in Section 5 of Volume 1, and sections 4.11, 4.12, 4.13 and 4.17 are of particular relevance. The future colour of the hangars should be considered in a management plan, which should determine which period is to be reflected by the paint scheme. Paint scrapes may be required to determine earlier paint schemes. This is particularly relevant for Nose Dock 335 which is now painted a light blue colour.

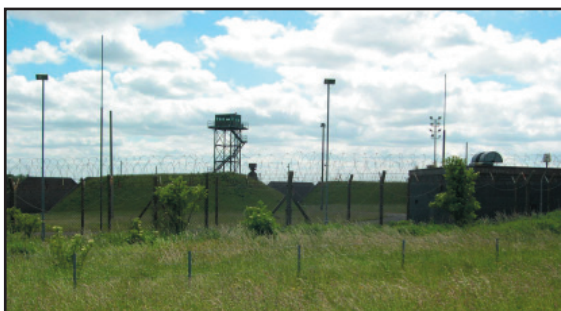
Gazetteer OA5
Former RAF Upper Heyford

The Northern Bomb Store and Special Weapons Area

- *Wall art:* environmental factors will result in deterioration of the external art.

- *Contamination*: an investigation was undertaken by Aspinwall & Company in 1997 on behalf of the North Oxfordshire Consortium. This found isolated occurrences of hydrocarbons within the bomb stores.

These are as detailed in Section 5 of Volume 1 and within this sections 5.4 and 5.6 are of particular relevance. The wall art should be conserved and recorded according to English Heritage guidelines¹². Contamination issues must be considered in the management plan.

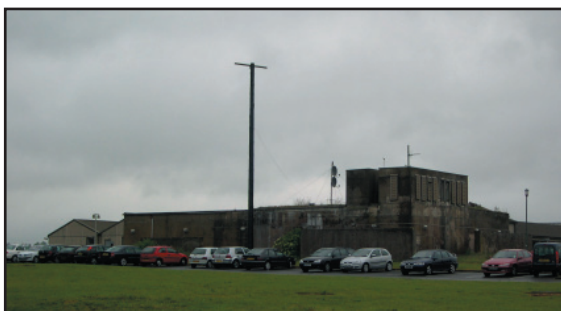
Gazetteer OA6

- *Wall art*: the art work within the Squadron building 370 is subject to deterioration
- *Preservation of extant fixtures and fittings*: building 234 in particular retains features that require protection/ recording. These add significantly to our understanding of the functional use of the structures.¹⁴

These are as detailed in Section 5 of Volume 1, and sections 5.4 and 5.6 are of particular relevance. The recording of the wall art should be to English Heritage guidelines¹⁵ and fixtures and fittings should be recorded in accordance with best archaeological practice and considered in a future management plan.

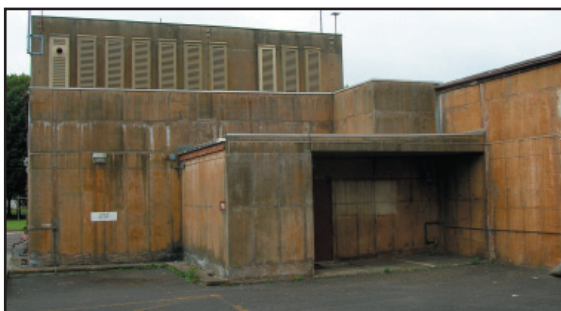
Gazetteer OA7

- *Preservation of extant fixtures and fittings*: those retained are in good condition, and greatly enhance our understanding of the function of this structure and the airbase.

These are as detailed in Section 5 of Volume 1, and sections 5.4 and 5.6 are of particular relevance. The fixtures and fittings should be recorded in alignment with archaeological best practice and considered in a future management plan.

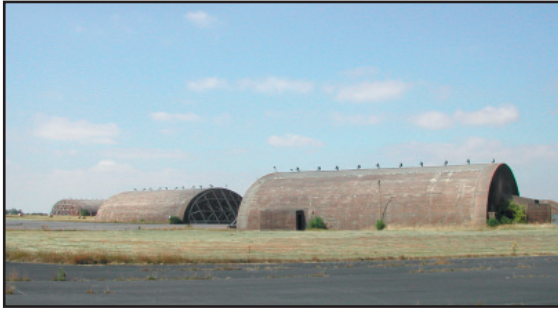
Gazetteer OA9
 Former RAF Upper Heyford

The 56 Hardened Aircraft Shelters (HAS) were each designed to house a single jet aircraft, in a secure blast proof environment. They are of **national** importance. Many replaced flimsy open weather shelters. The HAS(s) were built in accordance with NATO's policy in the late 1970 and typify contemporary NATO policy to harden its main facilities. They are organised roughly into groups between the four squadrons.

The majority of the shelters are 8.3m high, 36.5m in length and 21.5m wide (internal). Engines could be started inside the shelter to provide an instant response. To the rear of the HAS is an efflux and generator room. The efflux door to the rear allows for exit of gases. There are low level vents to allow for movement of gases. There are also 10 high-level u-shaped vents. HAS are constructed from corrugated galvanised steel anti-spall plates assembled in deep vertical corrugated arches for additional strength. The building is then covered with reinforced concrete. To the rear of the building is a concrete efflux tunnel and deflector. Internally, a sliding door (sometimes decorated with the painted emblem of the squadron) leads to this tunnel.

- *Wall art*: the artwork within the HASs is subject to deterioration.
- *Preservation of extant fixtures and fittings*: if possible the mechanical fixtures relating to the operation of the doors and vents should be retained, as these enhance our understanding of the structures.
- *Preservation of groups*: where possible, groups of HASs should be retained, as the repetitive pattern of the structures forms a distinctive characteristic of the Cold War landscape.

These are as detailed in Section 5 of Volume 1, and within these sections 5.4 and 5.6 are of particular relevance. The recording of the wall art should be according to English Heritage guidelines.²⁴ The internal fixtures and fittings should be recorded in alignment with archaeological best practice and considered in a future management plan.

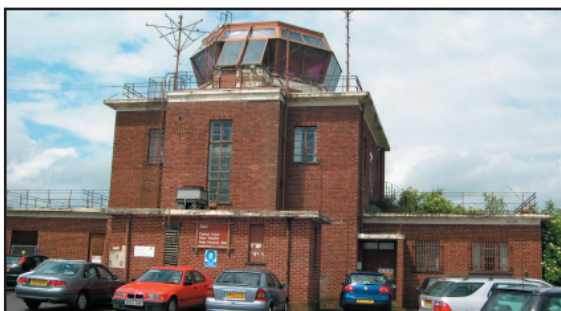
Gazetteer OA10
Former RAF Upper Heyford

Control Tower

- *External artwork*: this is subject to deterioration

These are as detailed in Section 5 of Volume 1 and within these sections 5.4 and 5.6 are of particular relevance. The artwork should be recorded according to English Heritage guidelines.²⁶

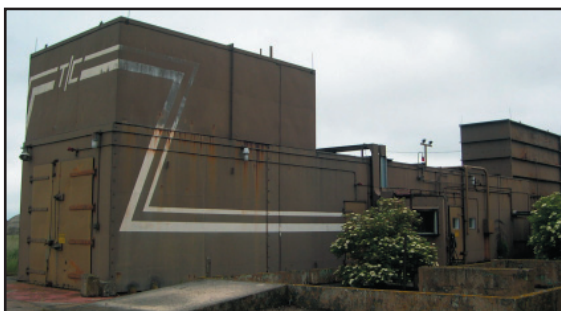
Gazetteer OA12

The second building is rectangular in plan, single-storey, red brick with a flat roof and tall crittall window. The front door has a sign stating 'Test Cell Break Area'. Internally, a concrete floor and walls are painted white with some wall art although no fixtures remain. The front elevation is a corrugated iron extension, with sections missing in the south east elevation.

The third building is the test cell, which is rectangular in plan, single-storey, metal-clad with main entrance via double doors at the front elevation. This once contained a water tank that generated an internal waterfall. The flame from the engine hit the cold water which caused steam and sound to be taken up an extractor. Elevations are painted brown with white 'jazzy' stripes to the front and partially to the side with "T/C" painted centrally above the double doorway. Internally walls are perforated mesh, painted white. There are two observation bays, one internal and one external with double glass for viewing. An exhaust detuner extends to the rear.

- *Long term stability:* building 1319 although structurally sound, and in reasonable condition appears to have been derelict for some time and the external paintwork is peeling.
- *Wall art:* this is subject to deterioration.
- *Fixtures and fittings:* these are important features subject to deterioration

These are as detailed in Section 5 of Volume 1, and within these sections 5.4 and 5.6 are of particular relevance. The artwork should be recorded according

to English Heritage guidelines.²⁷The fixtures and fittings should be recorded in alignment with archaeological best practice, and the long term stability of the building should be considered in a management plan.

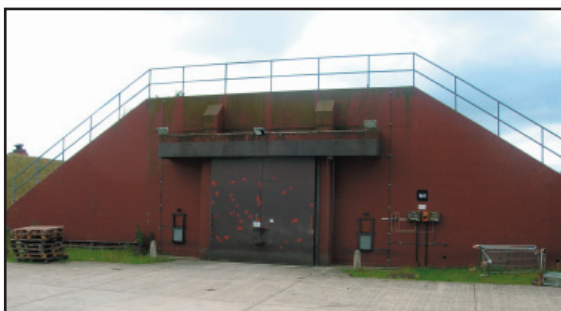
Gazetteer OA17
Former RAF Upper Heyford

The Southern Bomb Store

These are as detailed in Section 5 of Volume 1, and within this sections 5.4 and 5.6 are of particular relevance. Wall art should be recorded in accordance with English Heritage guidelines, and contamination issues should be considered in a future management plan.
