ACCIDENT AND INCIDENT REPORT FORM

Contract Title: UHCMS

Contract No:1246DOR

Site Address: HEYFORD PARK

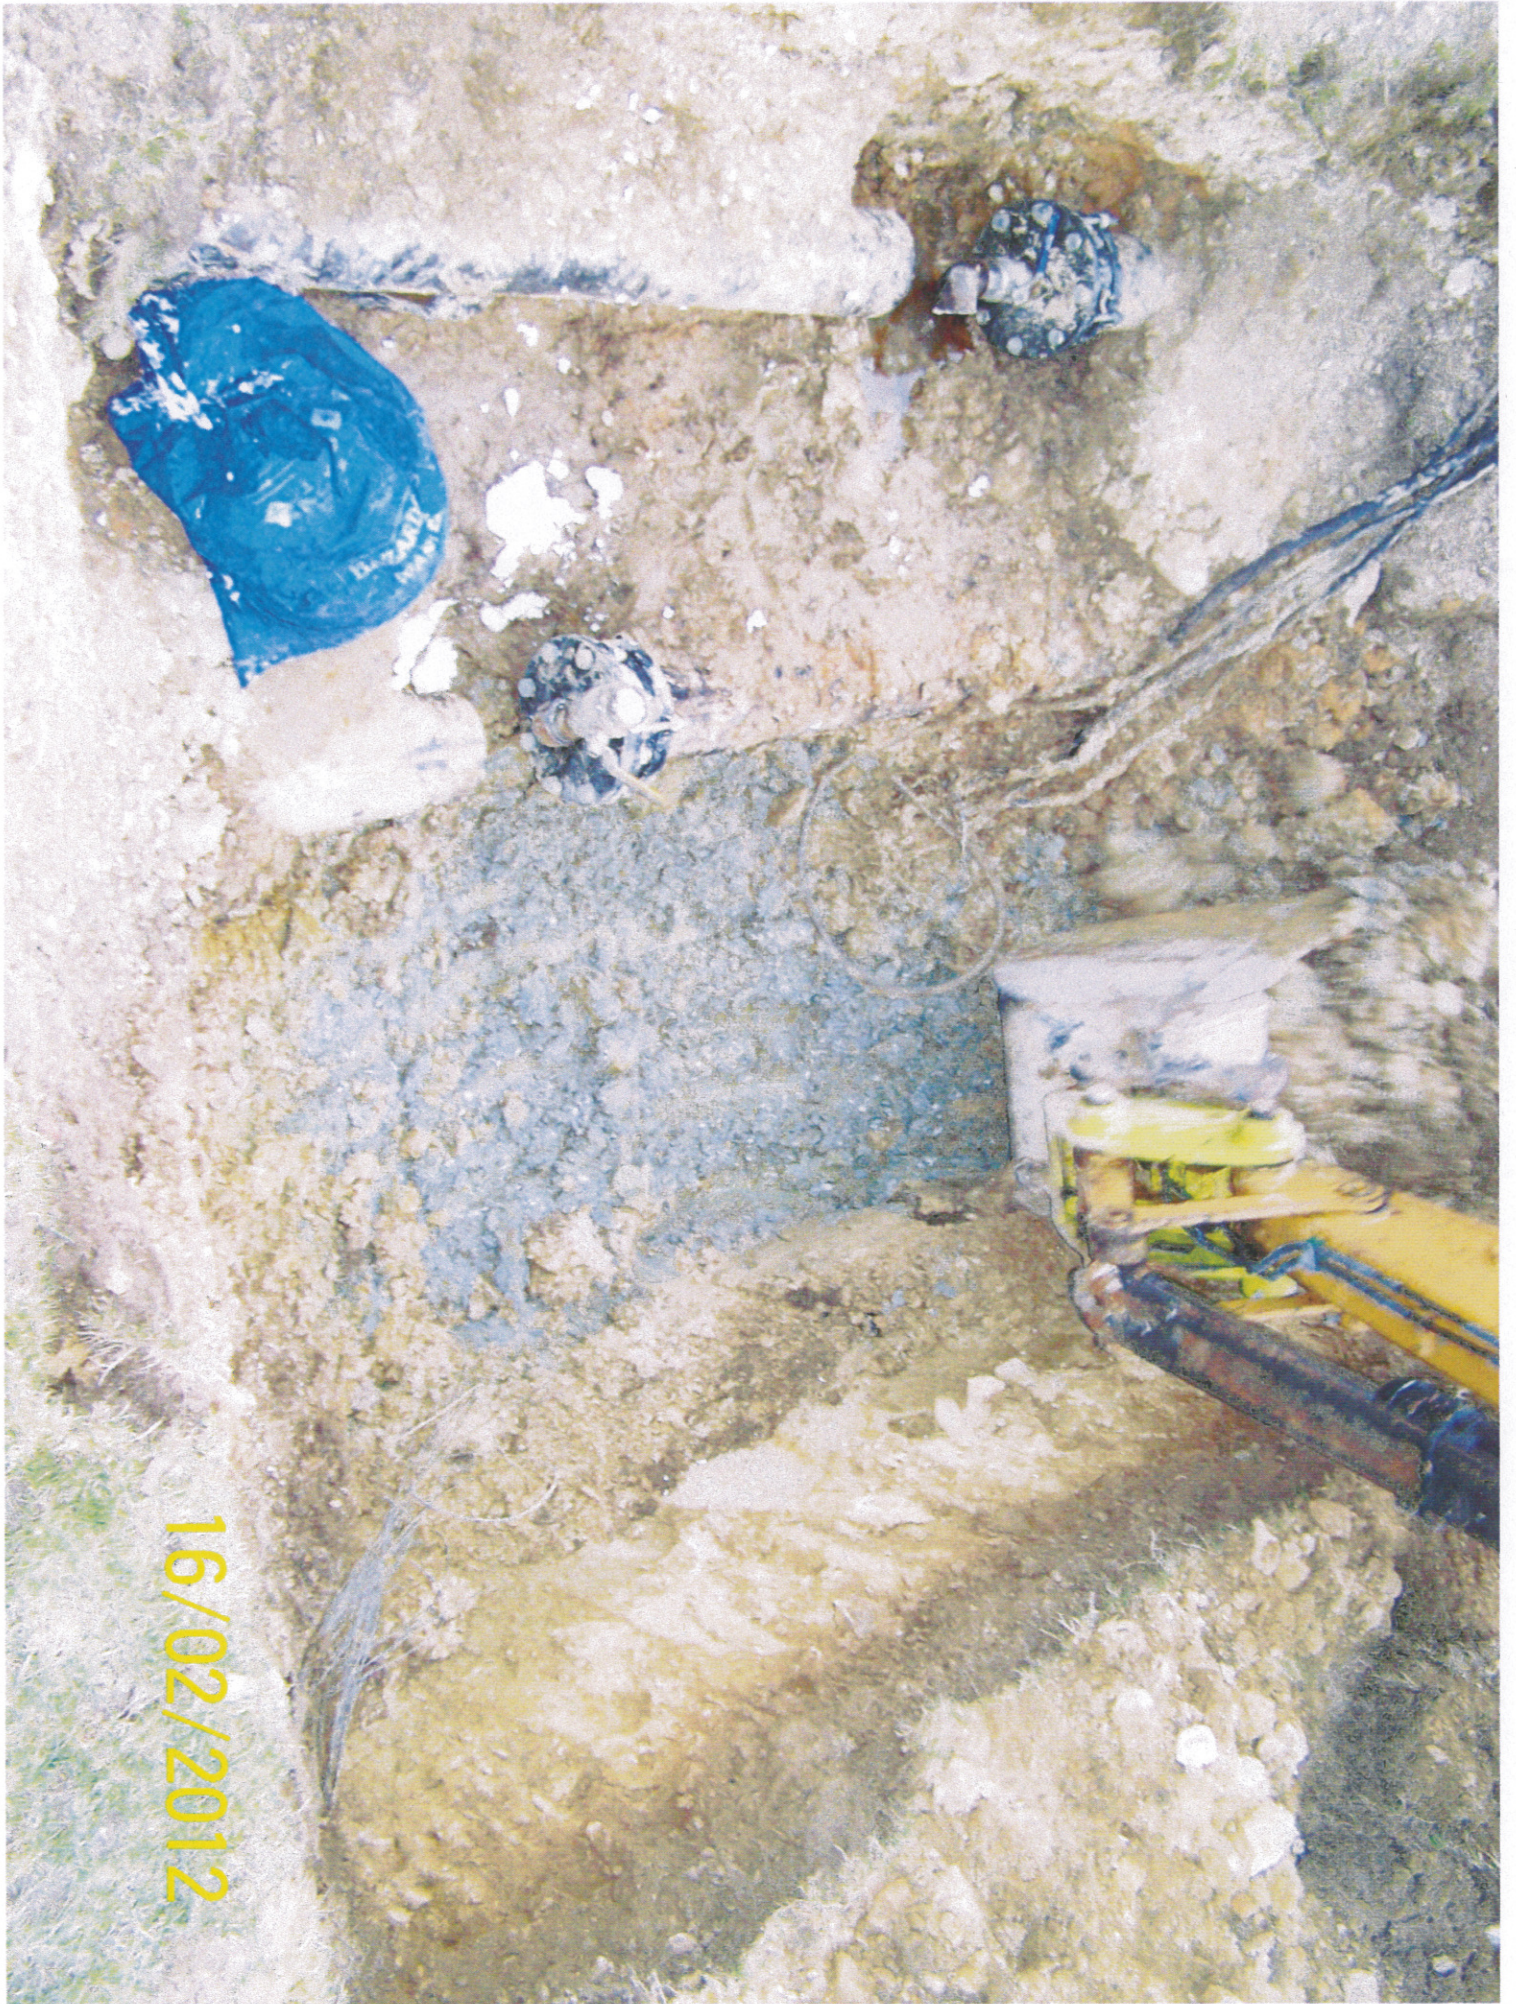
16/02/2012

Details of accident / incident		
IT WAS REPORTED TO MYSELF ON 16 FEB 2012 BY FREDDIE ALCOCK OF WATERMANS THAT THE EXCAVATION PIT NORTH OF POL 2 HAD FUEL IN IT. ON INVESTIGATION I FOUND THAT THE PIPES HAD BEEN CUT THE PREVIOUS NIGHT AND DRAINED DOWN WITH THE VACUUM TANKER AS PER THE METHOD STATEMENT, AND A VIPER JOHNSON FITTING HAD BEEN PUT IN PLACE ON THE END OF THE PIPE. I CHECKED THE FITTING TO ENSURE IT WAS IN PLACE PROPERLY AND FOUND THAT THE VALVE HAD BEEN LEFT OPEN ALLOWING RESIDUES FROM THE PIPE TO ESCAPE INTO THE PIT.		
Additional sheets attached:	Y <input type="checkbox"/> N <input checked="" type="checkbox"/>	Photos attached: Y <input checked="" type="checkbox"/> N <input type="checkbox"/>
RIDDOR CLASSIFICATION:		
<input checked="" type="checkbox"/> Not Reportable:		
<input type="checkbox"/> Death or Major Injury:	<input type="checkbox"/> Over 3-Day Injury:	
<input type="checkbox"/> Dangerous Occurrence:	<input type="checkbox"/> Over 3-Day Absence Possible:

<input type="checkbox"/> Disease:	<input type="checkbox"/> Accident Form F2508 to be submitted	
Accident Book completed: Y <input type="checkbox"/> N <input checked="" type="checkbox"/>		
Immediate action taken:		
I IMMEDIATELY BROUGHT IN THE VACUUM TANKER AND AN EXCAVATOR. I VACUUMED THE FLUID FROM THE PIT AND SCRAPPED THE SOILS FROM THE IMPACTED AREA IN THE PIT, THIS WAS TAKEN AWAY FOR OFFSITE DISPOSAL. A SAMPLE OF THE SOILS WAS THEN TAKEN AND SENT TO THE LAB FOR ANALYSIS.		
Investigation report: None <input checked="" type="checkbox"/> To follow <input type="checkbox"/> Attached <input type="checkbox"/>		
Managers comments / recommendations		
I HAVE CHECKED ALL REMAINING VALVES THAT HAVE BEEN FITTED AND ADVISED ALL OPERATIVES TO TAKE MORE CARE WHEN FITTING THE FITTINGS AND TO DOUBLE CHECK WHEN COMPLETED.		
Report No: 1246DOR/002	Signed:	Date: 16/2/12
Distribution: MD <input type="checkbox"/> H&S Man <input type="checkbox"/> H&S Admin <input type="checkbox"/> Contracts Man <input type="checkbox"/> File <input type="checkbox"/>
