# HOLLINS STRATEGIC LAND

Tappers Farm, Bodicote

Desk Study Assessment Report

EC/C3797/1552

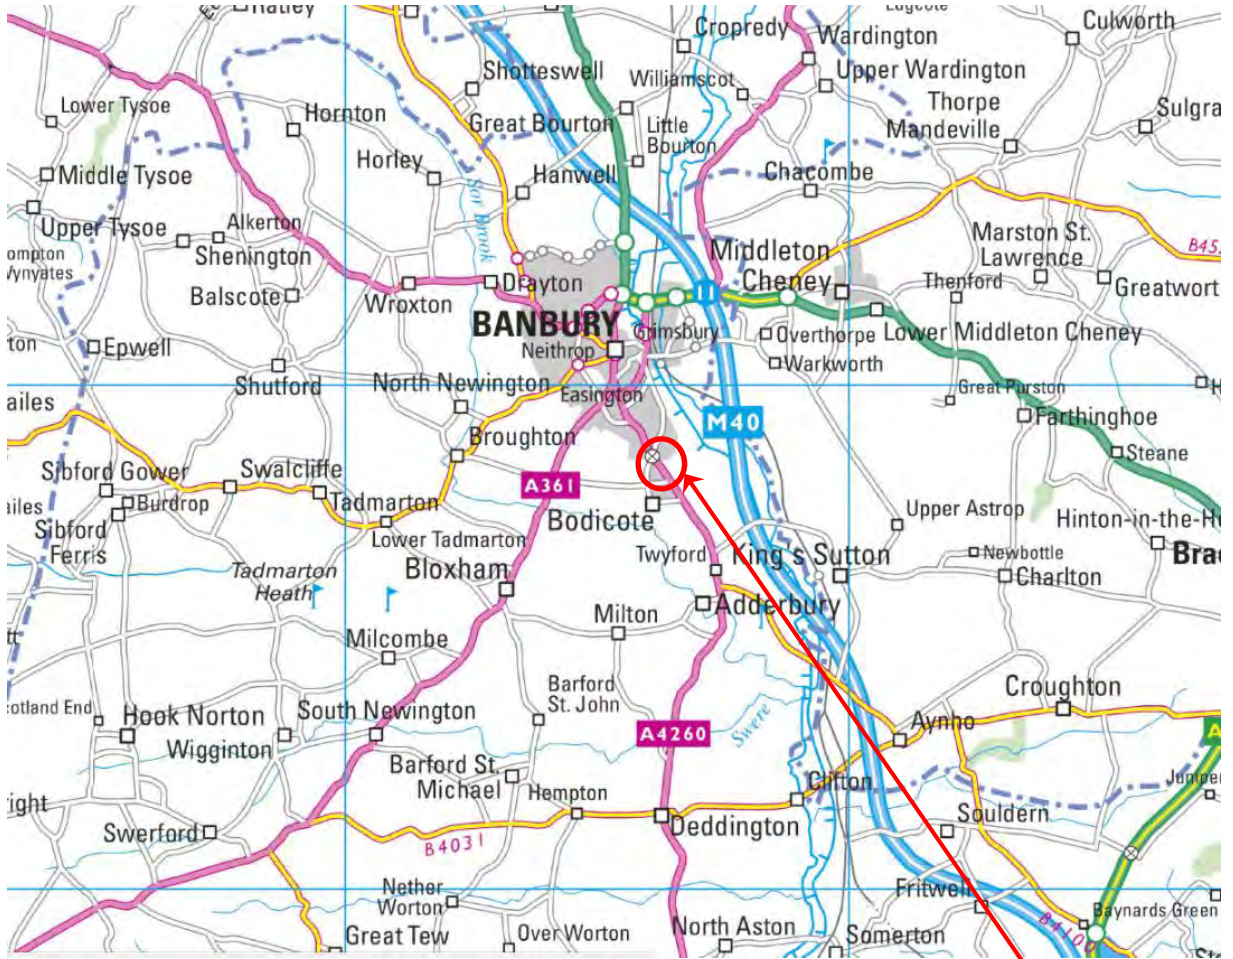
SITE

Drawing Number	Rev	Title
C3797/01	-	Site Location Plan
