North-west Bicester – Sites A, B and Caversfield

Desk Study and Site Investigation

Firethorn Development Ltd

Doc ref: 13603-HYD-XX-XX-RP-GE-1000

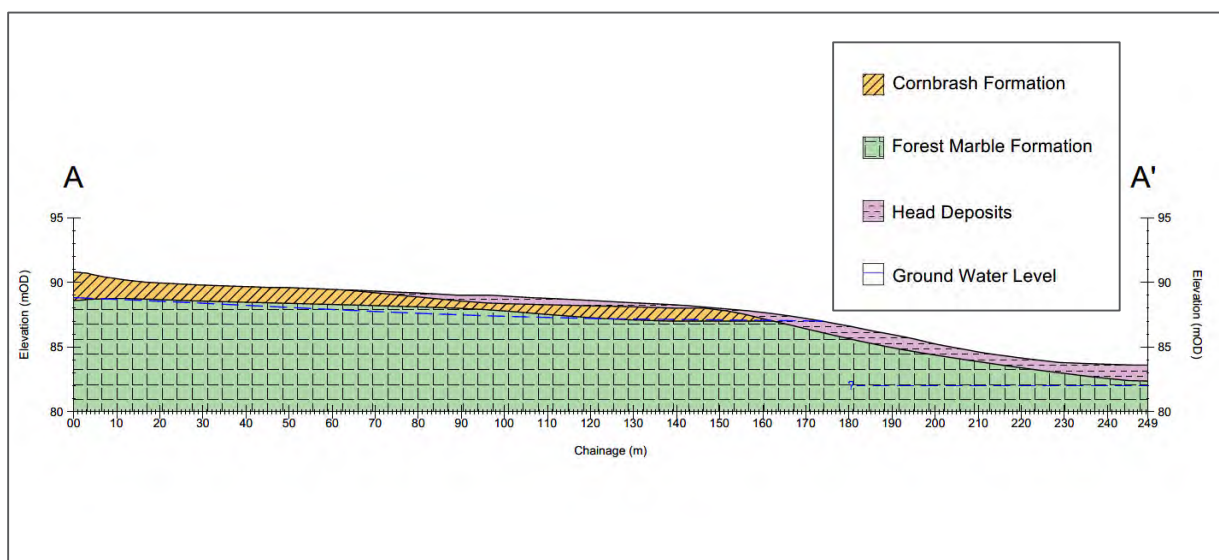
Figure 5.2 shows a cross section trending North-west to South east across Caversfield with the Cornbrash Formation outcropping in the north-west, Head deposits are shown on the slope, with the Forest Marble Formation sub-cropping in the south-east. The topography of the site slopes down to the stream of the south-eastern boundary. North-west of the slope, the Forest Marble Formation was encountered at approximately 87 to 88m OD.

Figure 5.2: Cross section across Caversfield trending North-west to south east.

A summary of the ground model described above is shown on the extract of the 'Geology Map – Solid and Drift' (Hydrock Drawing 13603-HYD-XX-ZZ-DR-GE-1005) shown in Figure 5.1 and an extract of the geological cross section for the site (Hydrock Drawing 13603-HYD-XX-ZZ-DR-GE-1008) shown in Figure 5.2 below.

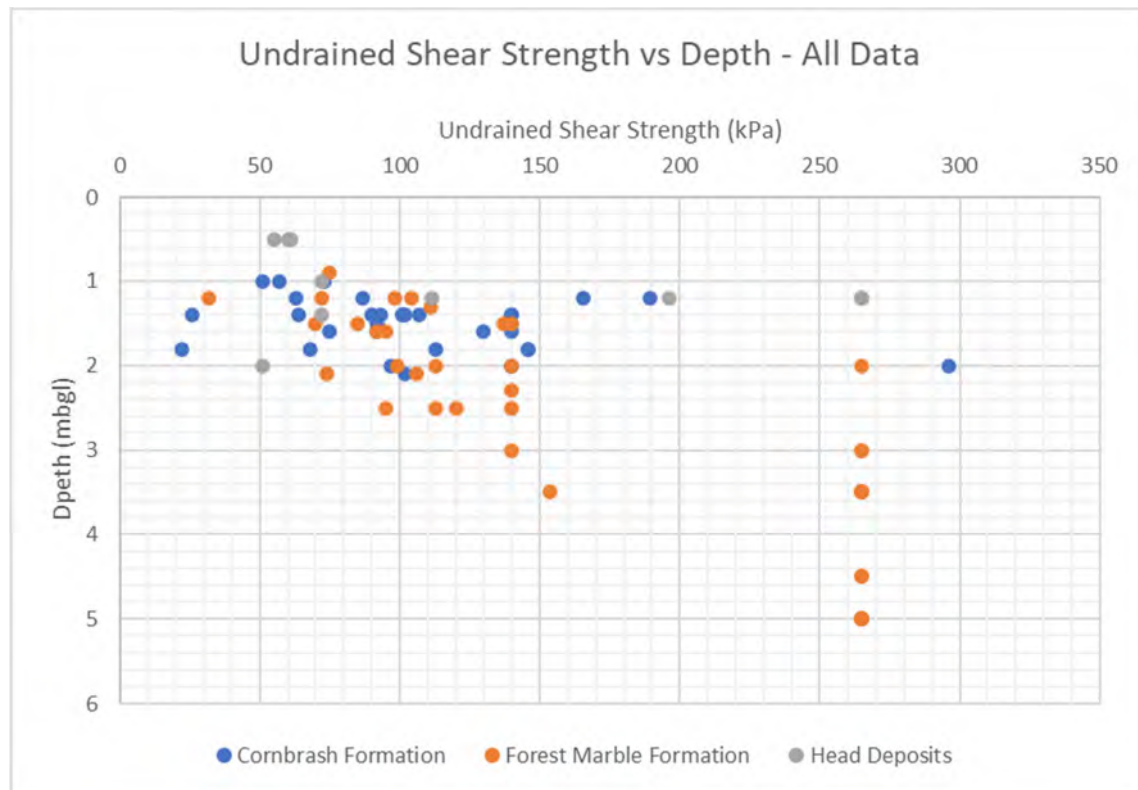
Figure 5.4: Undrained shear strength vs depth plot - all data

As shown by Figure 5.4, the undrained shear strength of the Head Deposits is varied, with values recorded between 51 and 265kPa. The small clay fraction within the more granular / rock stratum of the Cornbrash Formation is also highly varied with undrained shear strength values recorded between 22 and 296kPa (between approximately 1 to 2m bgl), which is likely to be a result of the interbedded nature of this stratum with varied bands of clays and limestone (with various degrees of weathering and water softening) encountered leading to higher and lower strength bands in the Cornbrash Formation.

Undrained shear strengths of approximately 32 to 100kPa are recorded in the Forest Marble Formation at approximately 1.00m bgl, increasing with depth to approximately 120 to 150kPa at approximately 2.50m to 3.00m bgl, and upto 265kPa at 5.00m bgl.

*Correlation with Stroud (1975) based on 'average' plasticity and using N₆₀ based on Stroud (1989) updated correlation.
 **140kPa is the upper recordable limit of the hand shear vane.
