Bicester Eco Town Exemplar Site			
Scale N/A		Datum N/A		Title	
		Site Location Plan		Project Code UA001881	
				Drawing Number 001	
				Issue A

Project	BICESTER ECO TOWN
Title	EXEMPLAR SITE WITH EXPLORATORY HOLE LOCATIONS

P3Eco (Bicester) Ltd and A2Dominion Group
NW Bicester Eco Development
Geotechnical Interpretative Report - Exemplar Site

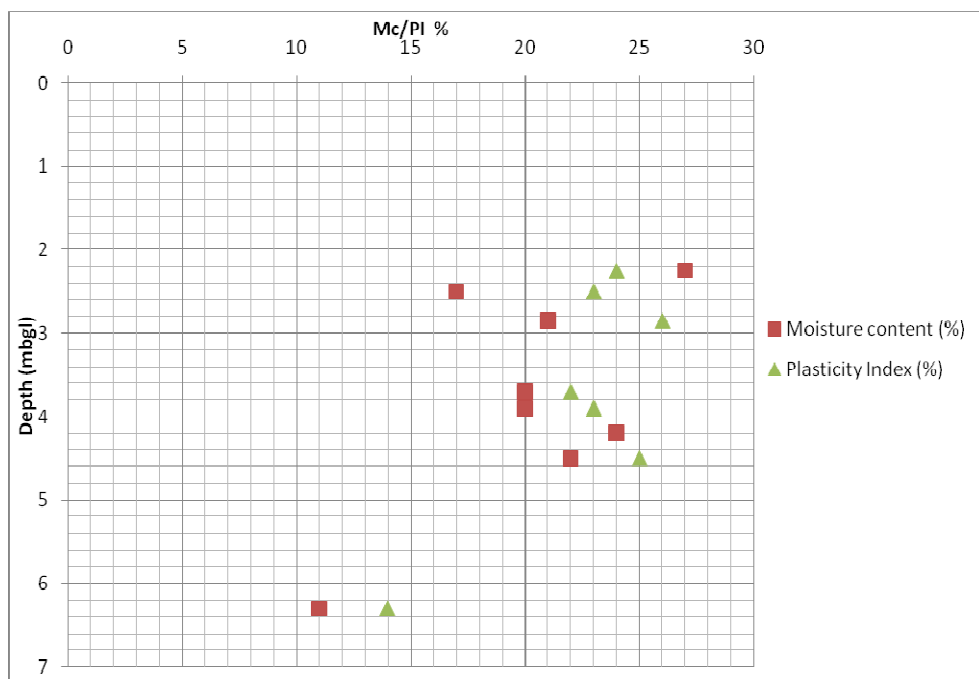
Chart 5.1 mc/PI profile for the interbedded Limestone

Eight Atterberg limit tests were carried out on the Clays that are interbedded within the limestone at various depths in order to get a moisture content/Atterberg Limit profile. The tests indicate that the material is generally of intermediate plasticity, with PI values of between 23% and 26% recorded. One test result at depth gives a lower plasticity of 14%, chart 5.1 shows the mc/PI profile for Clays within the interbedded Limestone:

Moisture content testing was carried out on all of the samples tested for Atterberg Limits and give mc values of between 11% and 27%. One dimensional consolidation testing was carried out on three clay samples from the interbedded Limestone, from borehole BH1 at 4.5m, BH5 at 2.25m and from BH5 at 3.9m. Test results indicate a coefficient of volume compressibility (M_v) values ranging from 0.013 m^2/MN to 1.119 m^2/MN and coefficient of consolidation (C_v) values ranging from 0.678 m^2/yr to 11.6 m^2/yr .
