Phase 2 Site Investigation

Ploughley Road, Ambrosden

B05927-CLK-XX-XX-RP-GT-002

Bellway Homes (North)

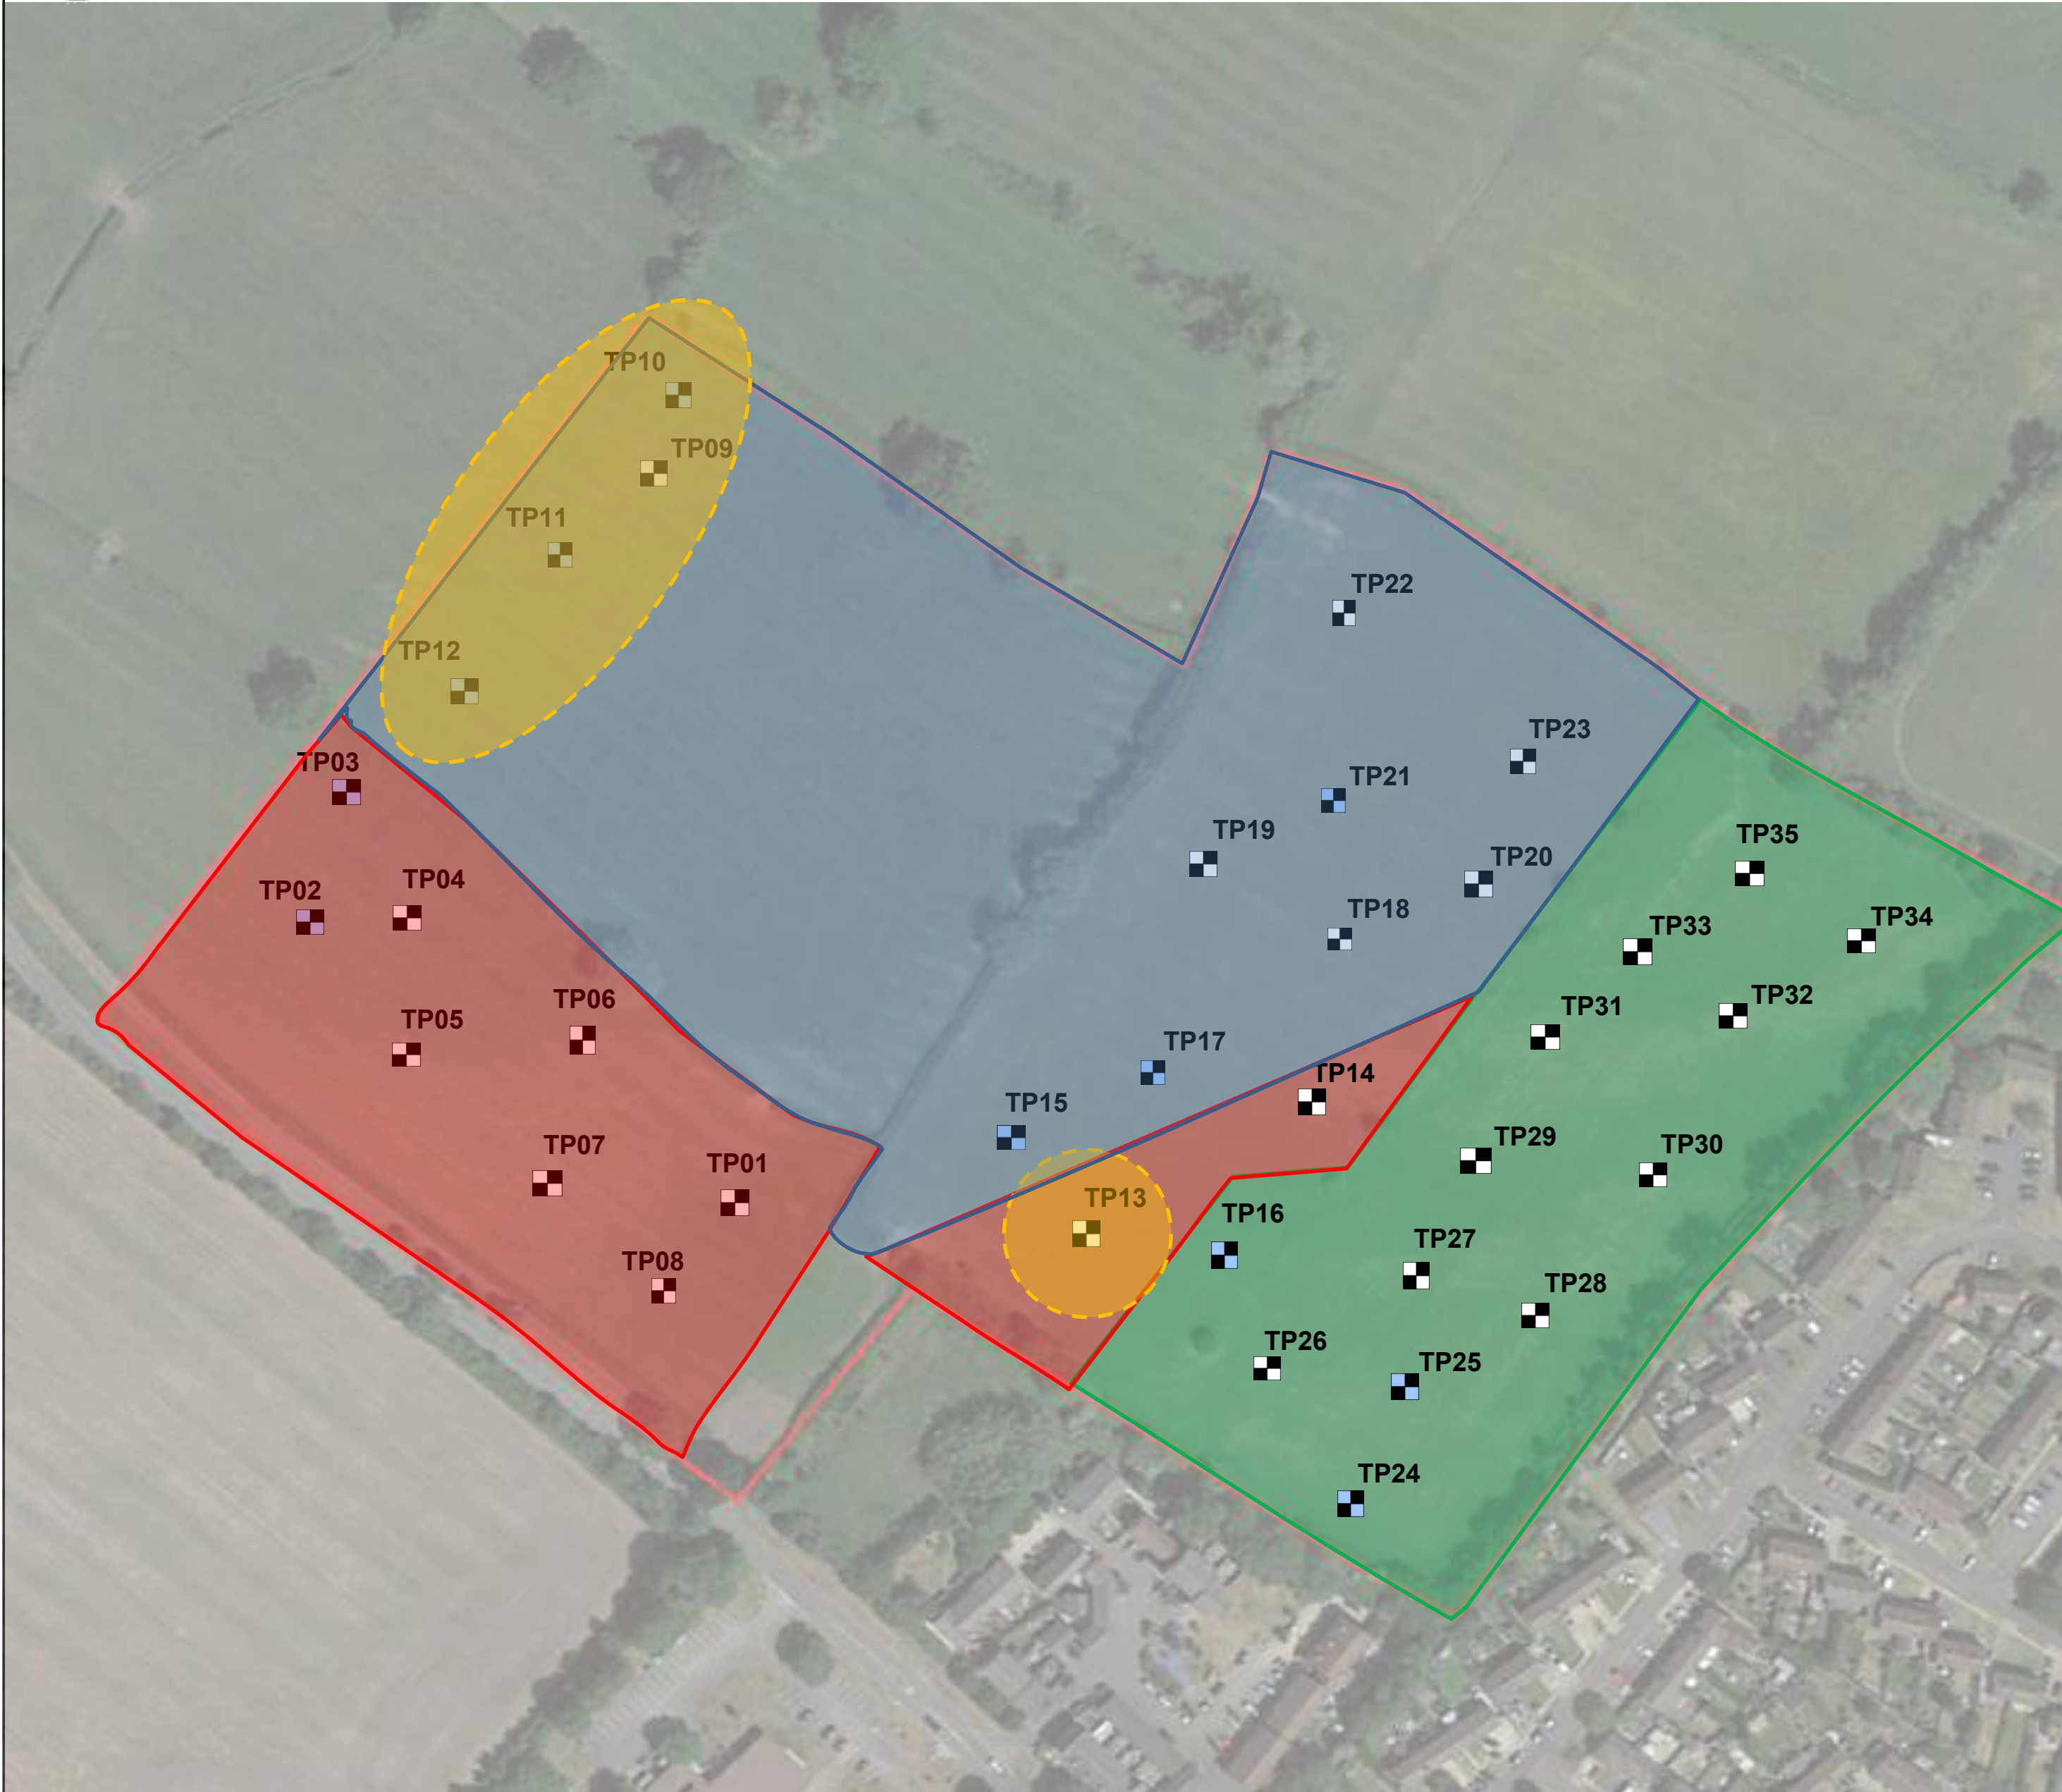
Hole Locations Approximate. Sizes exaggerated for clarity.
