Phase 1 Desk Study Report

# Land East of Warwick Road, Banbury

Project Name Land East of Warwick Road, Banbury

**Title** Phase 1 Desk Study Report

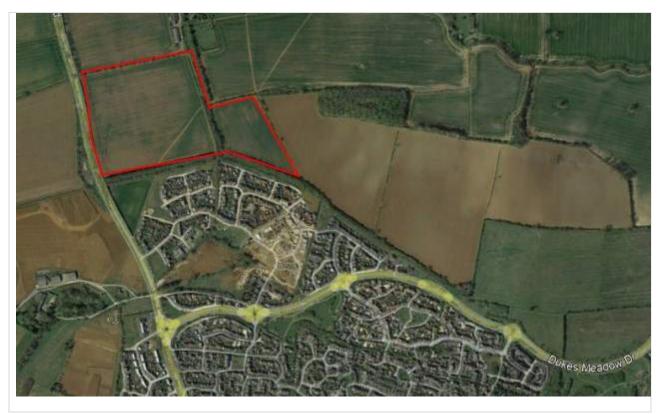
Figure 1: Site boundary

The site is located in a greenfield area between Warwick Road and the M40, just to the south of the village of Hanwell in Oxfordshire, approximately 4km to the north west of Banbury town centre. A site outline plan is shown in figure 1 below and is based on the supplied EDP Site Location Boundary drawing (Ref No. edp3253\_d007e, dated May 2022).

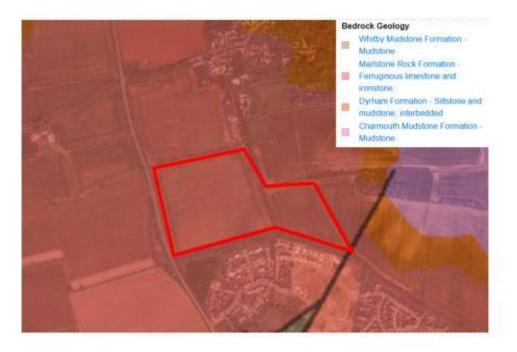
Figure 2: BGS Extract of Geology.

The British Geological Survey (BGS) 1:50,000 Solid and Drift Mapping (Banbury, Sheet 201) and the online BGS Geology of Britain Viewer identifies the site to be underlain primarily by the Marlstone Rock Formation described as sandy, shell fragmental and ooidal limestone interbedded with ferruginous calcareous sandstone, and subordinate ferruginous mudstone beds. This is underlain by the Dyrham Formation, described as pale to dark grey, and greenish grey silty and sandy mudstone, with interbeds of silt or very fine sand. An extract of the BGS geological map is shown below.

The Marlstone Rock bed tends to form a plateau which is terminated north-westwards by a steep scarp which is commonly softened by cambering. A geological fault is shown to cross under the south eastern corner of the site where it down throws to the west.

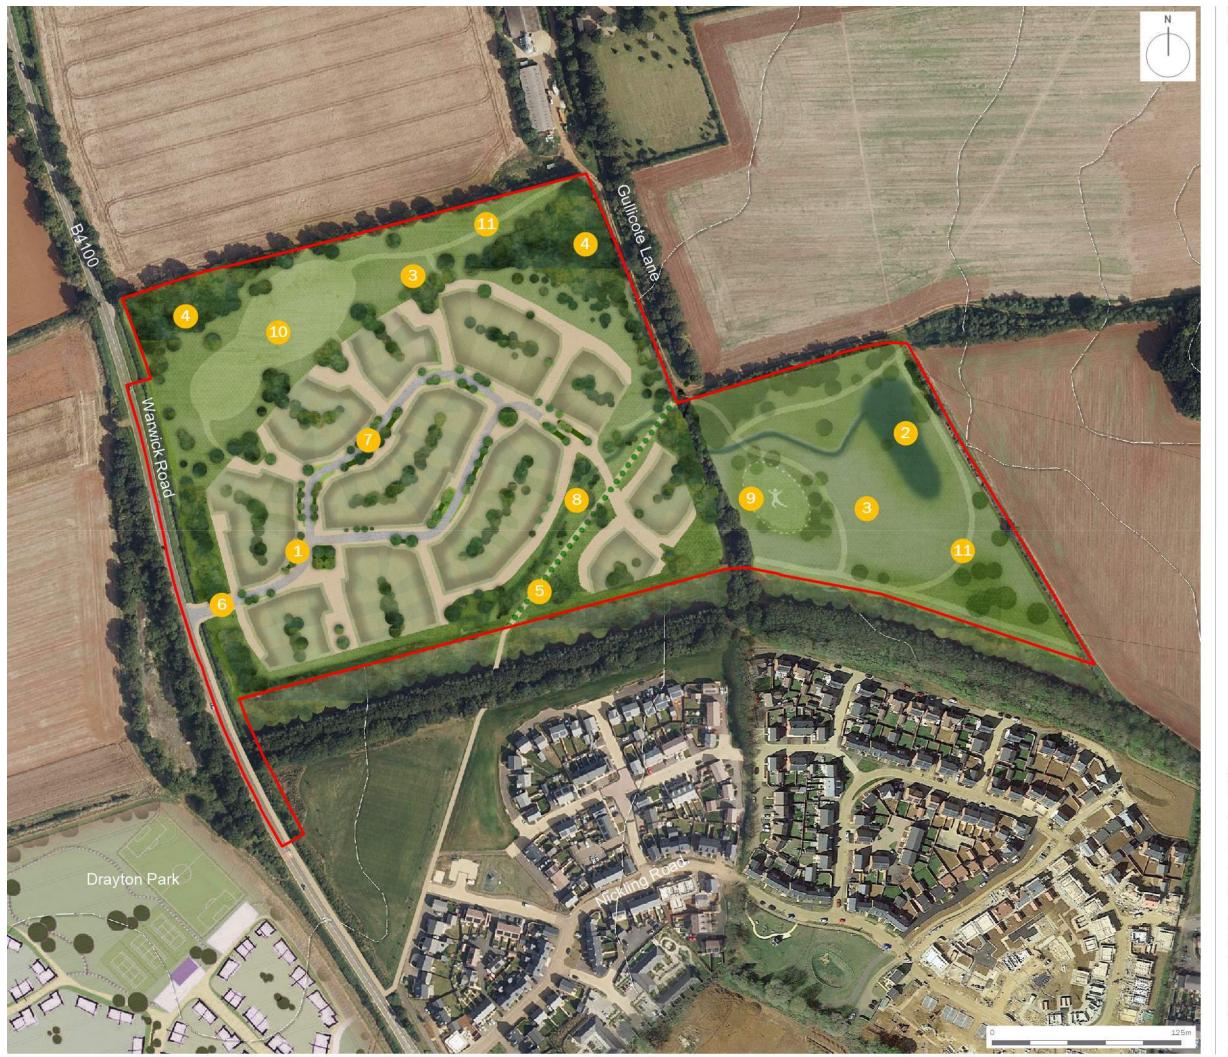
17279-G200A-04 iii

Site Boundary (12.63ha)

- Arrival Square
- Attenuation Pond
  - Wildflower Meadow and Oak Parkland
- Woodland Planting
- Public Right of Way Integrated within Green Corridor
- 6 Vehicular Access Point
- Main Street With Green Verge, Including Rain Gardens
- 8 Neighbourhood Green with Swale
- O Natural Play Space
- Informal Kick-about Space
- Mown Grass Trails
