PHASE 1 & 2 BAT SURVEY

**THE KENNELS, BICESTER ROAD,
STRATTON AUDLEY, BICESTER,
OXFORDSHIRE, OX27 9BS**

Date: 11th August 2019

Client: Bicester Hunt With Whaddon
Chase

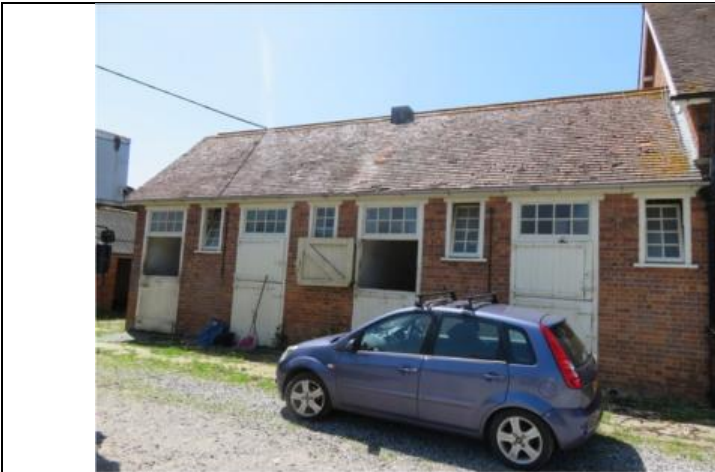
Brick stable block comprising four separate bays. The gable roof is covered with clay tiles and is unlined.

Photograph 1. The north -east elevation of Building 1

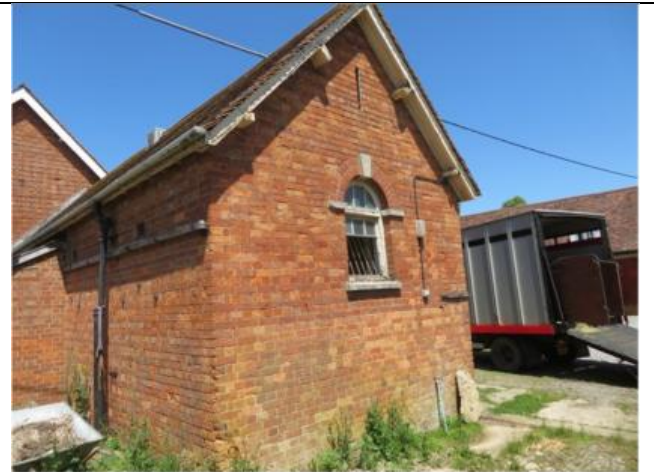
Photograph 2. The south-east elevation of Building 1

- A bat box will be installed near the apex of the south-east facing gable wall of Building 1 and at the apex of the south-east elevation of Building 3 (Photograph 25). The boxes will be located well away from windows and other light sources.

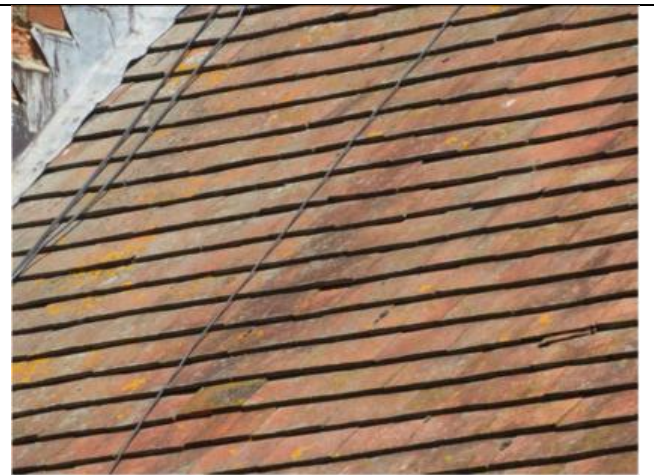
The roof is quite well sealed with no obvious access points under or between tiles on the pitches (e.g. Photograph 4) except possibly under the ridge on the north-east side. There are gaps between the barge board and the south-east wall as well as openings in the wall itself (Photographs 2 and 5). There are also gaps under tiles on the edge of the south-east gable (e.g. Photograph 6). Between the rafter tails there are a few gaps between the wall and the soffit (e.g. Photograph 7). There are also open window apertures.

Photograph 4. Example of the tiles on the roof of Building 1

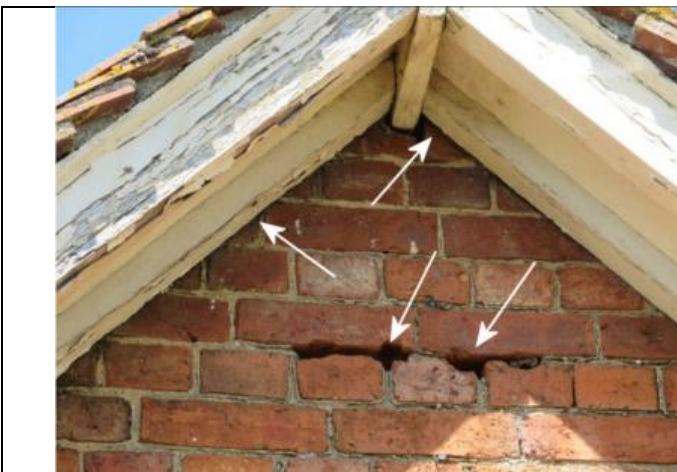
Photograph 5. Openings under the bargeboard and in the south-east gable wall of Building 1

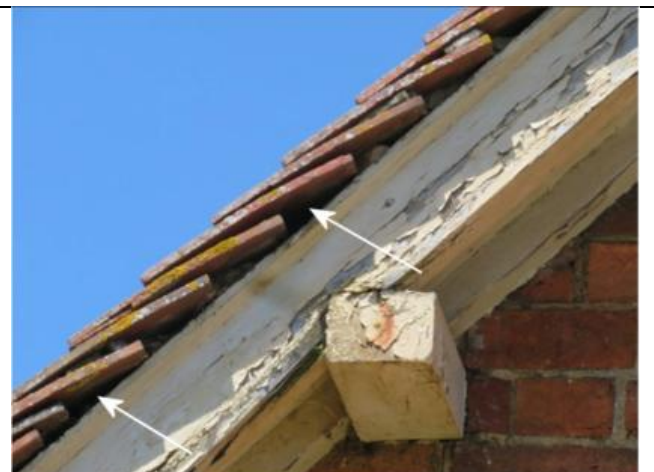
Photograph 6. Openings under tiles along the edge of the south-east gable wall of Building 1

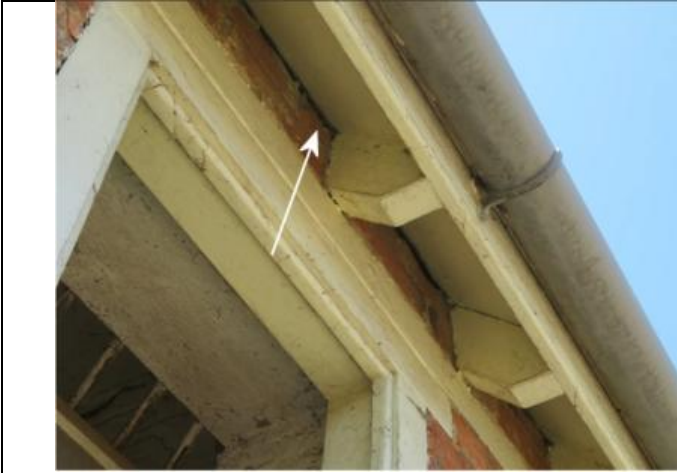
Photograph 7. Example of an opening between the soffit and the north-east wall of Building 1

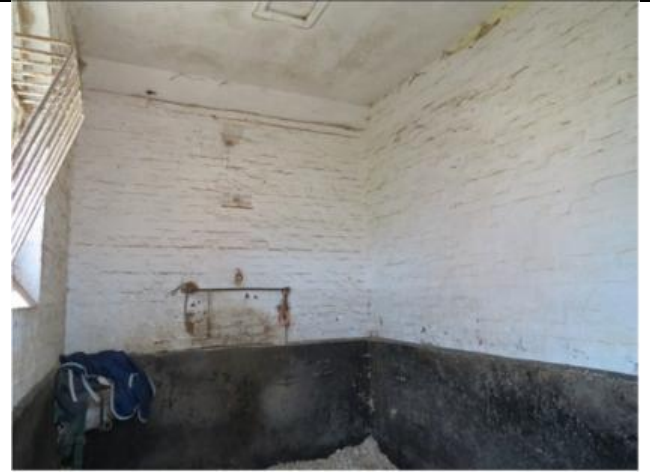
There are four separate bays which contains very little perching opportunities for bats (e.g. Photograph 8).

Photograph 8. Example of one of the bays in Building 1

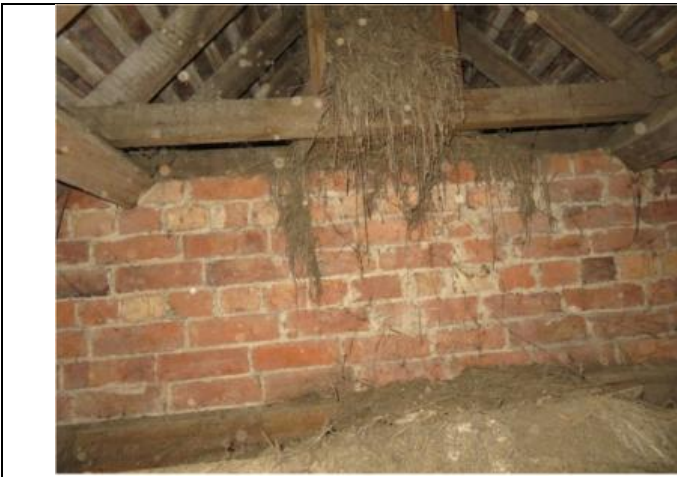
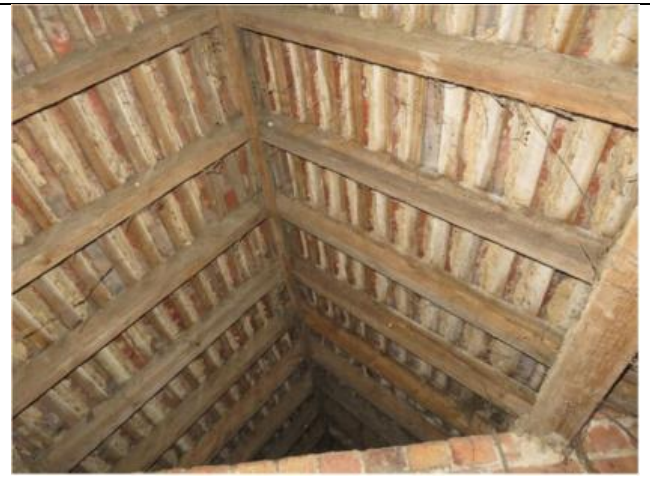
There is an enclosed roof void which contains exposed timbers suitable for perching (e.g. Photographs 9 and 10). Such roof voids could potentially be used by those species of bat that require a large flying area within the roost such as brown long-eared bats *Plecotus auritus*. However, the roof timbers are very dusty and covered with cobwebs indicating that bats have not been present for some time, if at all.

Photograph 9. Part of the enclosed roof void within Building 1

Photograph 10. Example of the underside of the roof in Building 1

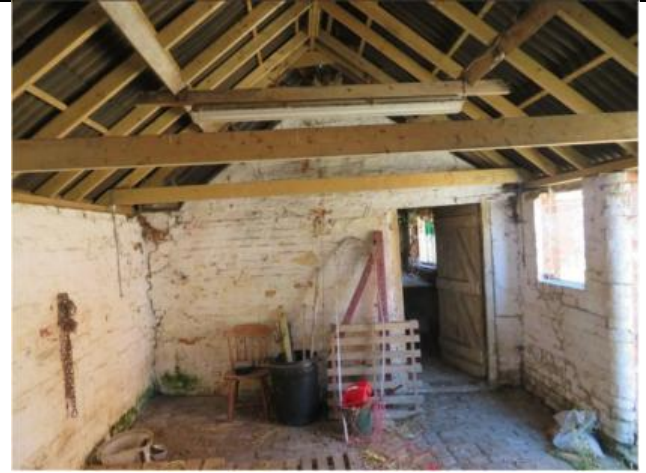
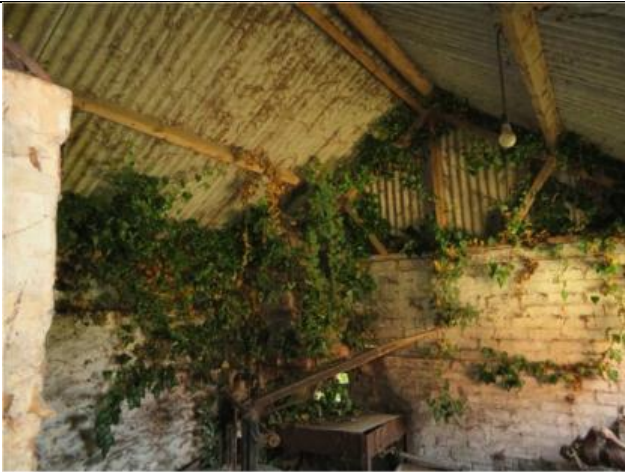
There is an open roof void which contains exposed timbers suitable for perching (Photographs 14 and 15). However, the interior is very bright during the day which may deter some species from roosting within this area during this period.

Photograph 14. The interior of the main part of Building 2

Photograph 15. The interior of south-western part of Building 2

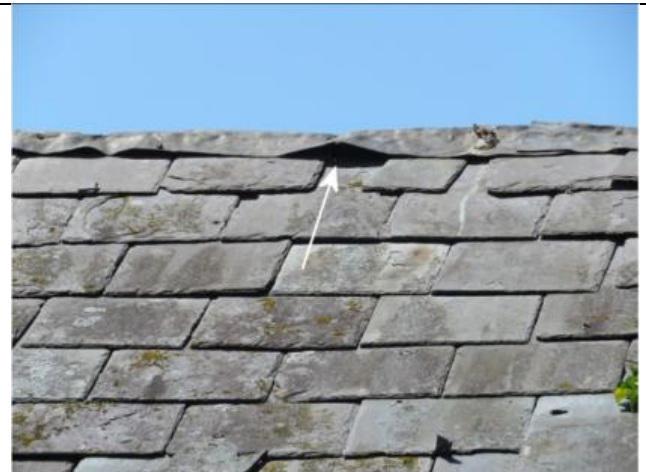
There are a few openings under the lead ridge covering (e.g. Photograph 18) as well as open window and door apertures, and gaps in and above the walls (e.g. Photographs 19 and 20).

Photograph 18. Example of an opening under the lead flashing on the ridge of Building 3

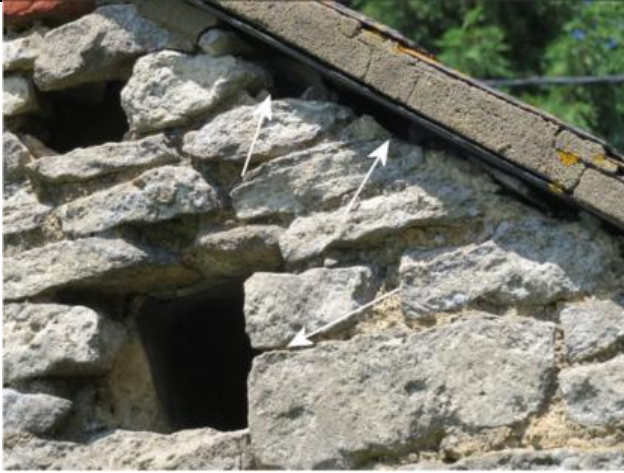
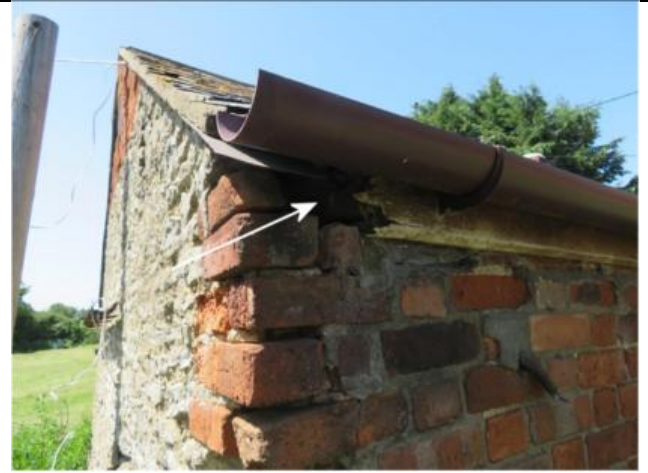
Photograph 19. Example of gaps between the roof and the south-east gable wall of Building 3

Photograph 20. Example of a gap at the corner of the wall of Building 3

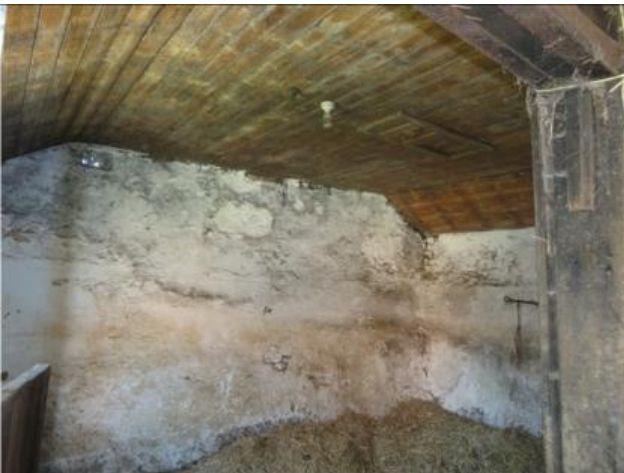
Bats could potentially perch on the timber ceiling (Photograph 21).

Photograph 21. Example of a bay within Building 3

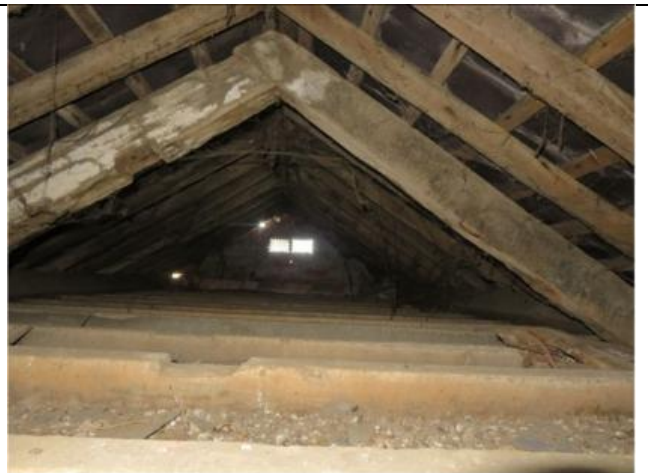
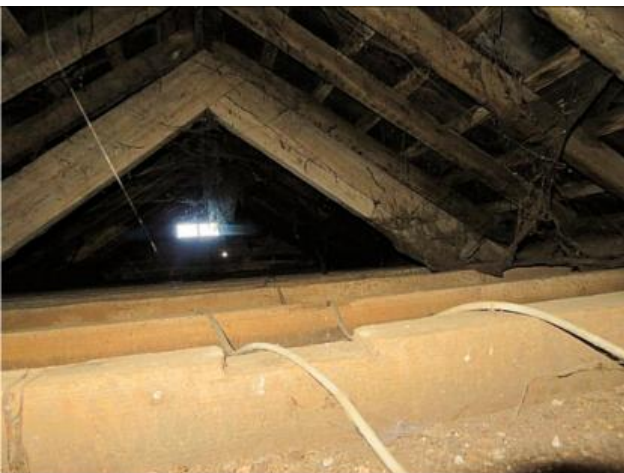
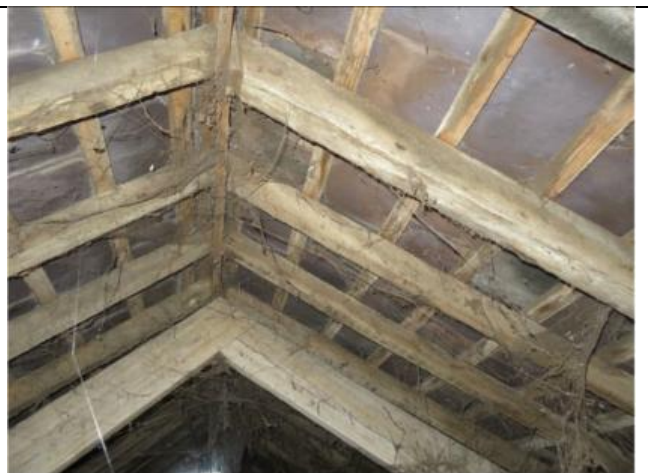
There is a small enclosed roof void (Photographs 22-24) which may be suitable for some species of bats, such as whiskered bats. However, the interior is very dusty and covered with cobwebs indicating that bats have not been present for some time, if at all.

Photograph 22. The enclosed roof void within Building 3 (view to north-west)

Photograph 23. The enclosed roof void within Building 3 (view to south-east)

Photograph 24. The underside of the roof within Building 3

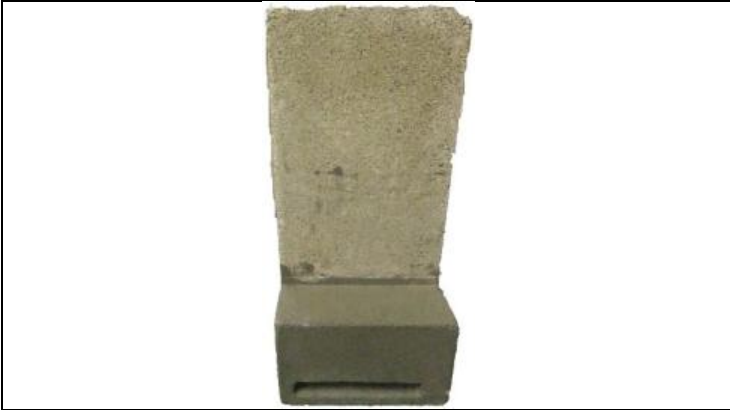
Photograph 25. Woodstone Bat Box

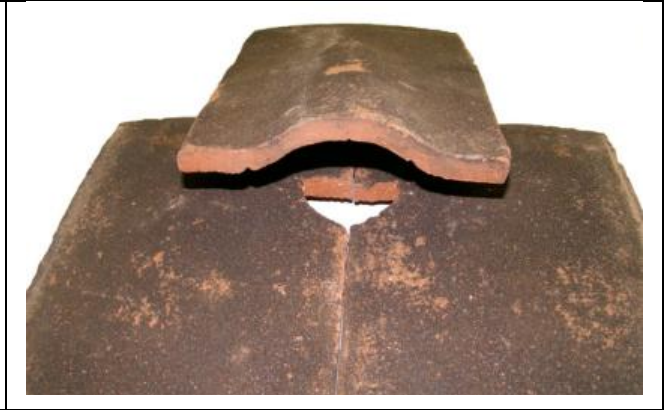
Photograph 26. Example of bat access tile
