Project Title.
**CATALYST
BICESTER**

Topographical Survey

Product 4 (Detailed Flood Risk) for : Promised Land Farm, Wendlebury Road, Bicester
Our Ref: THM_70557

**REPORT ON
GROUND INVESTIGATION
AT
THE PROMISED LAND FARM,
BICESTER**

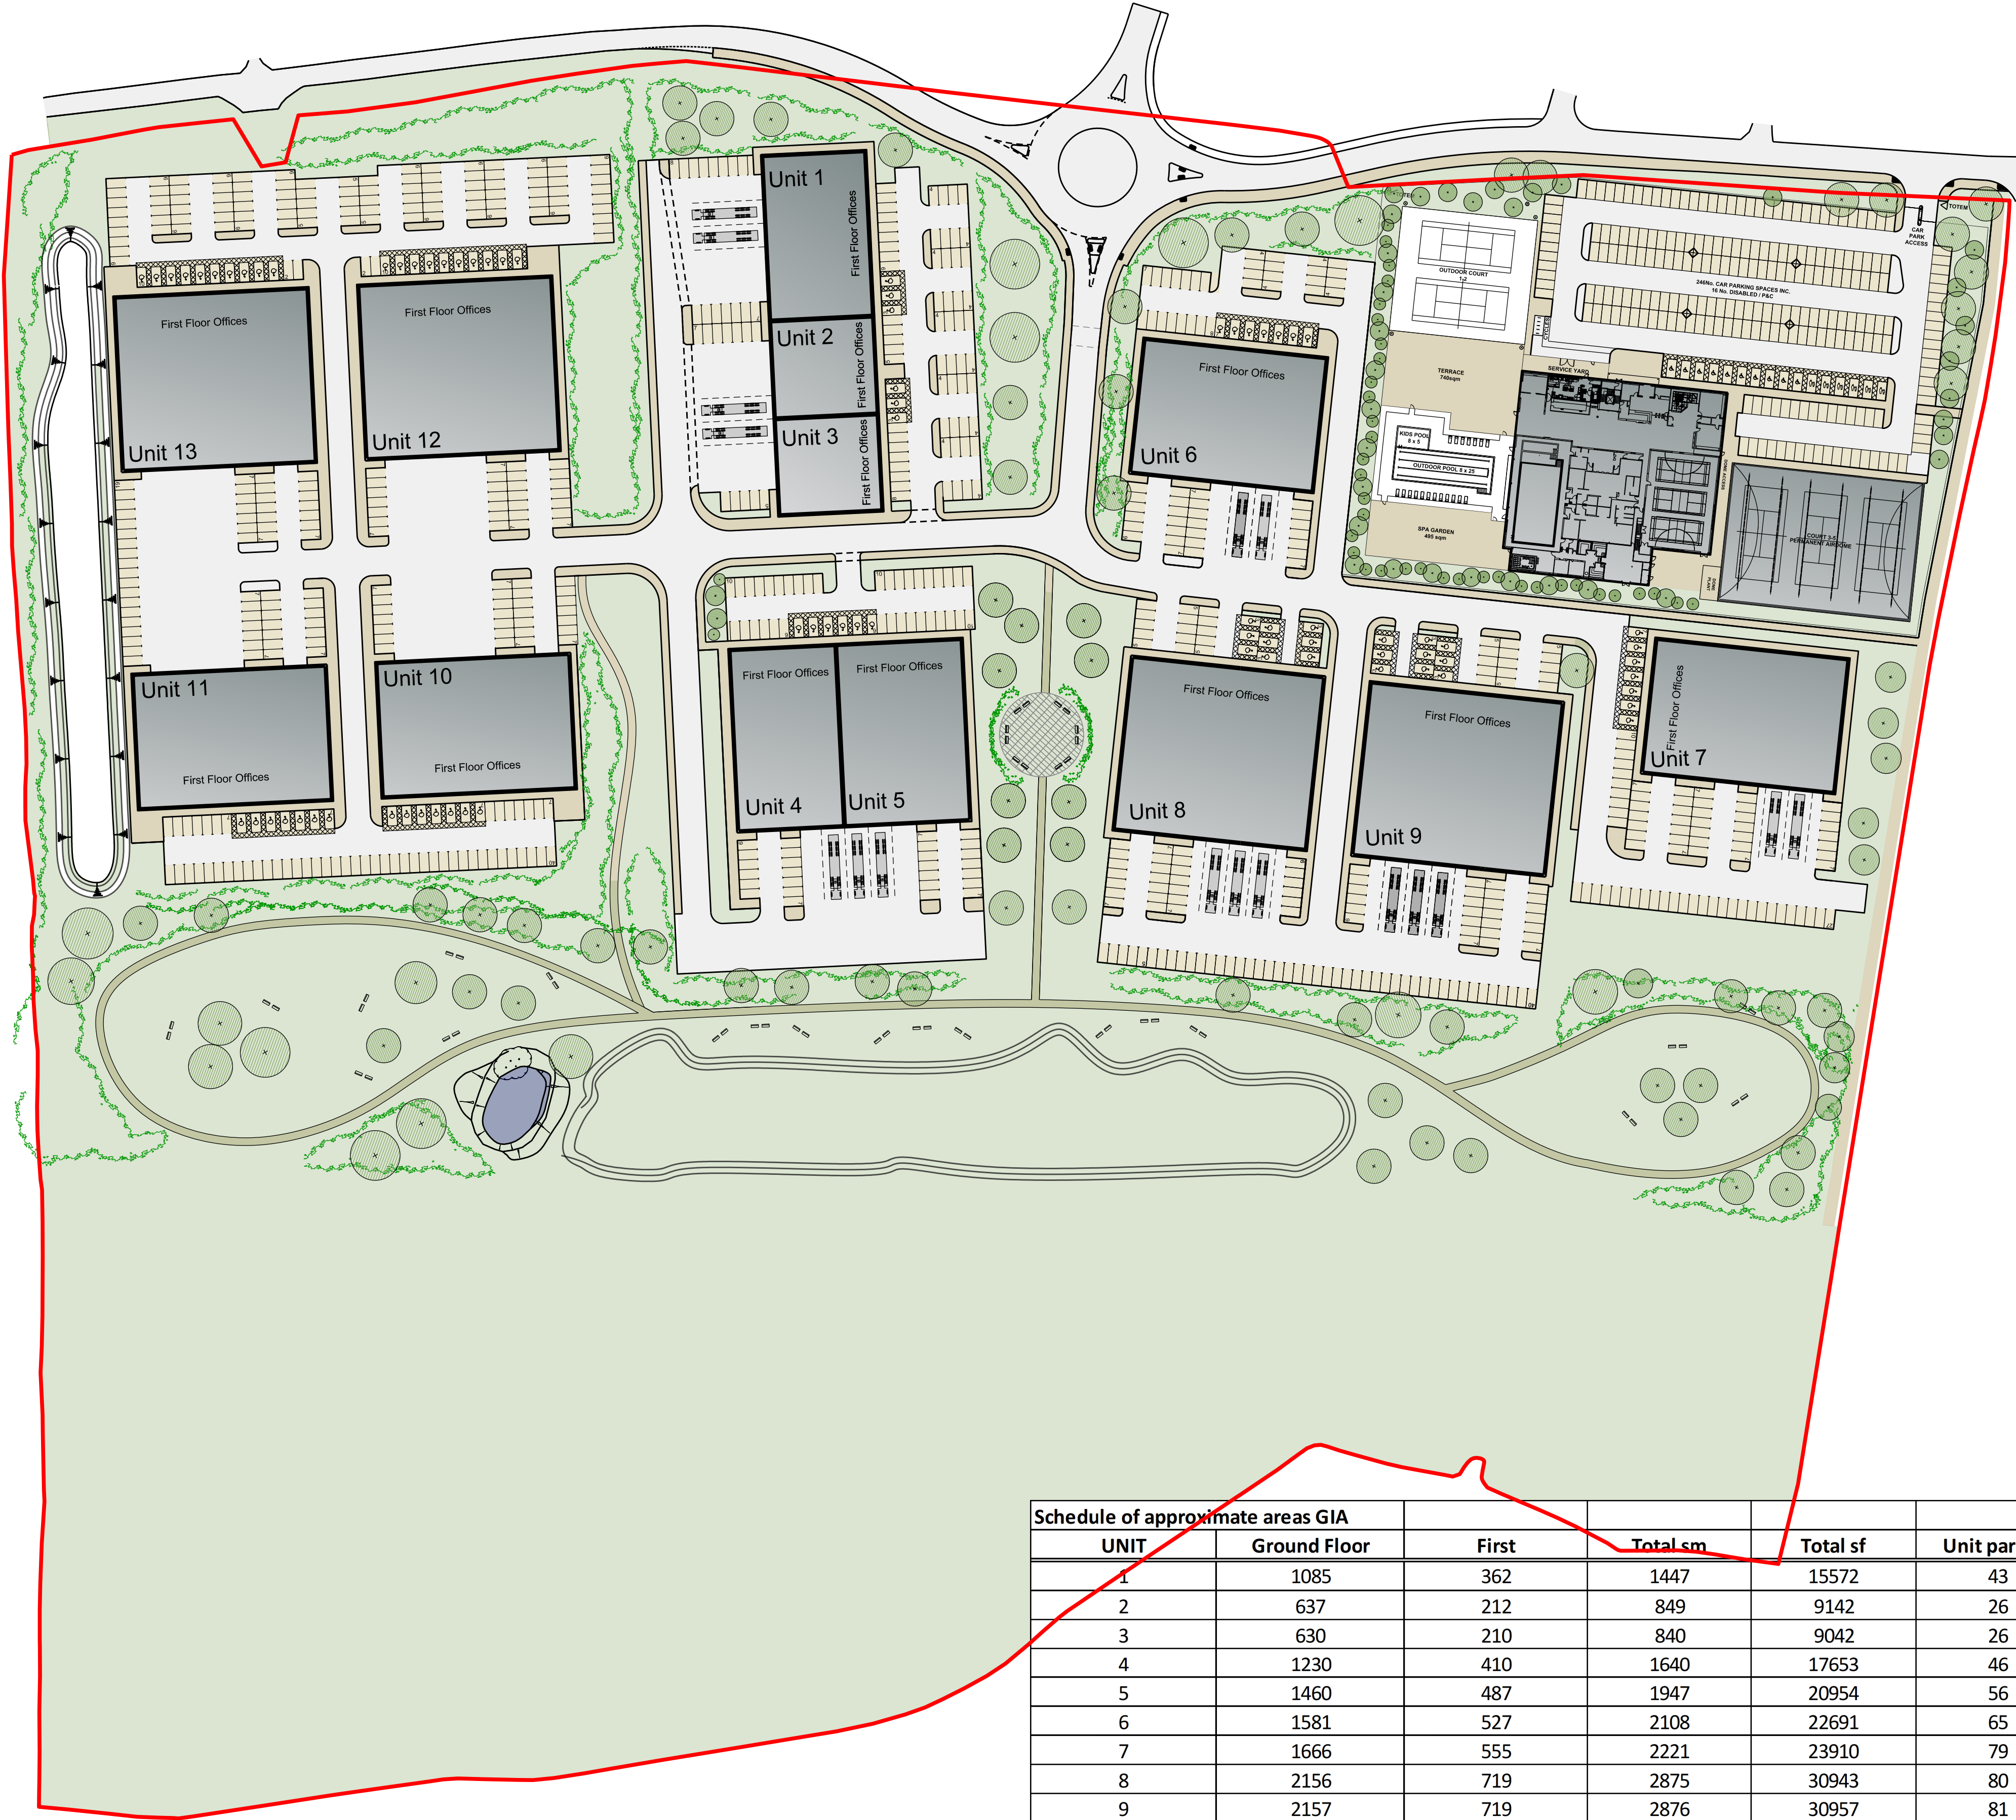
Drawing Title.
TECH SCHEME OPTION 8

Schedule of approximate areas GIA						
UNIT	Ground Floor	First	Total sm	Total sf	Unit parking	Total parking
1	1085	362	1447	15572	43	95
2	637	212	849	9142	26	
3	630	210	840	9042	26	
4	1230	410	1640	17653	46	102
5	1460	487	1947	20954	56	
6	1581	527	2108	22691	65	
7	1666	555	2221	23910	79	161
8	2156	719	2875	30943	80	
9	2157	719	2876	30957	81	
10	1666	555	2221	23910	63	127
11	1666	555	2221	23910	63	
12	2156	719	2875	30943	82	
13	2156	719	2875	30943	82	164
Totals			26995	290571	793	
Total Development area:			Parking @ approximately 1:35

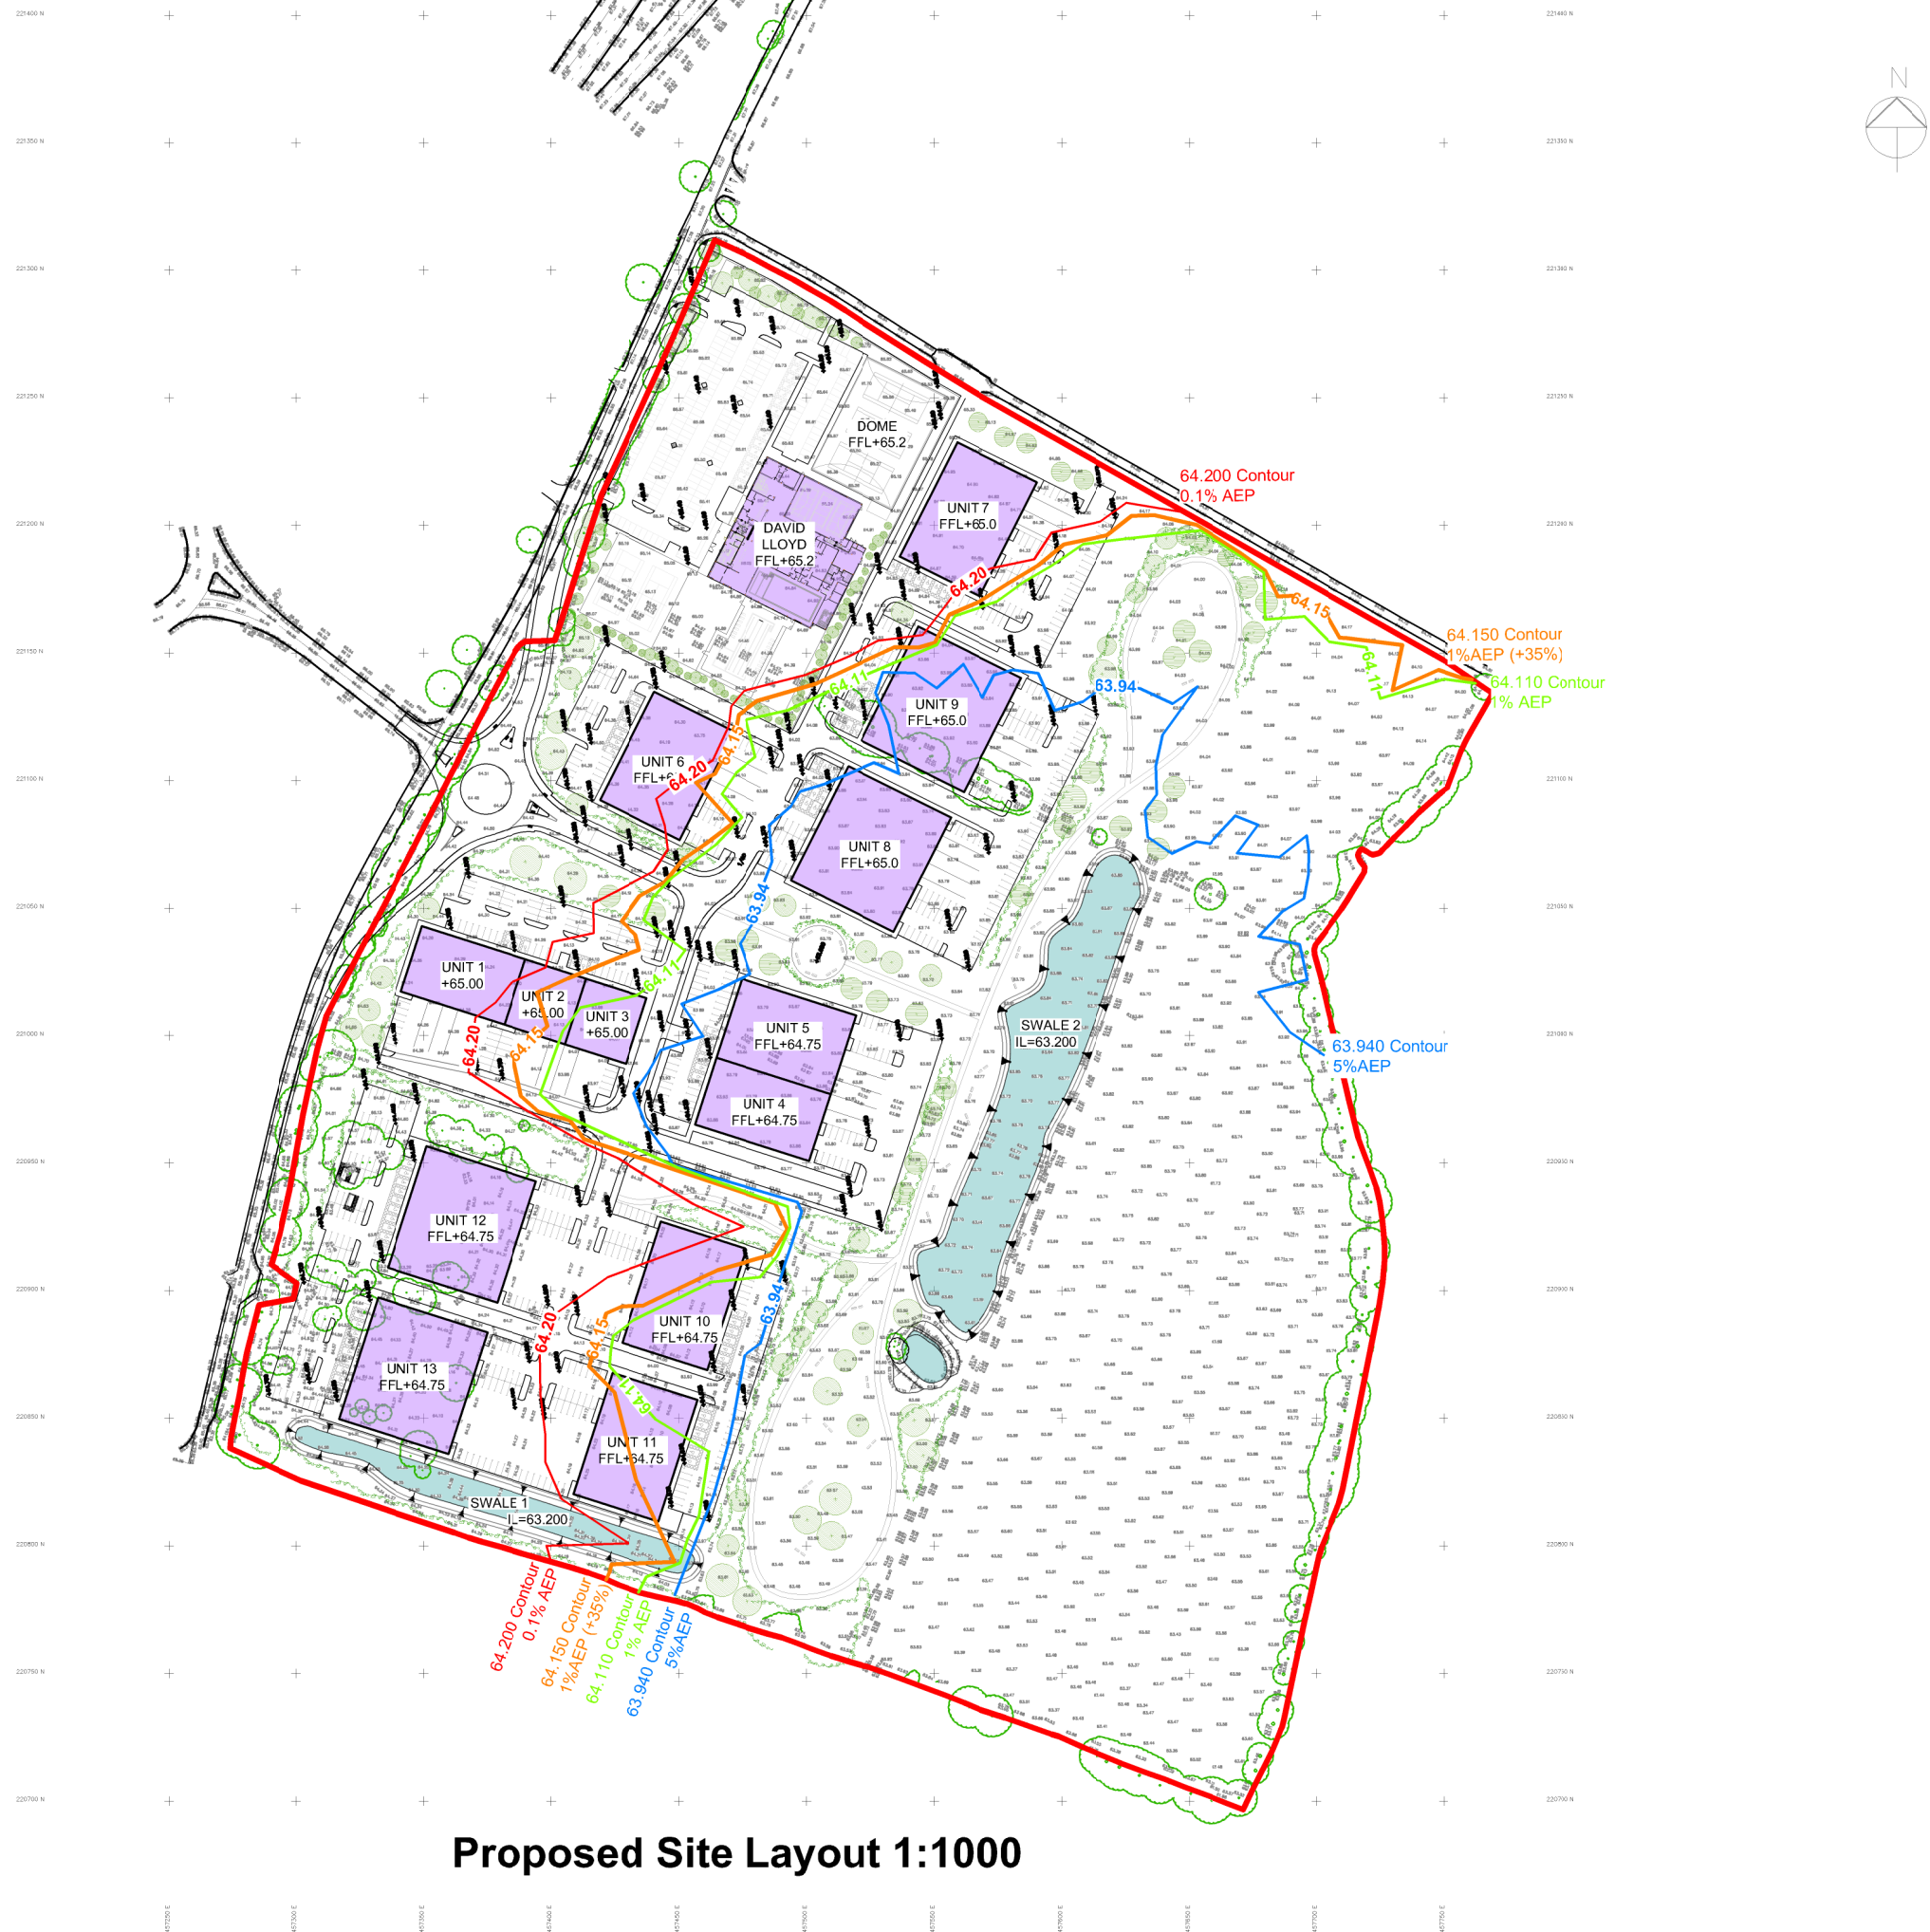
EA FLOOD CONTOUR
OVERLAY

Proposed Site Layout 1:1000

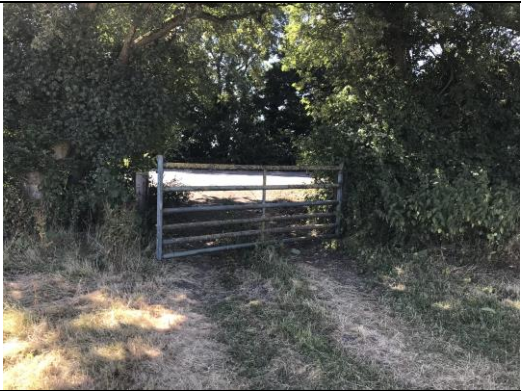
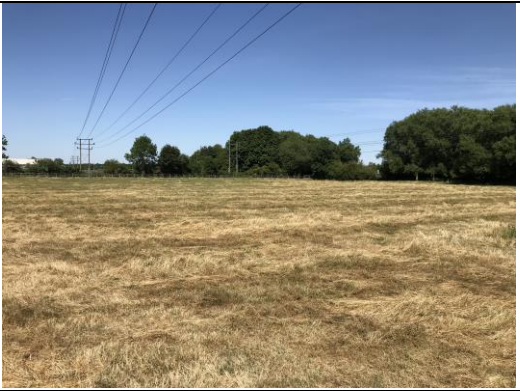
Gated entrance to the site in the northwest	Pylons with associated overhead cables in the west of the site

Pond in the south of the site, facing west towards Wendlebury Farm	Northern boundary of the site, facing east along the access road to the Severn Trent Sewage Works

At the time of the walkover the site comprised three undeveloped grassed fields, understood to be used as grazing for cattle. The fields were unoccupied at the time of the walkover; however, it is understood that the farmer had relocated the cattle for the duration of the investigation works. With the exception of the northern boundary of the site and the boundary with Wendlebury Farm in the south, the fields were all lined with hedgerows and semi-mature and mature trees. Electricity pylons with associated overhead cables, orientated north-south were located along the west of the site with two sets also located in the east. A pond, which was almost entirely hidden by overgrown vegetation and reeds, was present in the south of the site, covering an area of circa 10m x 20m.

The site was bound to the north by an access road to the Severn Trent sewage works, which was segregated by a post and rail fence line, to the east by Langford Brook, to the south by Wendlebury Farm and further fields belonging to the Promised Land Farm and to the west by Wendlebury Road.
