**Bicester Heritage**

**Phase 1 Desk Study**

**Phase 2 Site Investigation Report**

**New Technical Site**

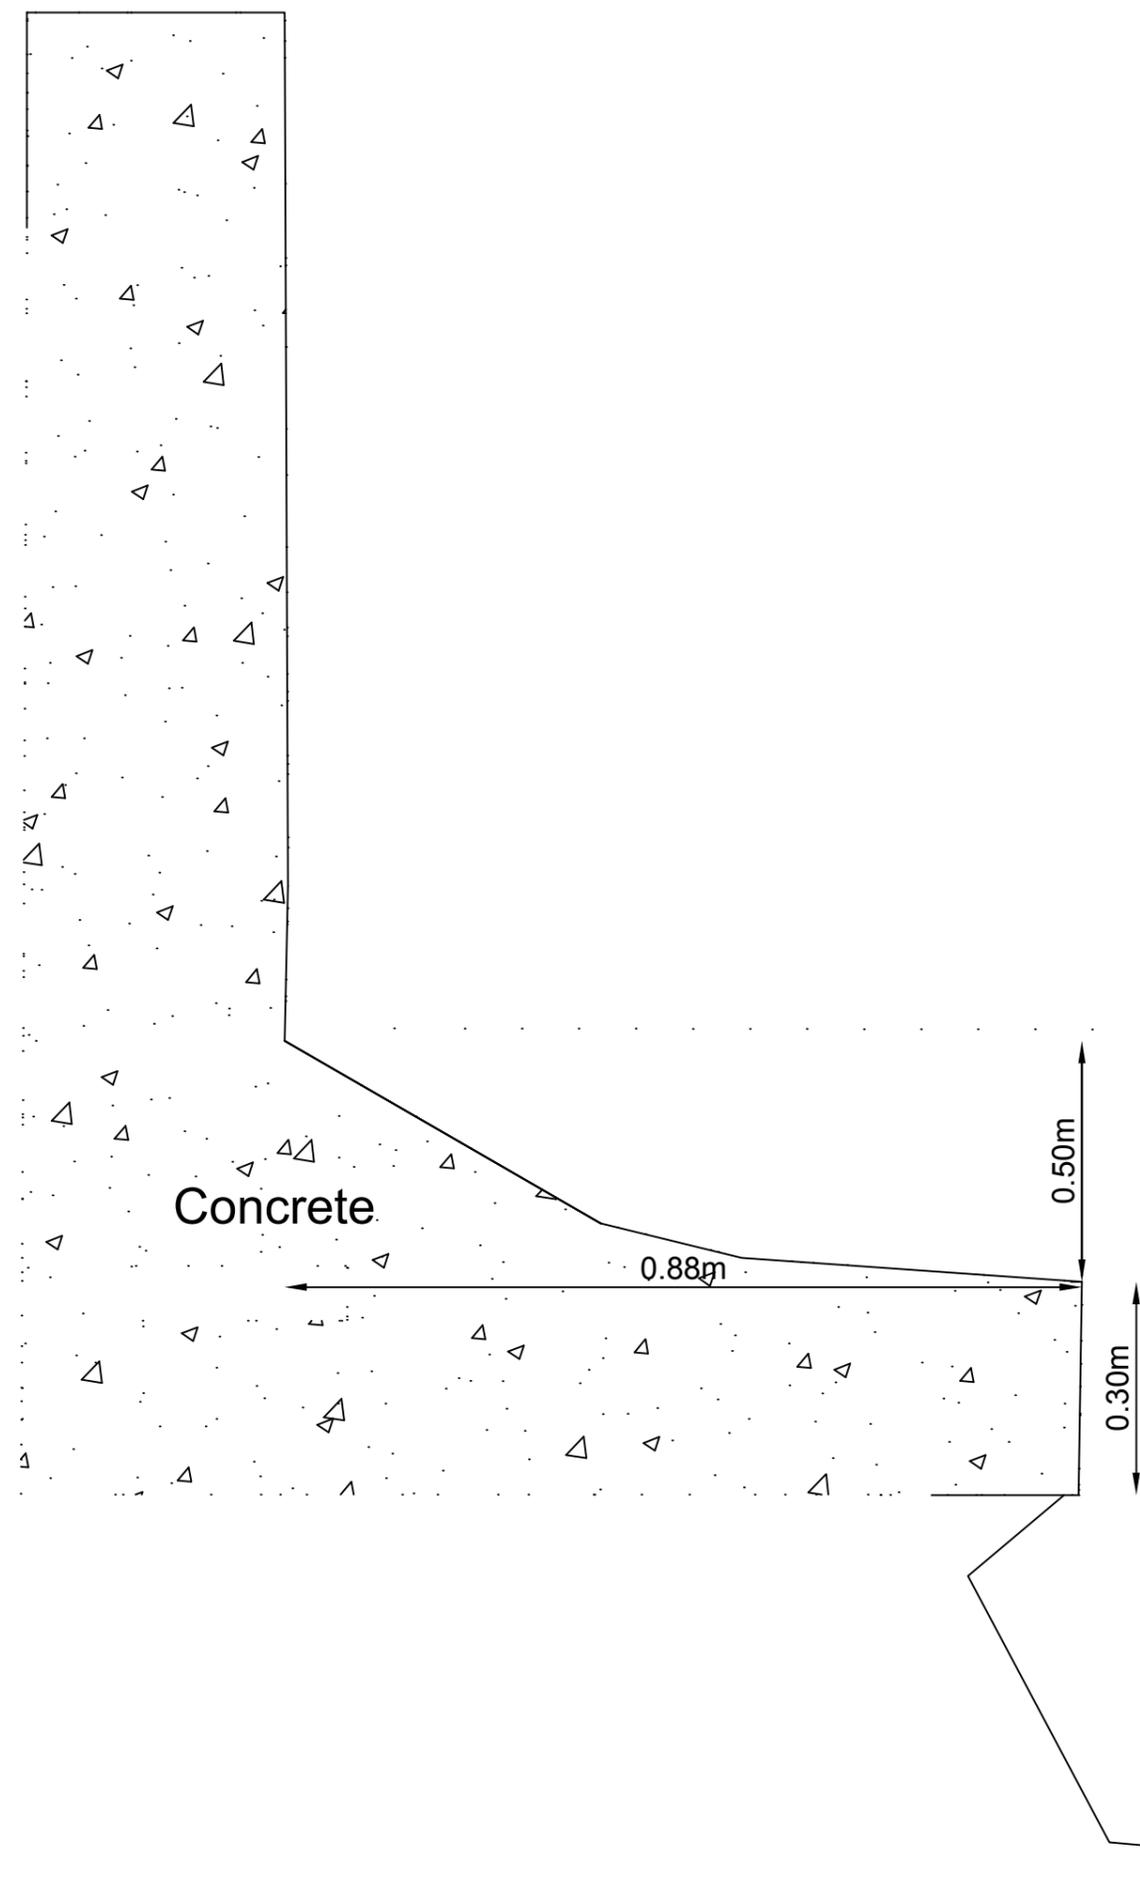
# TP 7

Concrete

0.88m

TP7 was the location of a foundation inspection pit, and was located alongside the external concrete northern blast wall of the pyrotechnics store. A diagrammatical illustration of the exposed foundation is presented in Appendix B of this document. The footing of the wall was located at 0.80m bgl, and was founded on Cornbrash Formation soils.

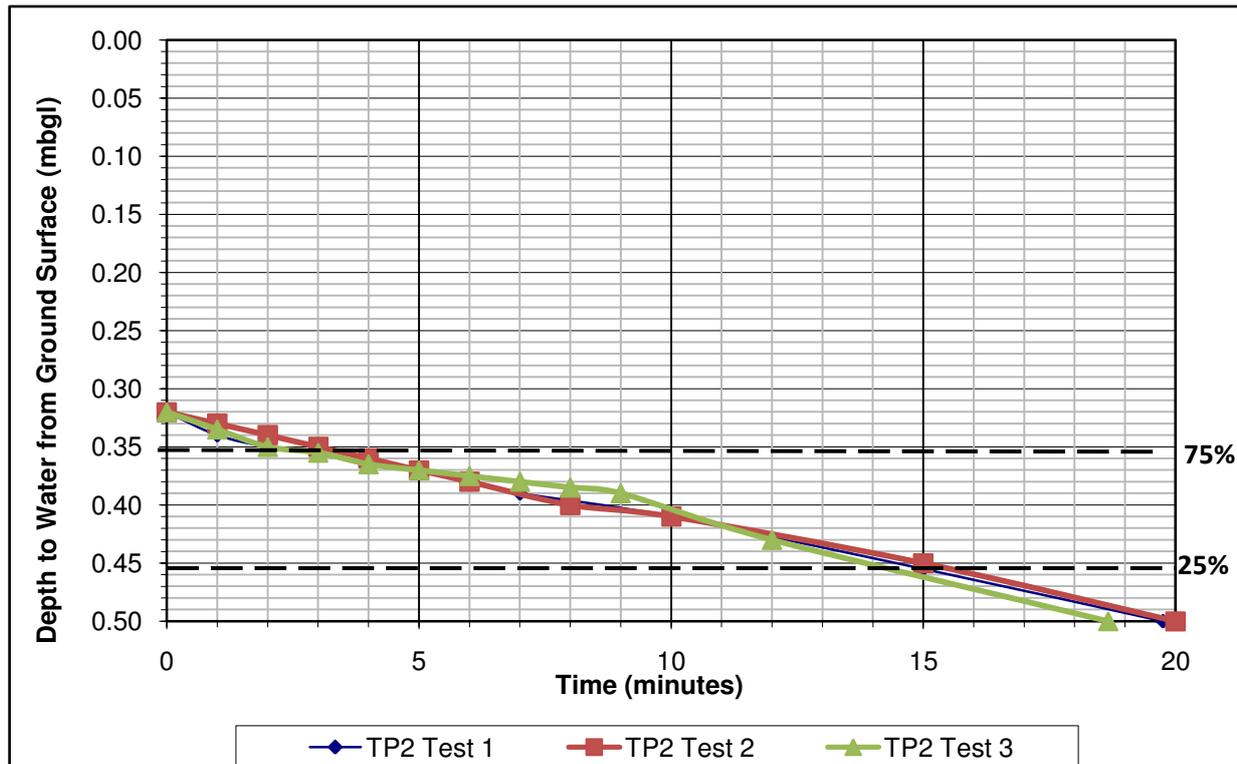
### Trial Pit Infiltration Testing to BRE Digest 365

<b>Client:</b> Bicester Heritage	<b>Report No:</b> 18-08-08
<b>Site:</b> New Technical Site	<b>Date Tested:</b> 17/09/18
<b>Dimensions:</b> 0.60m x 1.90m x 0.50m (width x length x depth)	<b>Test Location:</b> TP2

**Calculated Soil Infiltration Rate =  $9.78 \times 10^{-5}$  m/s to  $1.02 \times 10^{-4}$  m/s**

Infiltration tests were carried out in locations TP1, TP2 and TP3, in general accord with BRE Digest 365 'Soakaway Design'.

The results of the testing provided an infiltration rate of between  $1.02 \times 10^{-4}$  m/s to  $9.78 \times 10^{-5}$  m/s within the Cornbrash Formation, which is expected given that the material is a limestone, and fracture controlled flow, along defined fissures and bedding planes is likely somewhat in effect.

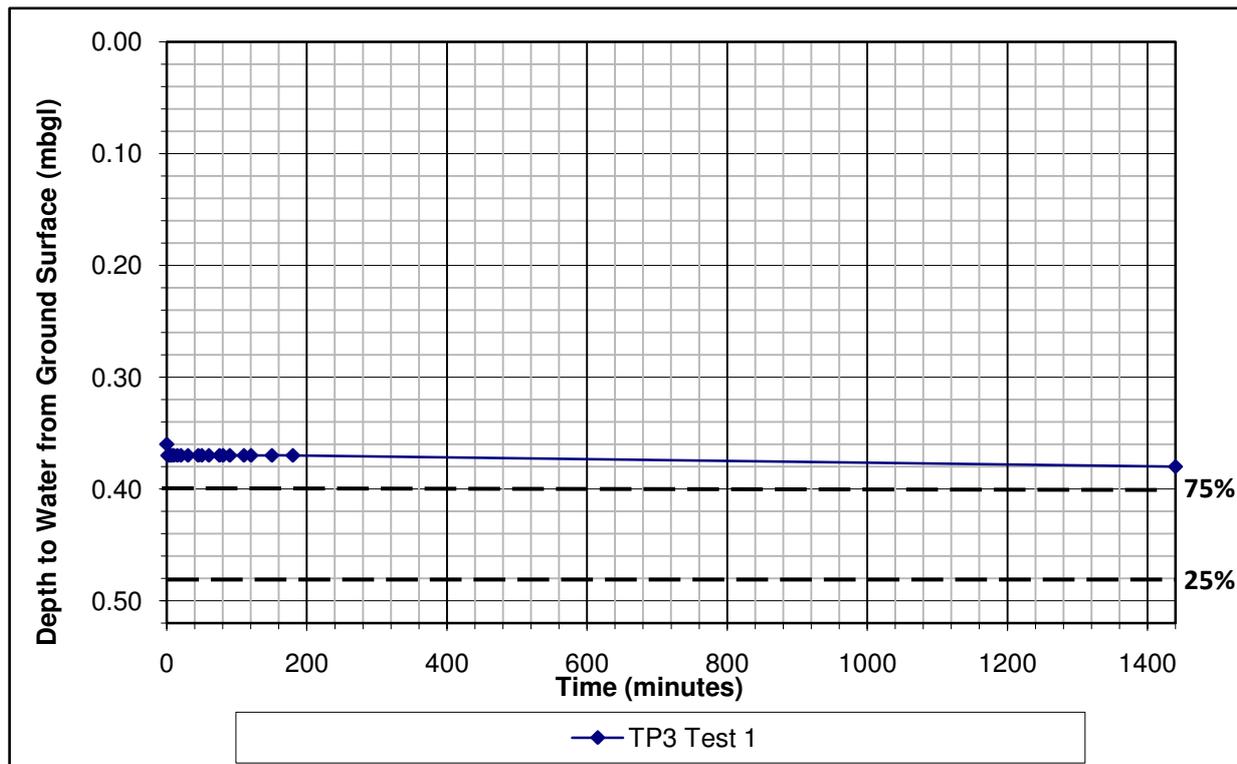
Unable to Calculate Average Soil Infiltration Rate  
Comment: Insufficient drop in water level.

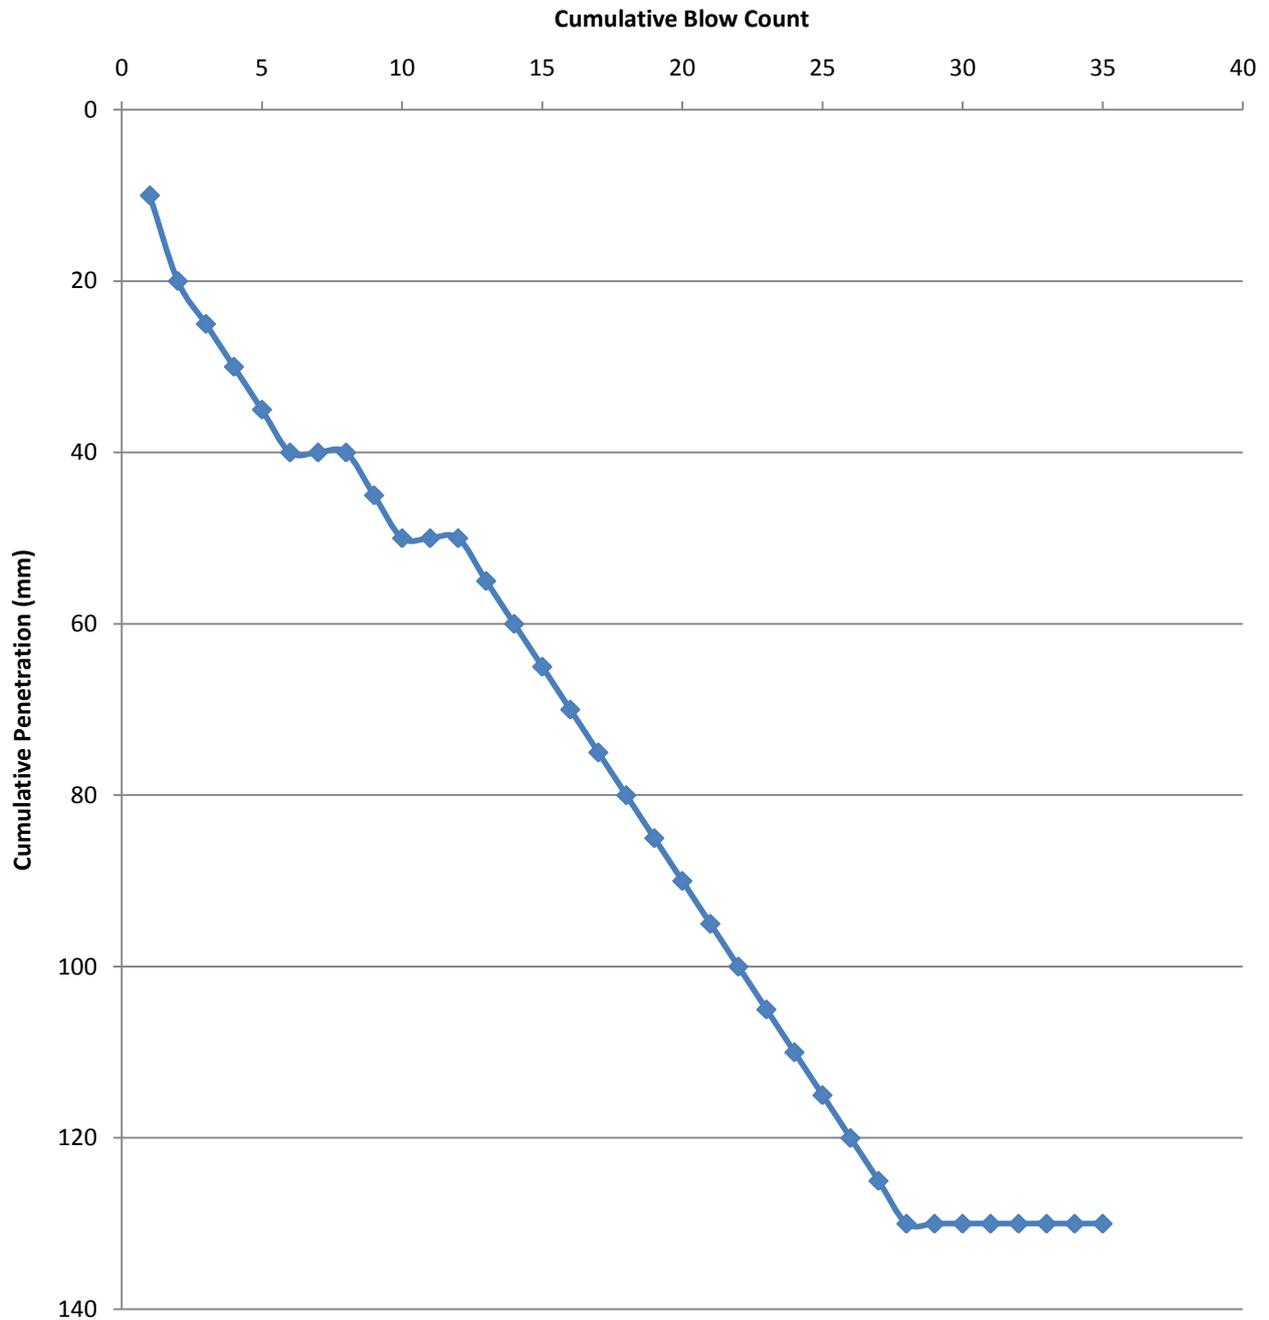
## TRL DYNAMIC CONE PENETROMETER RECORD

### Cumulative Blows Vs Penetration (mm)

Laboratory CBR tests undertaken in the weathered Cornbrash Formation soils from across the site, provided an equivalent CBR of 25.1%, additionally an in-situ TRL Dynamic Cone Penetrometer (DCP) tests (CBR 5) provided an equivalent CBR result of 28%. Therefore it is currently recommended that a value of 25% is adopted for design in these soils.

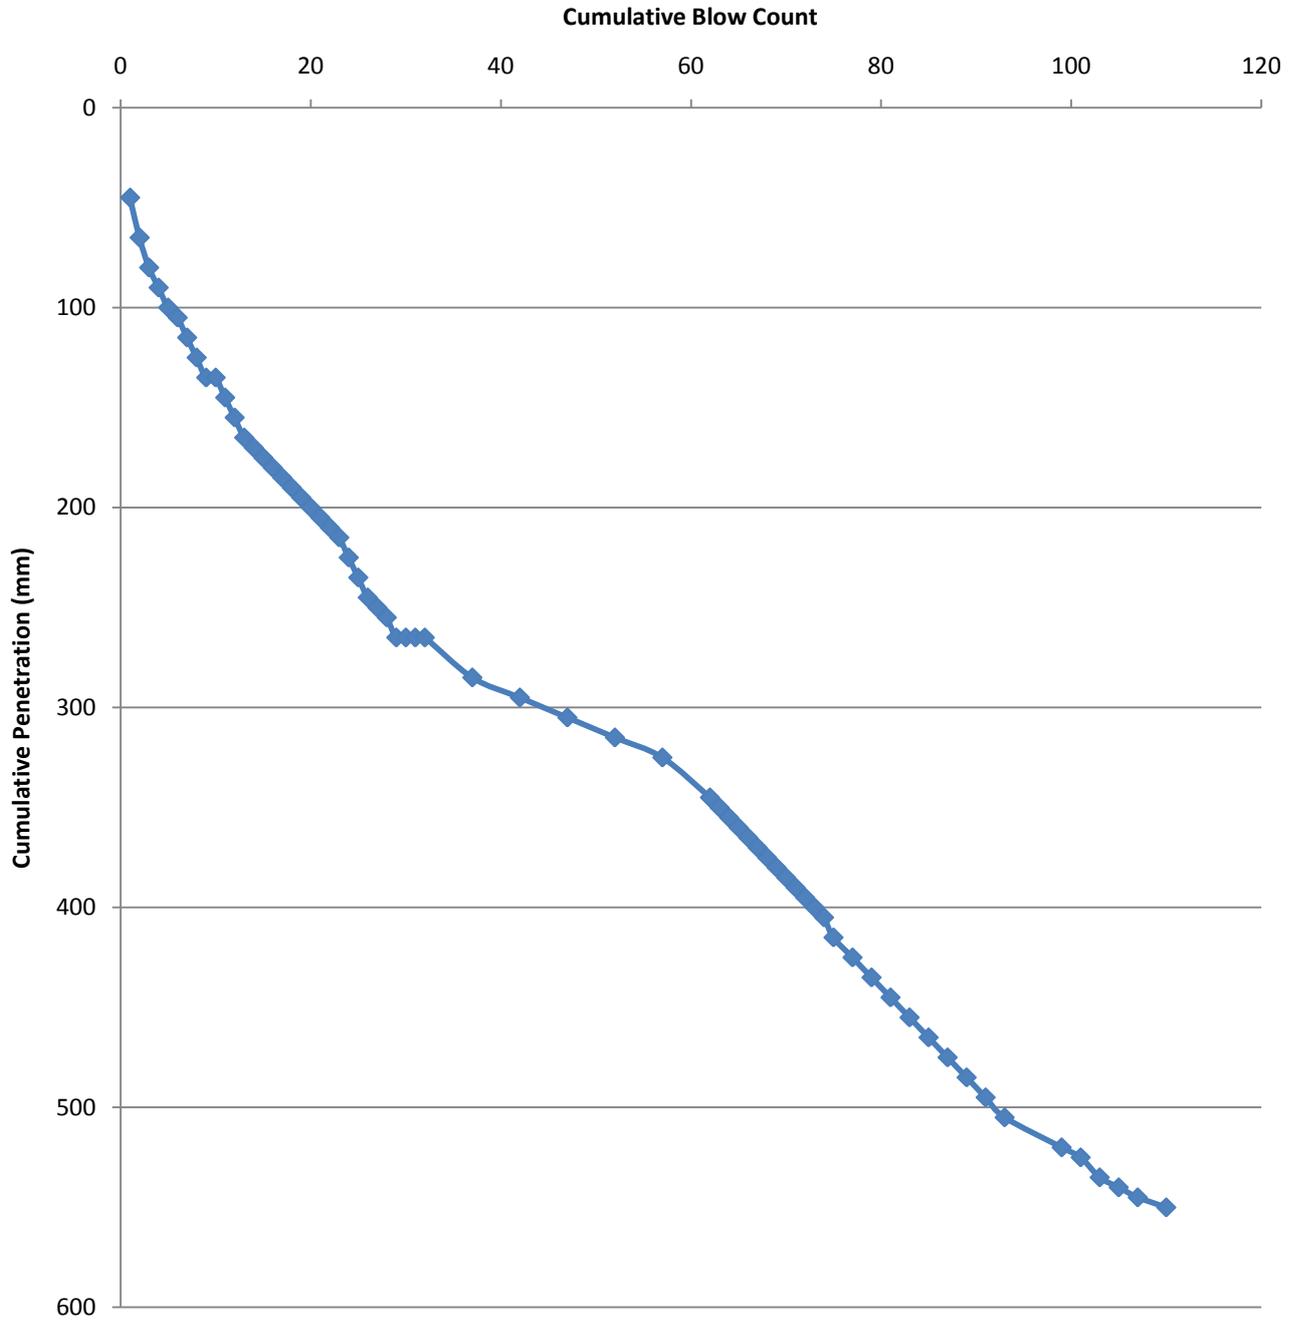
## TRL DYNAMIC CONE PENETROMETER RECORD

### Cumulative Blows Vs Penetration (mm)

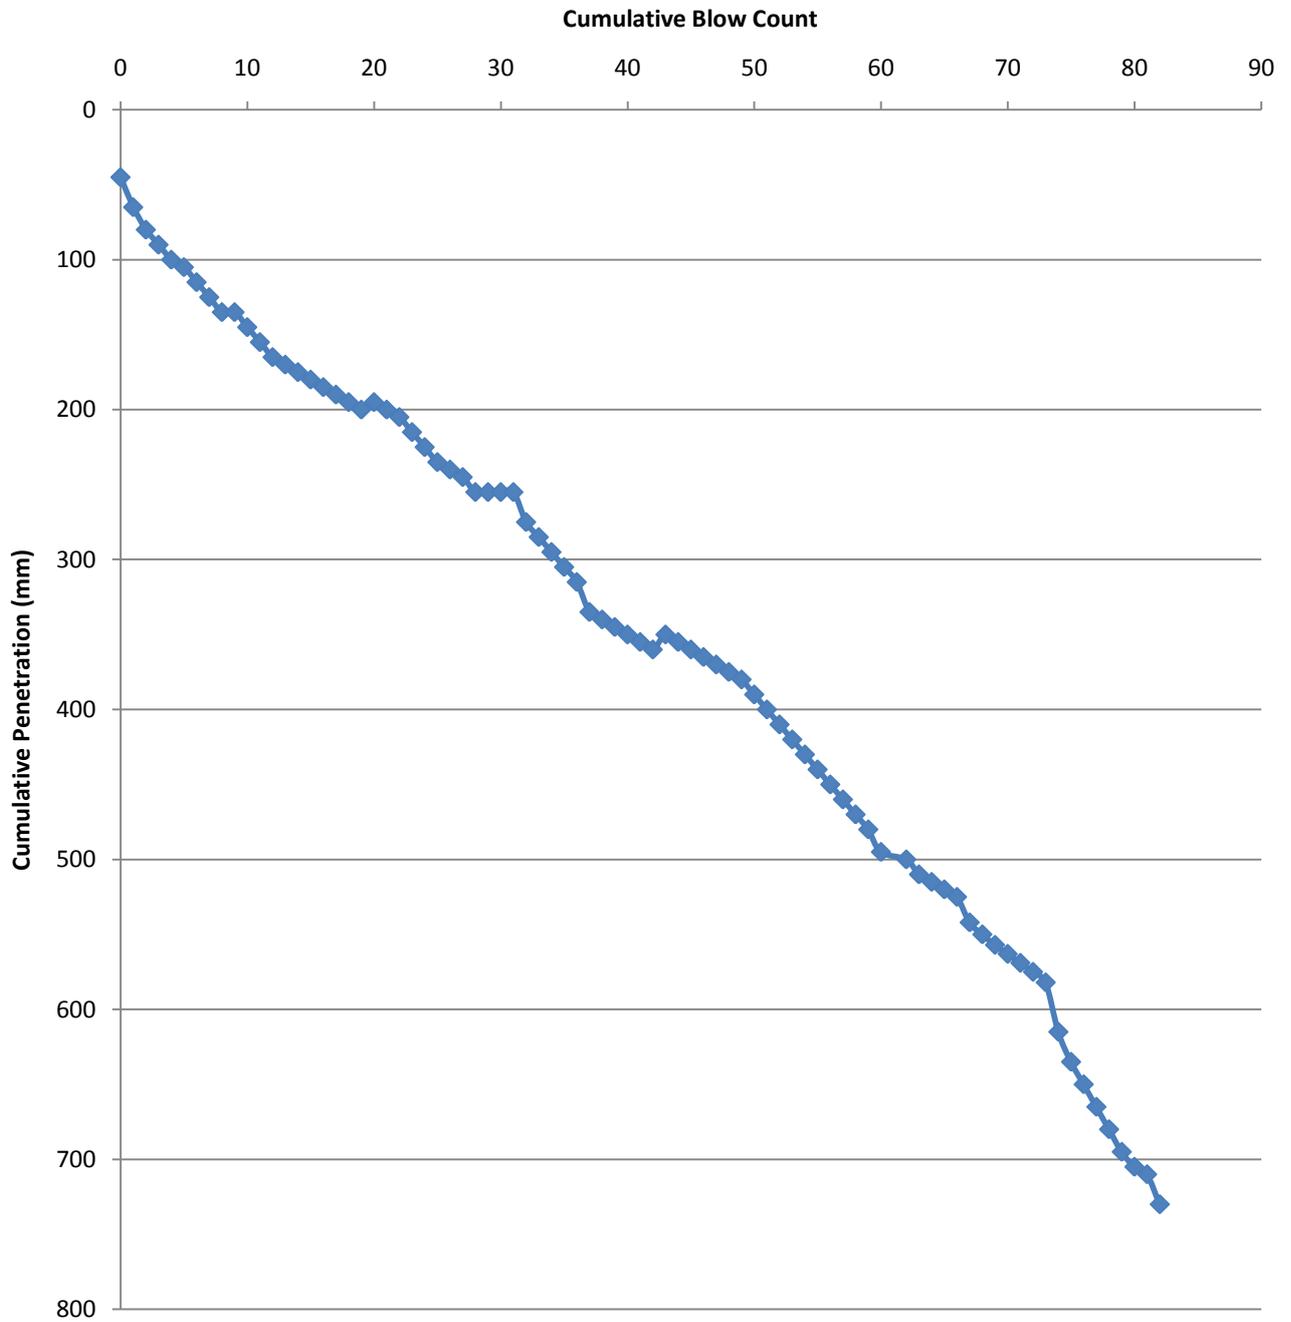
## TRL DYNAMIC CONE PENETROMETER RECORD

### Cumulative Blows Vs Penetration (mm)

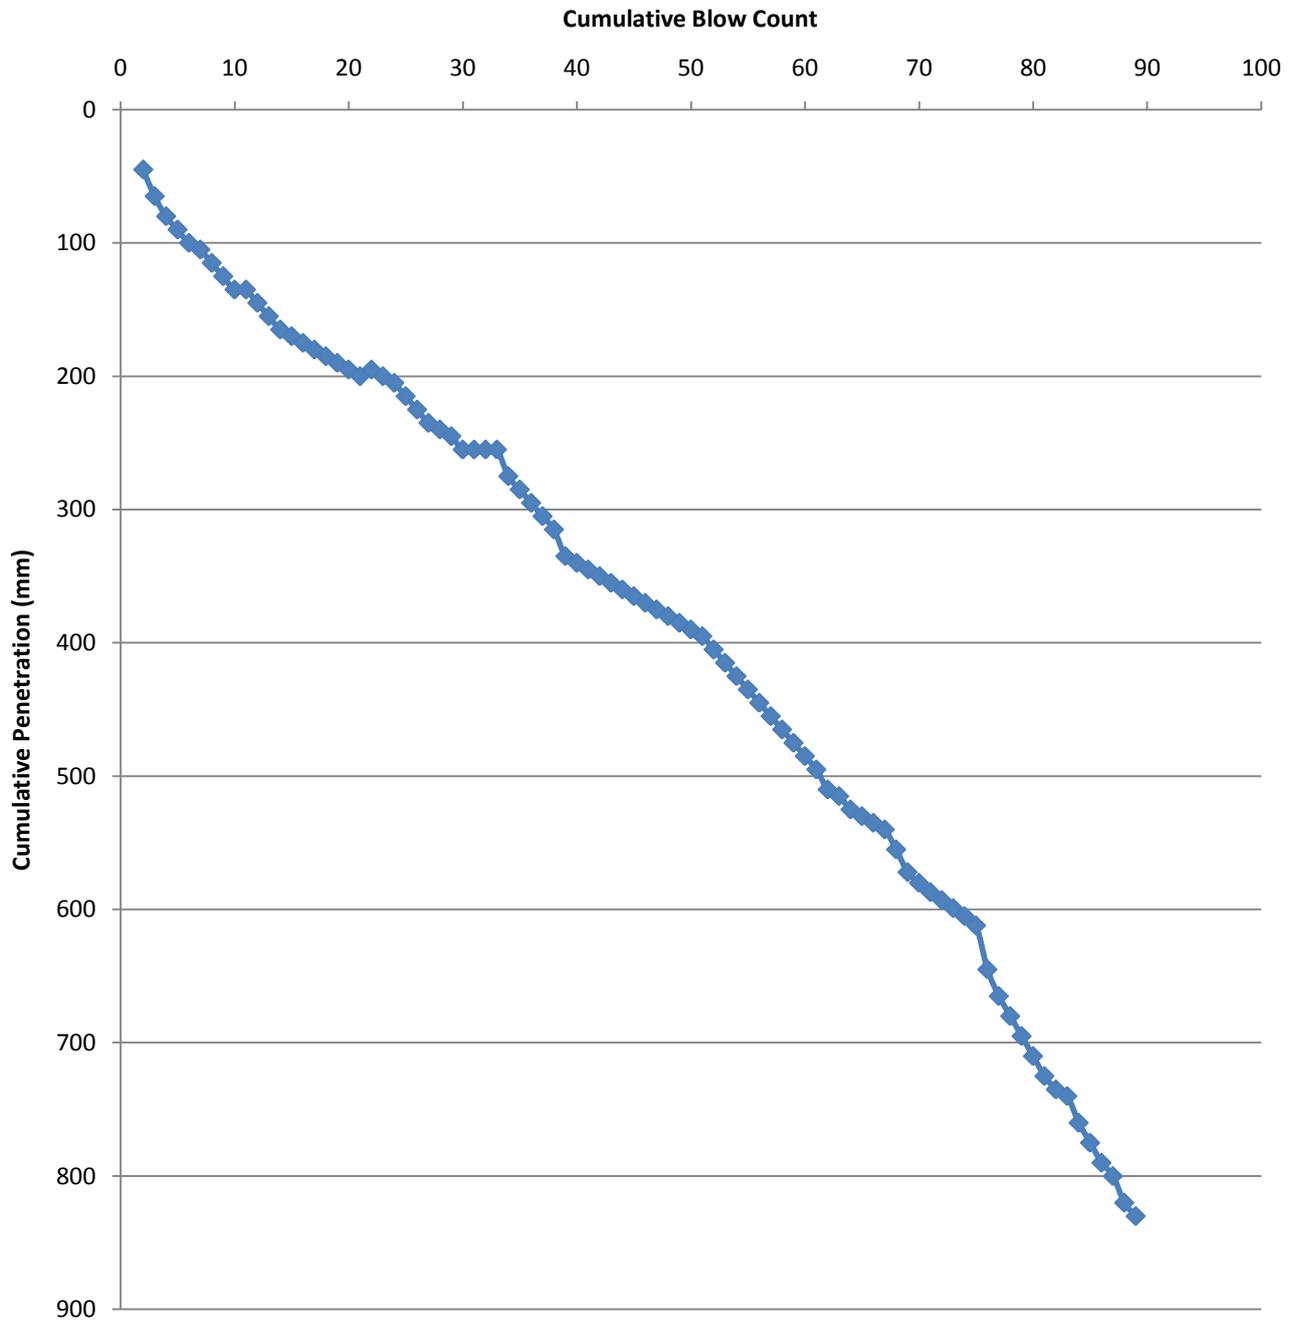
## TRL DYNAMIC CONE PENETROMETER RECORD

### Cumulative Blows Vs Penetration (mm)

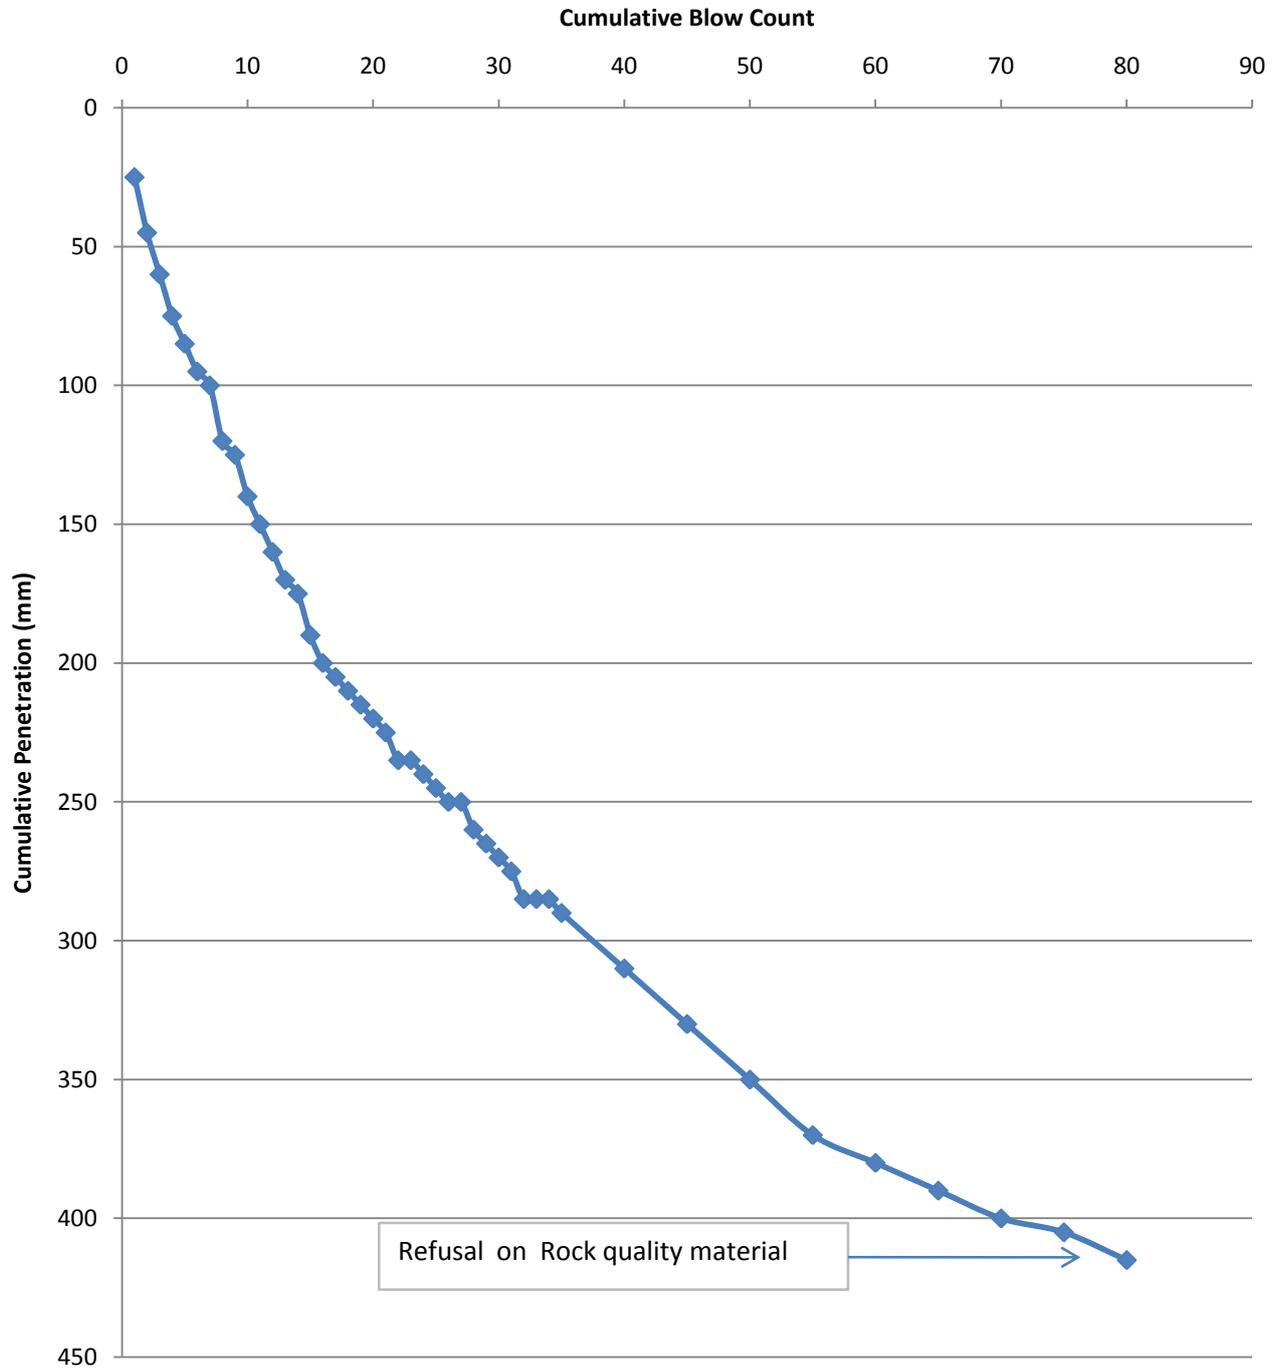
# TRL DYNAMIC CONE PENETROMETER RECORD

## Cumulative Blows Vs Penetration (mm)

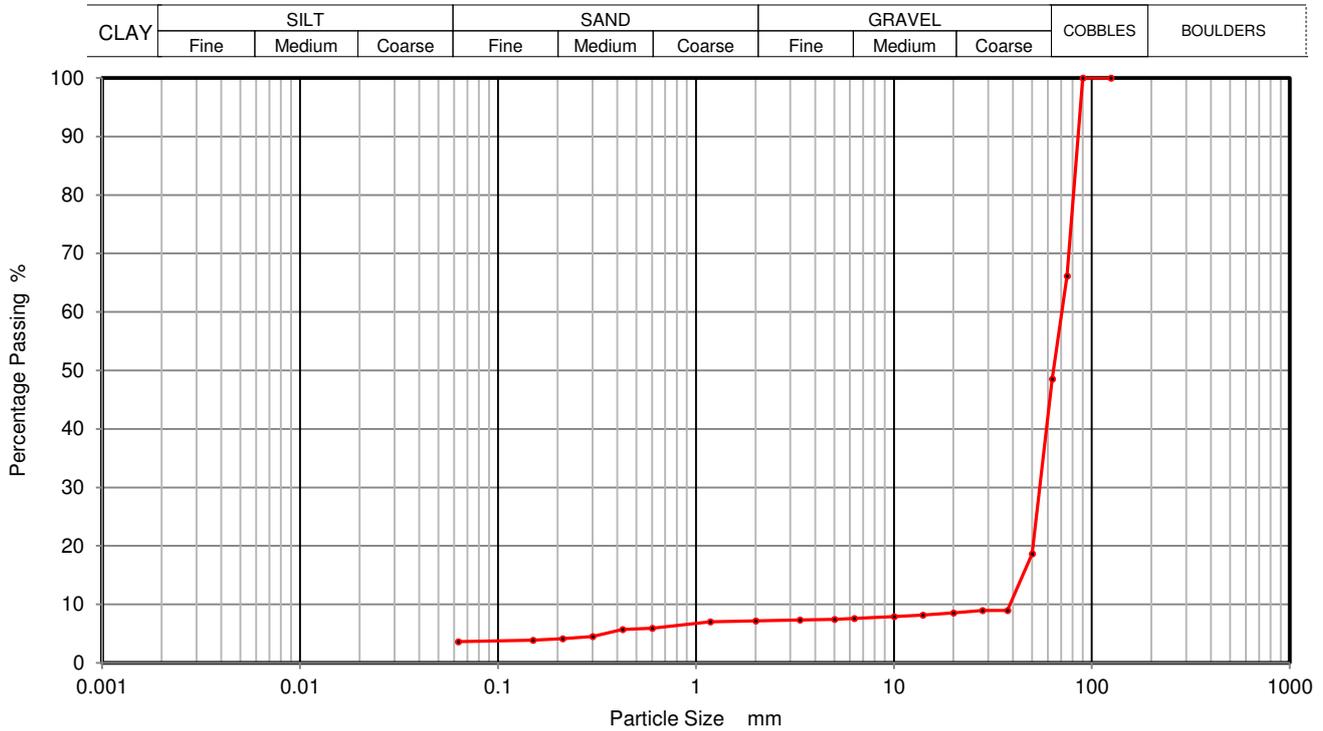
Sieving		Sedimentation	
Particle Size mm	% Passing	Particle Size mm	% Passing
125	100	0.0200	
90	100	0.0060	
75	66	0.0019	
63	49		
50	19		
37.5	9		
28	9		
20	9		
14	8		
10	8		
6.3	8		
5	7		
3.35	7		
2	7		
1.18	7		
0.6	6		
0.425	6		
0.3	5		
0.212	4		
0.15	4		
0.063	4

Sample Proportions	% dry mass
Cobbles	51
Gravel	42
Sand	3
Silt and Clay	4

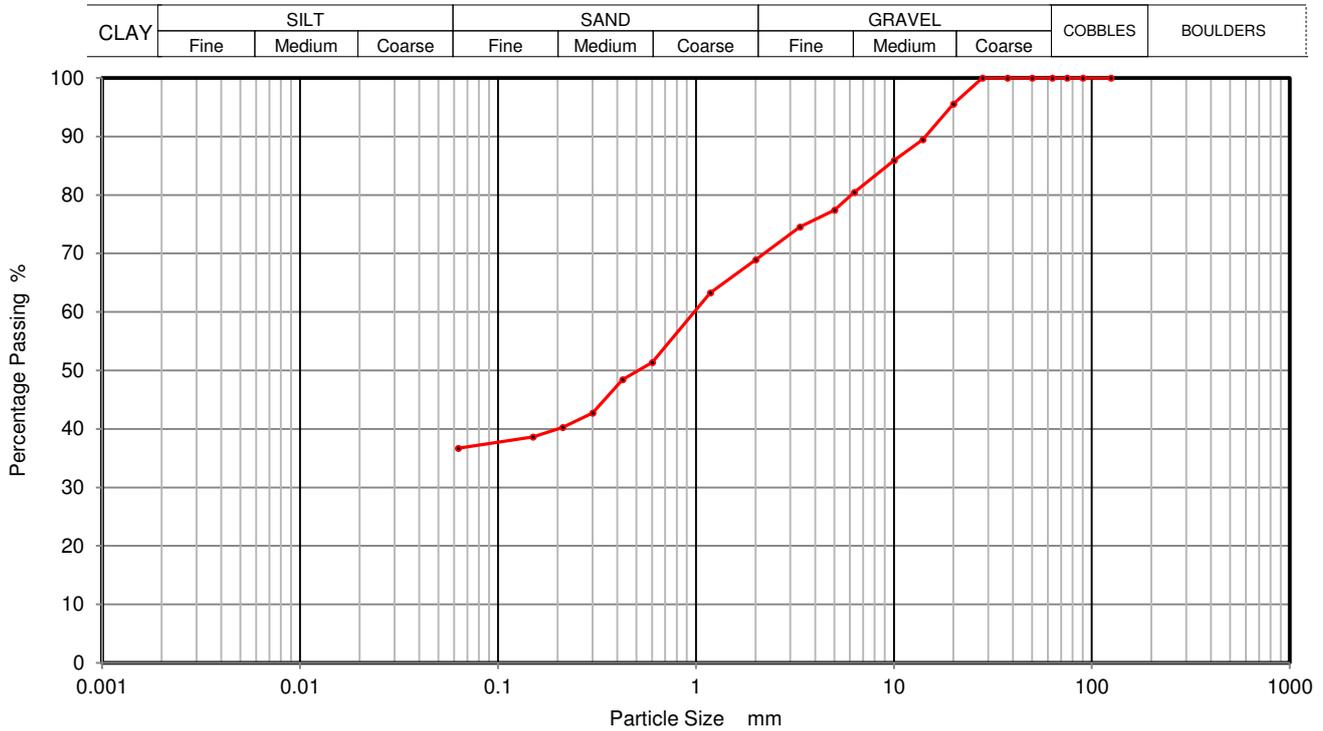
Sieving		Sedimentation	
Particle Size mm	% Passing	Particle Size mm	% Passing
125	100	0.0200	
90	100	0.0060	
75	100	0.0019	
63	100		
50	100		
37.5	100		
28	100		
20	96		
14	89		
10	86		
6.3	80		
5	77		
3.35	75		
2	69		
1.18	63		
0.6	51		
0.425	48		
0.3	43		
0.212	40		
0.15	39		
0.063	37

Sample Proportions	% dry mass
Cobbles	0
Gravel	31
Sand	32
Silt and Clay	37

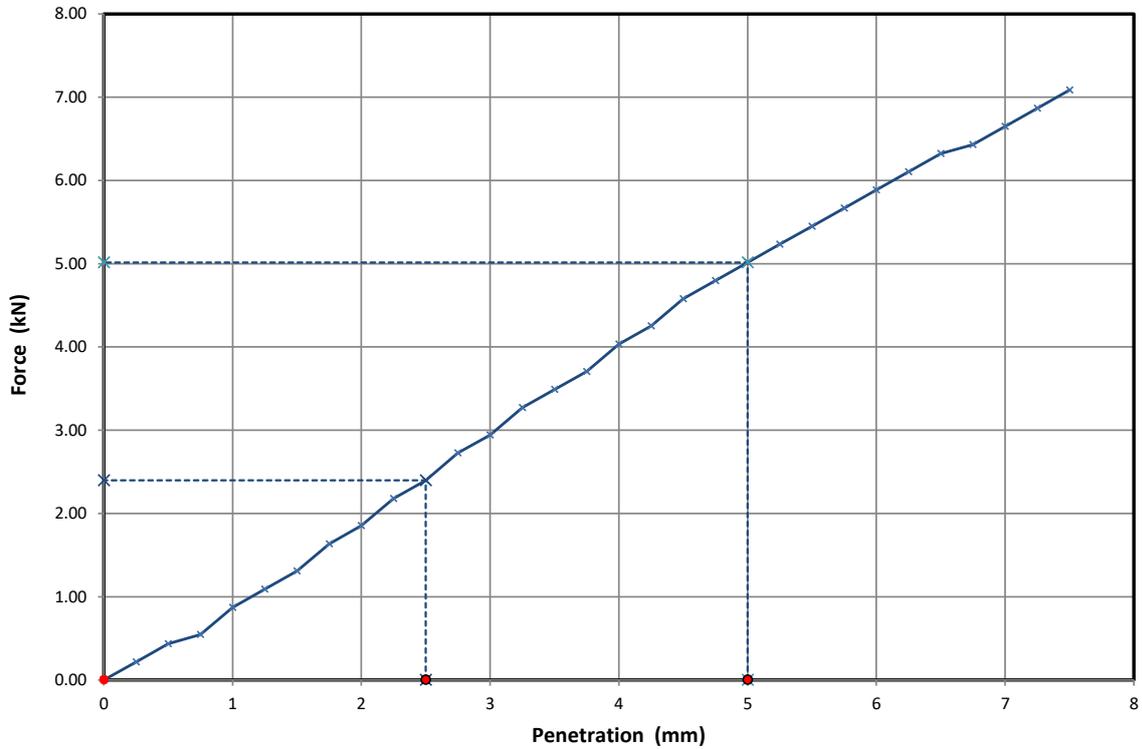
Initial Sample Conditions	
Moisture Content (%)	7.7
Moisture Top (%)	8.5
Moisture Bottom (%)	
Bulk Density (Mg/m3)	1.69
Dry Density (Mg/m3)	1.57

Specified Testing Parameters	
Surcharge (Kg)	2
Soaking Time (hours)	N/A
Swelling (mm)	N/A
Remarks

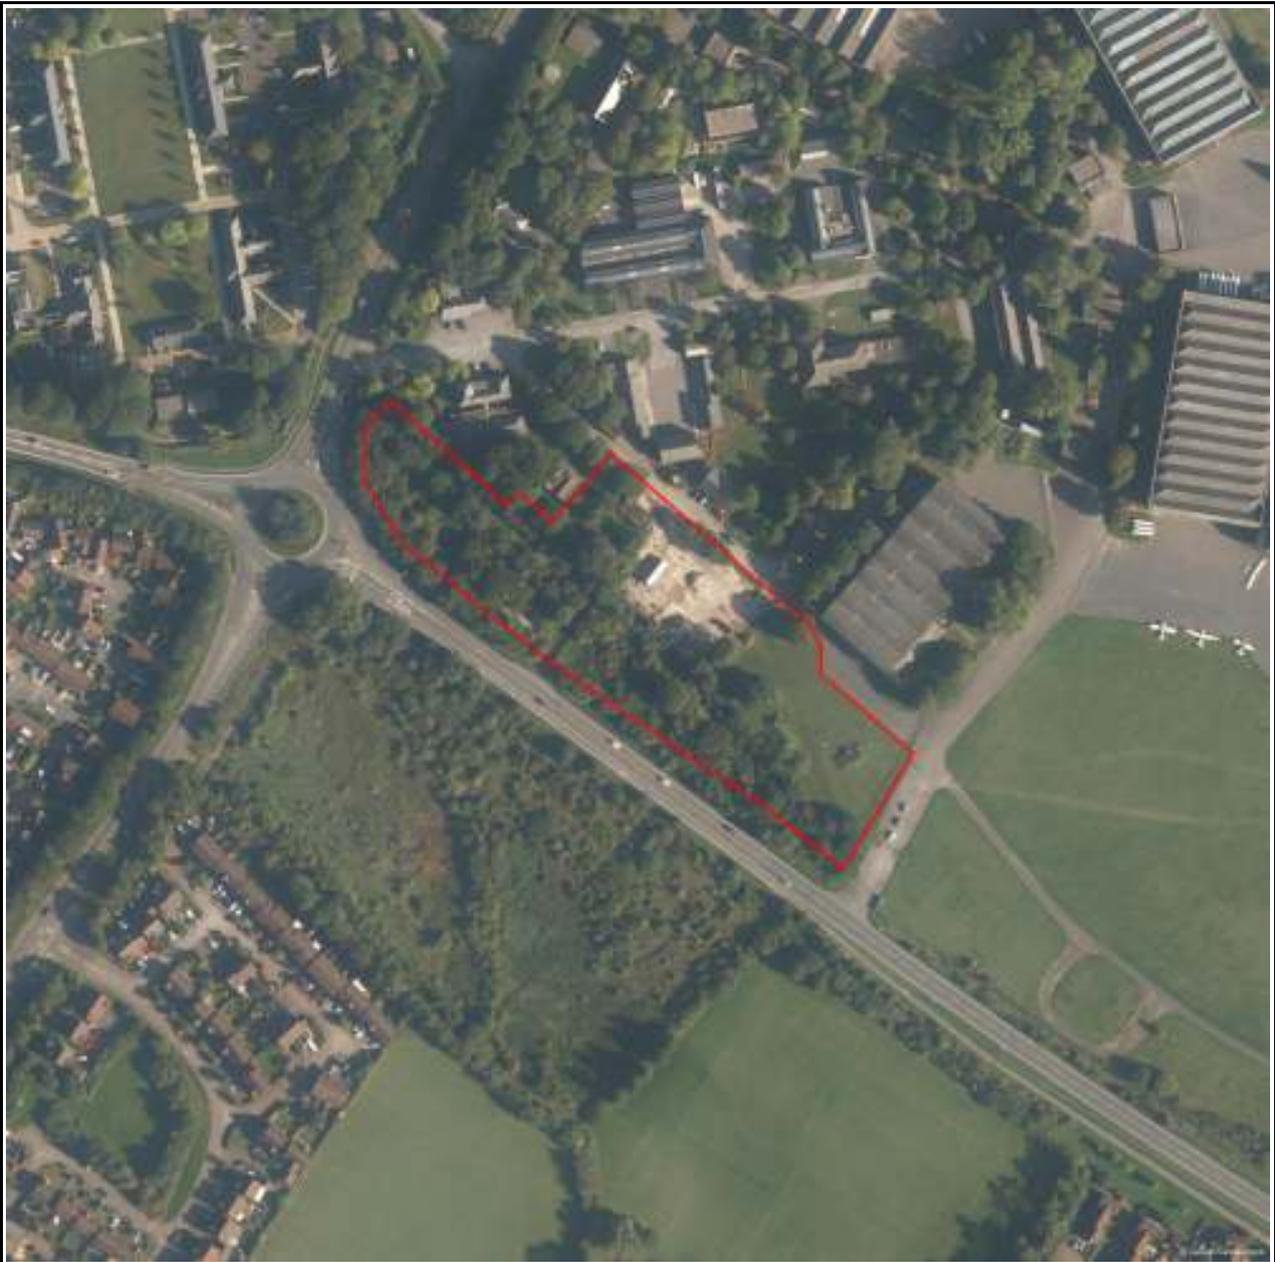
Aerial Photograph Capture date: 20-Apr-2016  
Grid Reference: 459133,224305  
Site Size: 1.66ha

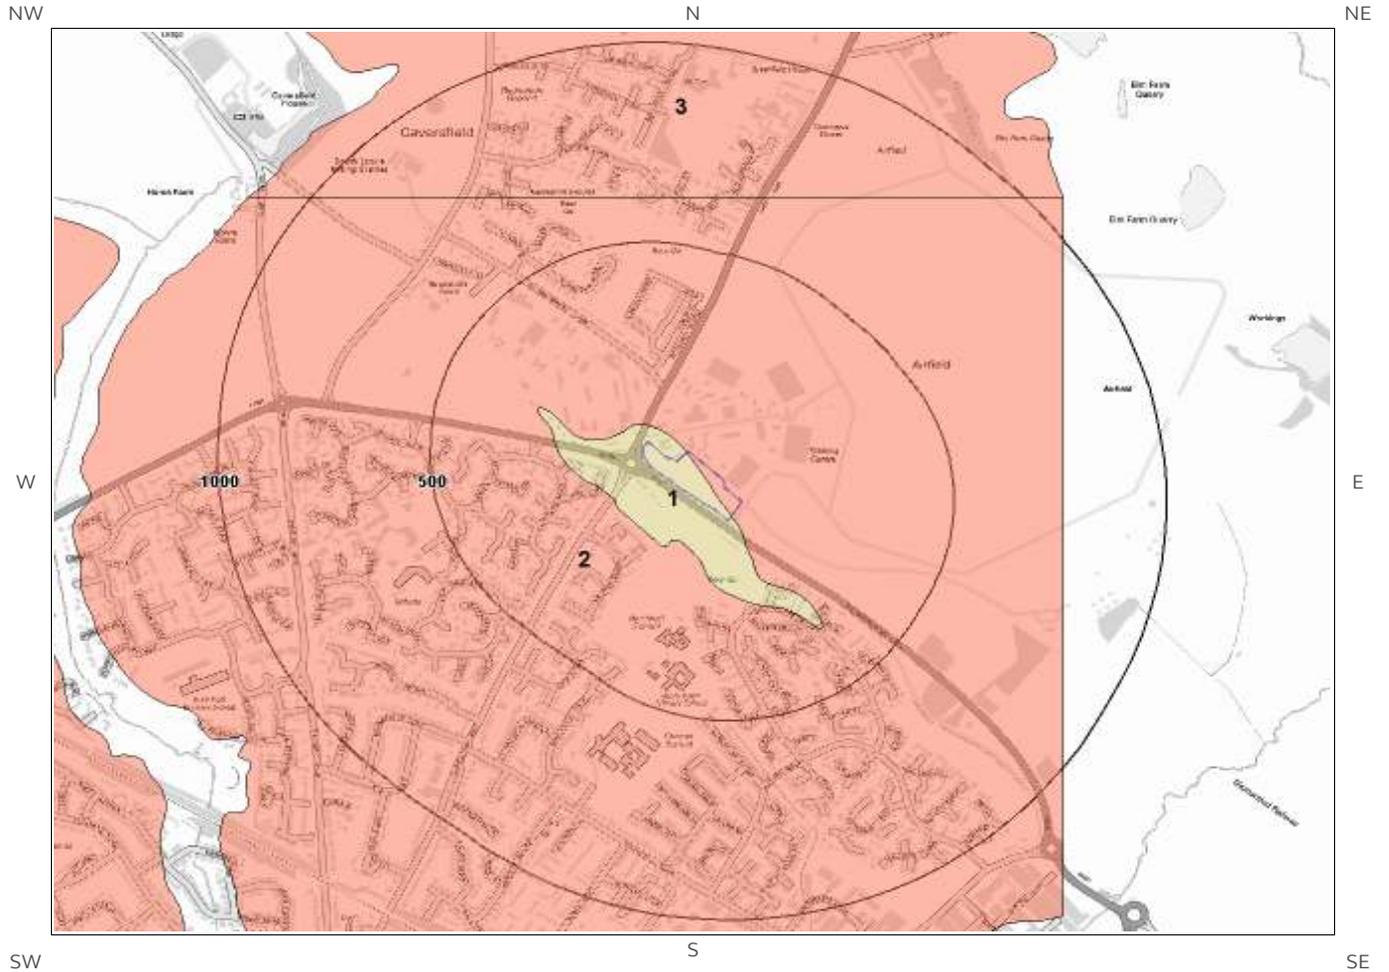
# 1.3 Bedrock and linear features map (1:10,000 scale)

This Geology shows the main components as discrete layers, these are: Artificial / Made Ground, Superficial / Drift Geology and Landslips. These are all displayed with the BGS Lexicon code for the rock unit and BGS sheet number. Not all of the main geological components have nationwide coverage.
