## DESIGN and ACCESS STATEMENT

### The Finishing House

### APPLICATION FOR CONVERSION OF BARN TO DWELLING

**Proposal:** Change of Use, conversion of, and associated works to, the existing agricultural building to form a dwellinghouse

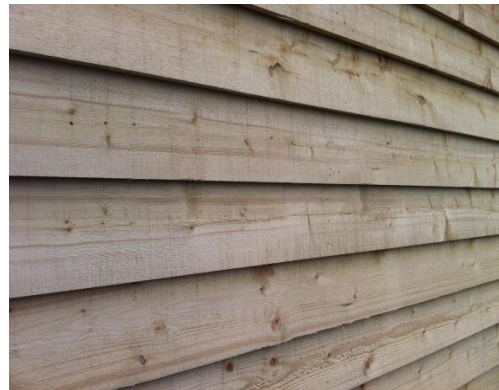
It is proposed to retain the 1960's farm building aesthetic. The existing gables are fully clad in timber, echoing other timber clad buildings in the adjacent farmyard, so the main gable wall panels would be reclad where necessary in horizontal, tanilised, square edged Larch boards (25x150mm showing 125mm of each board) to match the existing. The walls between the blockwork piers will be clad in horizontal timber boarding to match the gables.

Typical square edged boarding detail

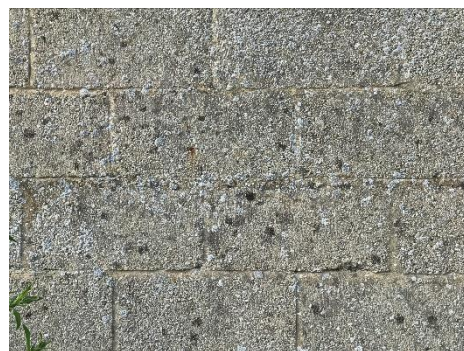
The existing exposed concrete block piers that thicken the walls to form buttresses would remain exposed as concrete block built structures. Concrete blocks will also be visible at plinth level below the cladding. The concrete blockwork is in good condition and will only require repointing.

Typical existing concrete block detail  
(before repointing)

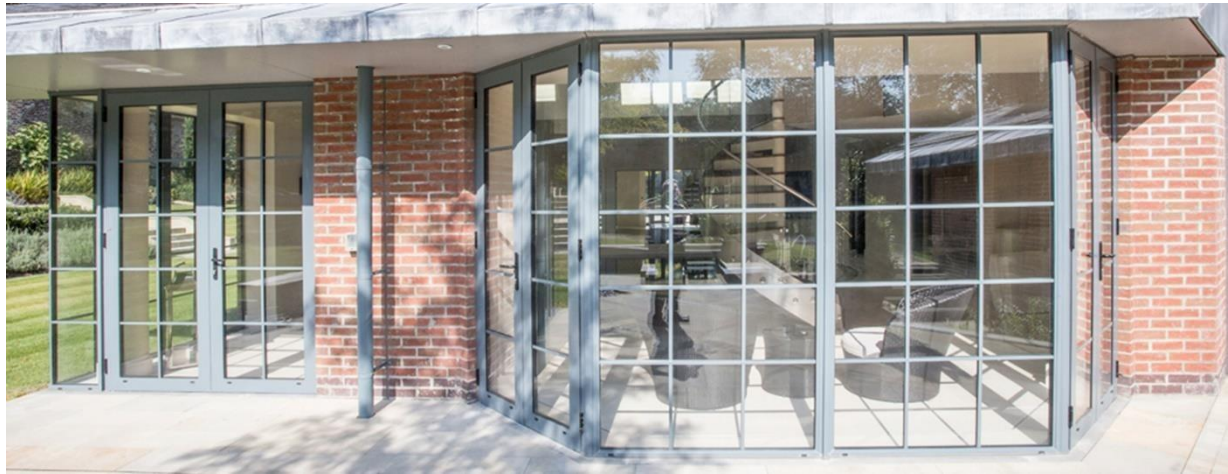
The windows will be of a metal 'Crittall'-type manufacture with a galvanised finish, painted to RAL7016 (Anthracite). The standard Crittall section of frame, casements and glazing bar details are proposed. The upper part of the windows that corresponds to the existing vent flaps will be delineated by incorporating galvanised breeze-soleil to reduce summer solar gain, again RAL7016.

Typical detail of Crittal-type windows (to illustrate style, colour to be RAL7016, Anthracite, see below)

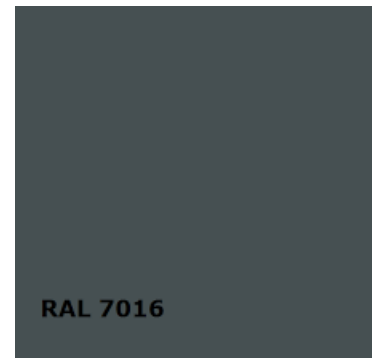
The fibre cement roof covering will be replaced by a Kingspan RW1000 (or similar), which is a composite profile metal sheet upper and lower with integral rigid insulation, 120mm overall thickness to meet exceed ADL1B Building Regulations.

Kingspan RW1000 color swatch RAL7016

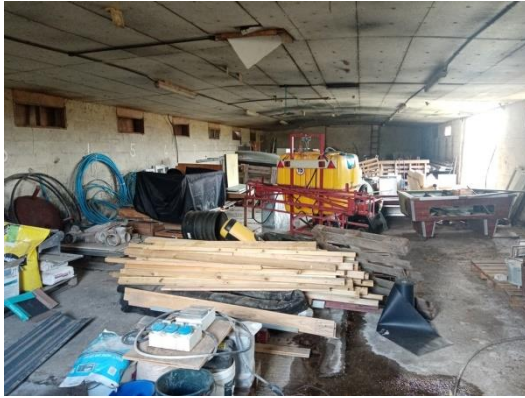
- 2.3.1 The barn is a disused pig sty which is currently used for farm storage (see Plate 1 below). The barn has a pitched corrugated cement/asbestos roof with 3 large vents on the ridge (see Plate 2 below). In some places ridge sections are missing. The walls have been constructed using concrete blocks with timber cladding on the east and west elevations (see Plate 2 below). Numerous timber boards are missing on the east elevation (see Plate 2 below) providing access to the interior loft void and promoting high light levels and a draughty internal environment. Large open access is available on the southern elevation via open barn door entrance with additional access via windows (see Plate 2 below). Occasional open cobweb shrouded gaps are present on the southwest elevation around window frames, they do not provide suitable potential bat roosting habitat.

Plate 1: Internal section of barn

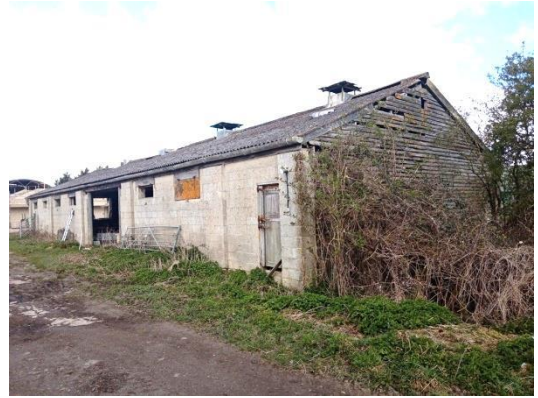
Plate 2: External view including timber boarding and open doorway

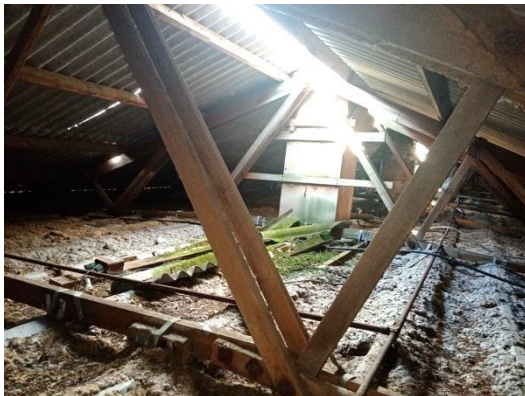
- 2.3.2 The barn includes a loft void running the length of the roof space with a single internal partition wall with large enough holes/gaps to consider the void as a single void (see Plate 3 below). Roof timbers are close fitting and cobwebbed with no potential roosting features for bats. No ridge-beam is present. Missing ridge sheets and missing timber boarding on gable walls promotes a draughty internal environment with relatively high light levels (see Plate 3 below).

Plate 3: Loft void with high light levels
