Crockwell Farm, Great Bourton, Oxfordshire

Conversion of an existing barn for residential use, and associated matters

Heritage Statement

Graham Keevill BA (Hon) FSA MCifA
Keevill Heritage Ltd
for Crockwell Farm LLP
June 2020

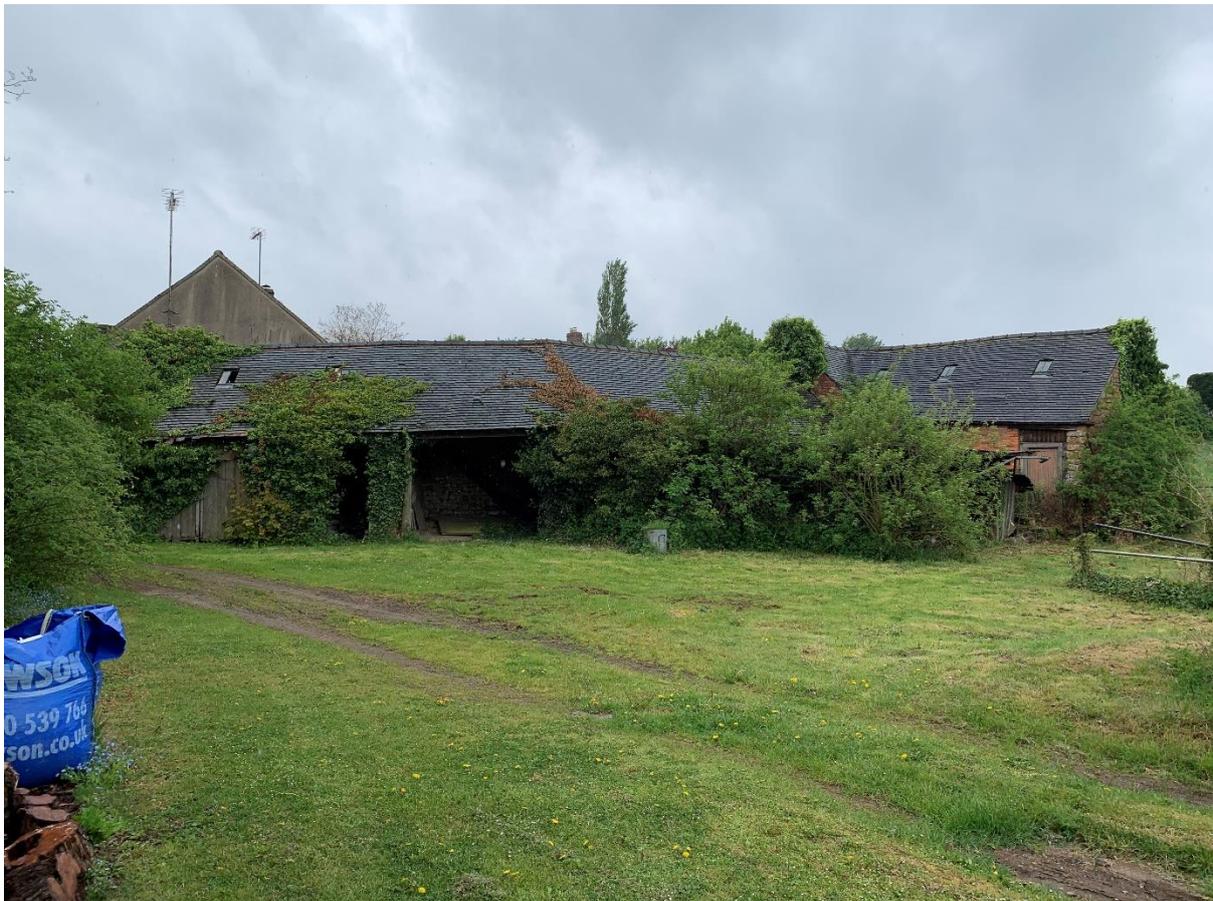
Figure 1: The barn range to be converted looking south, with building 1 to the left of centre, building 2 to right of centre, and building 4 on the right. The modern extension (building 3) is hidden by shrubs and saplings in the middle. The gable to the left is a separate property behind the farmyard, and not relevant to this report.

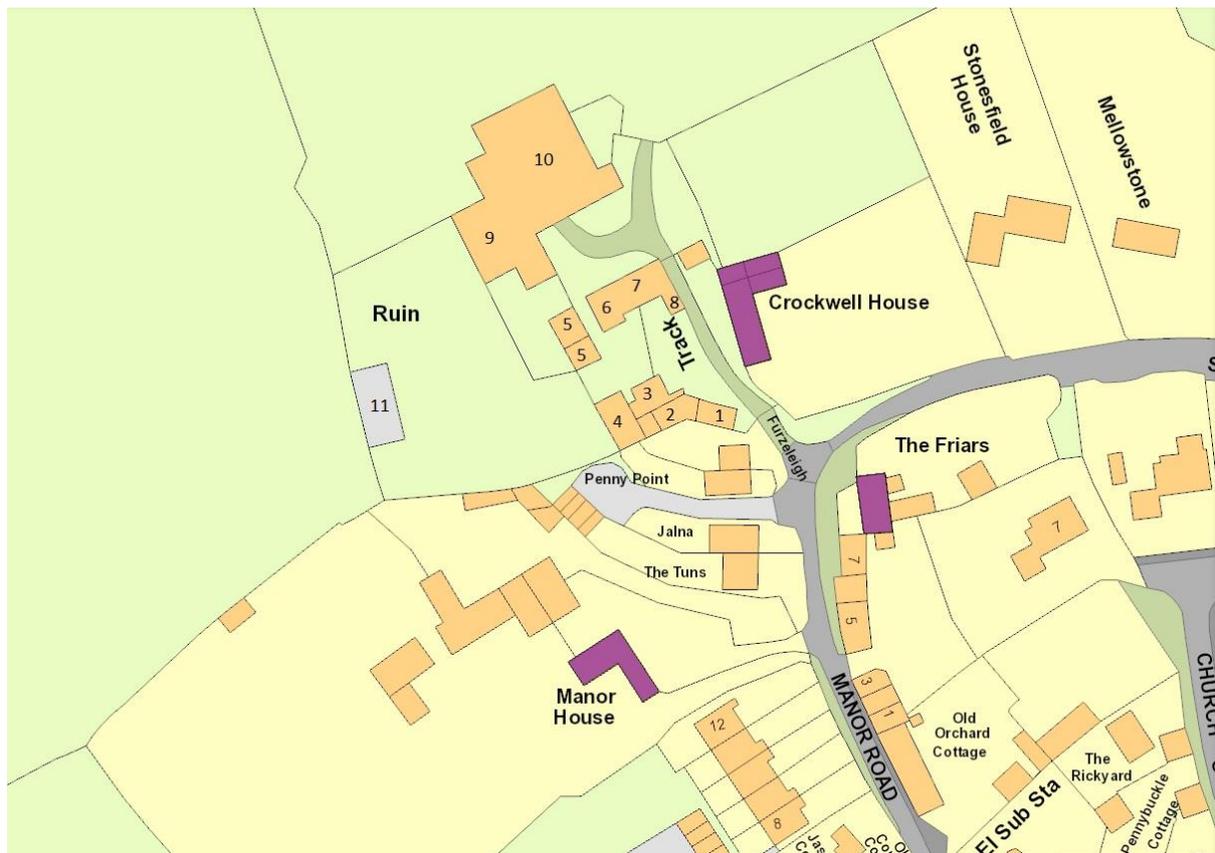
Figure 3: Plan of the farmyard with the building numbers included, after Soden 2016. The farmhouse, Manor House and The Friars are also shown; all three are Grade II listed.

The agricultural land at Great Bourton was the subject of inclosure under a private act of Parliament in 1777; the award was signed in 1778. Unfortunately there does not appear to be a Tithe award, perhaps because of the village's subservient position to Cropredy. The earliest useful historic map is therefore the 25inch to one mile (1:2500) Ordnance Survey edition of 1882. This shows all buildings then present.¹¹ Further 25inch editions followed in 1900 and 1922, but there was a hiatus from then until the next large-scale map was published in 1972. Fortunately a 6-inch (1:10,560) edition of 1955 fills the gap, although the smaller scale inevitably means that the buildings on any given site are not shown in as much detail. The accuracy, however, is still good. Extracts from the Groundsure-sourced copies of all these editions, as well as those of 1989 and 2003 (1:1250 mapping), are provided on the following pages. Short commentaries in the captions describe points of interest for the site's historic development. Reference should also be made to the building numbers from the Soden 2016 report, as shown on Figure 3.

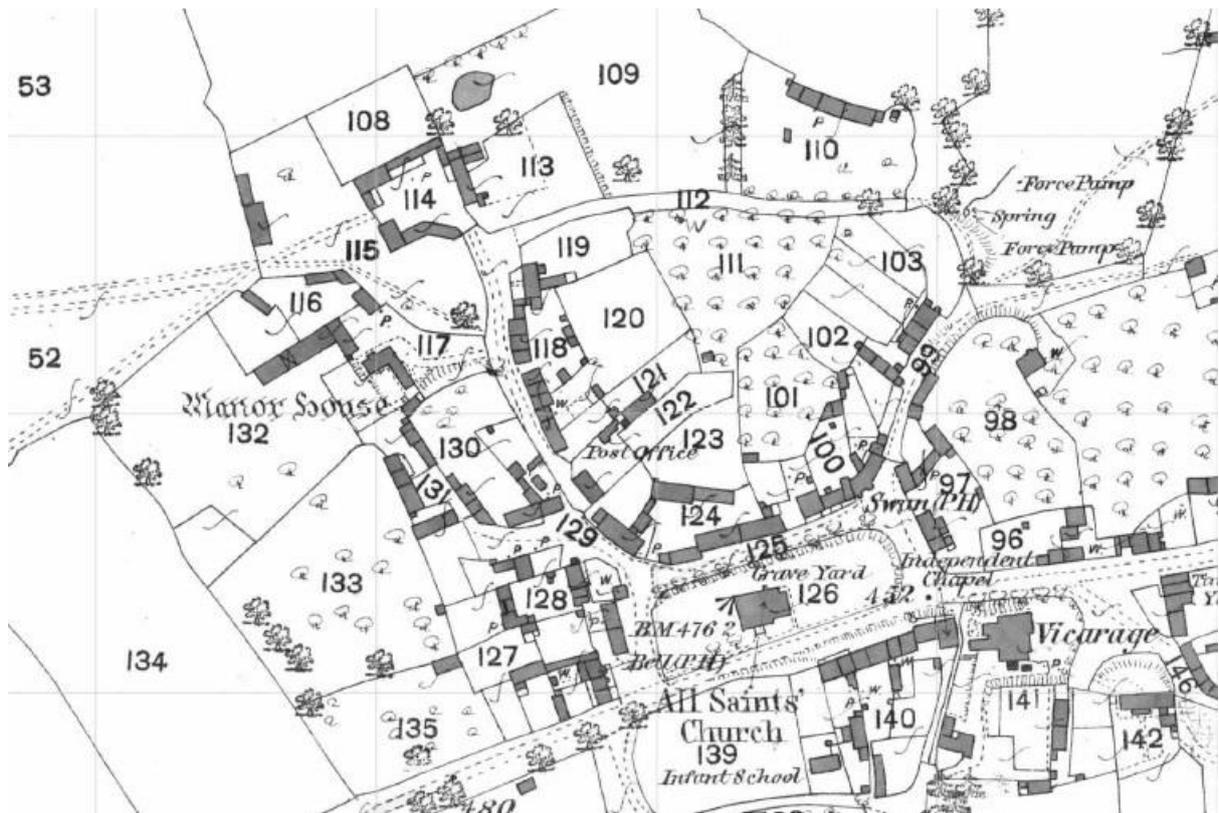
Figure 6: The 1882 OS 1:2500 map. Crockwell farmyard is shown around the number 114, with the farmhouse on the east (right) and buildings 1-3 to the south. The buildings to the north are not those extant here today, except possibly for part of building 5. The rest are of completely different plan and layout. Several of them are also clearly of modern materials (see below). Building 11 (or a structure on its site) is also shown.

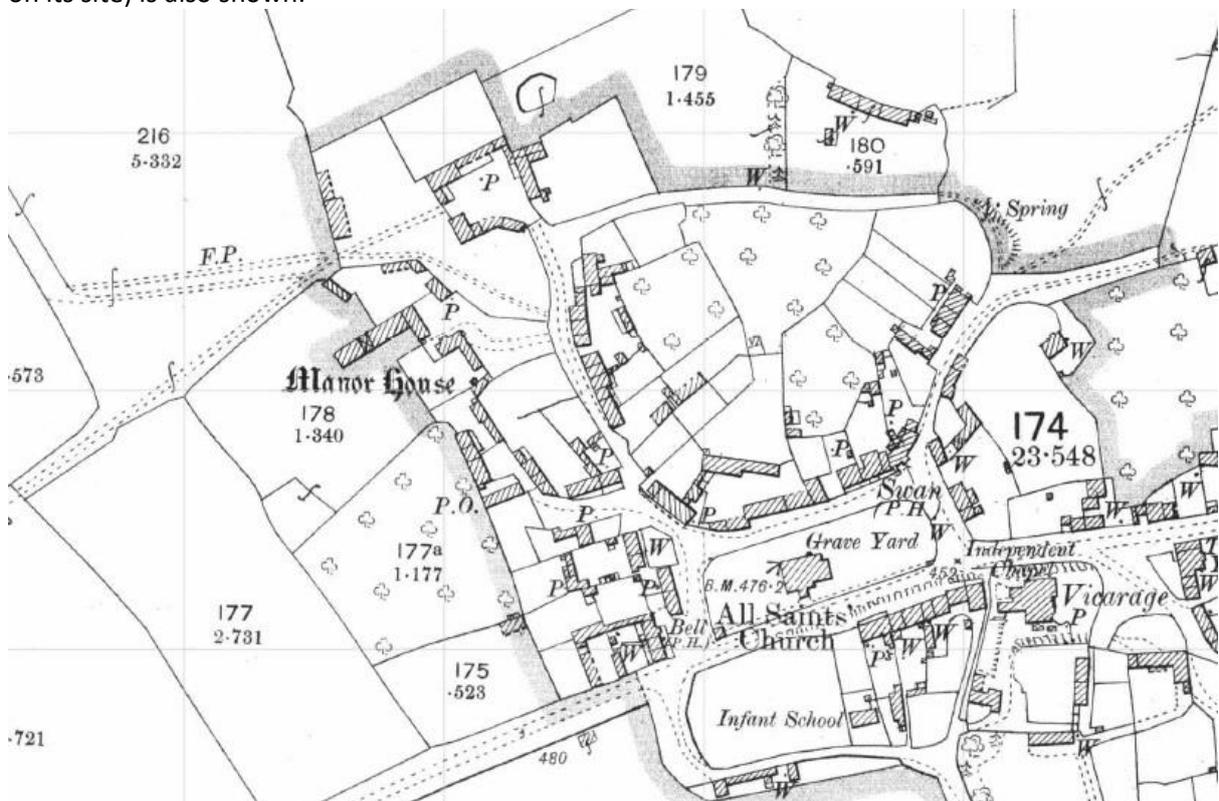
Figure 7: The OS 1900 1:2500 map. No changes but note the dotted line to the front of building 2 – this confirms that it was open-fronted. Note also the tone showing the extent of the village settlement.

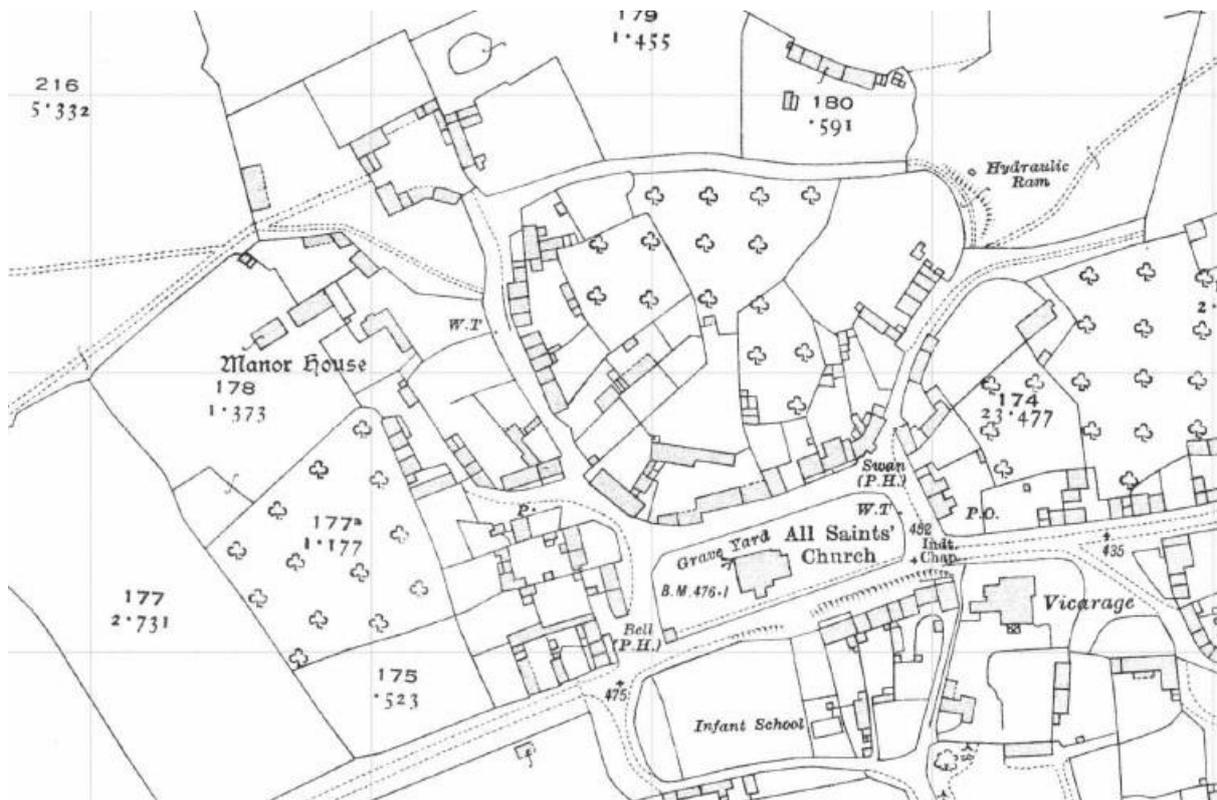
Figure 8: The OS 1922 1:2500 map. The north half of building 11 is no longer shown, but this is the only change in the farmyard. Indeed the village as a whole had changed very little in 40 years.

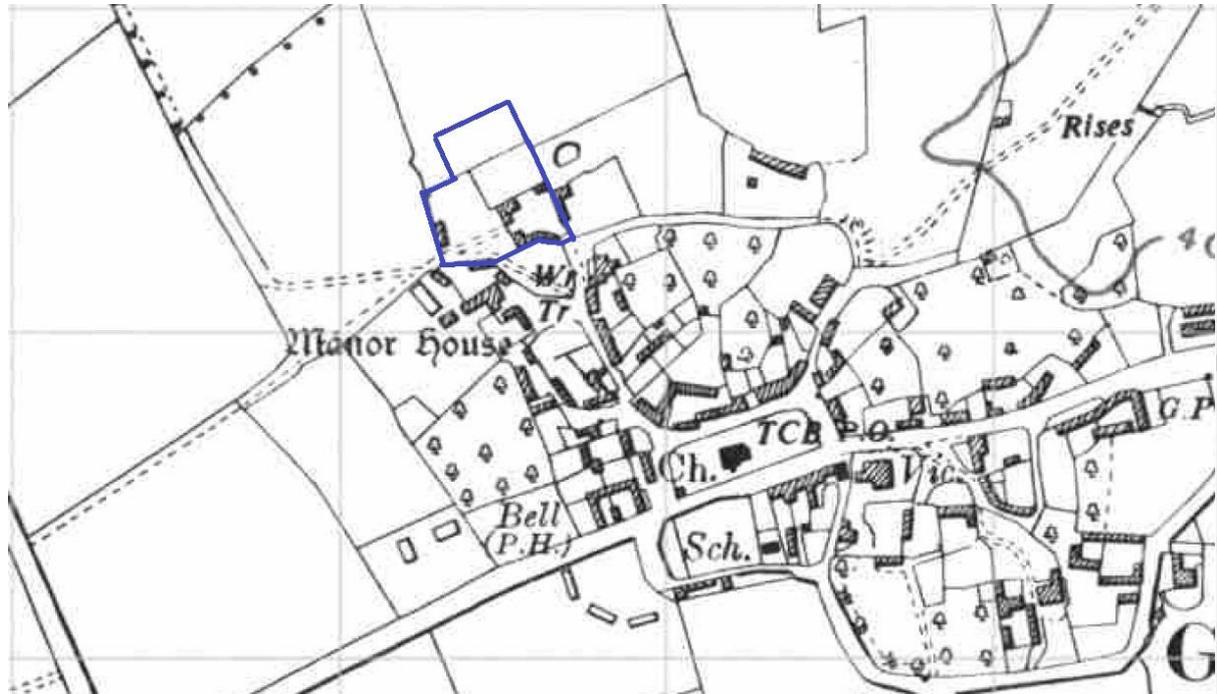
Figure 9: The 1955 1:10560 OS edition, site outlined in blue. Even at 6 inches to the mile it is clear that very little had changed at Crockwell Farm. The central and east parts of the building range on the north side of the yard had evidently been demolished, but the garage next to the farmhouse was still in place. A few new buildings are shown in the village, in open outline (under construction?).

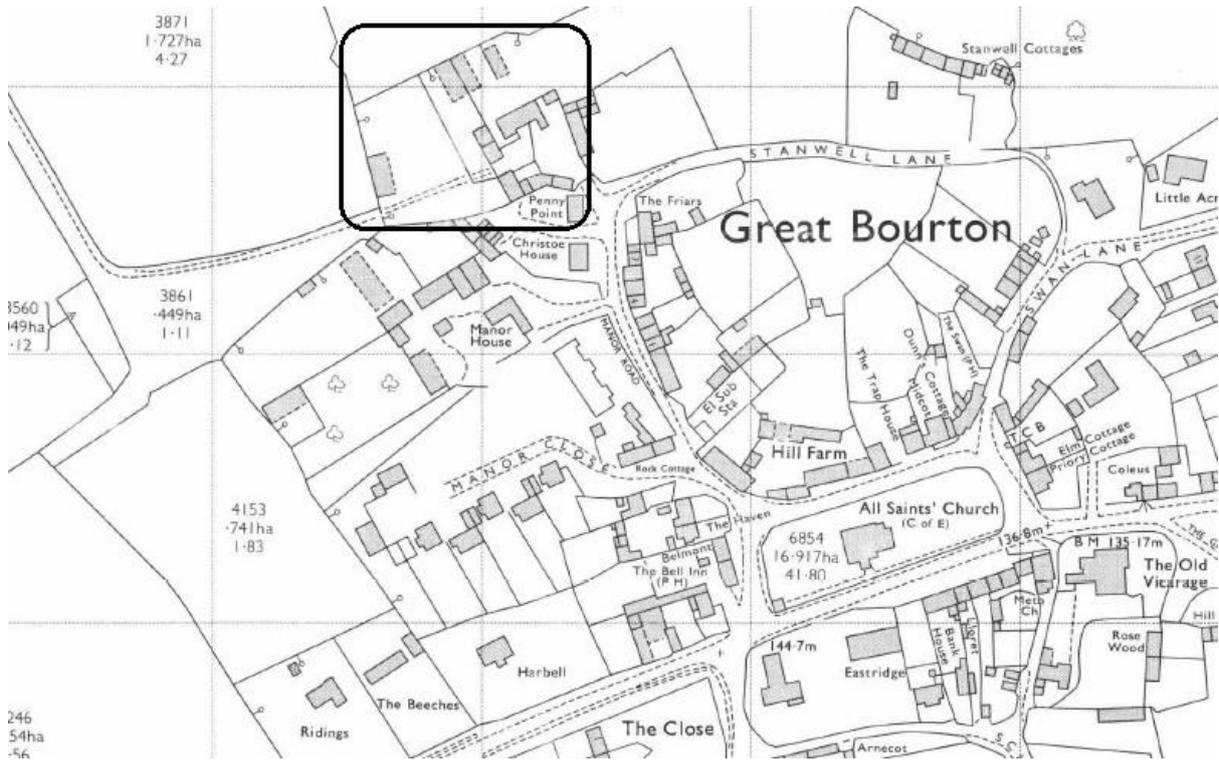
Figure 10: The OS 1972 1:2500 map, site outlined. Major changes had taken place at Crockwell Farm. Building 5 is shown in its current form, but the old range on the north side of the yard has been demolished in full and replaced with new buildings. The farmyard has also been extended north, with new buildings: the dotted outline shows that these were open 'Dutch' barns.

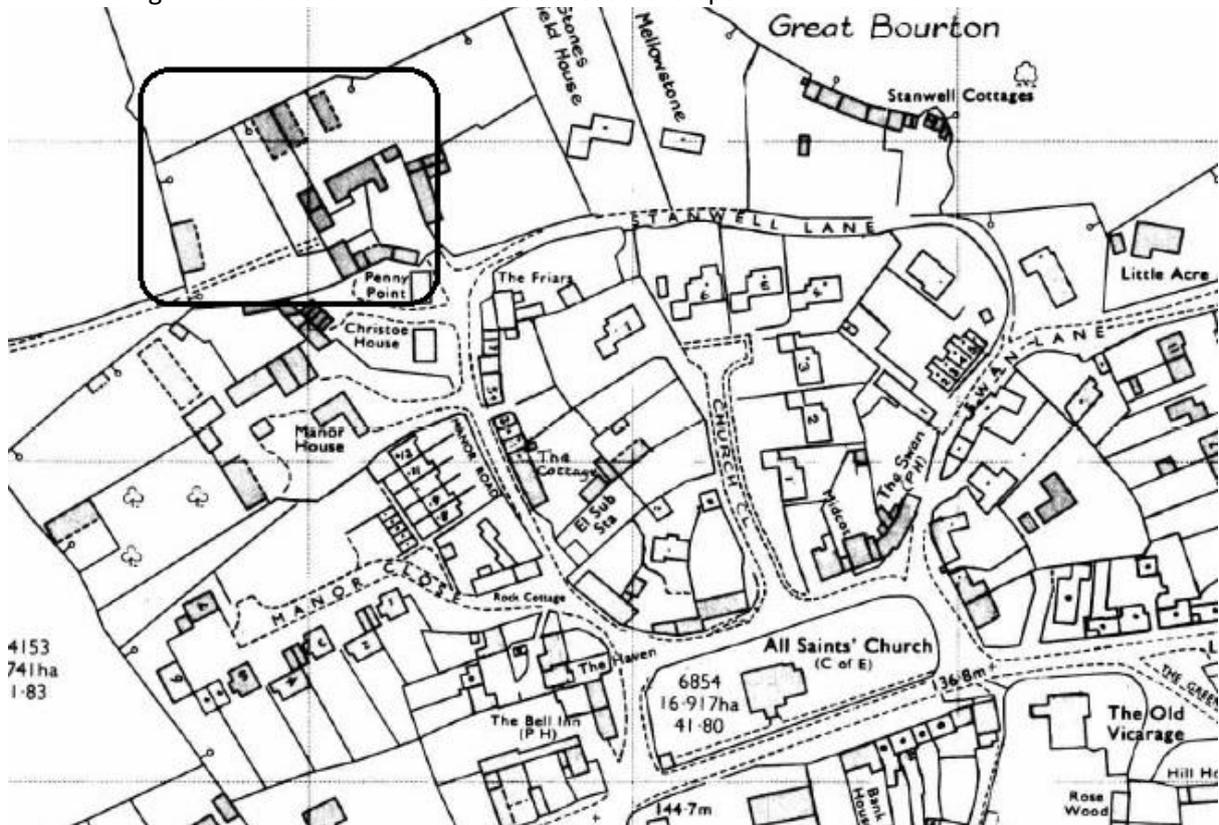
Figure 10: The OS 1989 1:2500 map, site outlined. Crockwell Farm is unchanged. This map shows an increasing pace of new housing development within the village, started after World War II and evident on both the 1955 and 1972 editions.

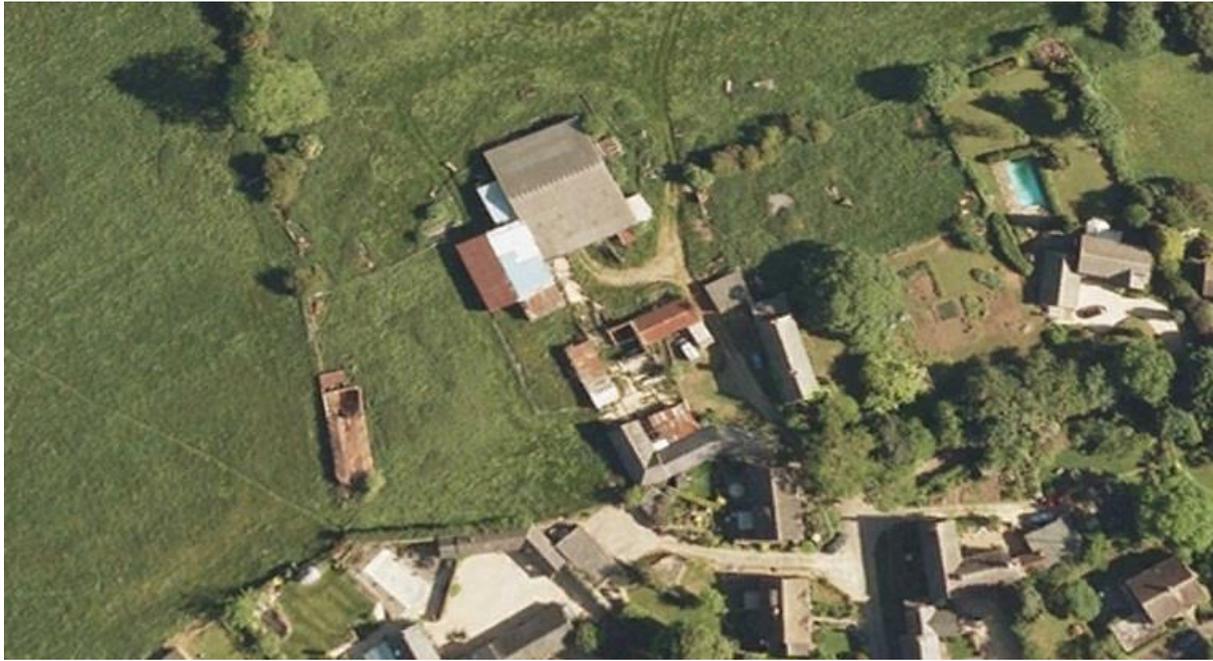
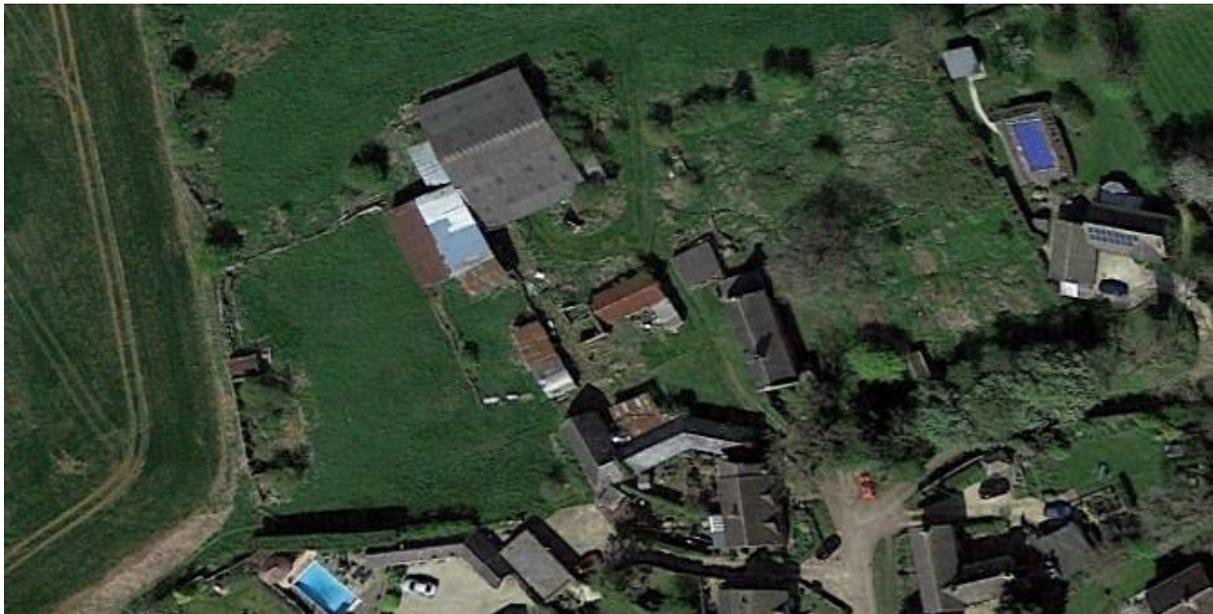
Figure 13: Google Earth images from 2009 (above) and 2017 (below) show the dramatic pace of decline in the largely abandoned outbuildings. In the earlier photograph building had lost its roof 6 in full, but only the north end of building 11 was unroofed. By 2017 its roof had gone completely, and the interior had been invaded by greenery.

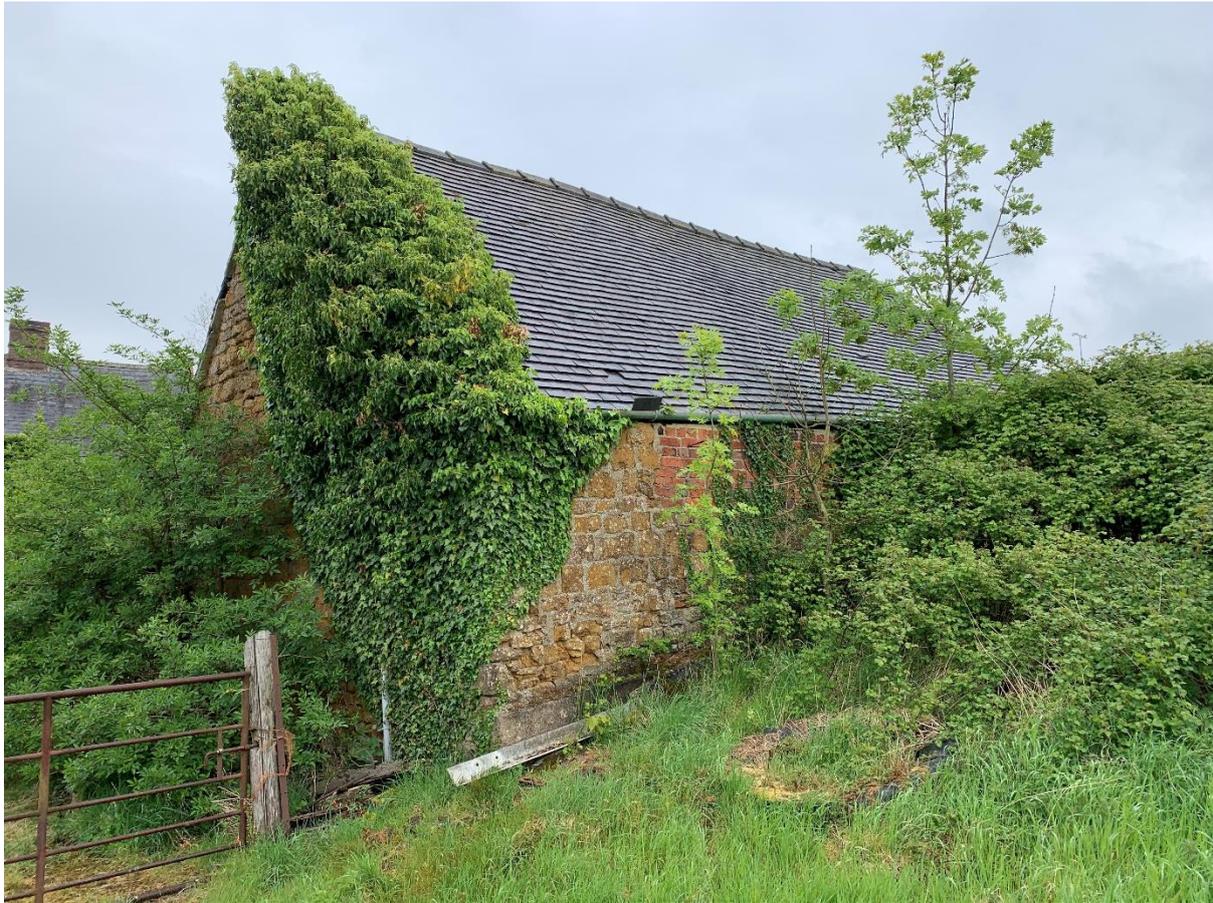
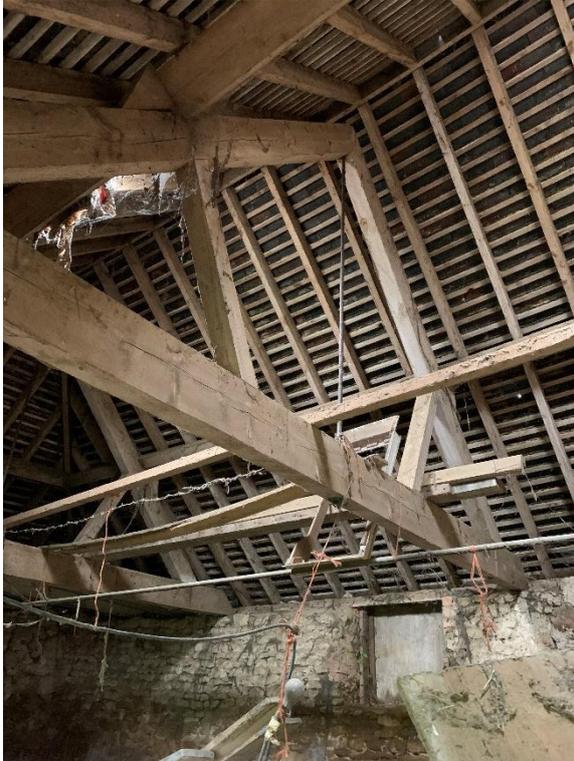
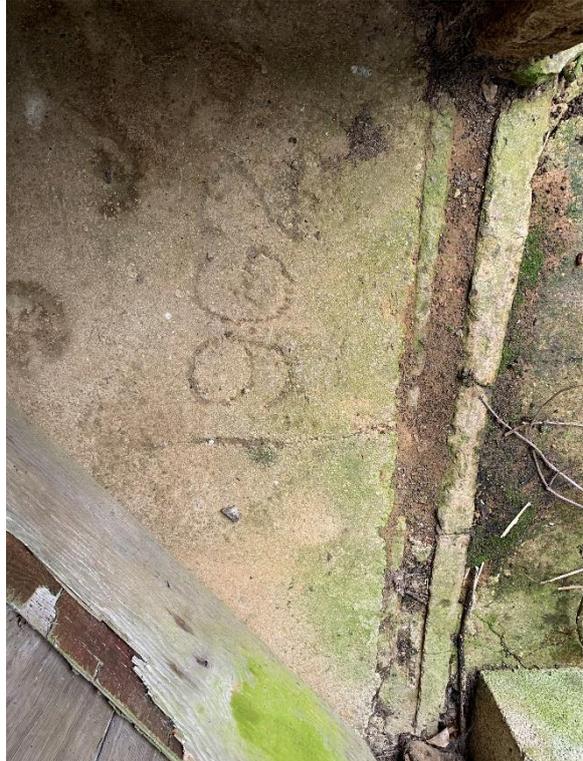
Figure 14: Views of building 4 – top, the rear (west) elevation showing ironstone ashlar construction but with some rebuilding in brick; bottom left, the late 19th/early 20th-century roof trusses and modern roof covering over them; bottom right, the date 1962 in the concrete floor. Vegetation is engulfing this elevation – compare with Soden 2016, figure 9.

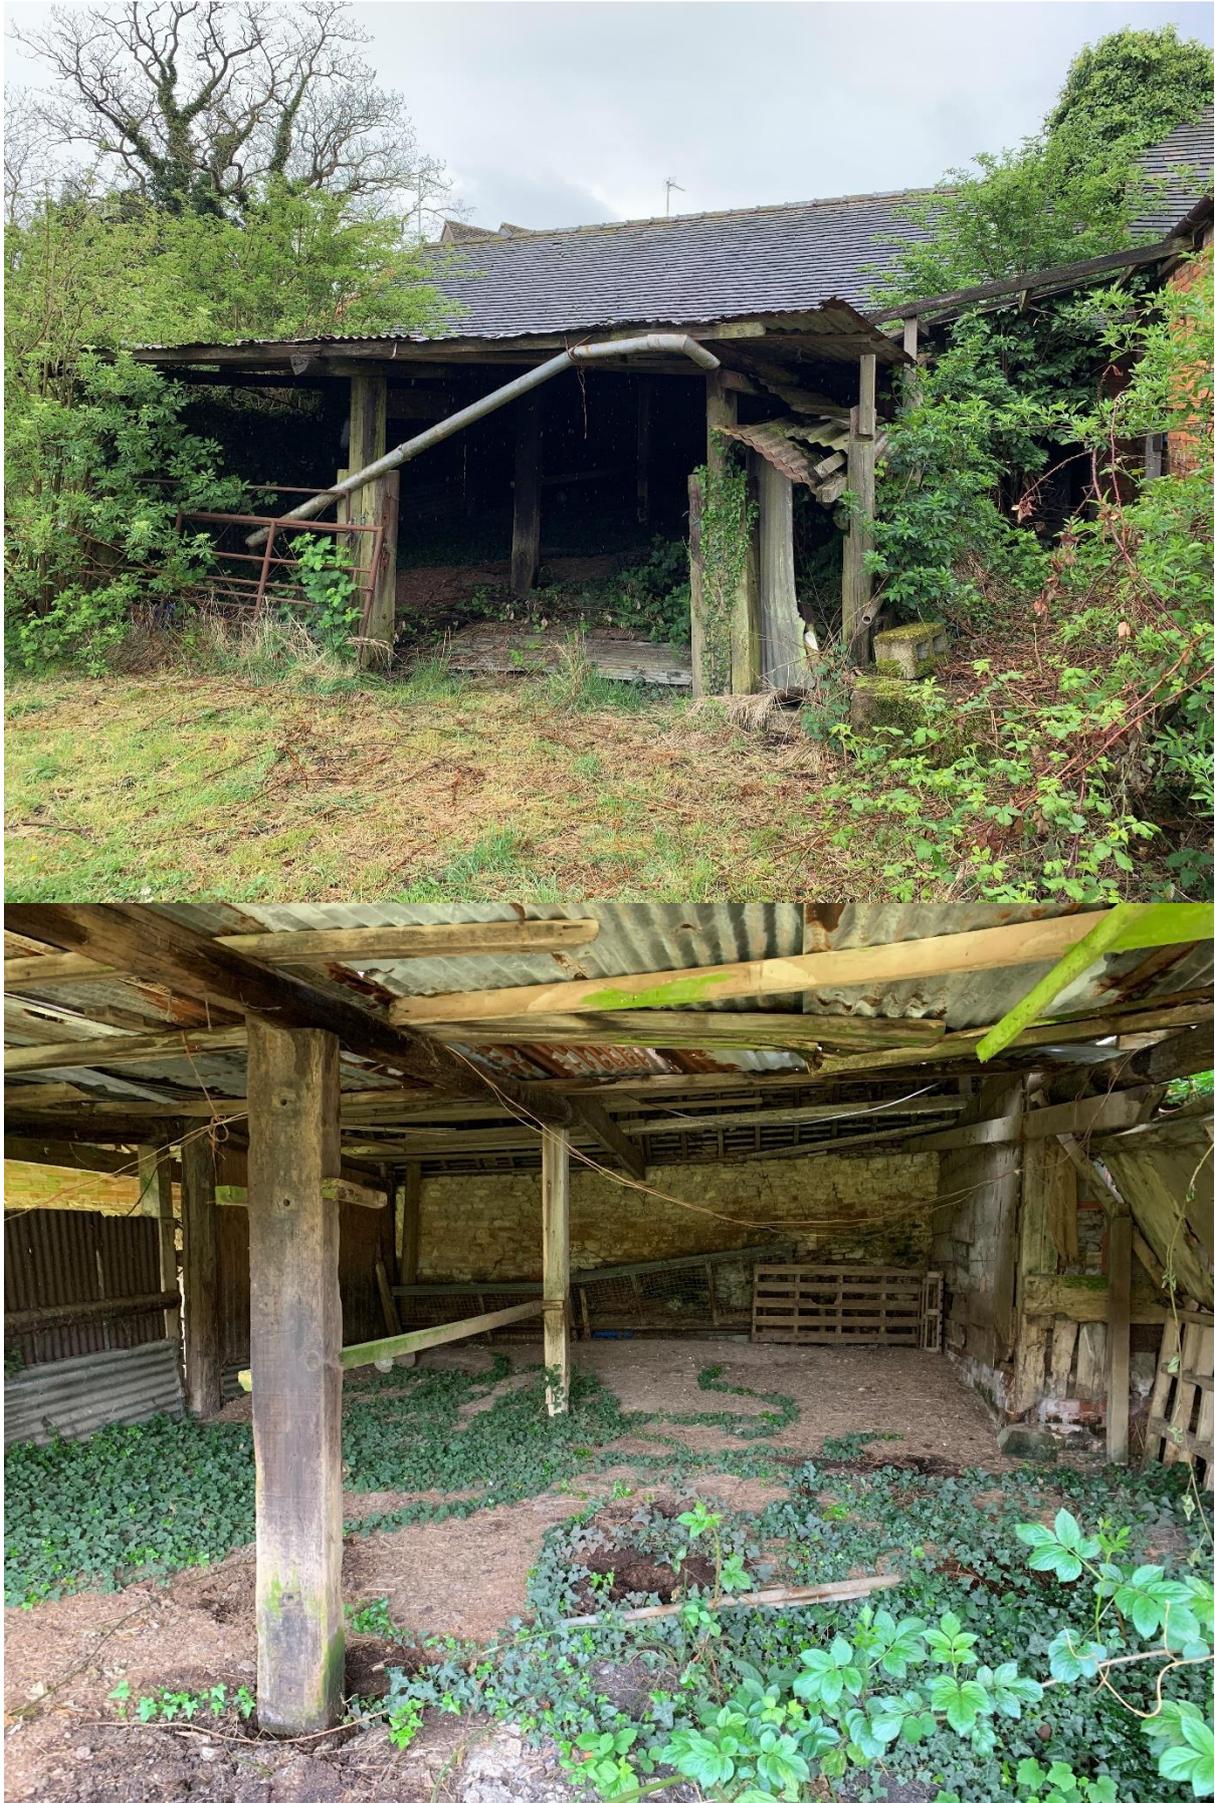
Figure 15: Views of the 'ramshackle' extension, building 3, in front (north) of building 2.

Building 3 was described by Soden (2016, 9) as a “ramshackle out-shut formed entirely of re-used railway sleepers, telegraph poles and miscellaneous timbers around original front and wall-plate of Building 2. Covering is a mixture of corrugated iron sheet, Trafford tile sheet and similar re-used sheeting. Sides are equally haphazard”. It might win prizes for ingenuity but not for use of authentic vernacular materials. It is **visually and physically intrusive** on building 2 in particular, as well as on buildings 1 and 4. Historic map evidence demonstrates that it was added after 1972, and therefore is not within the date range for consideration under curtilage listing. The materials used in building the extension are wholly consistent with its modern origin.

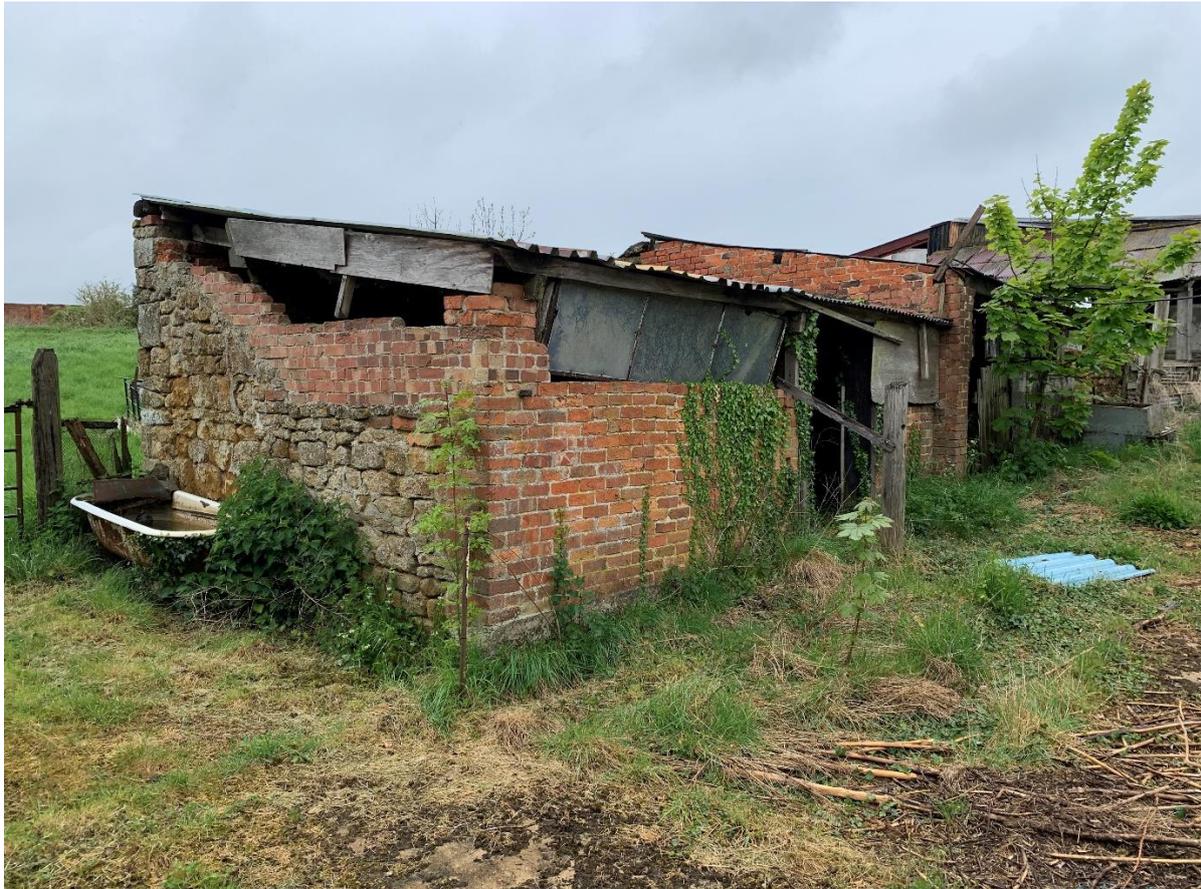
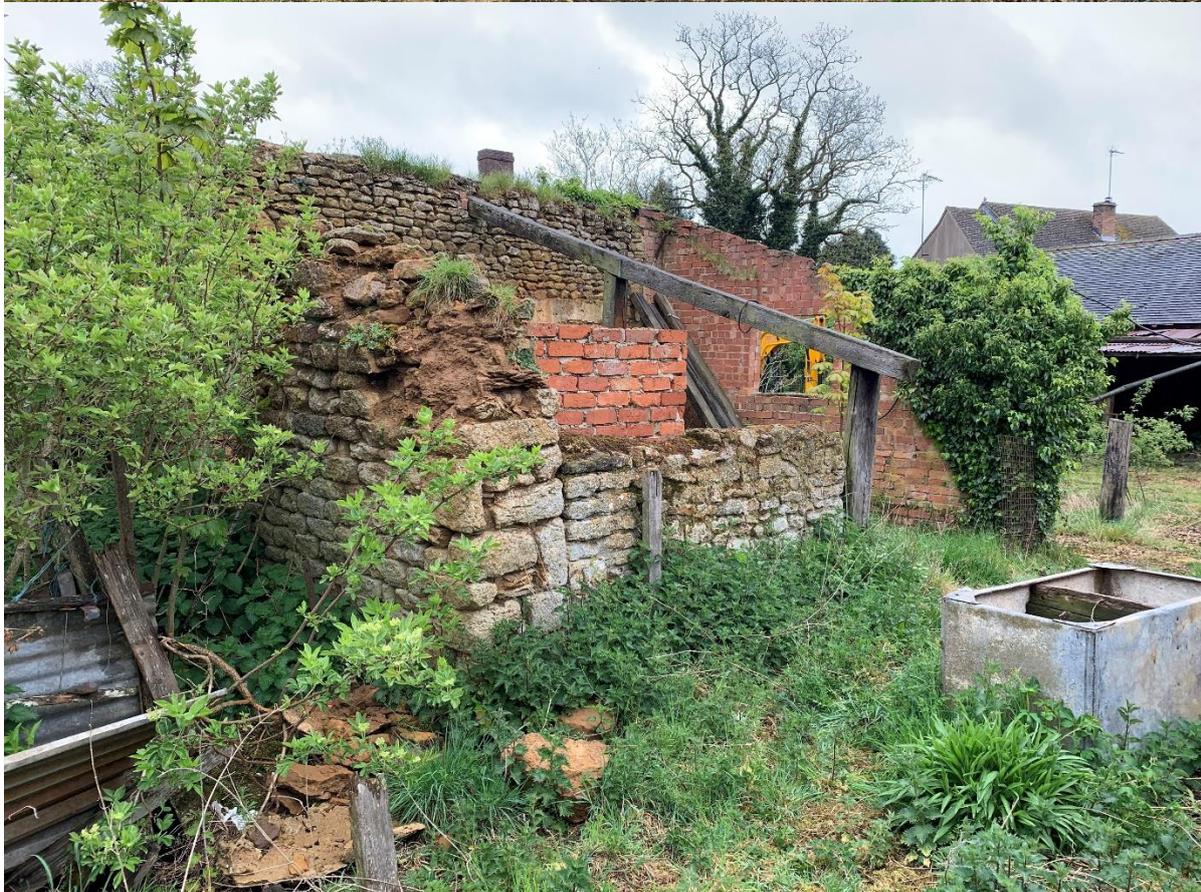
Figure 16: Buildings 5 (top, looking north-west) and 6 (looking south-east). The latter's condition has deteriorated since 2016 – compare with the same view in Soden 2016, figure 12.

The very poor condition of buildings 5-8 is **visually intrusive** upon the setting of the listed farmhouse. The materials, character, function and ‘design’ of buildings 7 and 8 are also harmful to the setting of the farmhouse. The secluded and isolated nature of the farmyard, however, means that the buildings do not have any effect or impact on other nearby listed buildings (eg the Manor Farmhouse and The Friars).

The 20th-century structures (7 and 8, with 5 and 6) on the north side of the core farmyard will be demolished under the existing consent. This will improve the visual character of the site, and thus the setting of the Grade II listed farmhouse. It will also improve the outlook of/from the converted barn buildings (1, 2 and 4). The detailed form and design of the replacement dwellings will be the subject of a separate planning application in due course, in accordance with the existing planning conditions.

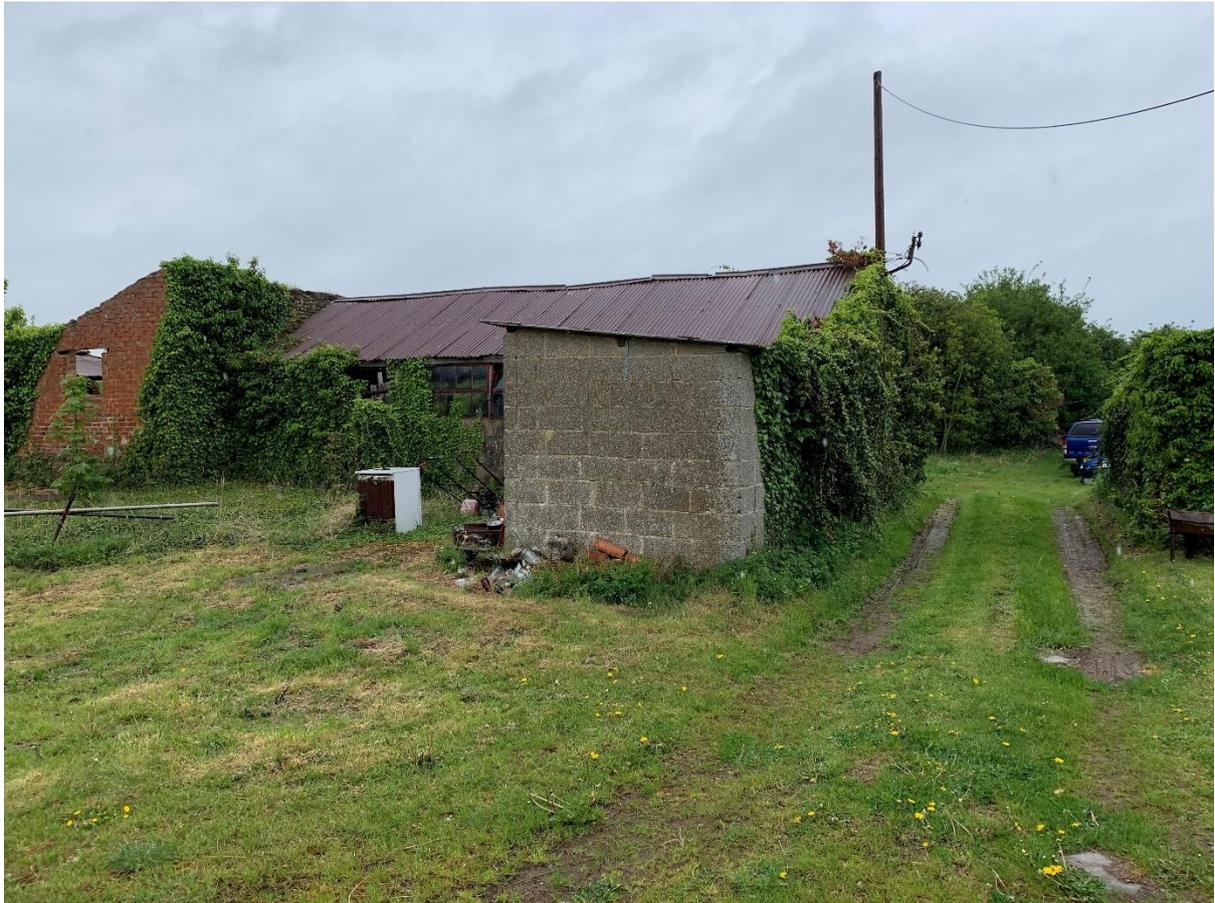
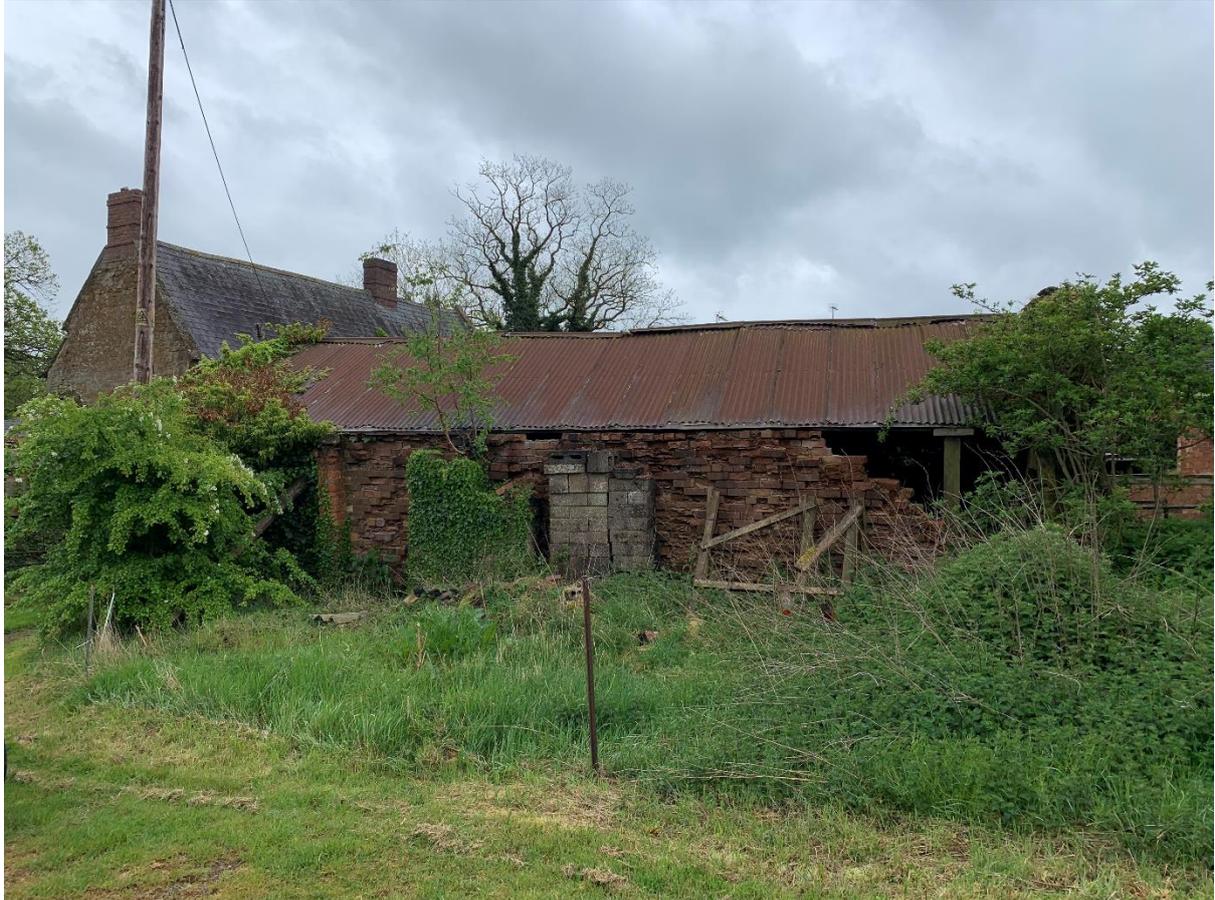
Figure 17: Buildings 7 and 8, front (top) and rear – note the very poor condition of the back wall.

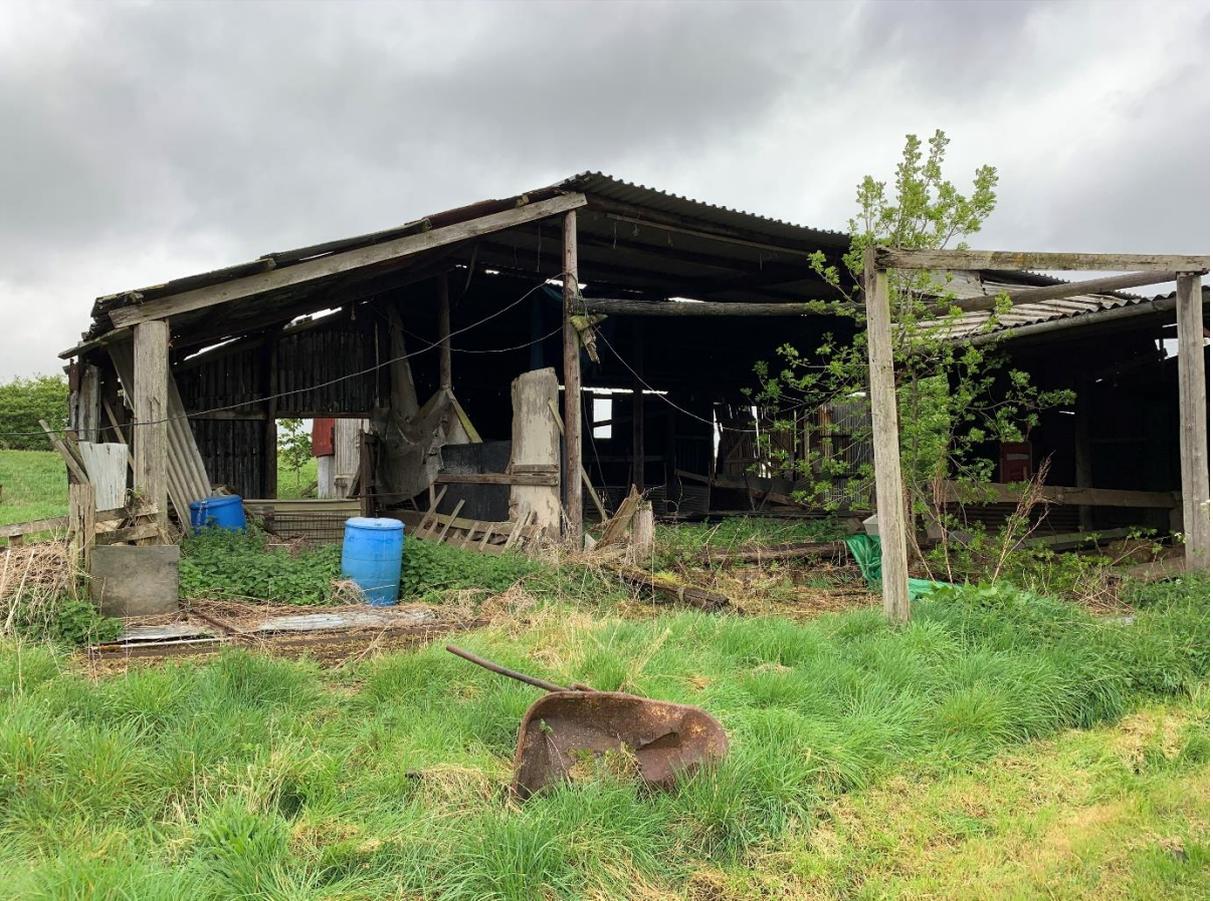
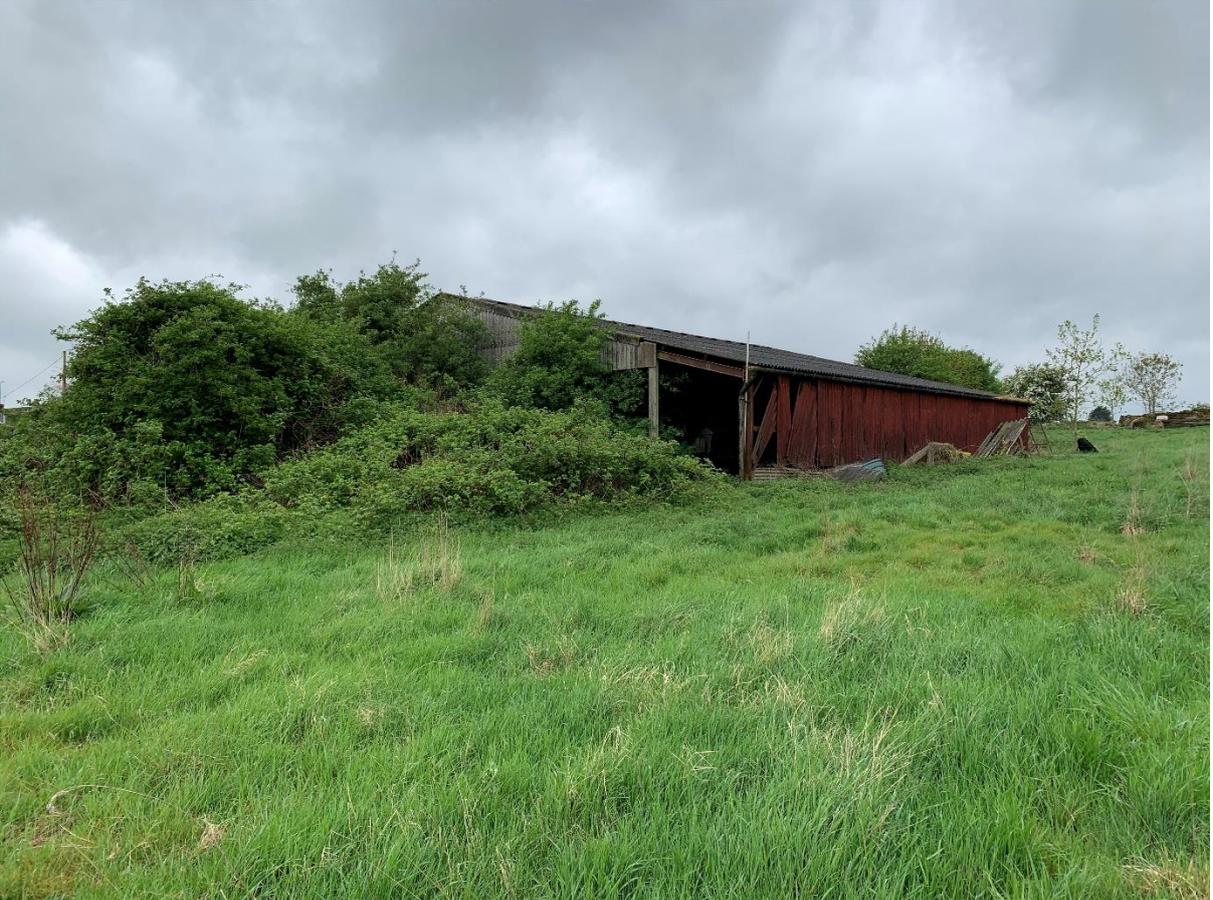
Figure 18: Buildings 9 (top, seen from the south) and 10 (bottom, seen from the north-east).
