Proposed residential development  
Crockwell Farm  
Great Bourton

## Ground Investigation Report

**Proposed residential development  
Crockwell Farm  
Great Bourton  
Banbury  
Oxfordshire  
OX17 1QT**

## **GROUND INVESTIGATION REPORT**

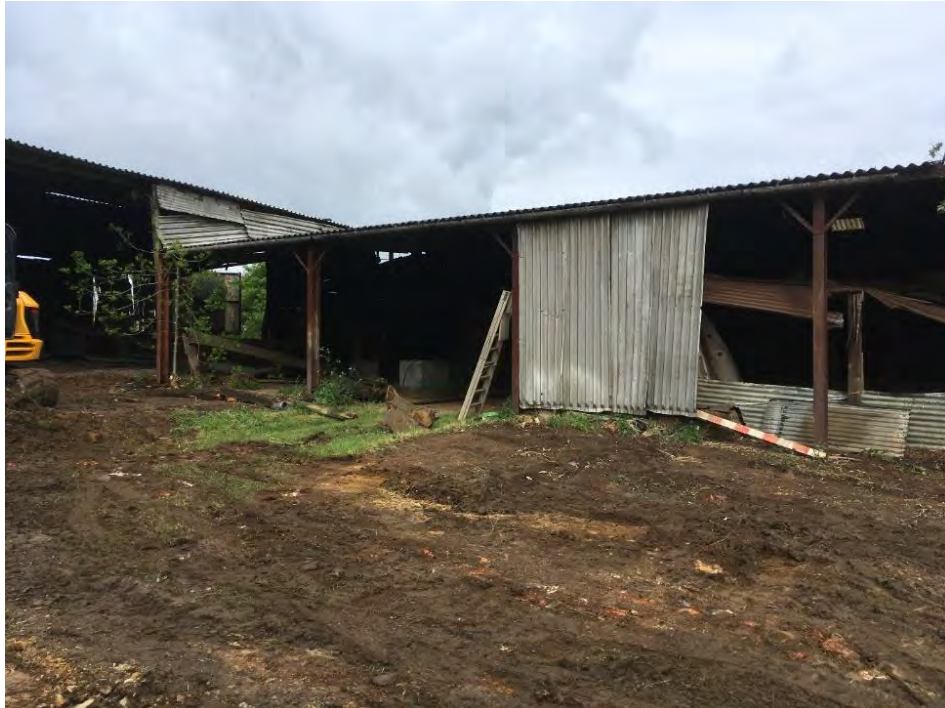
**Photo 1:** The site looking northwest showing the northernmost barn and northern courtyard.

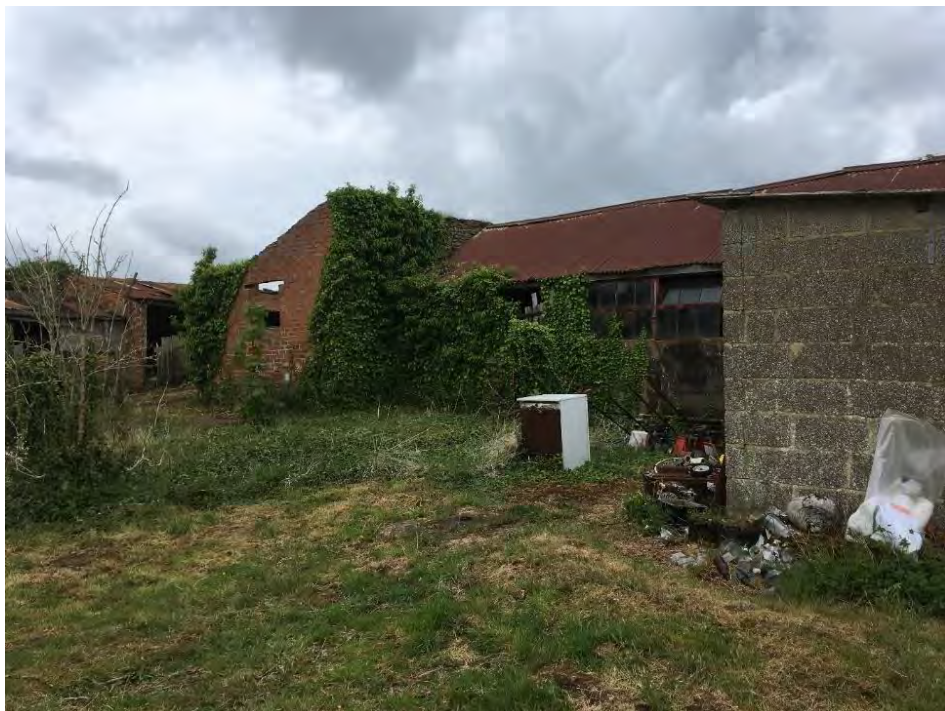
**Photo 2:** The site looking northwest showing the southern courtyard and dilapidated barns.

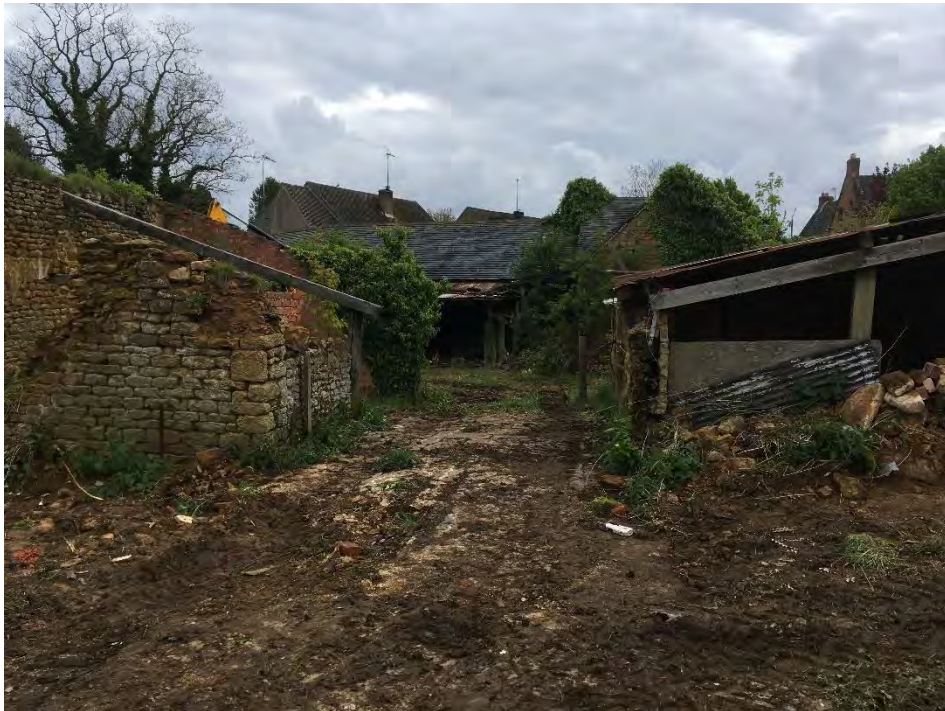
**Photo 4:** The site south showing the dilapidated farm buildings.

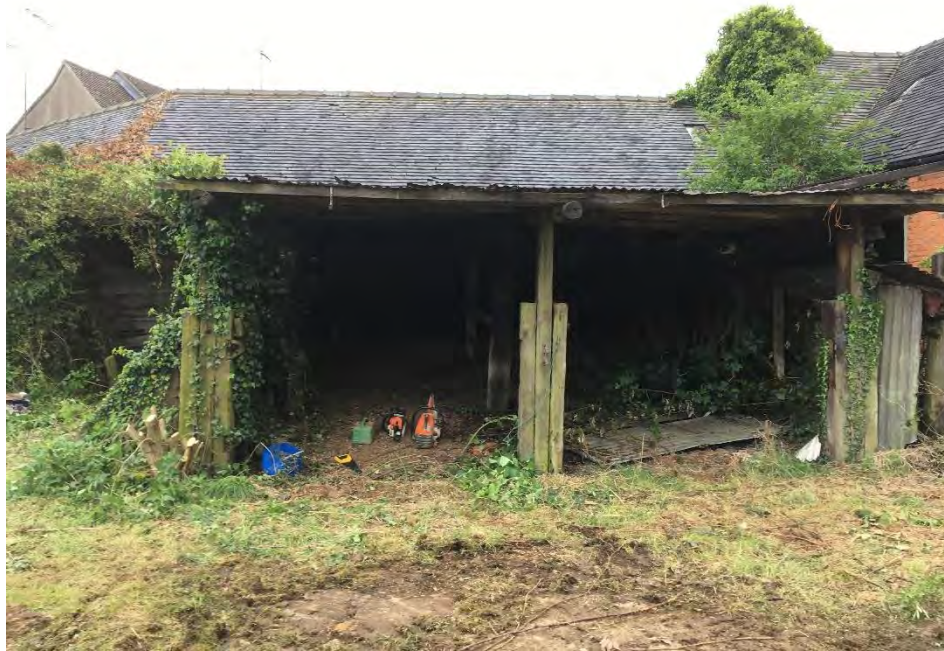
**Photo 5:** The site south showing the dilapidated farm buildings.

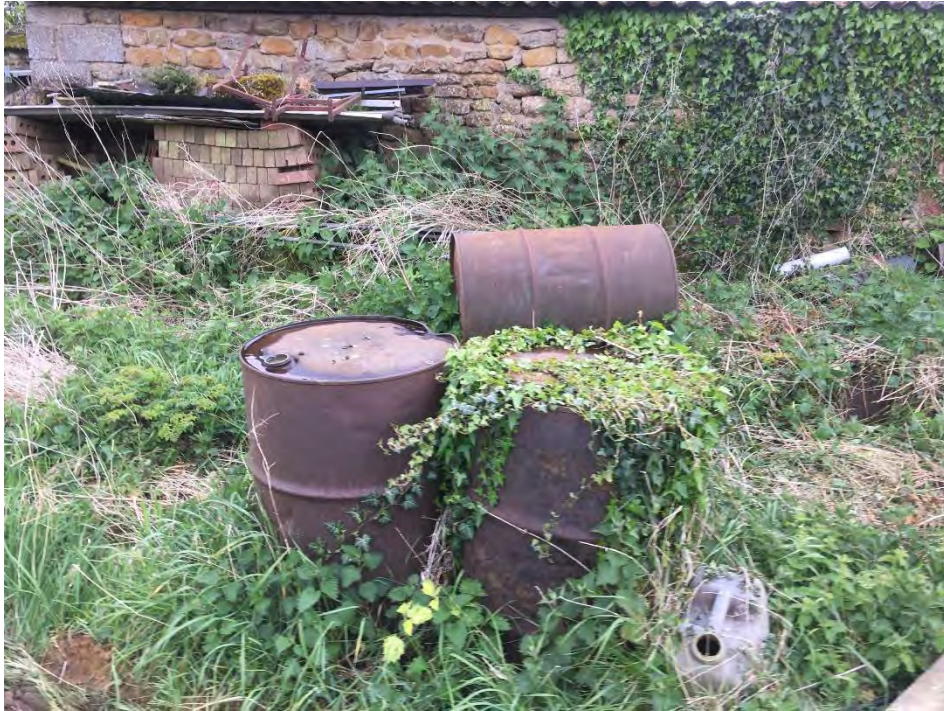
- 3.2.5 Two tanks were noted on or near the site (unclear if they had been used in their current locations), or along with multiple unlabelled drums in the east, which appeared to be either water filled or empty. One empty non-bunded metal tank with some obvious rusting and slight pitting was located at the crest of the neighbouring field to the west, which is suspected to have been moved from its original location. A second suspected tank or storage container was located neighbouring the northern barn in the east. Access could not be gained to inspect further due to overgrown vegetation and the safety of the barn structure. A well was observed in the centre of the site with a cover flush with the ground.

**Photo 7:** Multiple unlabelled empty/water filled drums in the east of the site.

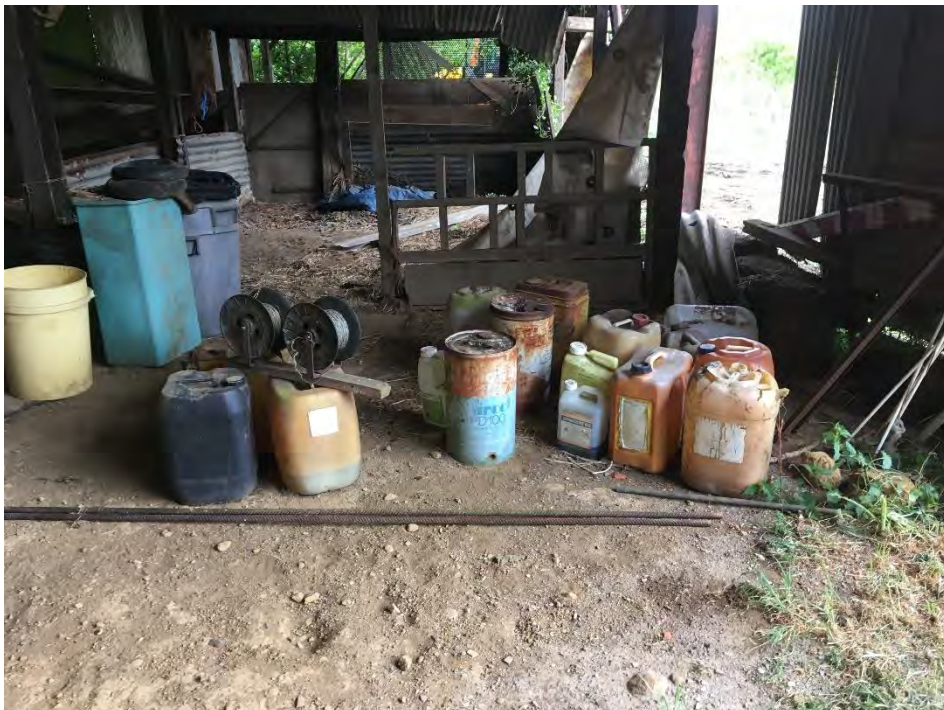
**Photo 8:** Various containers of oil, creosote and various other unmarked substances stored within the northern barn.

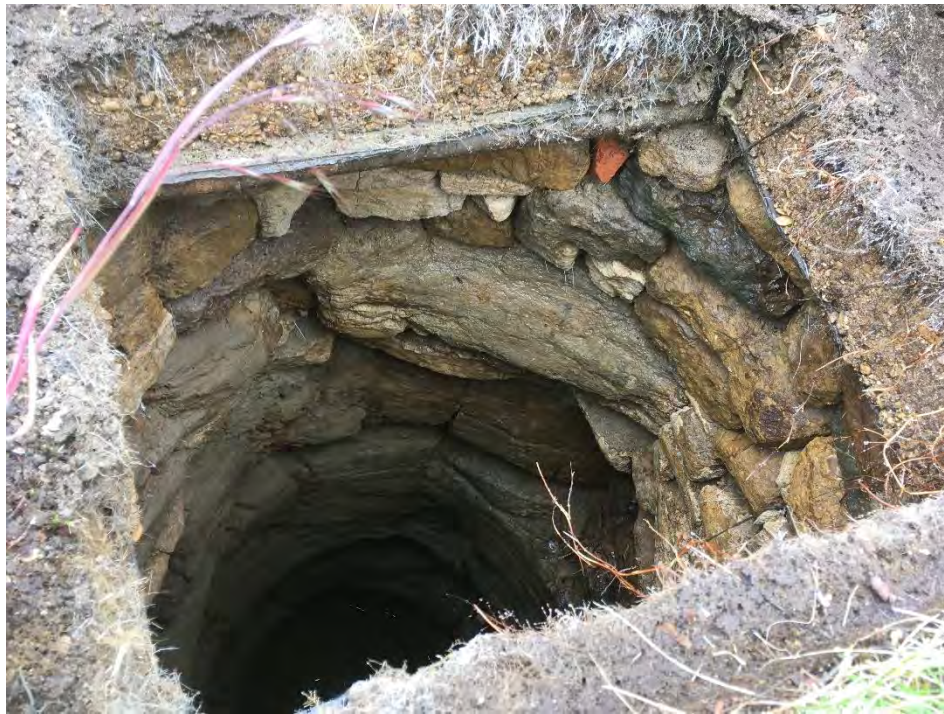
**Photo 9:** Well chamber is located to the centre of the site.

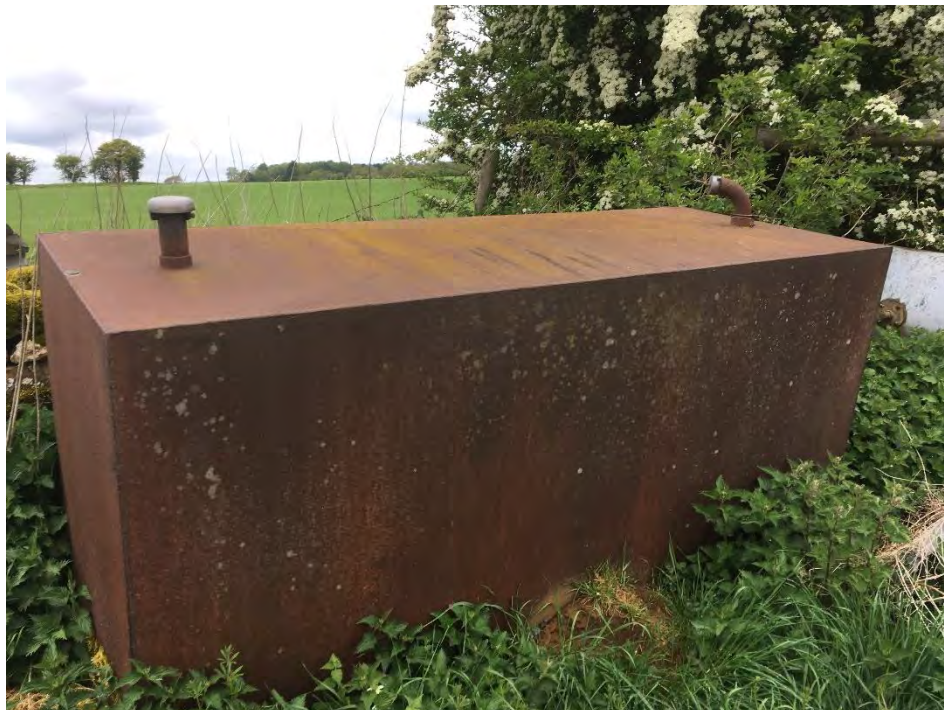
**Photo 10:** Empty non-bunded metal tank with some obvious rusting and slight pitting located in the neighbouring field.

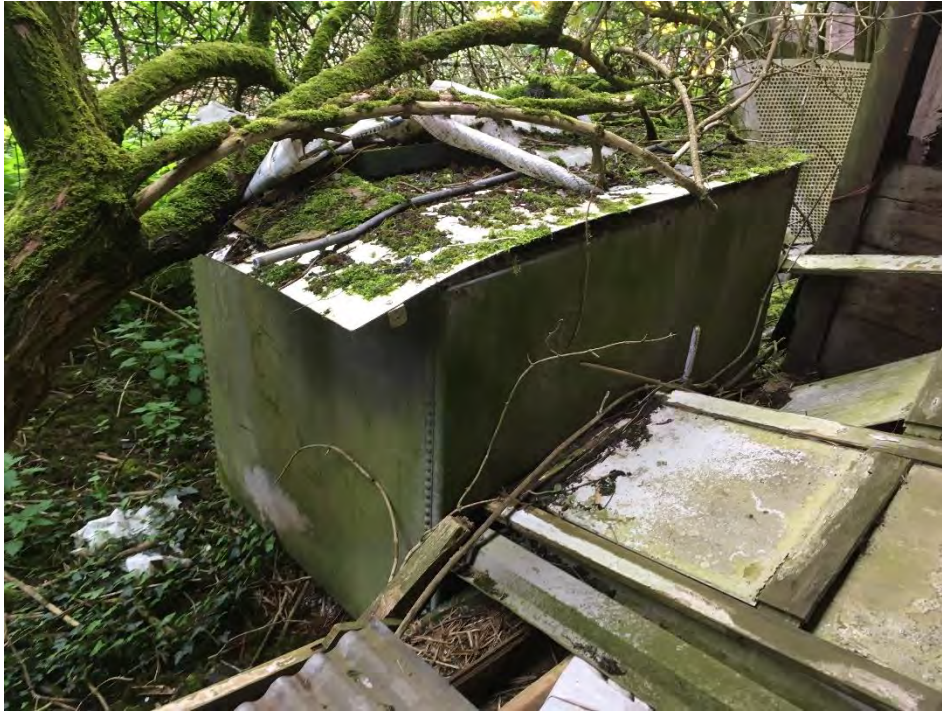
**Photo 11:** Suspected tank or storage container neighbouring the northern barn in the east. Access could not be gained to inspect further.

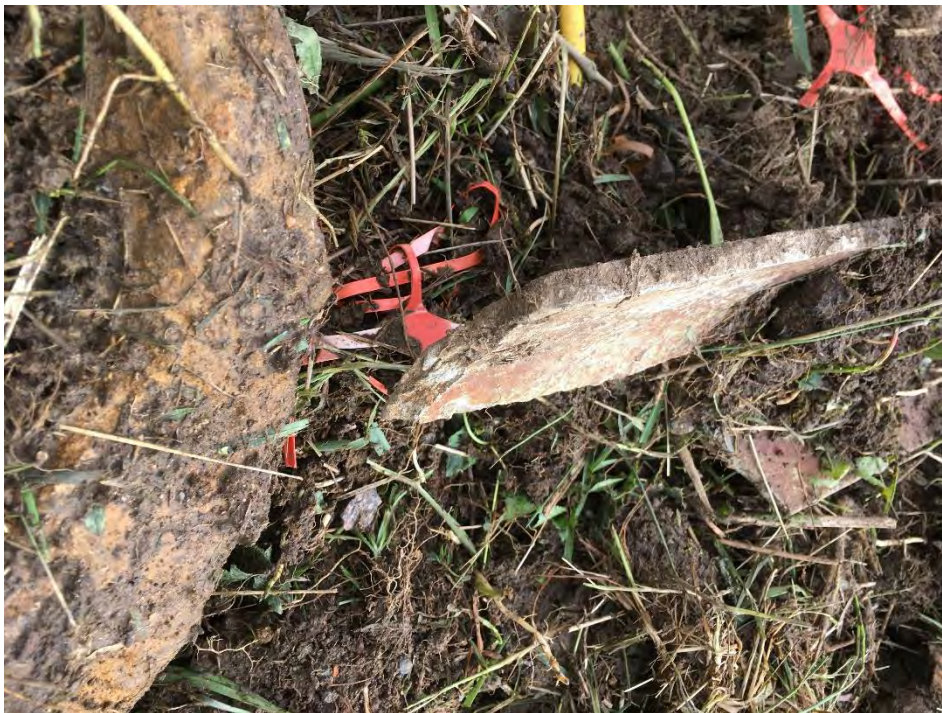
3.3.2.1 Our investigations exclude surveys to identify the presence or indeed absence of asbestos on site. It should be noted that we did observe potential asbestos containing materials on site in the form of corrugated roofing on one large barn to the north of the site. Fragments of suspected asbestos corrugated roofing were observed local to TP02. We took precautions to avoid disturbance of these materials during our on-site activities and recommend a specialist be appointed to confirm or otherwise the presence of asbestos. In addition, asbestos fibres were detected in samples of soil submitted for laboratory screening. This is discussed in Section 8 and 10.

6.4.2 It should be noted that fragments of suspected asbestos corrugated roofing were observed local to TP02 on the surface.

**Photo 12:** Fragment of suspected asbestos corrugated roofing observed local to TP02 located to the east of the site.

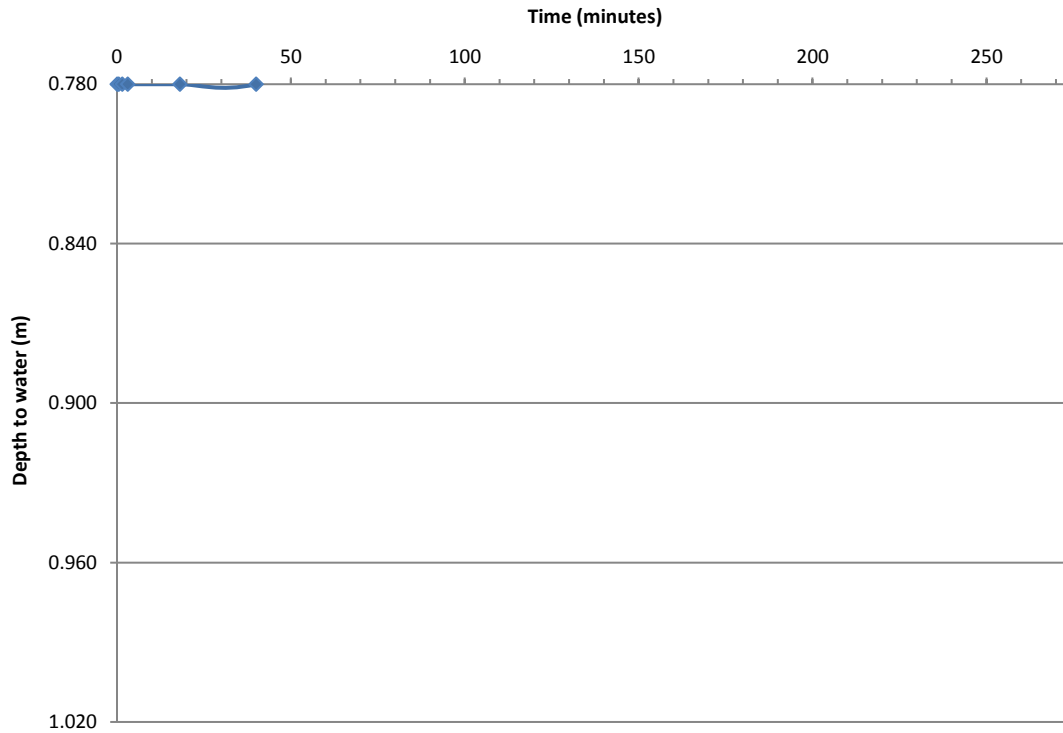
**Plot showing time against depth to water:**

- 4.3.7 The rate at which water placed in TP01, TP02 and TP07 dissipated very slow and only part of a full test cycle could be carried out during one day of fieldwork (the BRE document recommends three full test cycles). Test results have been used to produce an estimate of the soil infiltration rate using the methods described in the BRE publication. We will be pleased to carry out further testing (over a period of days) on further instructions.

TIME (mins)	DEPTH TO WATER (m)	TIME (mins)	DEPTH TO WATER (m)
0	0.78		
0.5	0.78		
1.5	0.78		
3	0.78		
18	0.78		
40	0.78		
88	0.76		
134	0.765		
191	0.77		
275	0.77

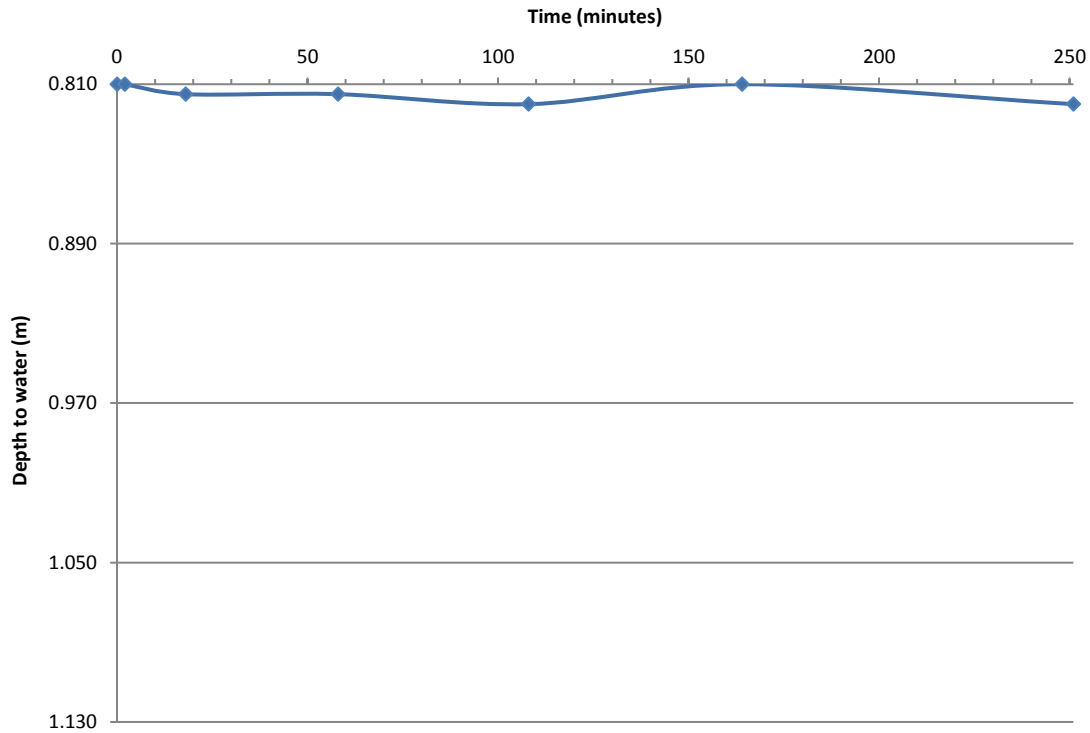
**Plot showing time against depth to water:**

TIME (mins)	DEPTH TO WATER (m)	TIME (mins)	DEPTH TO WATER (m)
0	0.81		
2	0.81		
18	0.815		
58	0.815		
108	0.82		
164	0.81		
251	0.82

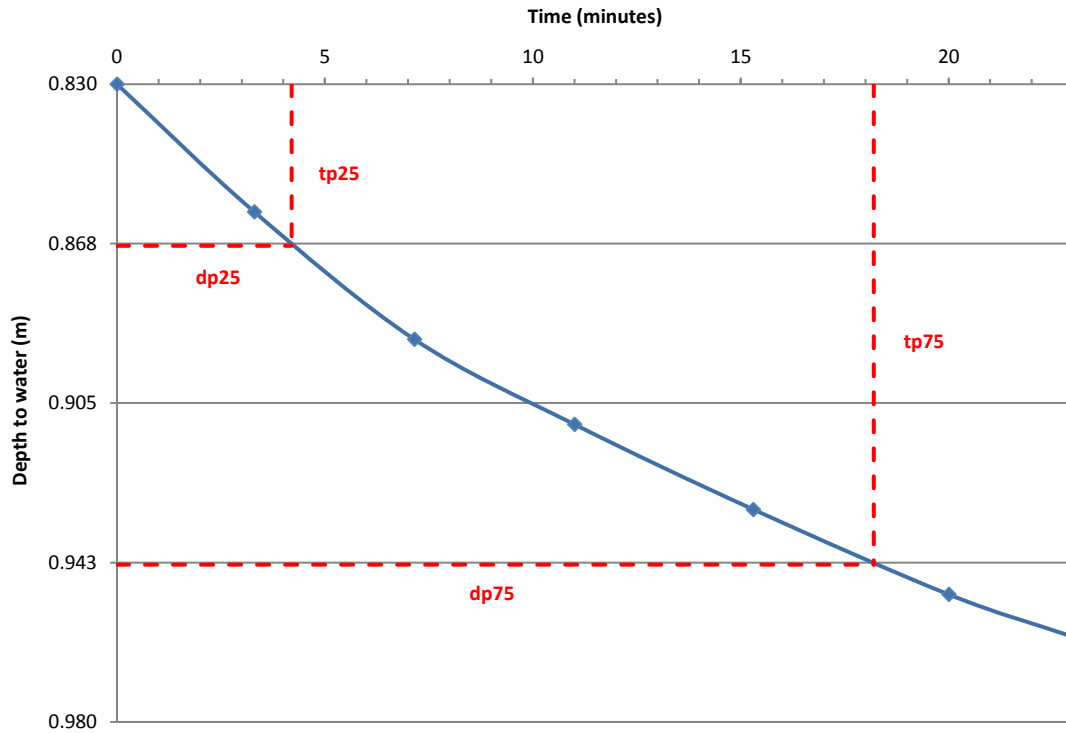
**Plot showing time against depth to water:**

TIME (mins)	DEPTH TO WATER (m)	TIME (mins)	DEPTH TO WATER (m)
0	0.83		
3.3	0.86		
7.15	0.89		
11	0.91		
15.3	0.93		
20	0.95		
23	0.96

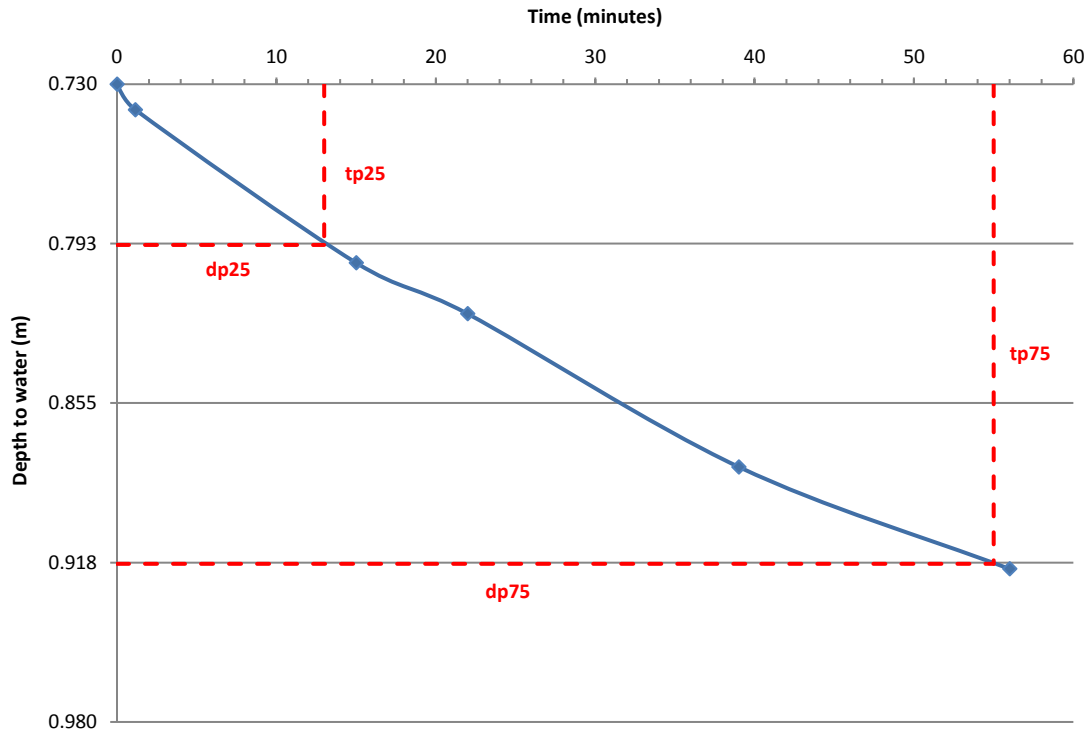
**Plot showing time against depth to water:**

TIME (mins)	DEPTH TO WATER (m)	TIME (mins)	DEPTH TO WATER (m)
0	0.73		
1.15	0.74		
15	0.8		
22	0.82		
39	0.88		
56	0.92

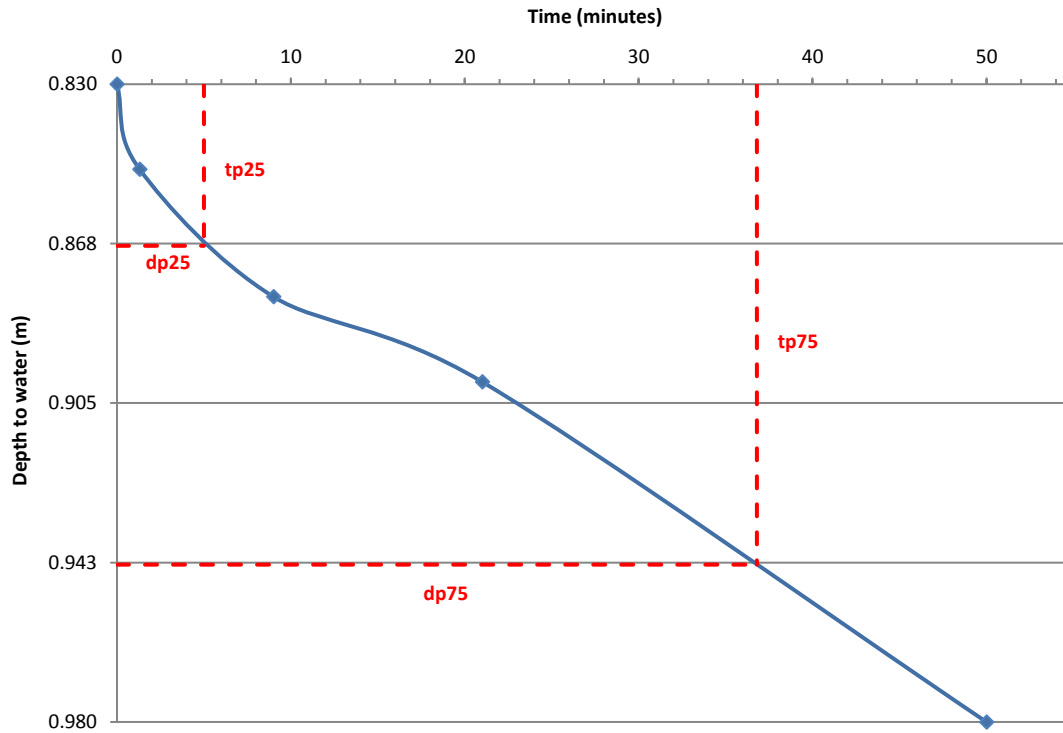
**Plot showing time against depth to water:**

TIME (mins)	DEPTH TO WATER (m)	TIME (mins)	DEPTH TO WATER (m)
0	0.83		
1.3	0.85		
9	0.88		
21	0.9		
50	0.98

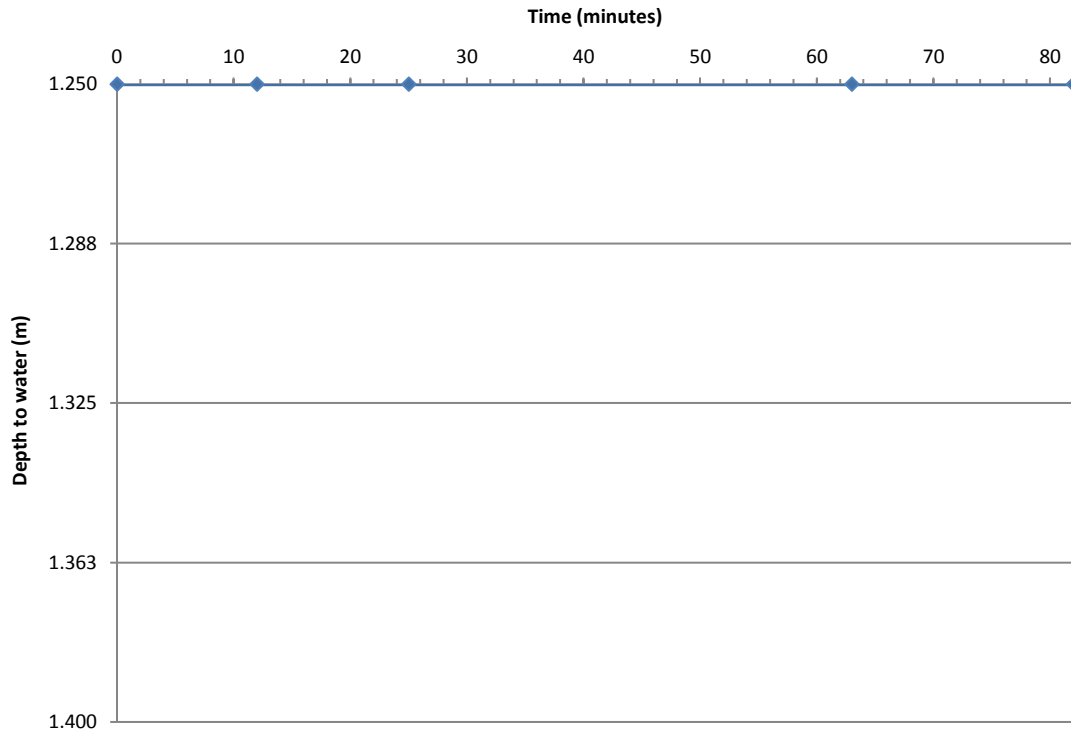
**Plot showing time against depth to water:**

TIME (mins)	DEPTH TO WATER (m)	TIME (mins)	DEPTH TO WATER (m)
0	1.25		
12	1.25		
25	1.25		
63	1.25		
82	1.25

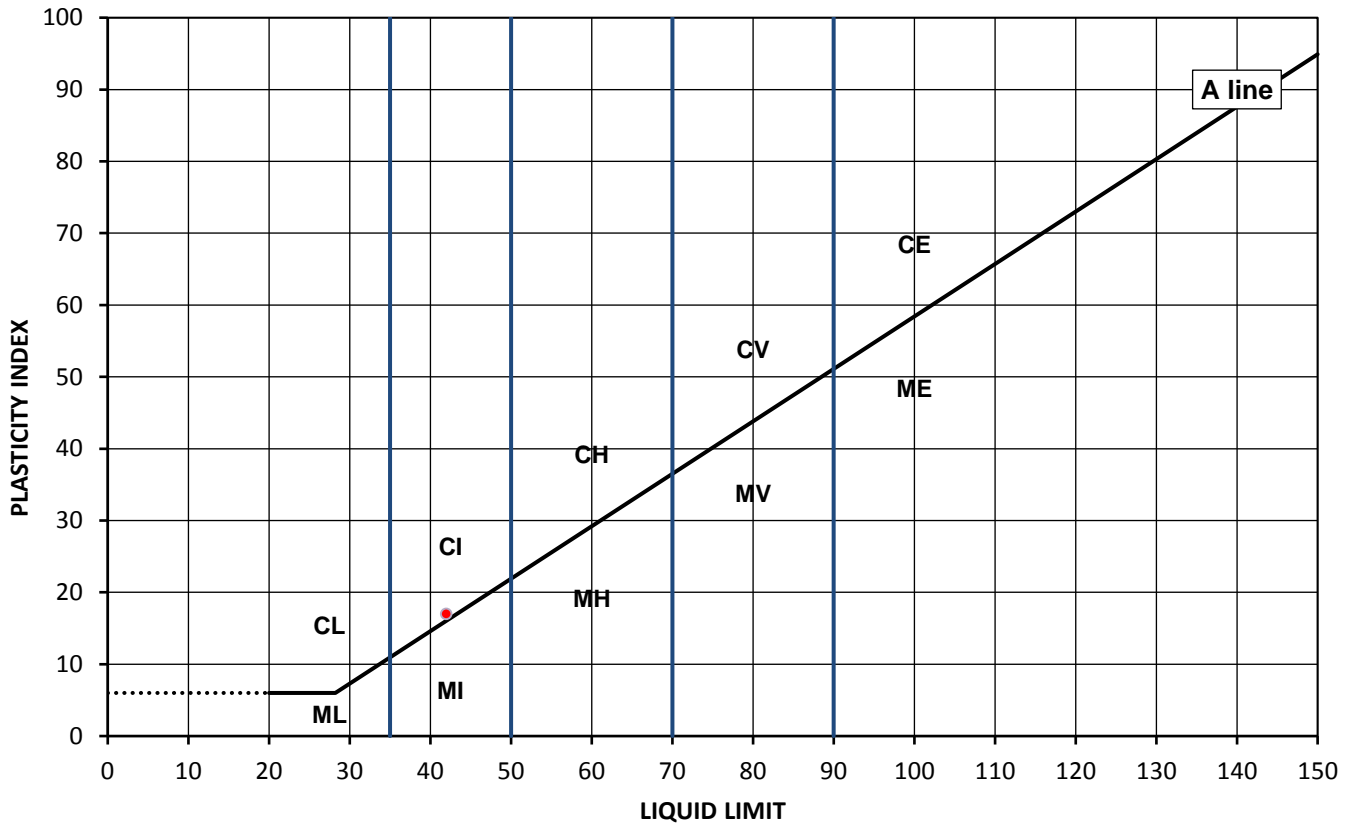
As Received Moisture Content [%]	Liquid Limit [%]	Plastic Limit [%]	Plasticity Index [%]	% Passing 425µm BS Test Sieve
22	42	25	17	100

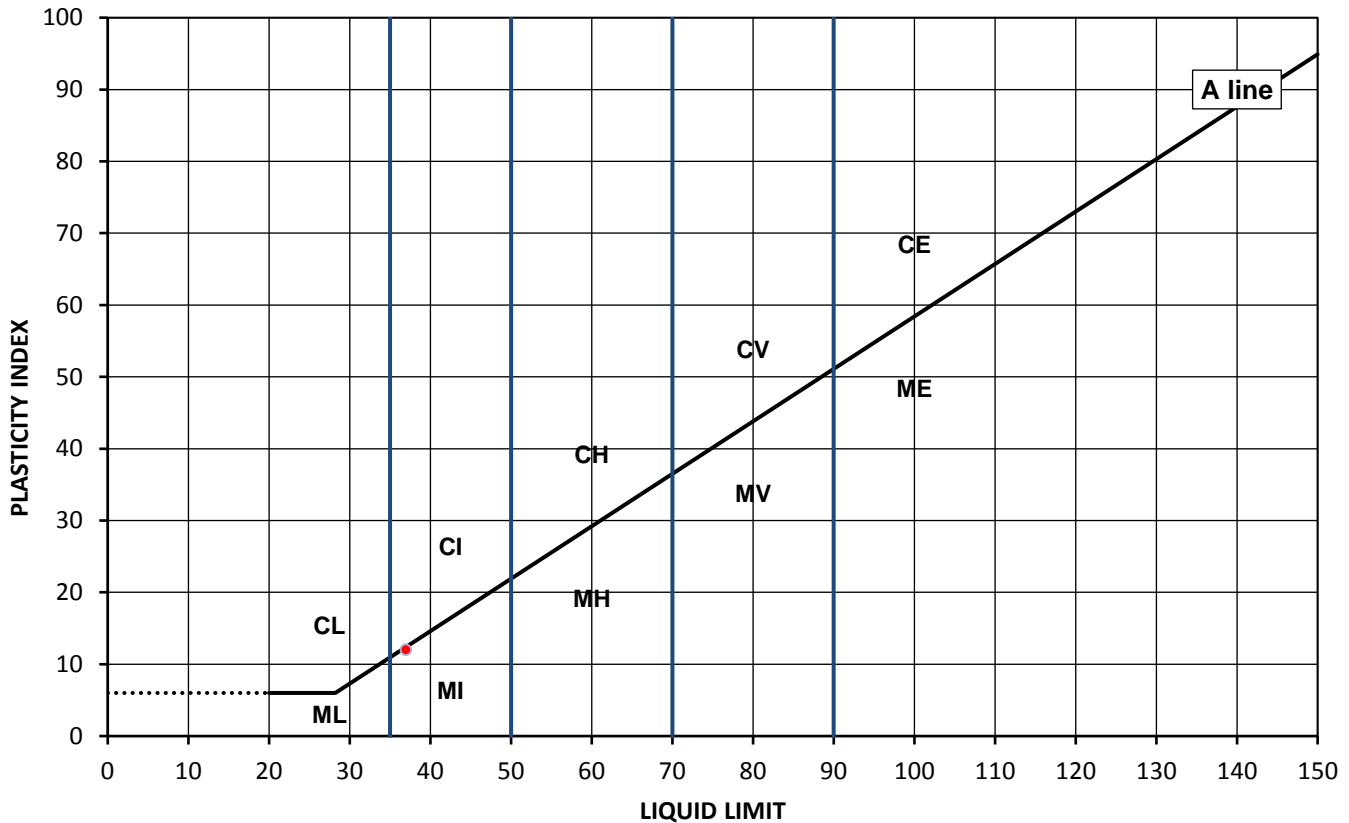
As Received Moisture Content [%]	Liquid Limit [%]	Plastic Limit [%]	Plasticity Index [%]	% Passing 425µm BS Test Sieve
31	37	25	12	98

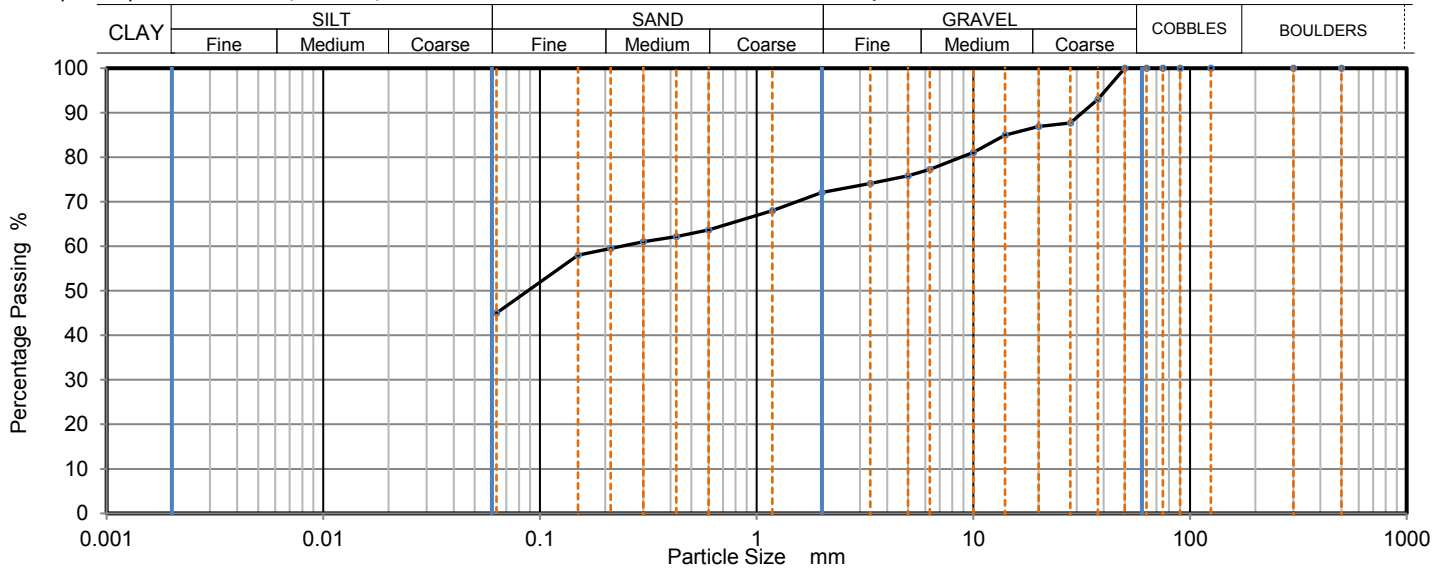
Depth Top [m]: 0.80  
Depth Base [m]: Not Given  
Sample Type: B

Laboratory Reference: 1507661  
Hole No.: TP03  
Sample Reference: Not Given  
Sample Description: Yellowish brown very gravelly very sandy CLAY with fragments of shale  
Sample Preparation: Sample was quartered, oven dried at 106.2 °C and broken down by hand.

Sieving		Sedimentation	
Particle Size mm	% Passing	Particle Size mm	% Passing
500	100		
300	100		
125	100		
90	100		
75	100		
63	100		
50	100		
37.5	93		
28	88		
20	87		
14	85		
10	81		
6.3	77		
5	76		
3.35	74		
2	72		
1.18	68		
0.6	64		
0.425	62		
0.3	61		
0.212	60		
0.15	58		
0.063	45

Sample Proportions	% dry mass
Very coarse	0.00
Gravel	27.90
Sand	26.80
Fines <0.063mm	45.40

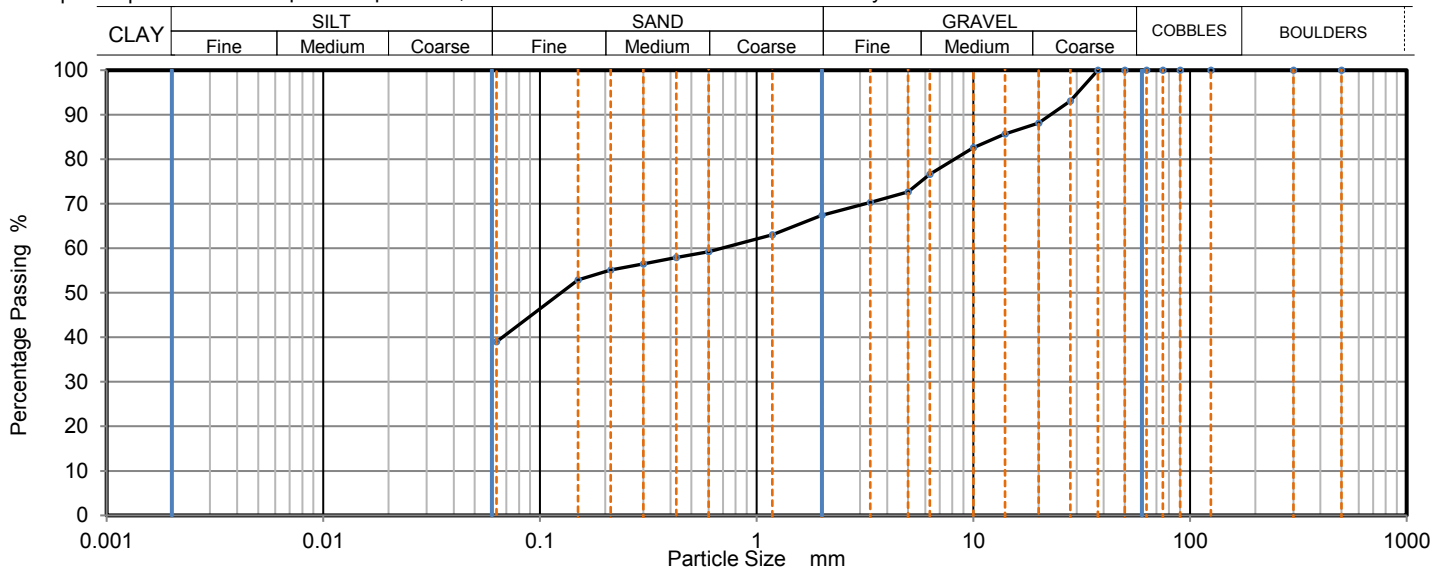
Depth Top [m]: 1.50  
Depth Base [m]: Not Given  
Sample Type: B

Laboratory Reference: 1507662  
Hole No.: TP05  
Sample Reference: Not Given  
Sample Description: Yellowish brown very gravelly very sandy CLAY with fragments of shale  
Sample Preparation: Sample was quartered, oven dried at 106.7 °C and broken down by hand.

Sieving		Sedimentation	
Particle Size mm	% Passing	Particle Size mm	% Passing
500	100		
300	100		
125	100		
90	100		
75	100		
63	100		
50	100		
37.5	100		
28	93		
20	88		
14	86		
10	83		
6.3	77		
5	73		
3.35	70		
2	67		
1.18	63		
0.6	59		
0.425	58		
0.3	57		
0.212	55		
0.15	53		
0.063	40

Sample Proportions	% dry mass
Very coarse	0.00
Gravel	32.60
Sand	27.80
Fines <0.063mm	39.60
