ANALYSIS OF THE SITE
2.11 THE ASH PLANTATION AND POND

ANALYSIS OF THE SITE
2.12 VIEWS TO ADJACENT FIELDS

ANALYSIS OF THE SITE
2.13 WIDER WATER CONTEXT

LANDSCAPE & BIODIVERSITY PROPOSALS

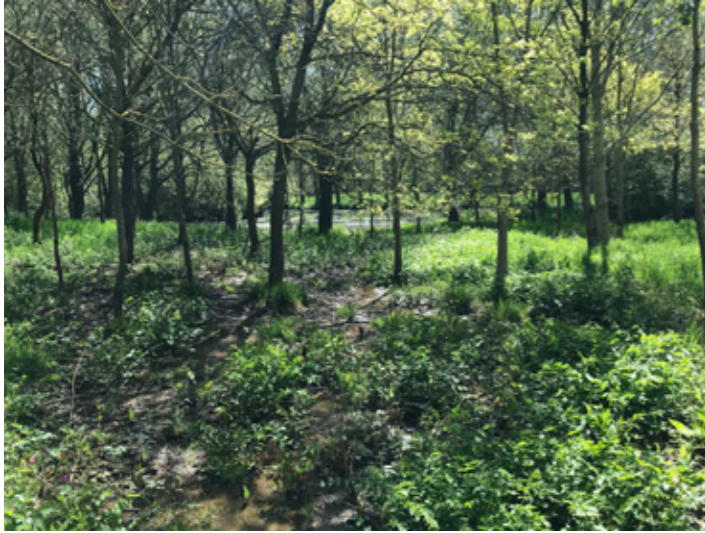
The braided stream flows into the site from the north west forming a wetland.

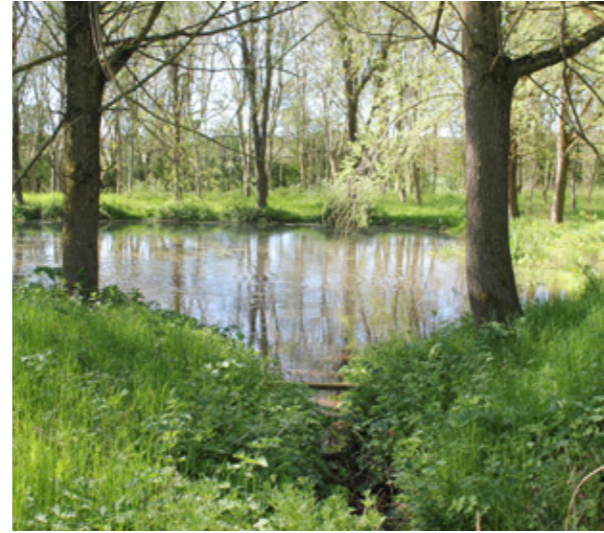
The stream flows into the man made pond in its north west corner.

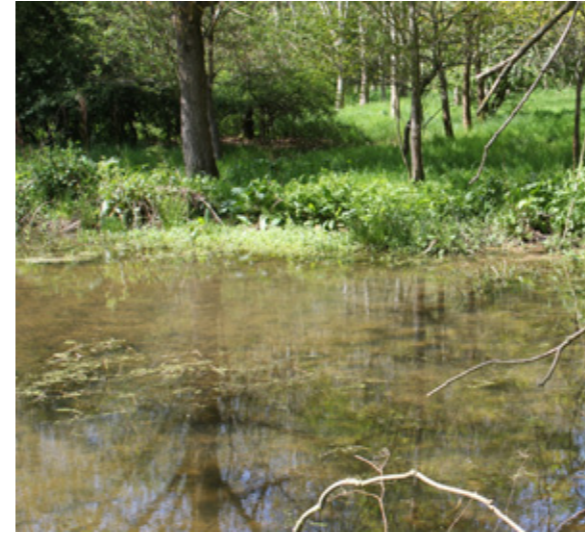
Duck weed is apparent in the pond, but generally the water is clear and looks clean.

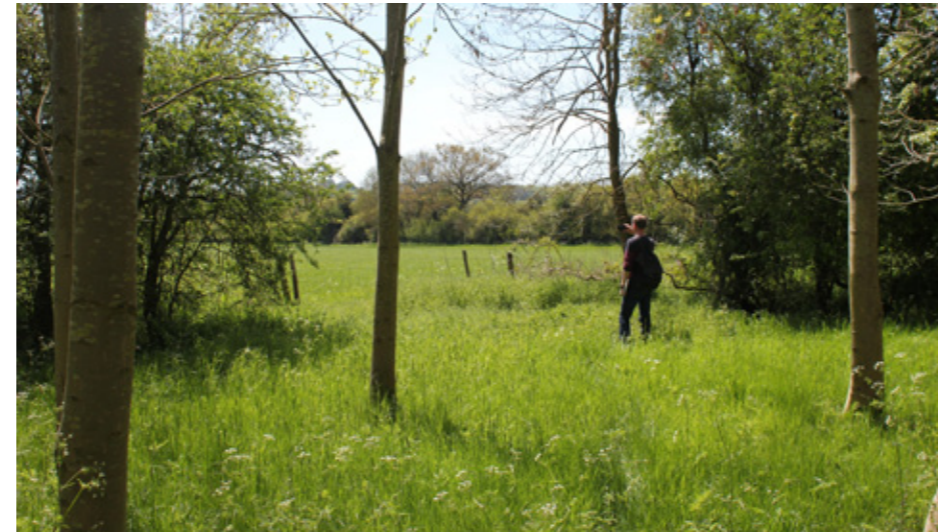
Gaps in the South boundary reveal long distance views out.

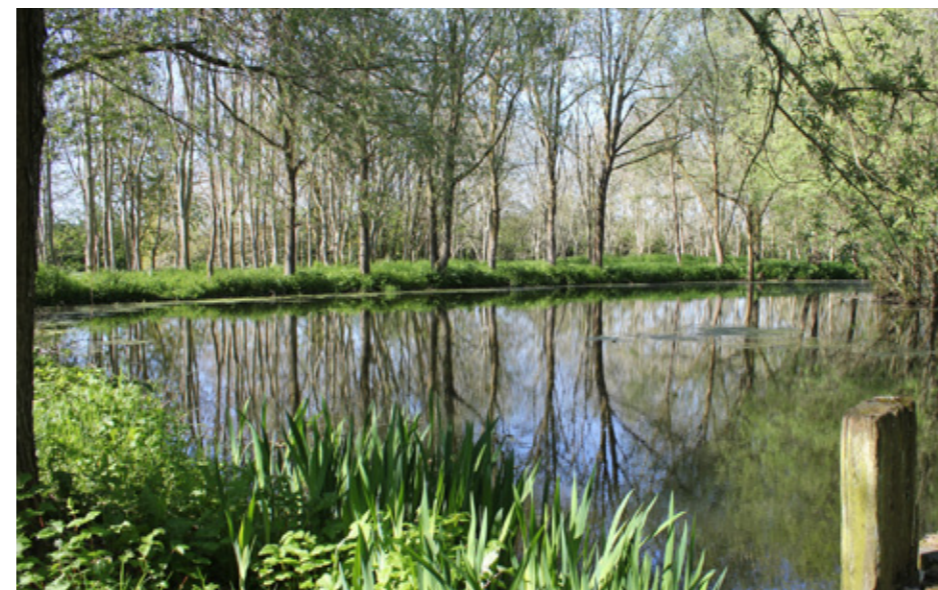
The rectangular pond is lined with evenly spaced crack willow.

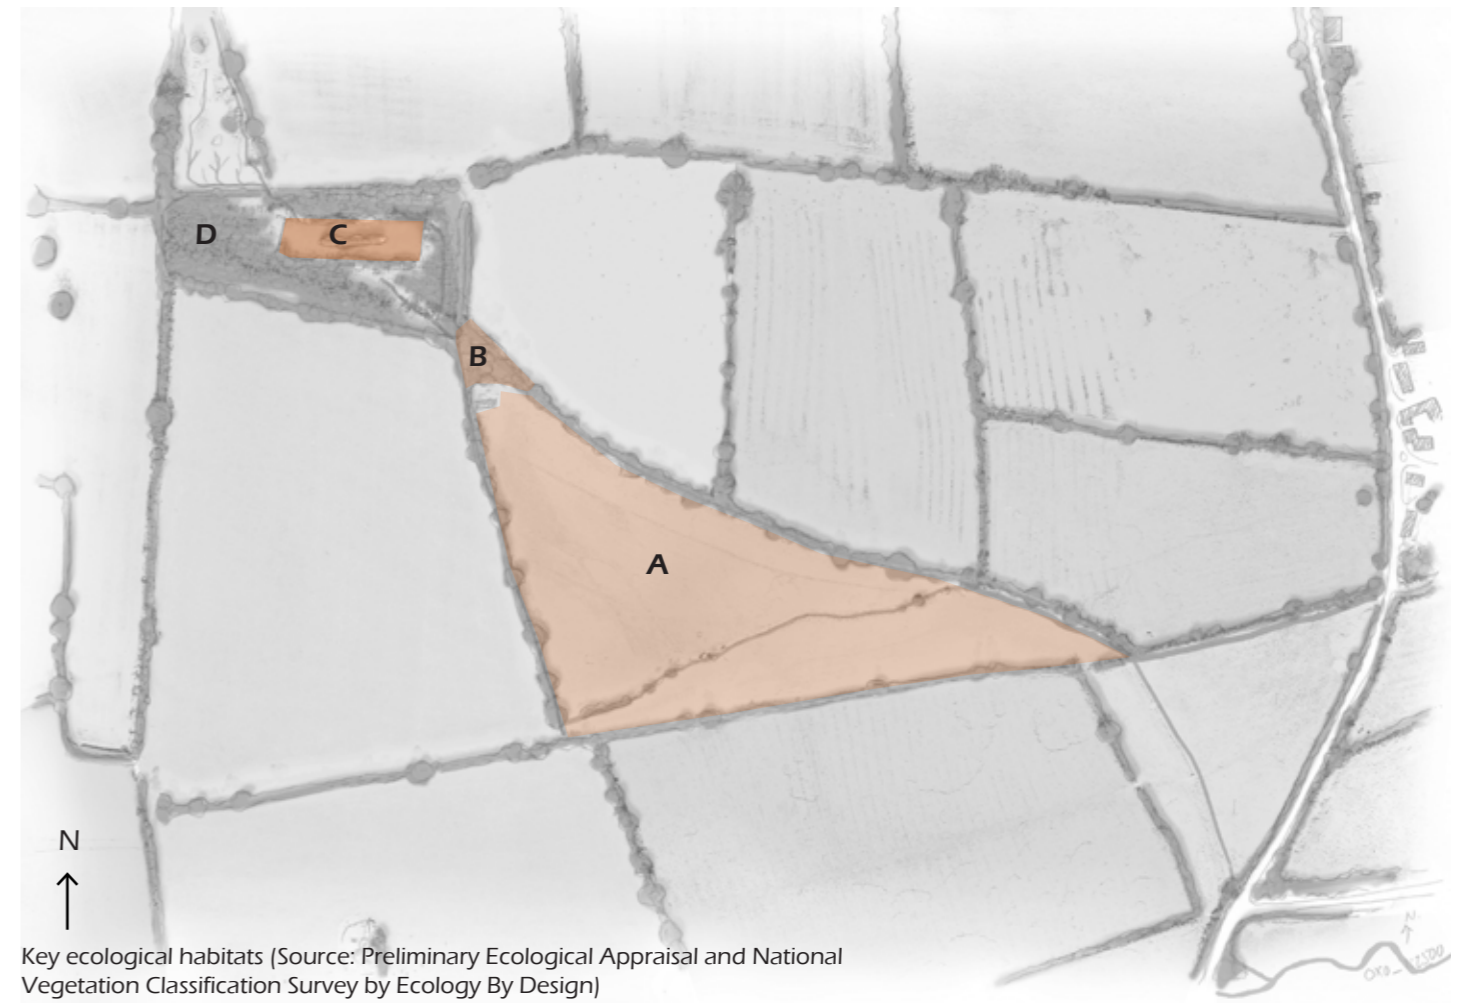
Key ecological habitats (Source: Preliminary Ecological Appraisal and National Vegetation Classification Survey by Ecology By Design)

- A NVC community MG4 *Alopecurus pratensis* – *Sanguisorba officinalis* grassland.**
This is a lowland neutral grassland community characterised by a species-rich sward. There are 16 species listed as 'constants' of this community in Rodwell 1992. Of these species, 13 were present within the Site and all were found in quadrats. Of the 35 species recorded in the grassland of the site, only six would be considered untypical of the MG4 community, and these were all infrequently encountered.
The grassland on Site can therefore be considered to have an assemblage of species typical of the MG4 community. However, the constancy with which many of these species occur is lower than that that which would be found in a 'good' example of the community.
MG4 grassland falls within the definition of a lowland meadow and as such is 'habitat of principal importance for the conservation of biodiversity under the provisions of the Natural Environment and Rural Communities Act (NERC) 2006 (See Section 7.2).

- B Broadleaved semi-natural woodland**
A fragment of broadleaved semi-natural woodland is present at the narrowest point at the site where the grassland meets the plantation woodland. Here the ground flora is diverse and includes many bluebells (*Hyacinthoides non-scripta*), lords-and-ladies (*Arum maculatum*) and foxglove (*Digitalis purpurea*).

- C Standing water**
A man-made pond was created by the previous landowner in the plantation woodland. It is shaded and there is quite a lot of leaf litter present with little aquatic vegetation. There were some strands of Yellow iris (*Iris pseudacorus*) on the margins.

- D Broadleaved plantation woodland**
The previous landowner created an area of plantation woodland around twenty years ago. This was primarily formed of dozens of young ash (*Fraxinus excelsior*) specimens. The trees are planted in uniform rows and are still young. The ground flora is still primarily composed of grassland species present prior to the tree-planting although there are clumps of tufted hair-grass (*Deschampsia cespitosa*) and evidence of some developing woodland ground flora at the edges of the plantation.

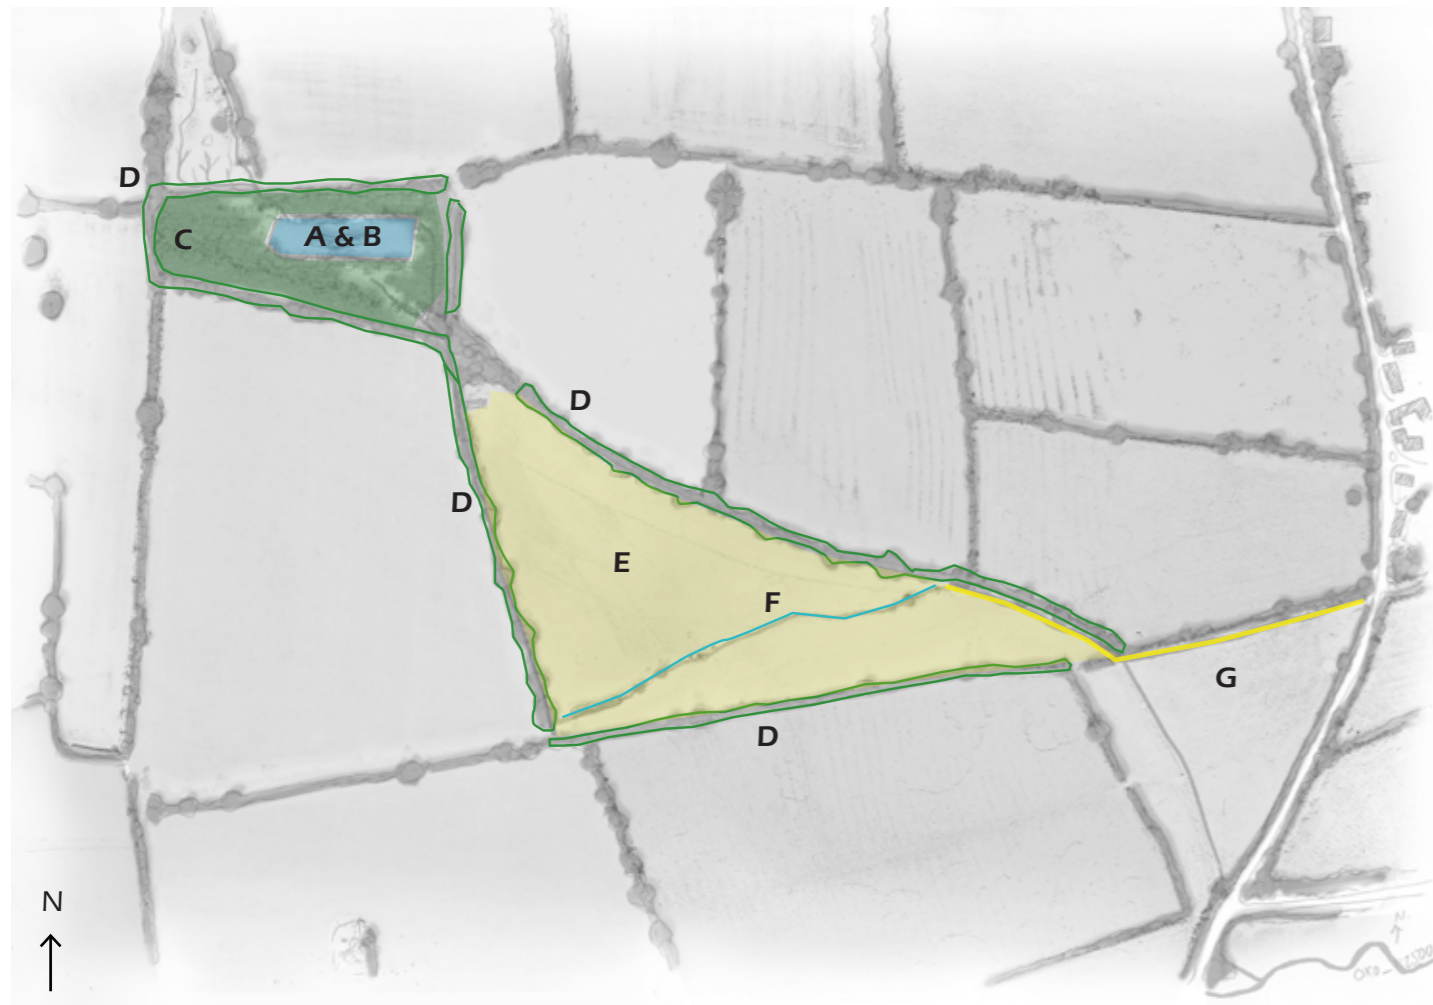
Existing Damaged Landscape

- A** The introduced poorly designed pond and trees almost certainly absorbs floodwater that otherwise would have flooded the damp meadow.
- B** The pond has little ecological value due to its steep edge profiles and over shading by the surrounding trees.

- C** Un-managed, dark mono culture of the Ash plantation has little ecological benefit or diversity. Given that Ash die-back is present in the surrounding hedgerows it is almost certain that the trees will die.

- D** The hedgerows are un-managed and although they are diverse and ecologically rich at the moment if they are not managed as field boundaries they will start to grow out and decline.

- E** The damp meadow is nationally important, but is relatively species poor, almost certainly due to the change in winter flooding caused by the pond and Ash plantation.

- F** The stream is un-managed, hidden and currently has little influence on its adjacent landscape context.
- G** A Cotswold aggregate access road was laid within the last 2 years. It is wide, very yellow and dominant within the landscape.

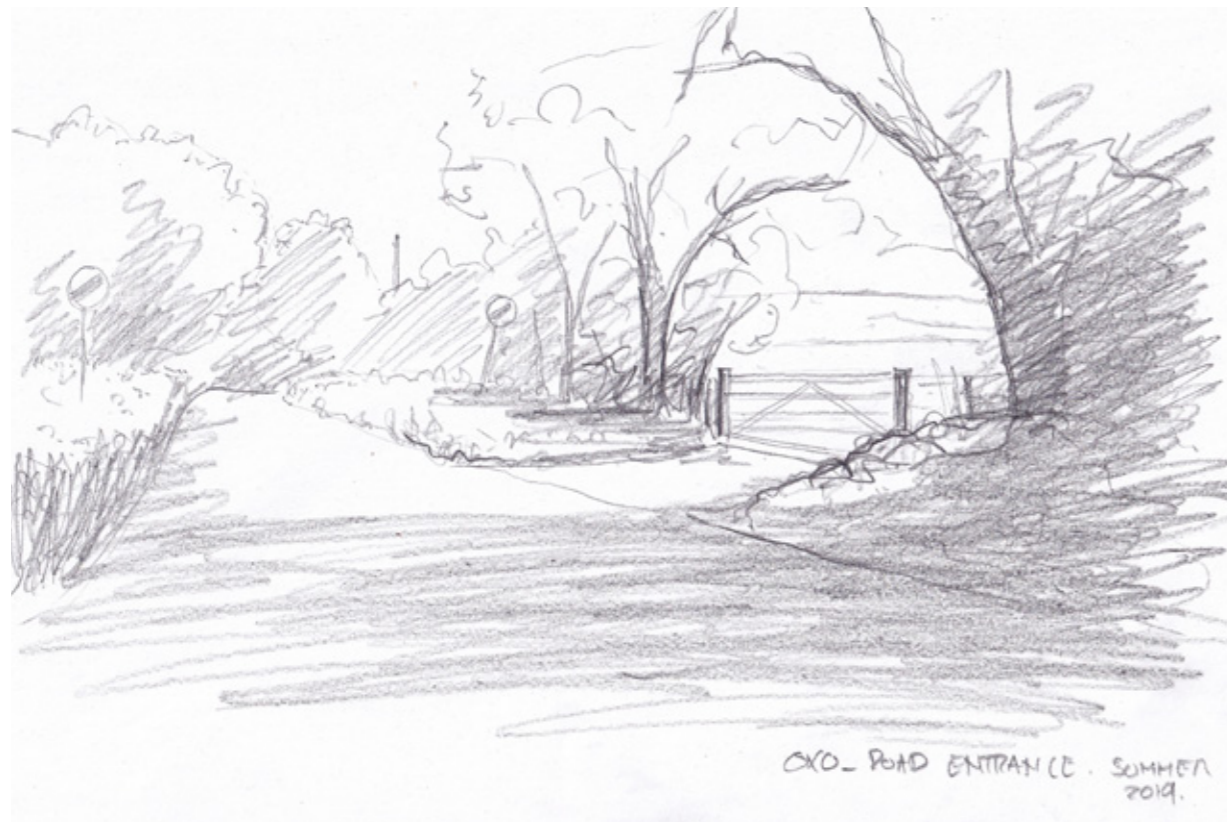
1. ENTRANCE OFF PUBLIC HIGHWAY:
A new agricultural gate will be set 6m back from the edge of the highway.

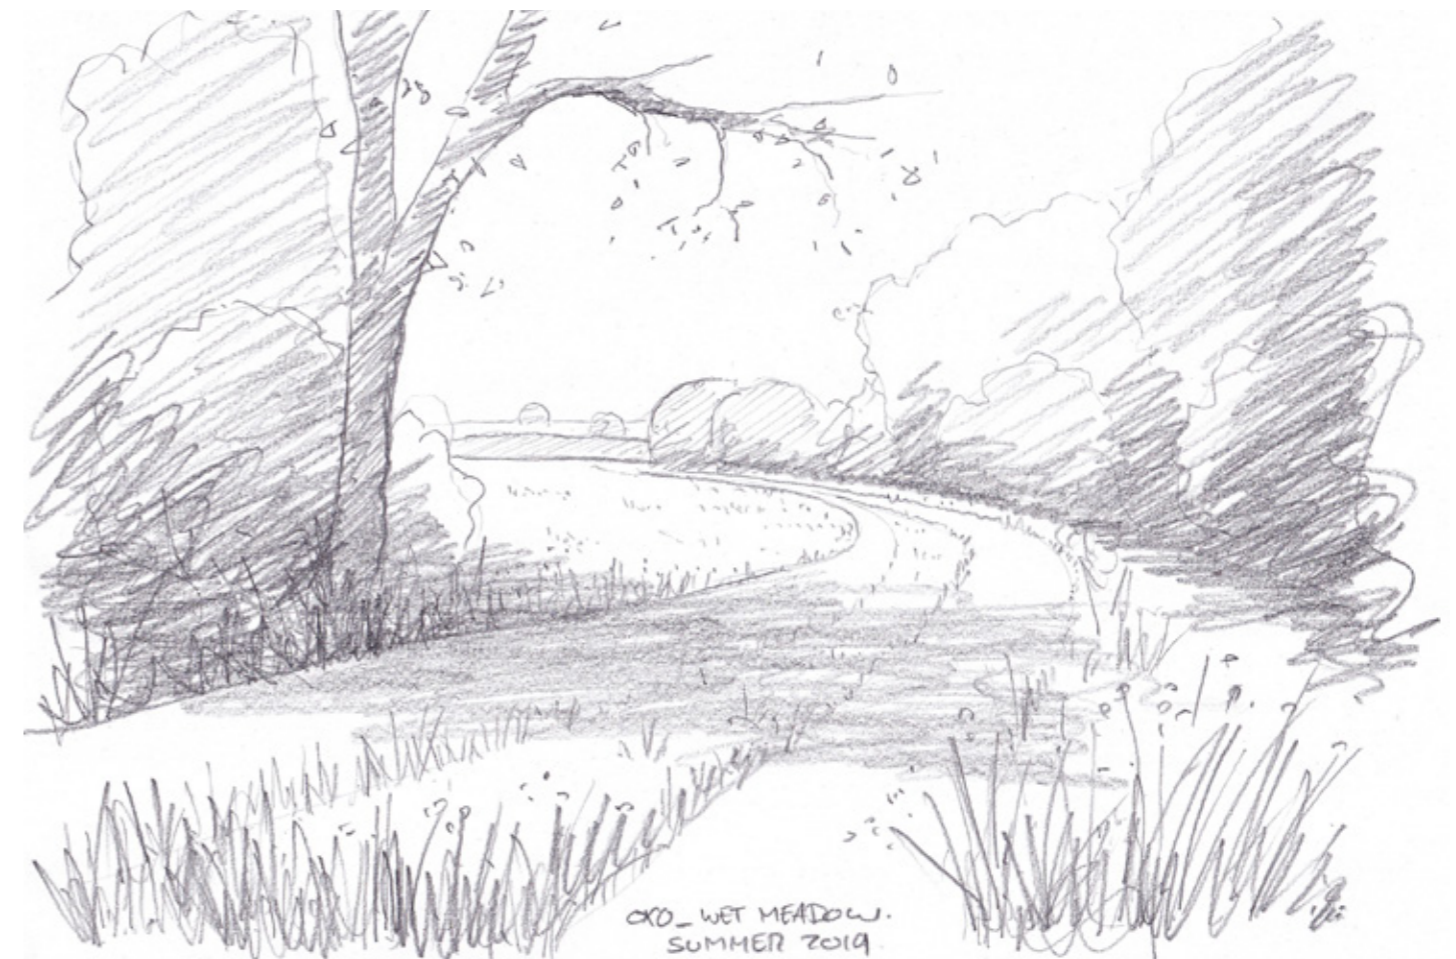
3. SENSE OF ARRIVAL AT THE DAMP MEADOW:
The hedgerow separating the top field from the damp meadow will be managed and reinforced. A new hedgerow tree will be planted to frame the threshold into the damp meadow. The wide cotswold chipping road will be reduce to a 3.1m wide understated farm track, with a passing place.

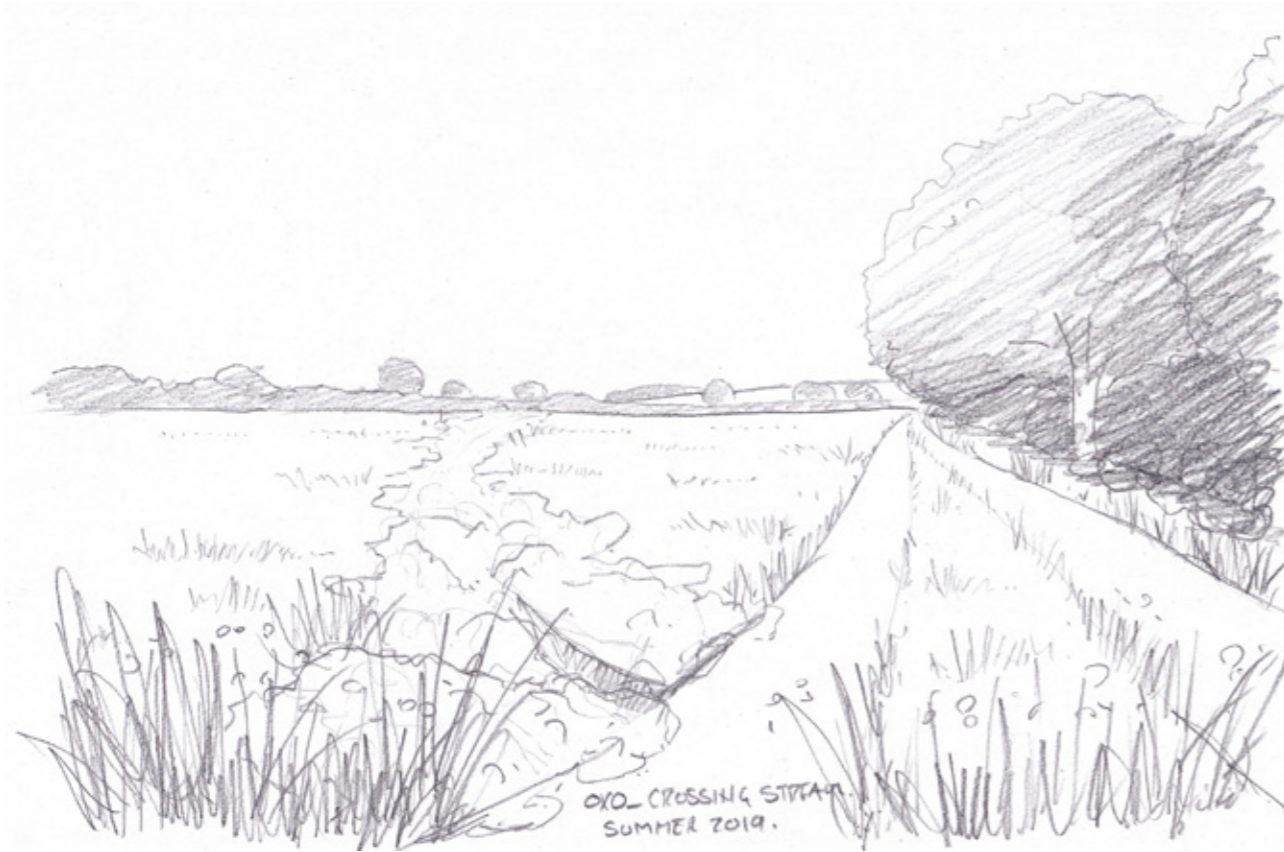
4. THE DAMP MEADOW:

The stream will be cleared of self-seeded shrubs and along with the damp meadow managed as detailed on 4.25 page.

A new low key access track will link the existing track to the Barn.

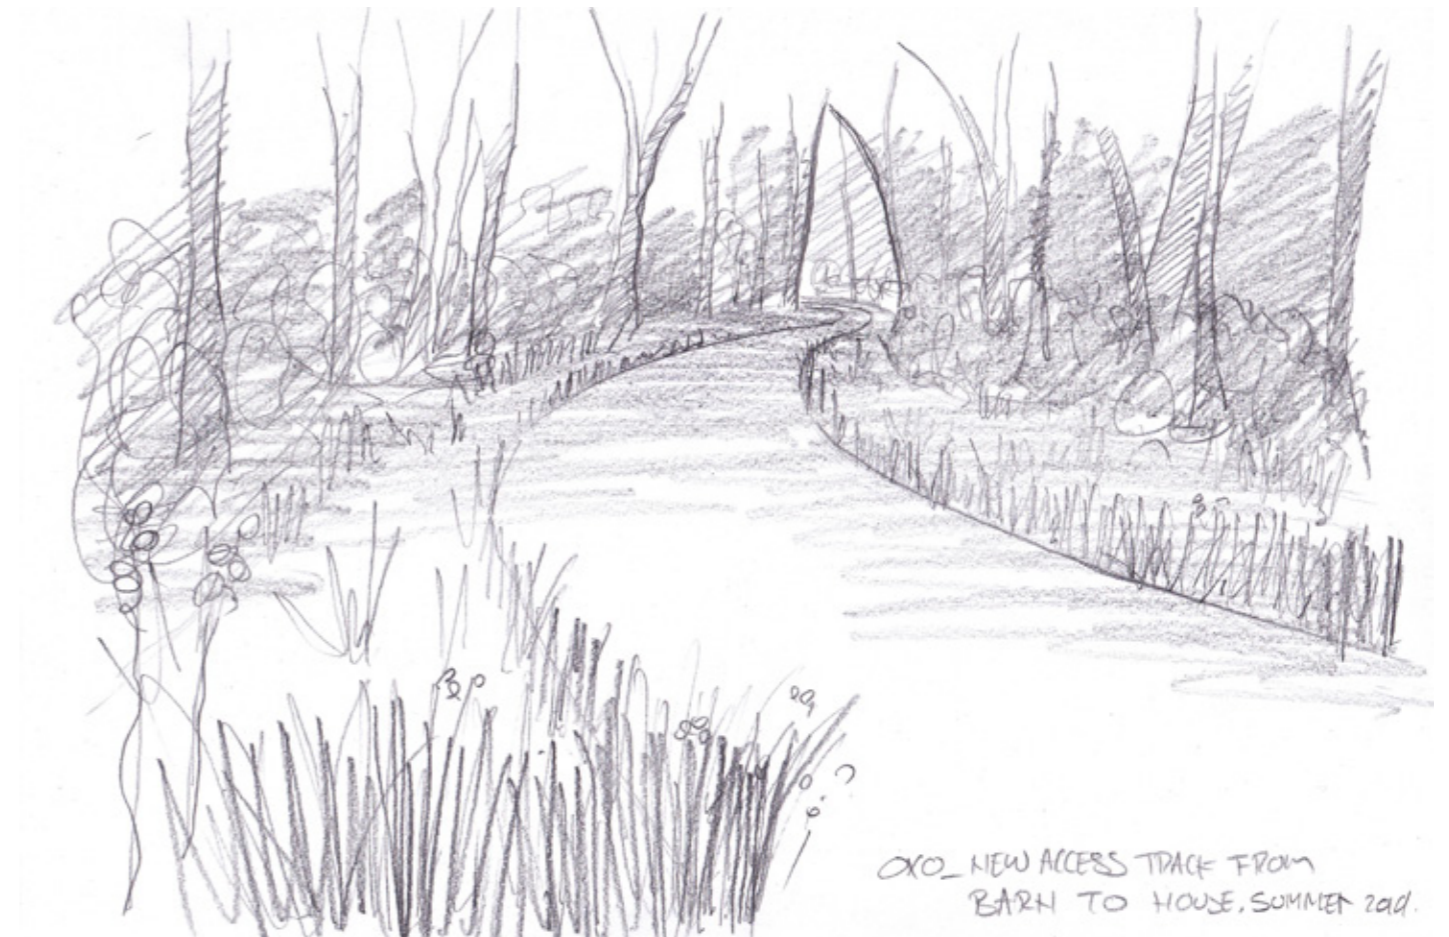
8. SENSE OF DESTINATION TO THE HOUSE:

A new tarmac access track surfaced in gravel would be carefully woven through the existing woodland. The construction would be no dig and only adjacent scrub would be cleared to facilitate it.

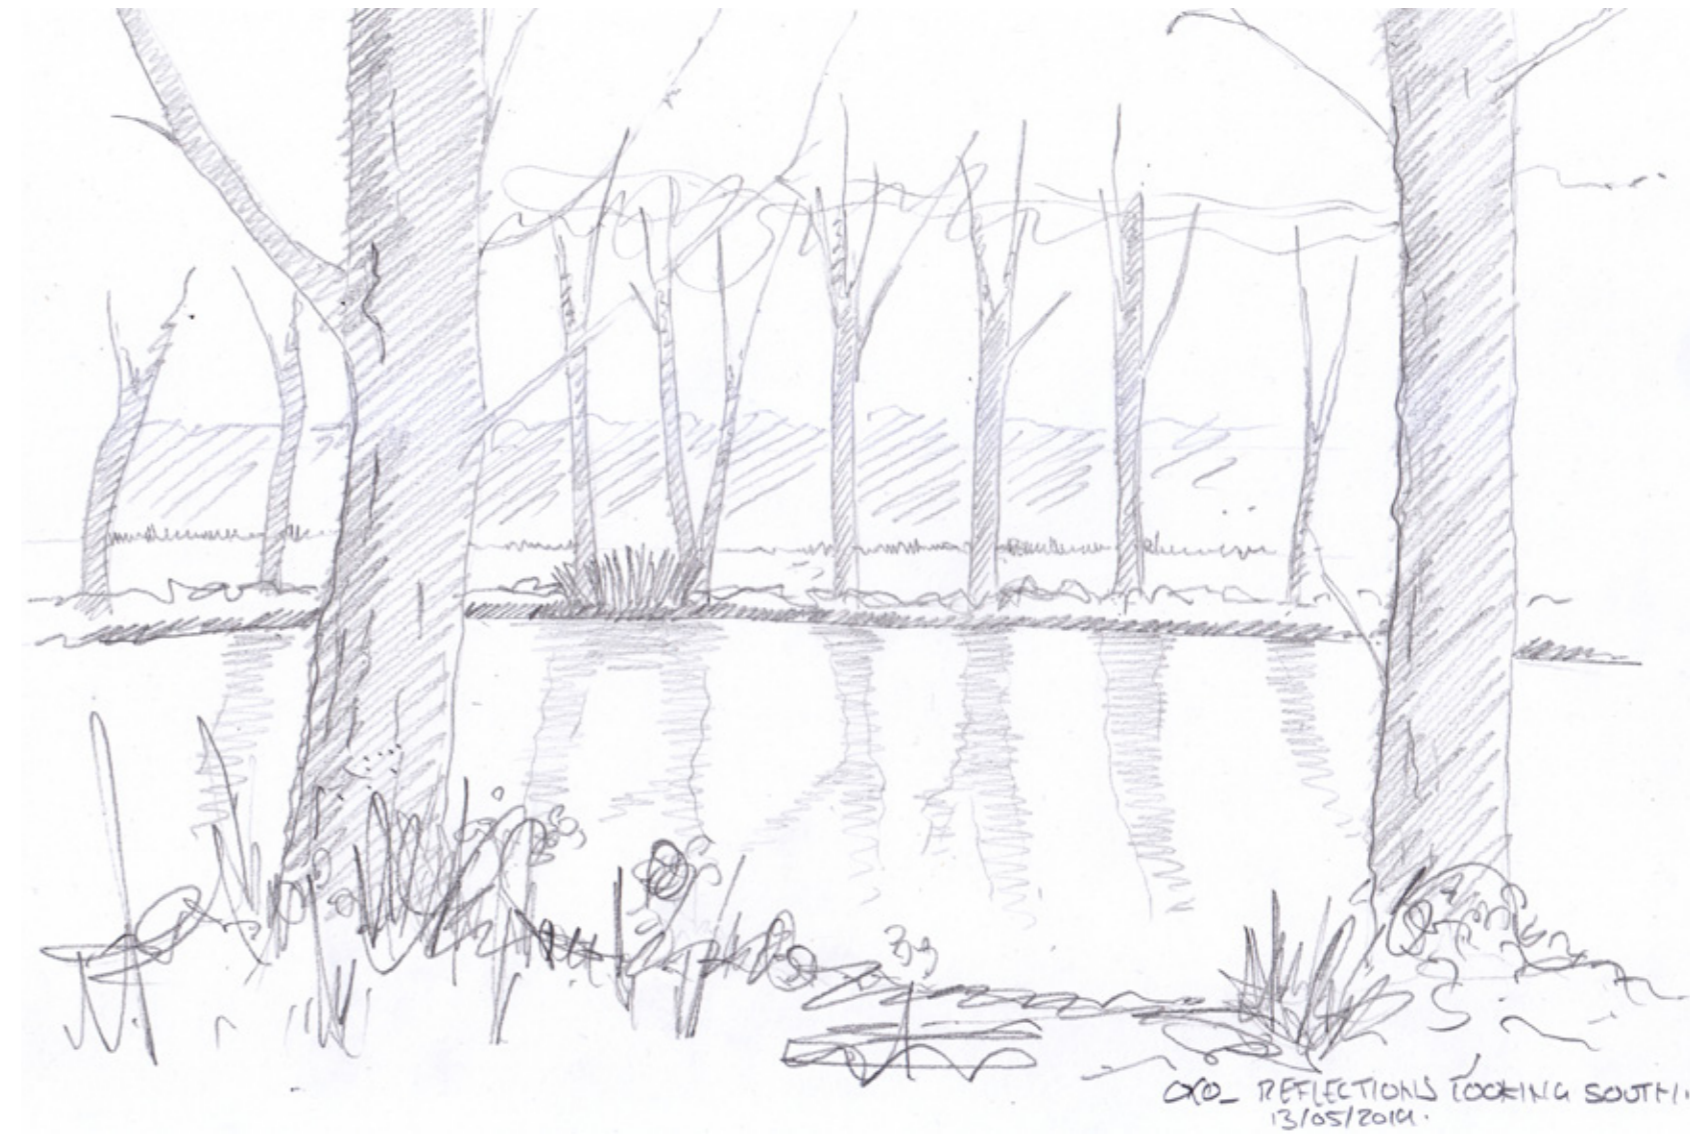
SOUTH REFLECTIONS:
 Crack Willow / Obscured Views Out / Steep Converted Banks / No Marginals Except Yellow Flags / Sky and Trees Reflected / Clear Water / Duck Weed
