**New Settlement Area, Heyford Park,  
Oxfordshire.**

**Dorchester Phase 5,  
Contamination Hotspot: Phase 4 Remediation  
Works Verification Report.**

**For: Urban Regen Ltd.**

**July 2020**

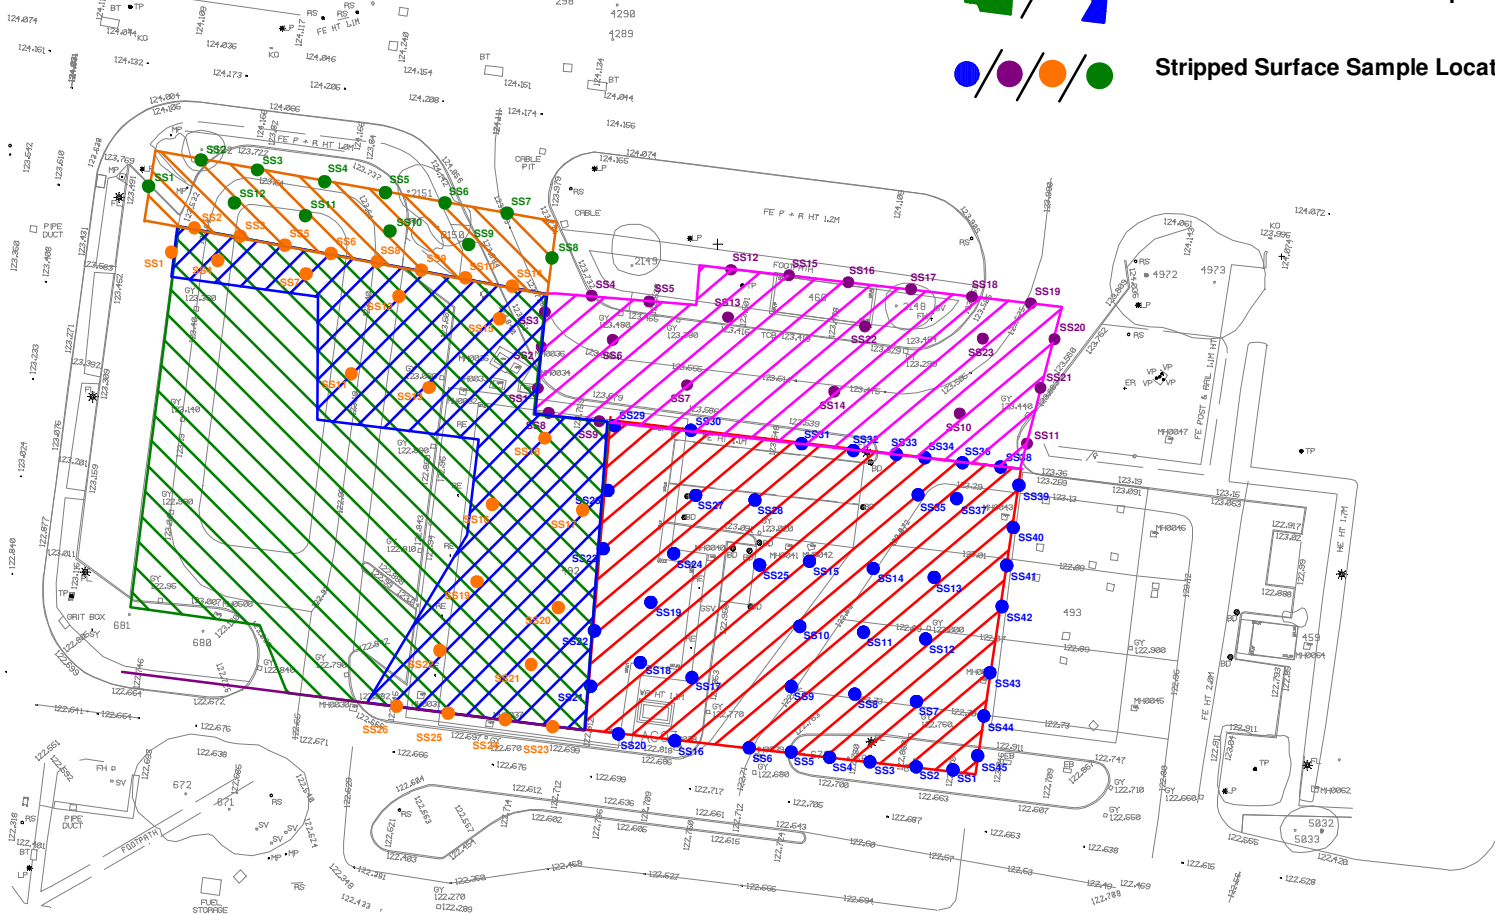
Hotspot Excavation Extents (Ph1 / Ph2 / Ph4)

Stripped Surface Sample Locations (Ph1 / Ph2 / Ph3 / Ph4)

3.4.5. The extents of the Phase 4 excavation works (which had a total area of approximately 285m<sup>2</sup>) including the areas of previous remediation phases are shown in Drawing D01.

4.3.3 The extents of the Phase 4 excavation area and the hydrocarbon hotspot are indicated in Drawings D01 and D02.

collected from the base of the excavation. Validation sample locations are indicated on Drawing D01.

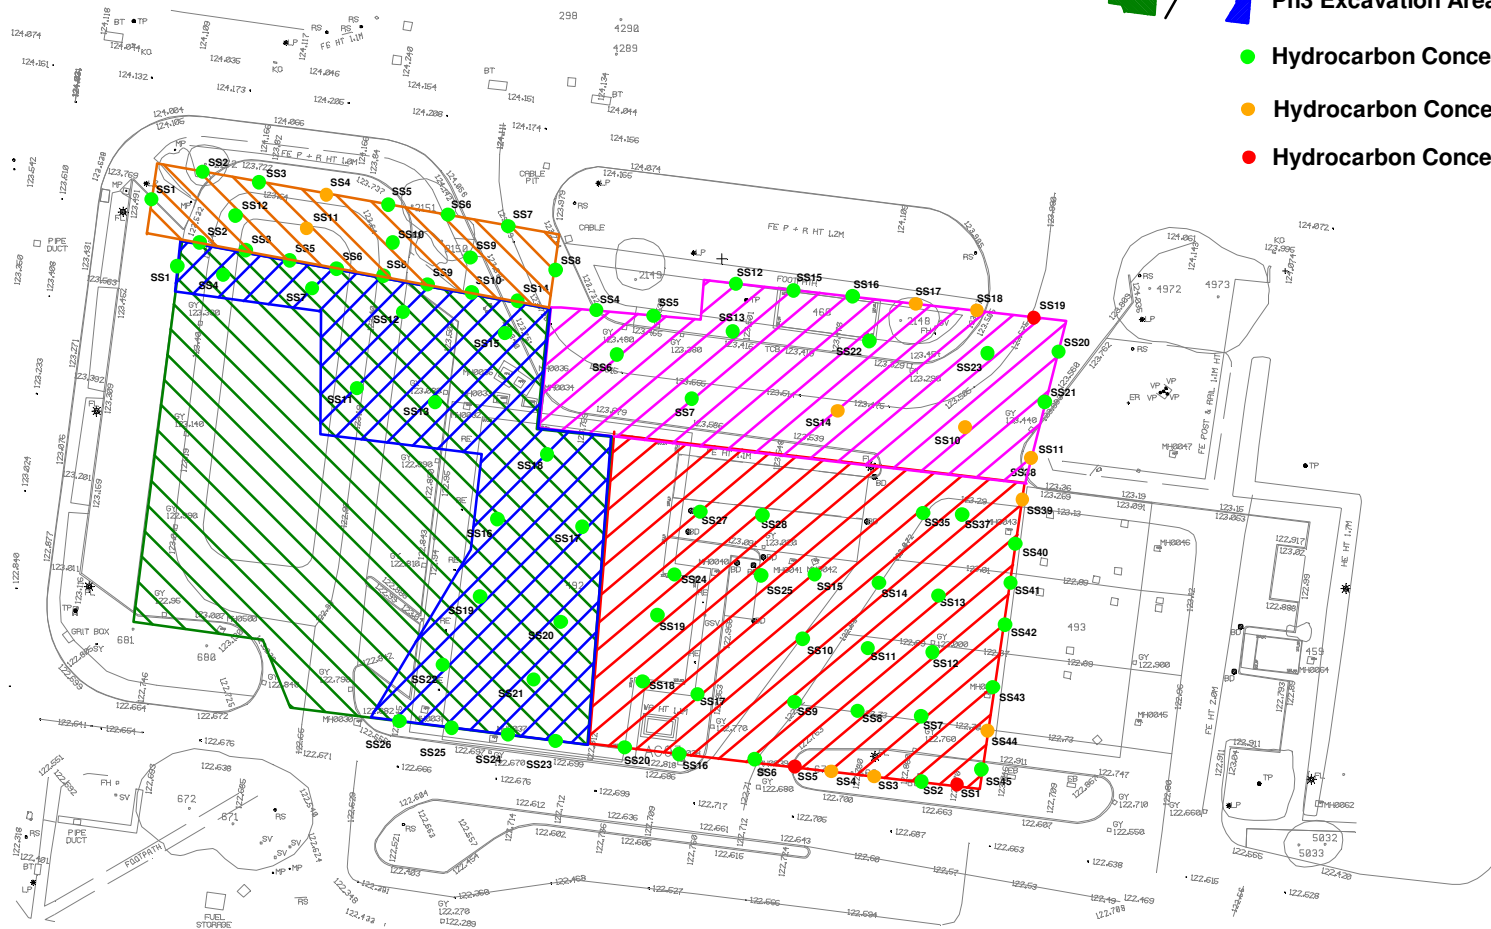
Hydrocarbon Concentrations 5-10x RTVs

4.3.9 Drawing D02 indicates the locations of the samples with the concentrations of hydrocarbons relative to the RTVs.

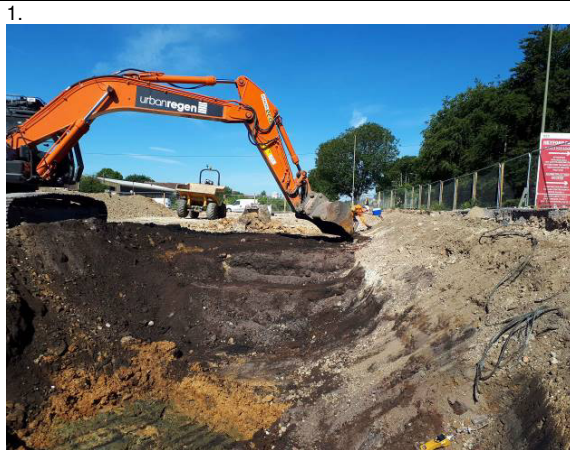
02.06.20 – Recovery of clean stone

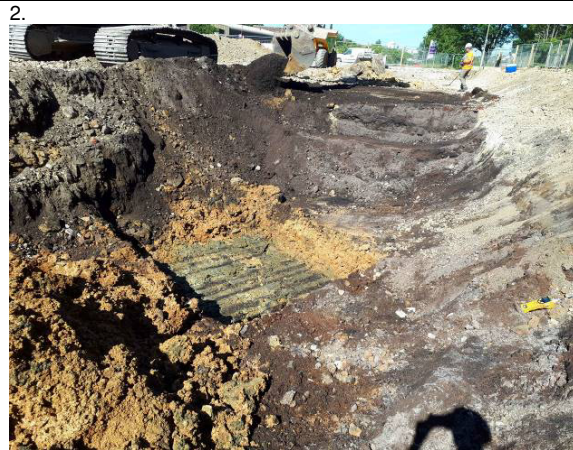
02.06.20 – Clean stone removed from surface exposing impacted clay soil at base

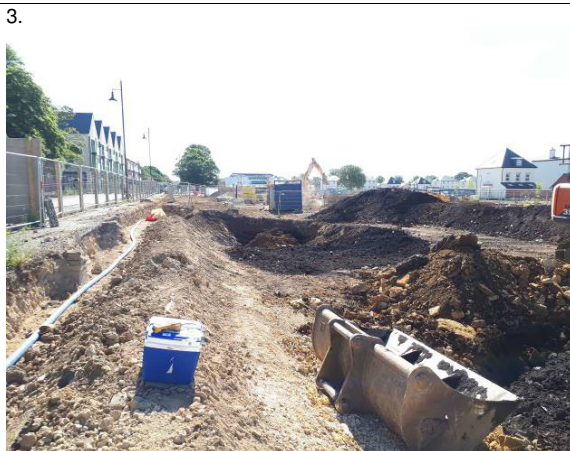
02.06.20 – Eastern view down remediation area (Camp Road visible to left)

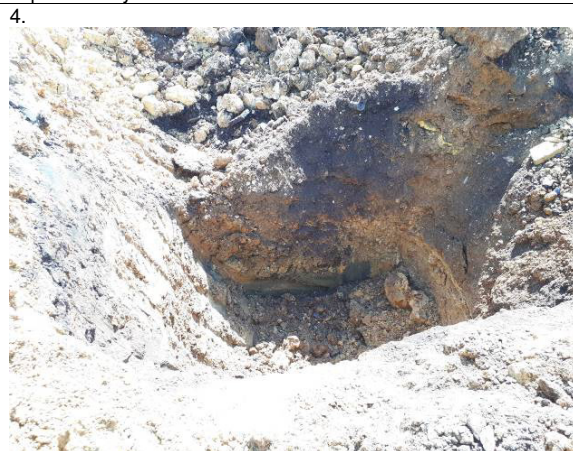
02.06.20 – Exploratory trial-pit to determine extent of impacted soils

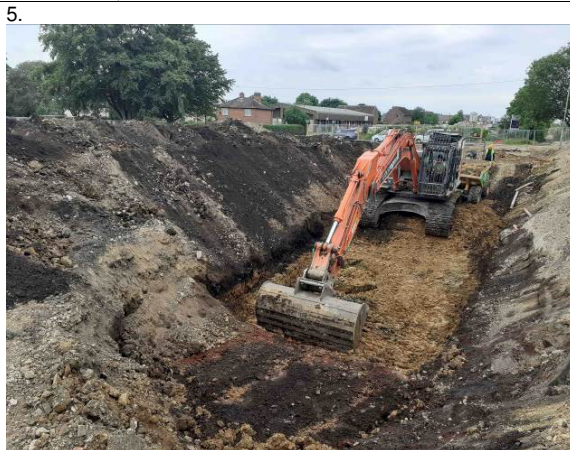
04.06.20 – Strip of soils not demonstrating significant contamination indicators to direct north of previous Phase 3 hotspot excavation area.

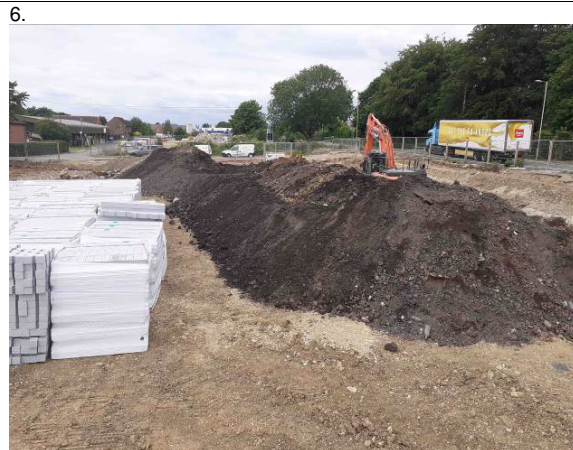
04.06.20 – Soils not demonstrating significant contamination indicators stockpiled to south of excavation area (1/2).

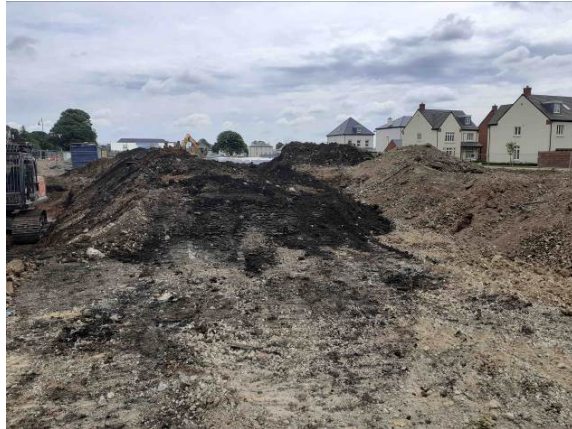
04.06.20 – Soils not demonstrating significant contamination indicators stockpiled to south of excavation area (2/2).

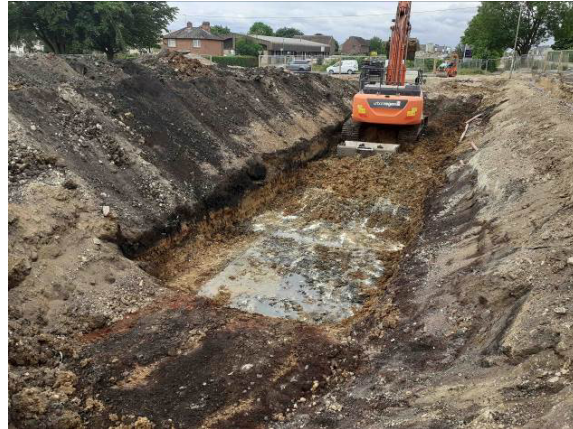
04.06.20 – Excavation of hydrocarbon contaminated soils down to weathered bedrock.

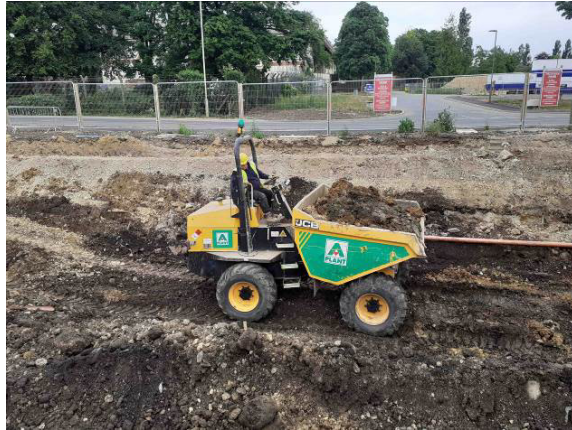
04.06.20 – Removal of contaminated soils to quarantine area within wider development.

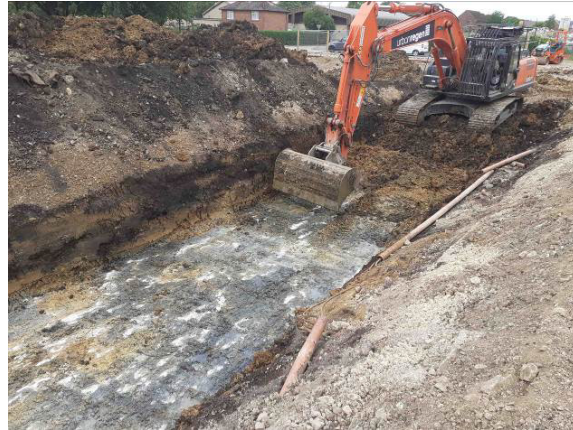
04.06.20 – Continuation of excavation of hydrocarbon contaminated soils down to weathered bedrock.

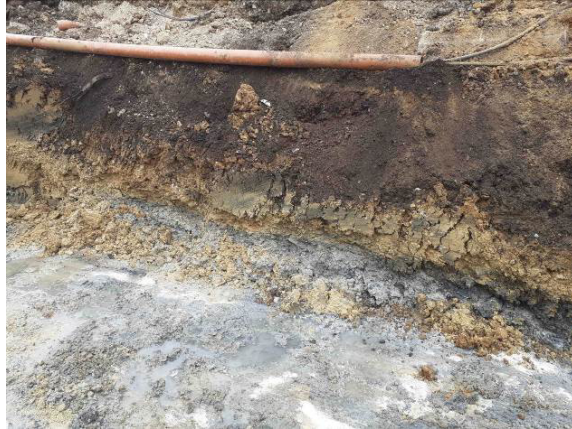
04.06.20 – Soils demonstrating residual indicators of contamination present within northern sidewall of excavation; unable to progress excavation northwards.

3.4.4. Upon completion of these works indicators of contamination were still present within the northern excavation sidewall; however, as Camp Road is located directly to the north of the site and is to be incorporated within the wider development no further excavation works are

proposed. The hydrocarbon impacted northern sidewall was therefore sampled as part of the validation sampling regime, as discussed in Section 4.

4.3.7 Both exceedances were minor with the C12-16 aliphatic hydrocarbon concentration of sample 'S4' reported at 1,215mg/kg (screening criteria 1,000mg/kg) and the C10-12 aromatic hydrocarbon of sample 'S11' at 24.1mg/kg (screening criteria 23mg/kg). This is therefore not

considered to be indicative of the presence of unacceptable levels of residual contamination with the potential to cause significant pollution.

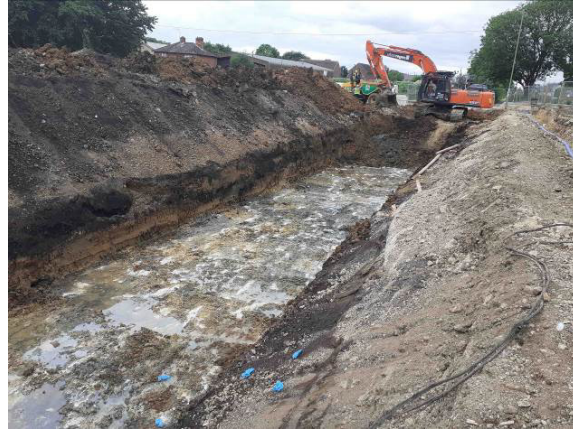
04.06.20 – View west across excavation area.

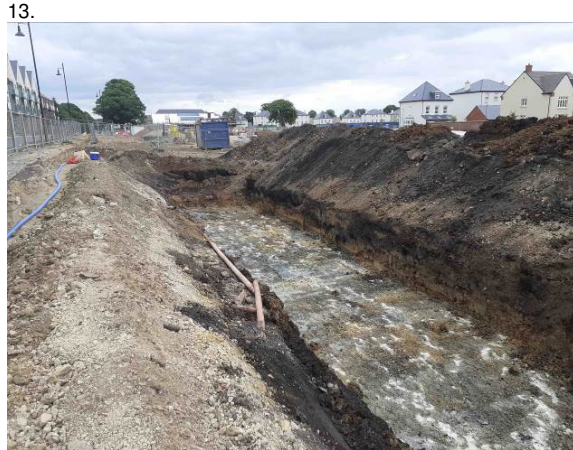
04.06.20 – View east across excavation area.

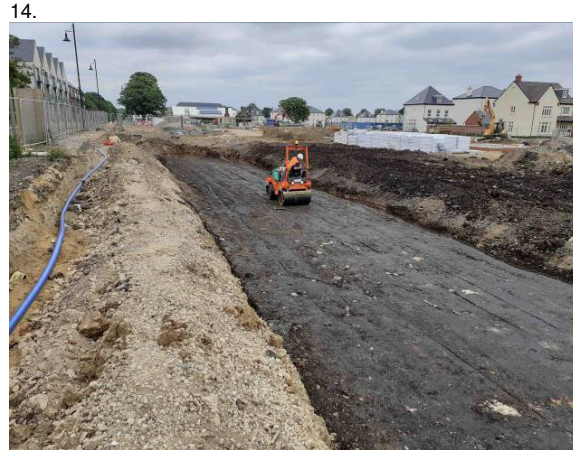
08.06.20 – Retained soils replaced and compacted into Phase 4 excavation.

3.2.2 Upon receipt of laboratory results confirming that the soils stockpiled adjacent to the hotspot were suitable to be retained, these were replaced into the excavation area and compacted.

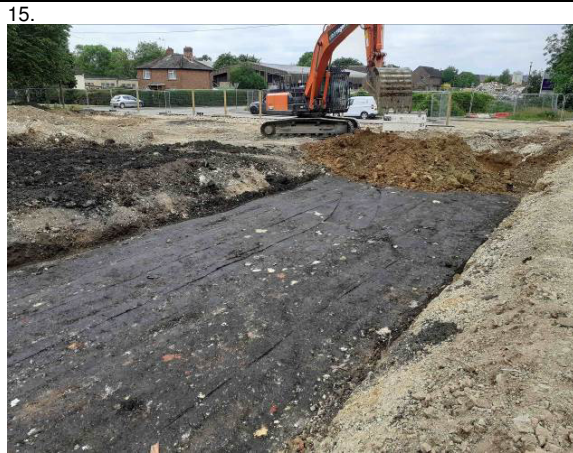
08.06.20 – Continuation of excavation to west

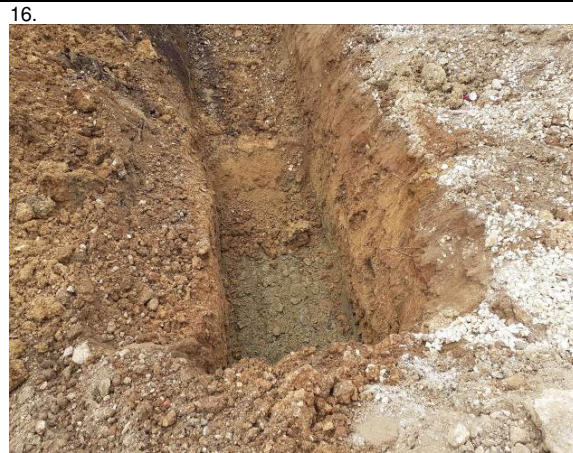
08.06.20 – No significant indicators of contamination noted in west of Phase 4 excavation area.
