PHASE 2 GEO-ENVIRONMENTAL SITE ASSESSMENT

SITE NAME Hornton Quarry

CLIENT Finsco Property

REPORT R001 - 6114

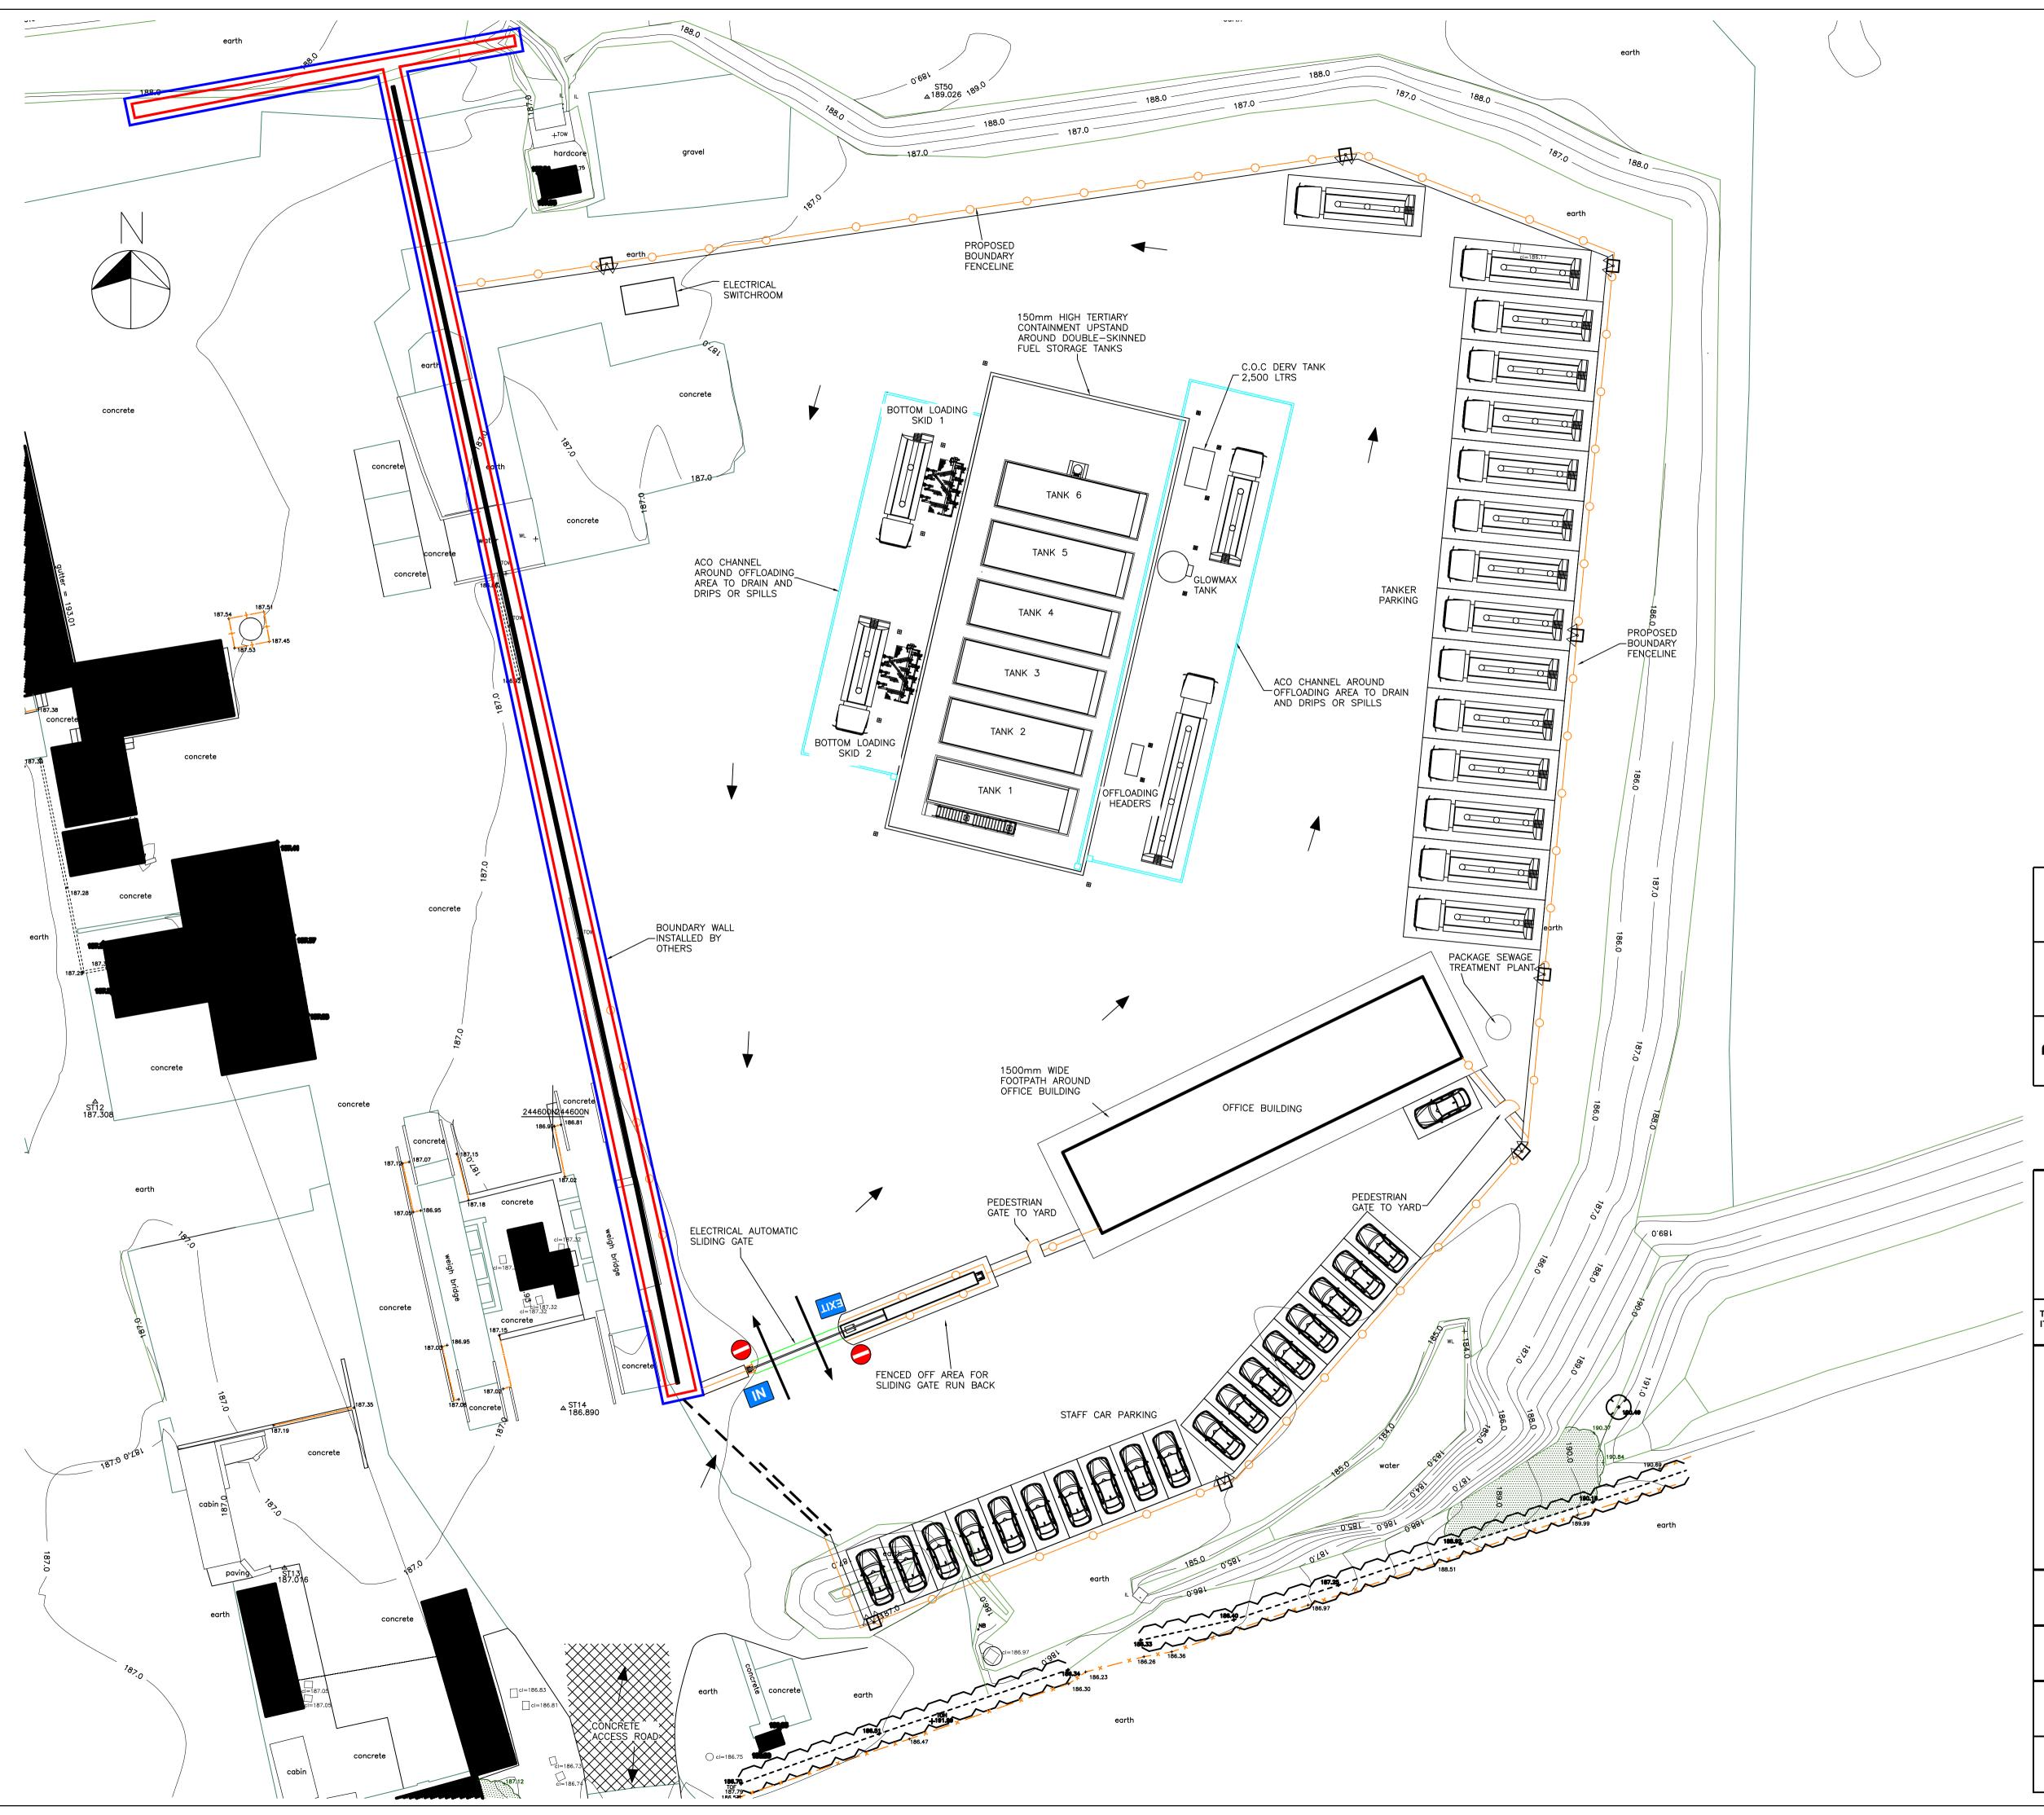
A map showing the location of the site is presented as Figure 1. A copy of the proposed development drawings is provided in Figure 3.

Rev:	Date:	Revision Details:	Rev By:	Chk:	Appr:
A	02.12.19	FOR COMMENT	Ь	НЭ	ΜN
В	21.05.20	INTERNAL BOUNDARY WALL ADDED SITE DEMISE REVISED LIGHTING COLUMN ADDED	YF	СН	ΝN

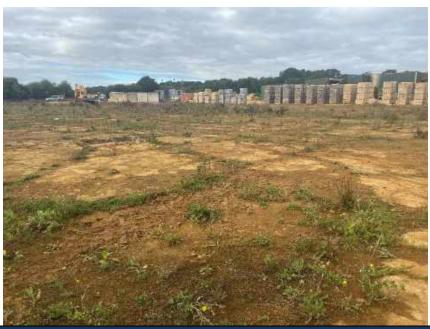
Photograph 2 – Photo is taken facing south-west. This photograph shows the vegetation growing within the fractures in the bedrock.

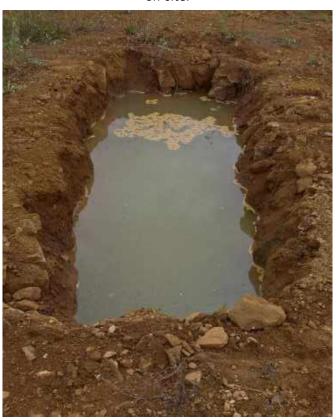
Photograph 3 – This photograph is of soakaway pit 2, illustrating the shallow depth to groundwater on-site.

Four soakaway pits were excavated within the site boundary (SA1-SA4) and two additional soakaway pits were excavated along the ditch down the access road (SA5-SA6). It was noted whilst excavating the trial pits that water seepage was coming in at around 0.55m and 0.65m bgl, on the day of the site investigation all of the soakaway pits contained significant amounts of water, therefore no soakaway tests could be completed on-site.

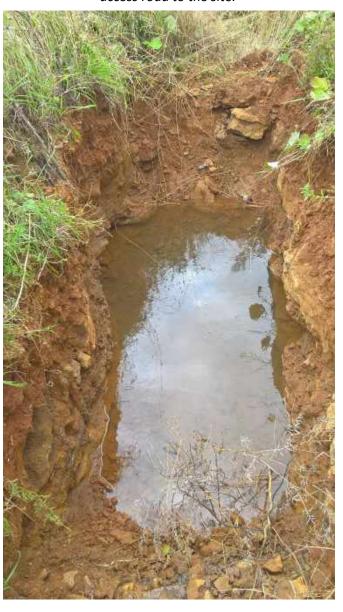
Photograph 4 – This photograph shows soakaway pit five progressed along the ditch next to the access road to the site.

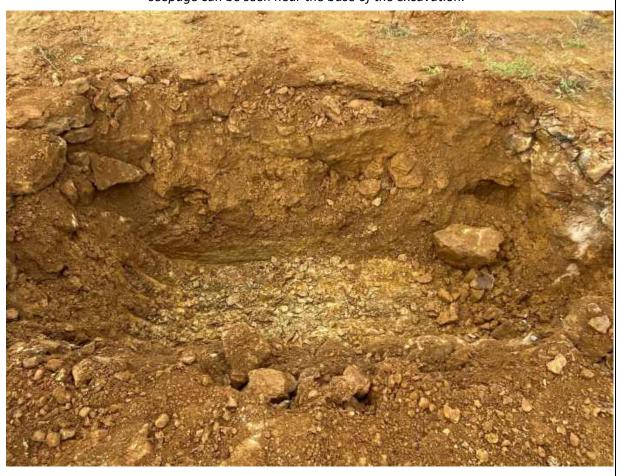
Photograph 5 – This photograph is of trial pit two showing the various geological horizons. Water seepage can be seen near the base of the excavation.

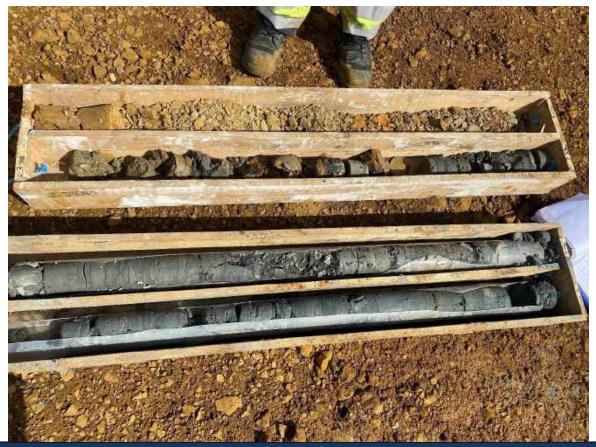
Photograph 6-This photograph shows the core run taken from BH2.

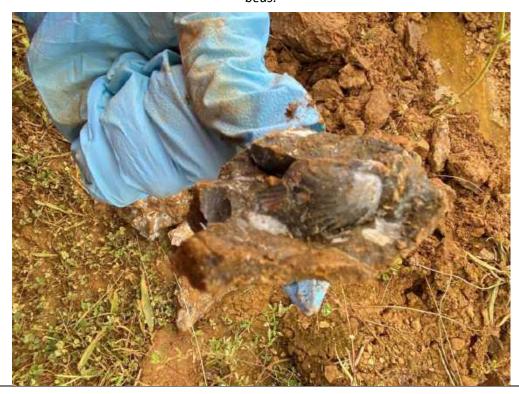
Photograph 7 – This photograph shows a Tetrarhynchia braciopod fossil found within the limestone beds.

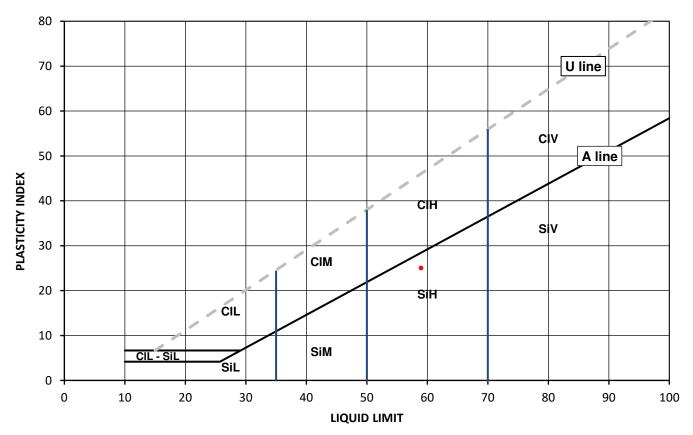
As Received Moisture	Liquid Limit	Plastic Limit	Plasticity Index	% Passing 425μm
Content [W] %	[WL] %	[Wp] %	[lp] %	BS Test Sieve
28	59	34	25

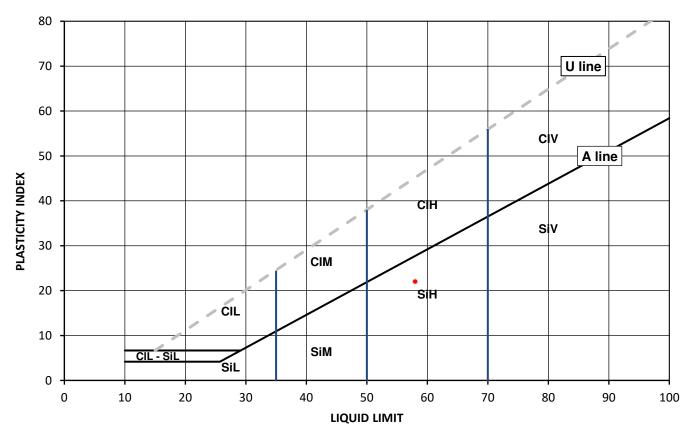
As Received Moisture Liquid Limit Plastic Limit Plasticity Index % Passing 425µm Content [W] % [WL]% **BS Test Sieve** [Wp]% [lp]% 24 58 36 22 62
