**PROPOSED ENERGY HUB
HORNTON GROUNDS QUARRY, HORNTON, OXFORDSHIRE
FLOOD RISK ASSESSMENT**

July 2020

E4040-FRA Report-Rev 0

Client: Certas Energy

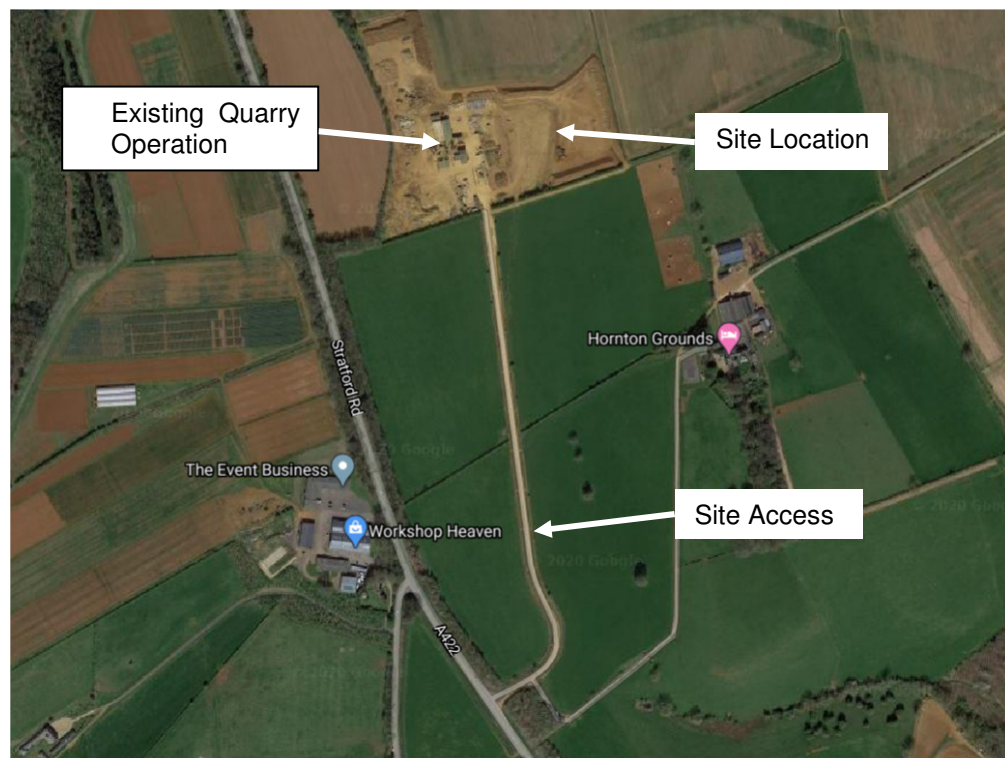
Figure 1 – Aerial View of Site

- 2.1.3 The village of Hornton lies approximately 1.2 kilometres north-east of the application site while Shenington lies approximately 2.0 kilometres south of the site. Upton House is located approximately 1.0 kilometre north of the site.

- 2.1.4 Sor Brook flows approximately 3.35km east of the site and a tributary from the brook is located approximately 0.75km to the south.

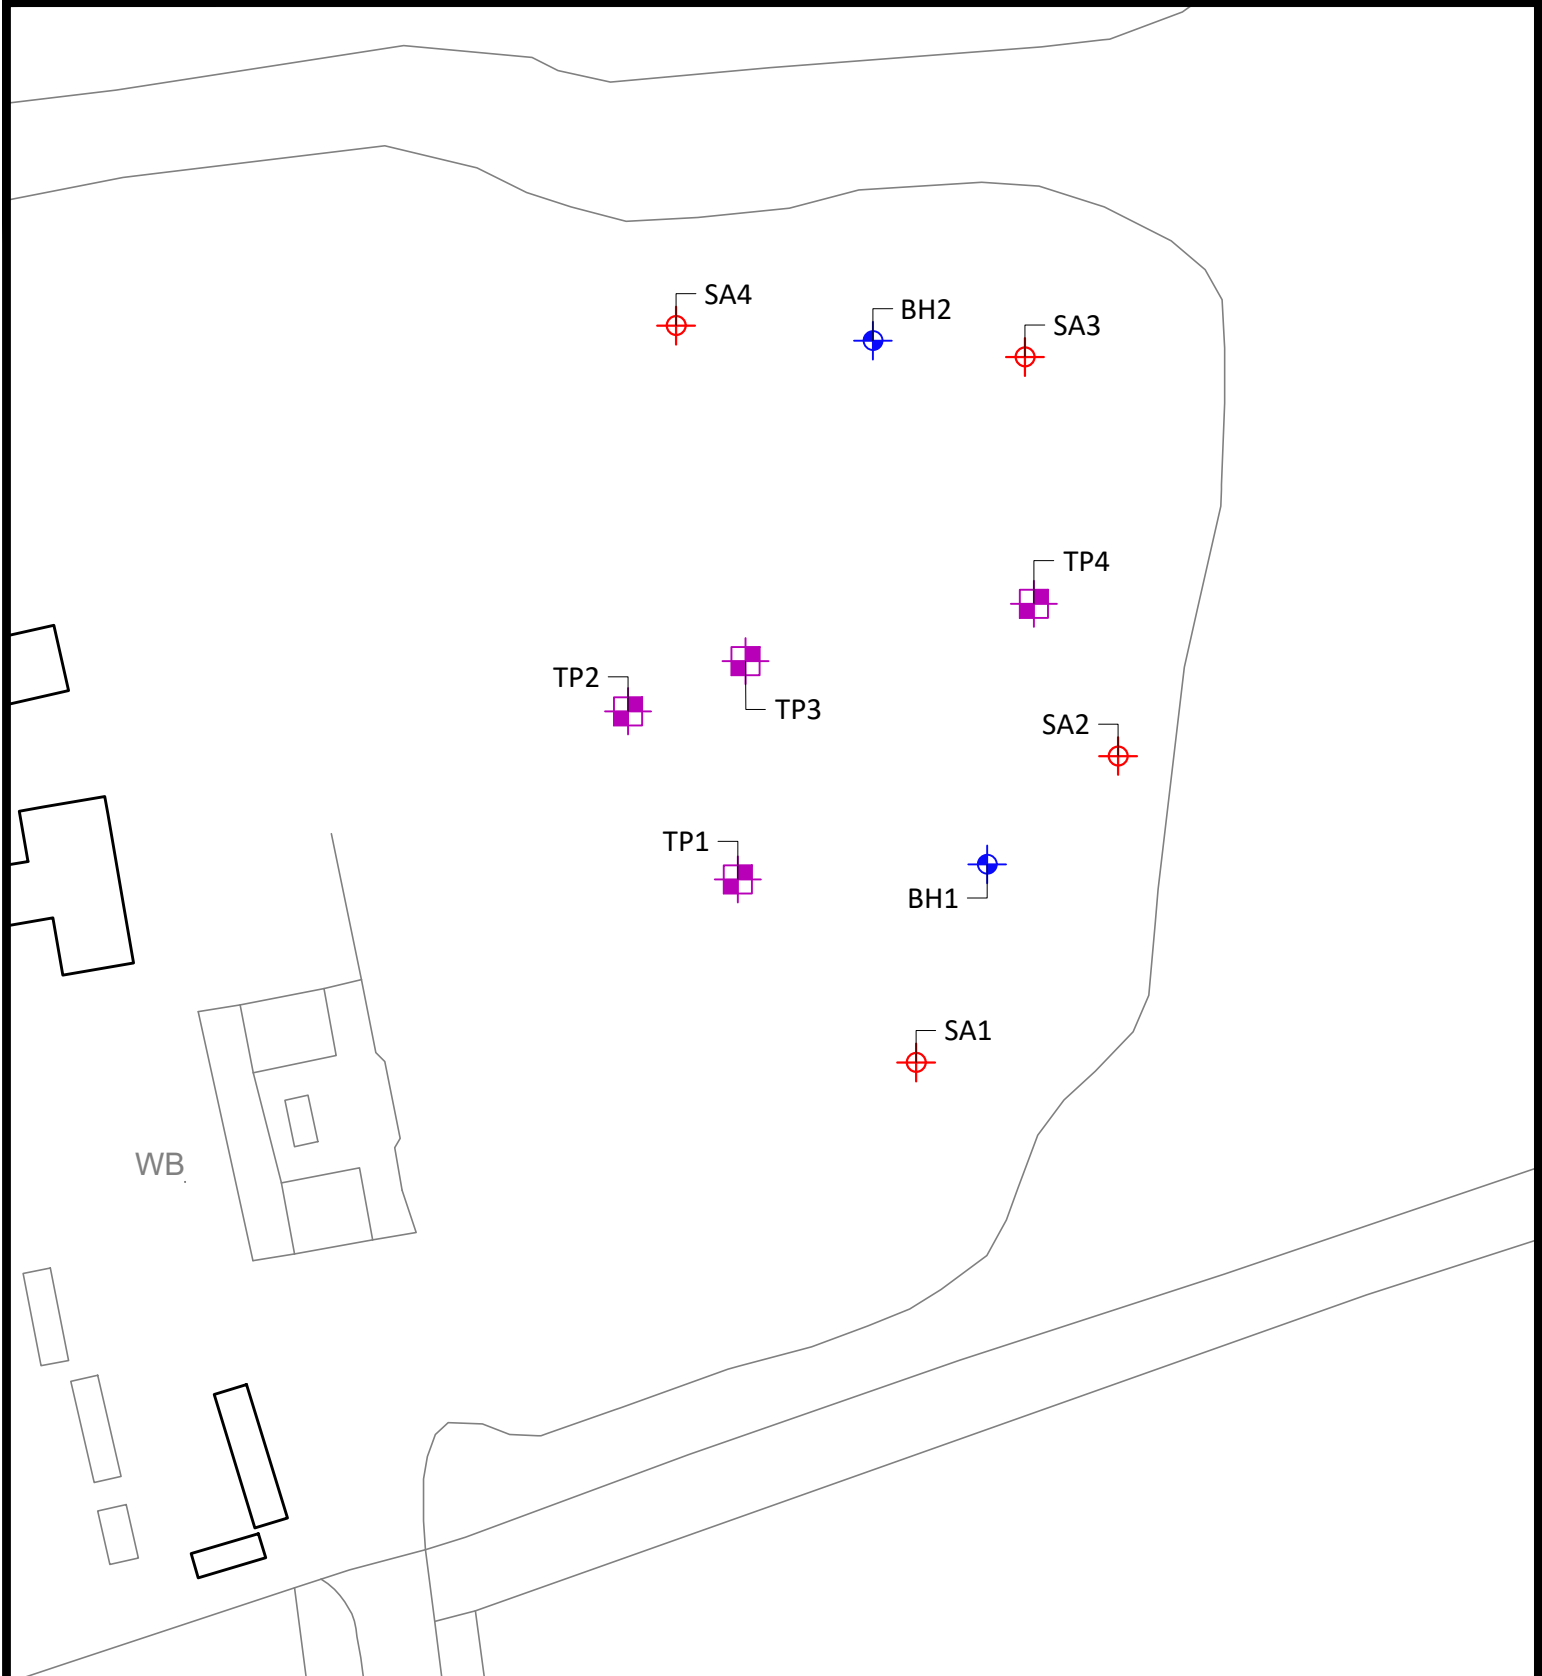
CURRENT SITE LAYOUT AND INTRUSIVE LOCATION PLAN

Legend BH = Borehole TP = Trial Pit SA = Soakaway	Figure:	Intrusive Location Plan
	Site:	Hornton Quarry
	Job No:	FJ6114

At one location (TP4) the upper 0.85m of ground comprised of reworked soil and rock (Made Ground). It is possible these conditions are replicated elsewhere on site.

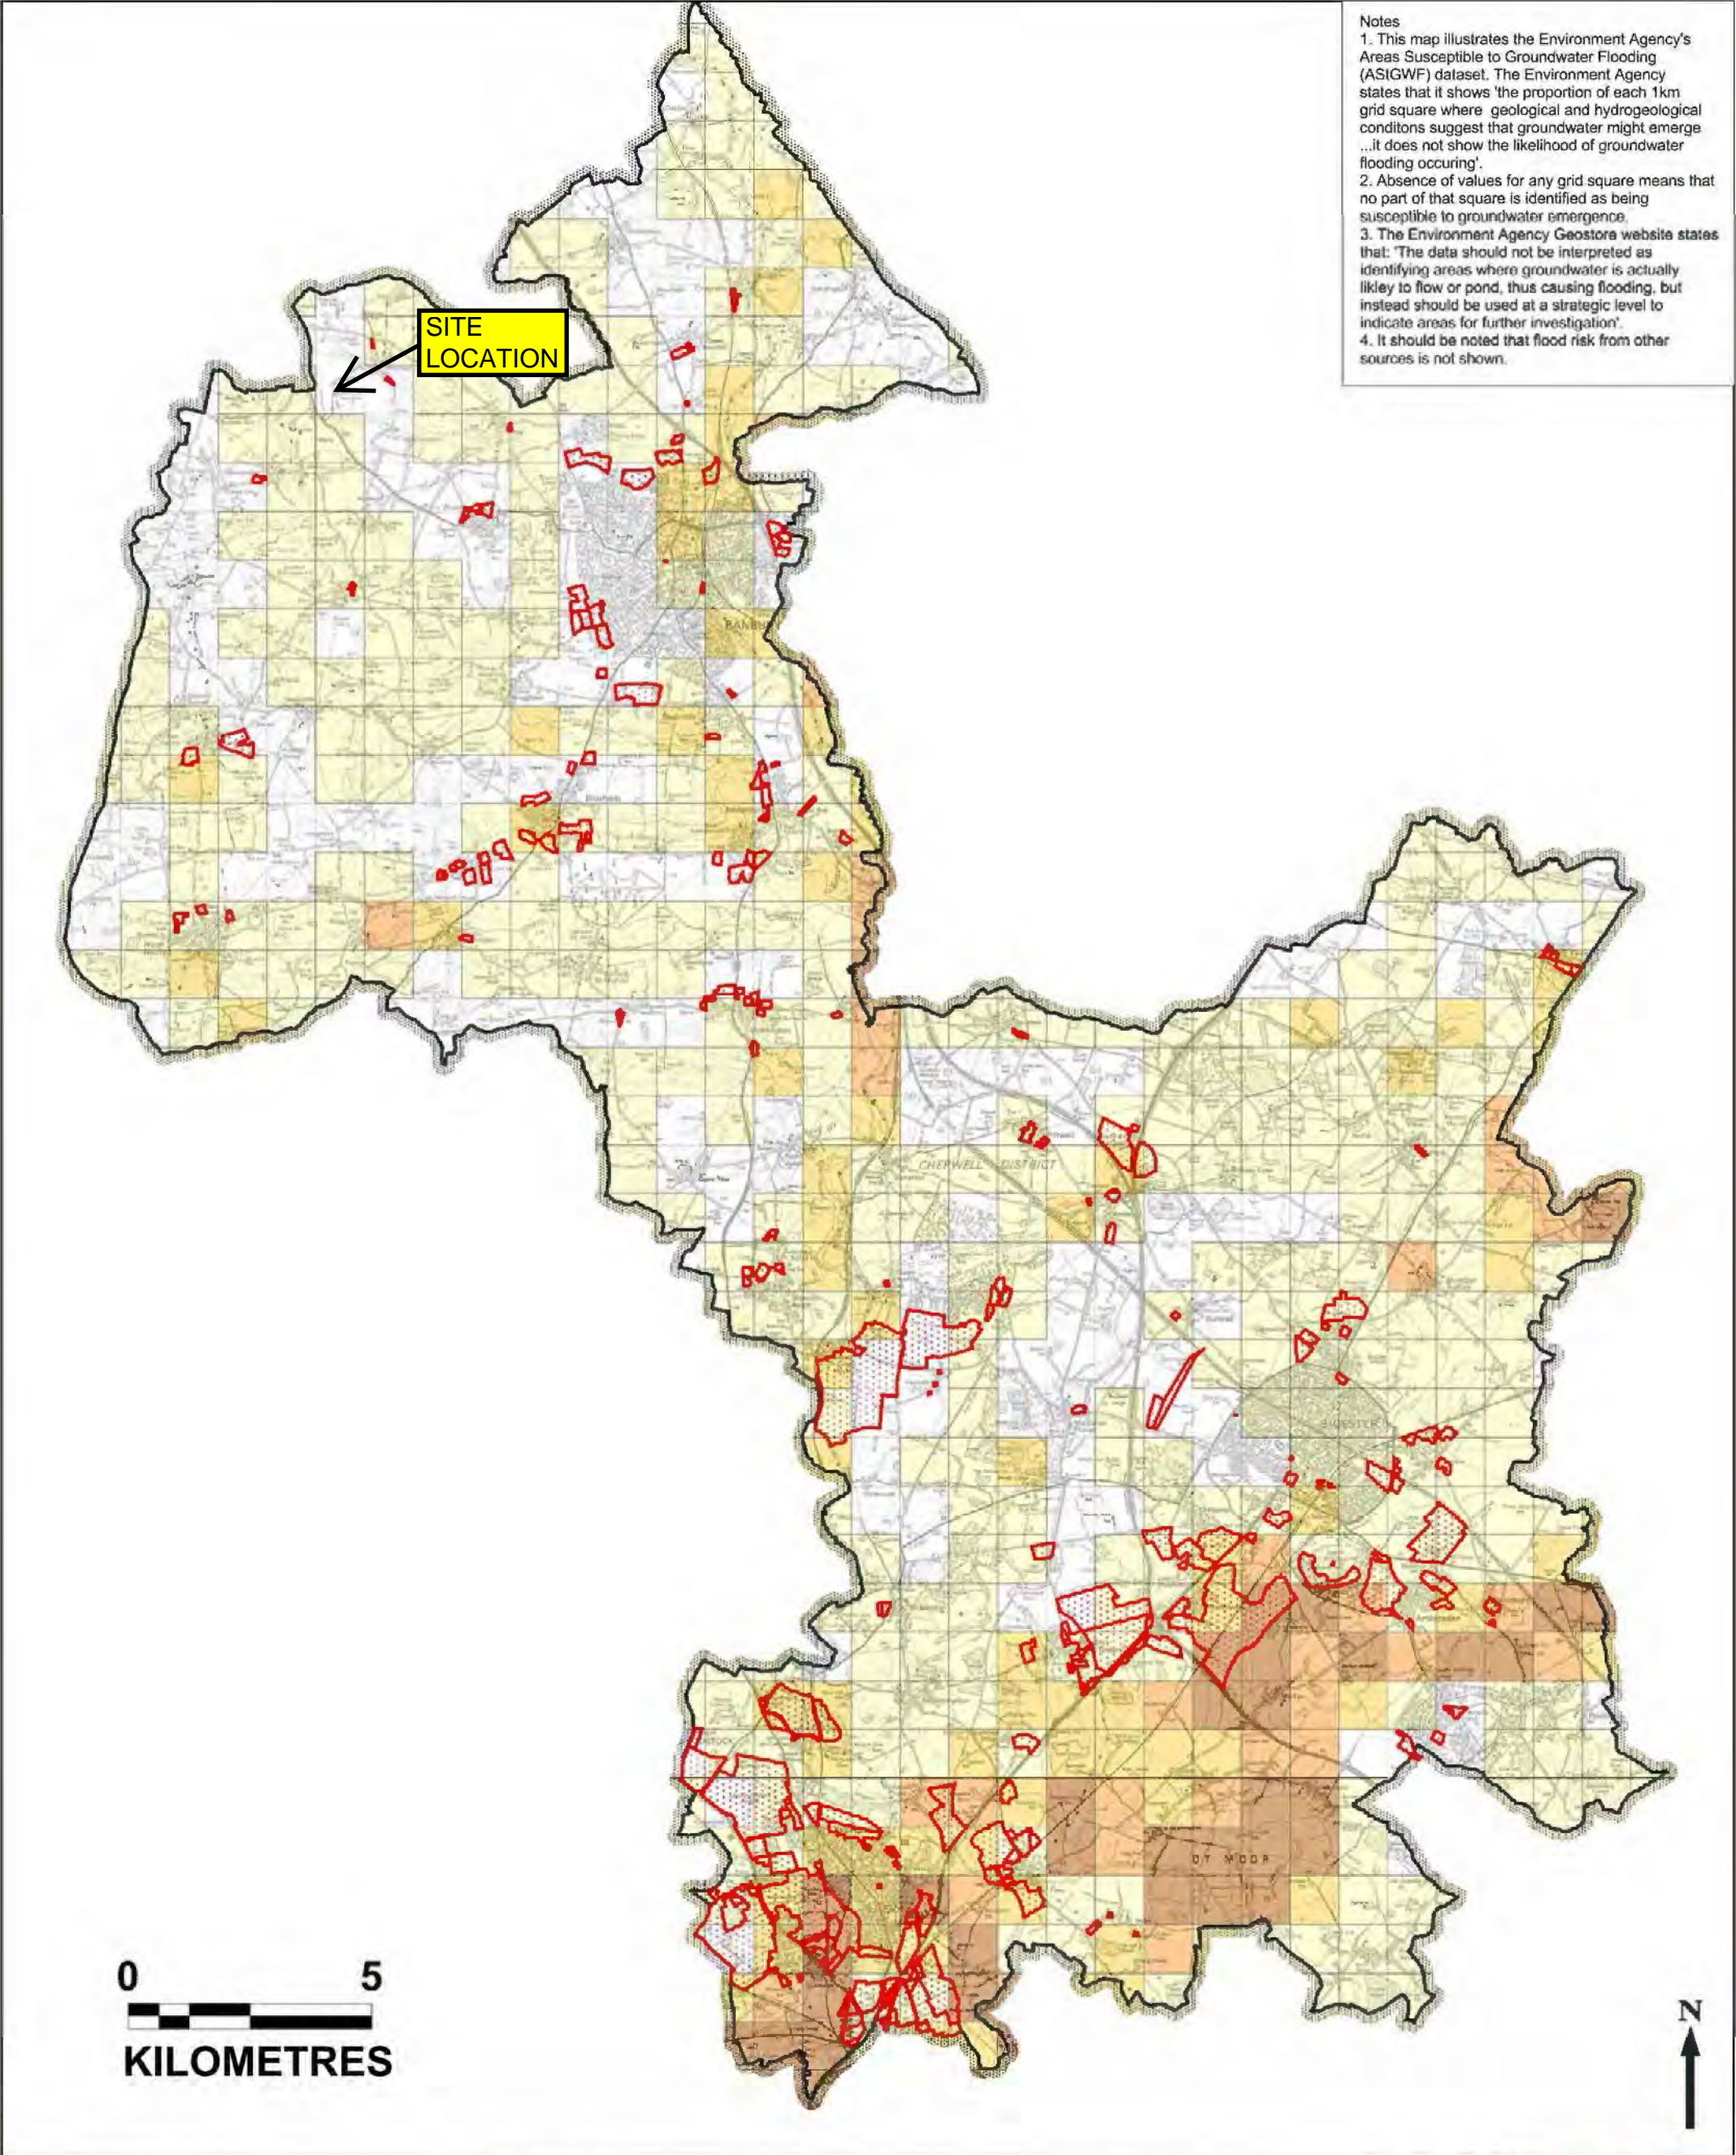
- Notes
1. This map illustrates the Environment Agency's Areas Susceptible to Groundwater Flooding (ASIGWF) dataset. The Environment Agency states that it shows 'the proportion of each 1km grid square where geological and hydrogeological conditions suggest that groundwater might emerge ...it does not show the likelihood of groundwater flooding occurring'.
 2. Absence of values for any grid square means that no part of that square is identified as being susceptible to groundwater emergence.
 3. The Environment Agency Geostore website states that: 'The data should not be interpreted as identifying areas where groundwater is actually likely to flow or pond, thus causing flooding, but instead should be used at a strategic level to indicate areas for further investigation'.
 4. It should be noted that flood risk from other sources is not shown.

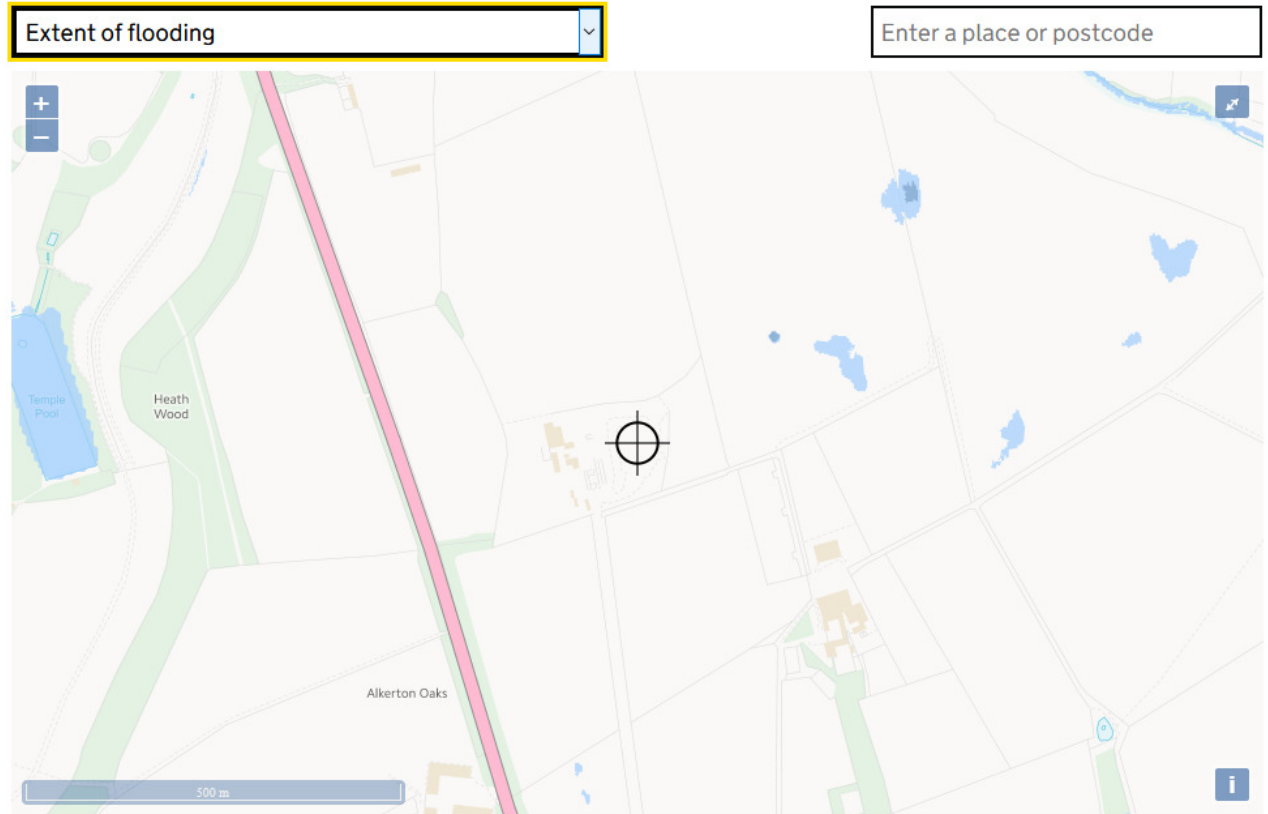
EA Map of Flooding from Surface Water

Extent of flooding from surface water

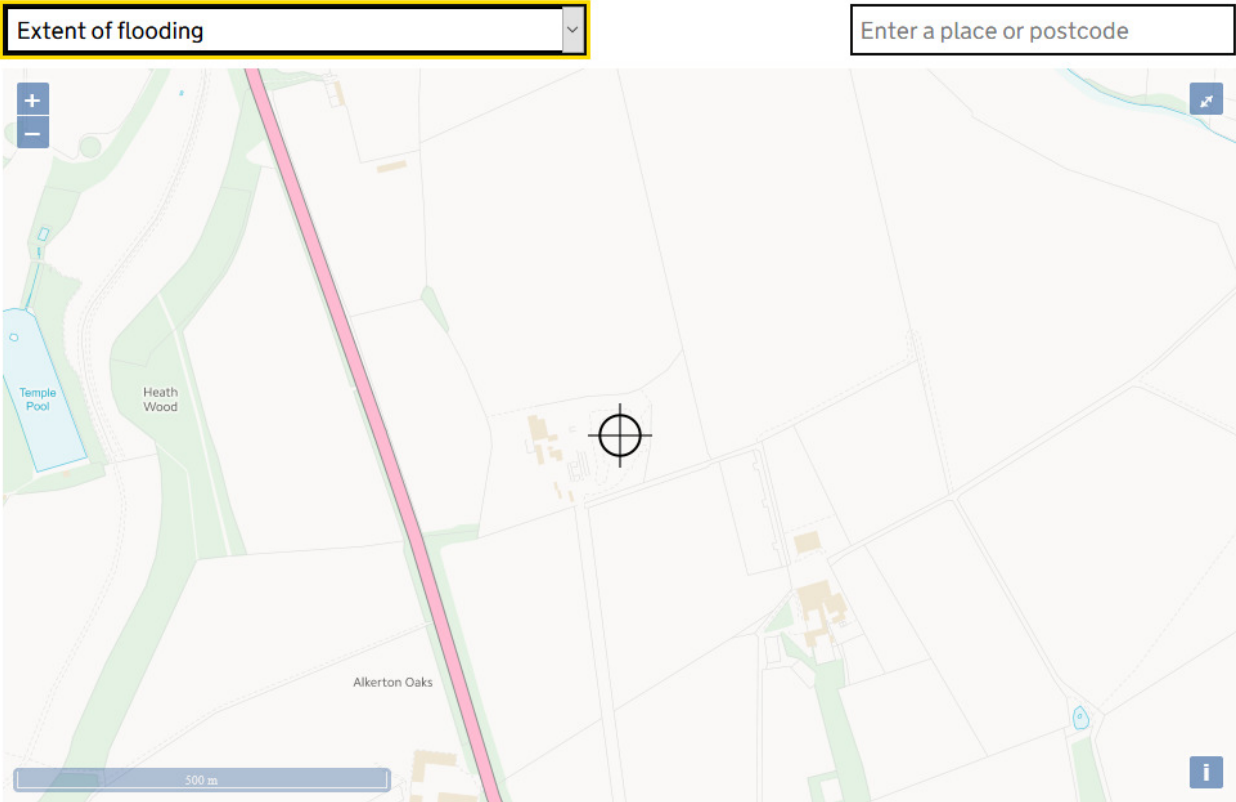
EA Map of Flooding from Reservoirs

Extent of flooding from reservoirs

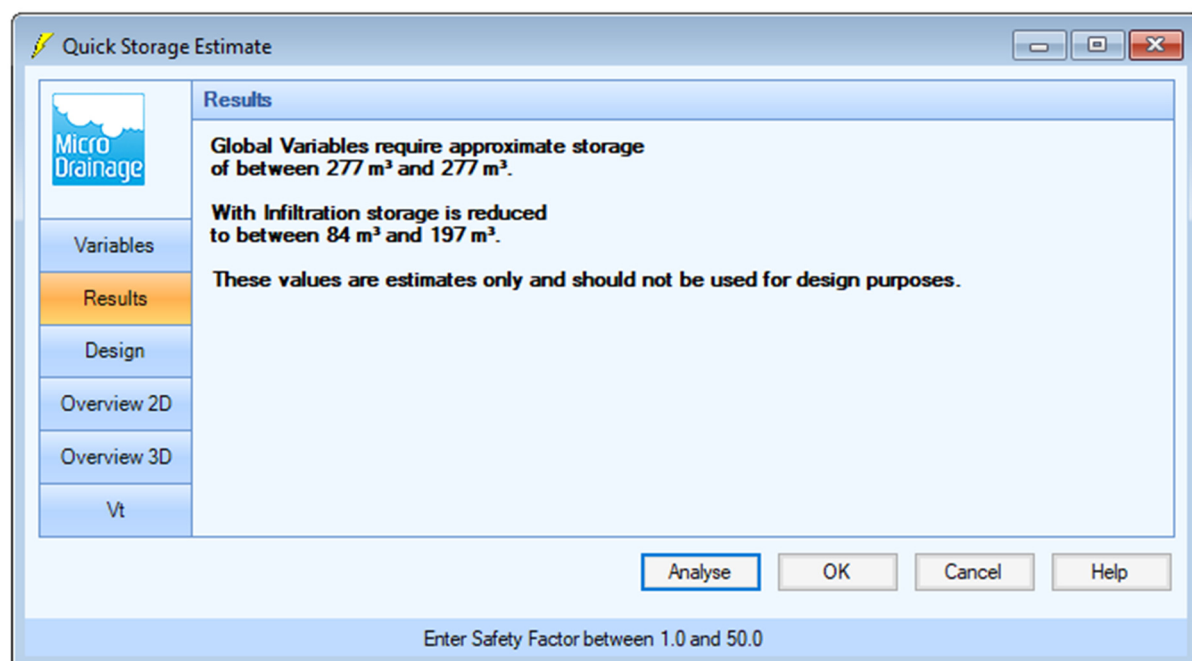
Area A – Office and car park area

OPT 1 - Infiltration storage estimate

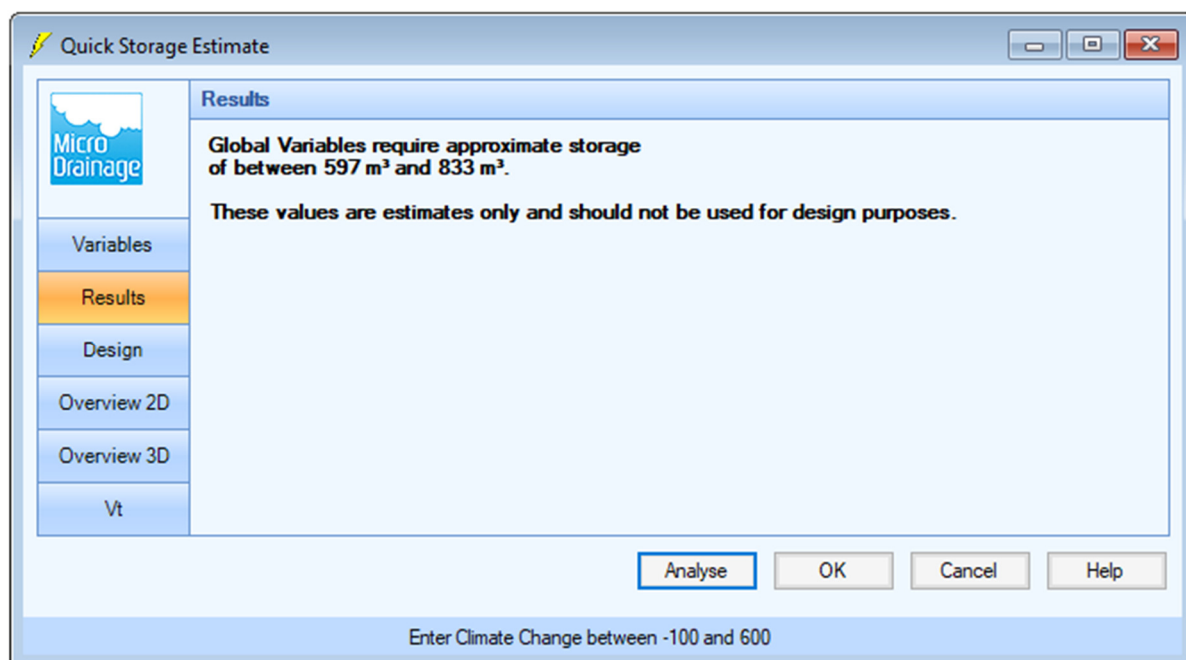
Area A and B

OPT 2 - Ditch outfall storage estimate
