**REPORT ON  
GROUND INVESTIGATION  
AT  
CATALYST BICESTER,  
WENDLEBURY ROAD**

<b>Client:</b>	Albion Land Ltd
<b>Report Title:</b>	Report on Ground Investigation at Catalyst Bicester, Wendlebury Road
<b>Report Number:</b>	AG2875A-20-AK72
<b>Report Status:</b>	Validated Issue 1
<b>Date:</b>	September 2020

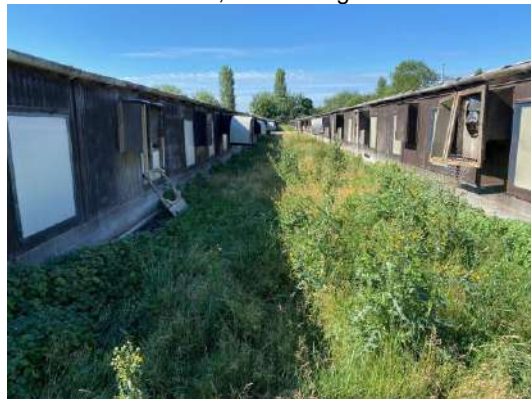
View facing south between two former chicken sheds
