## **Heyford Park – Western Development, Phase 9, 10, 16 and 16A**

Desk Study and  
Ground Investigation

Hydrock BIM Ref: HPW - HYD - MS - ZZ - RP - G - 0001

**Title:** Desk Study and Ground Investigation Report

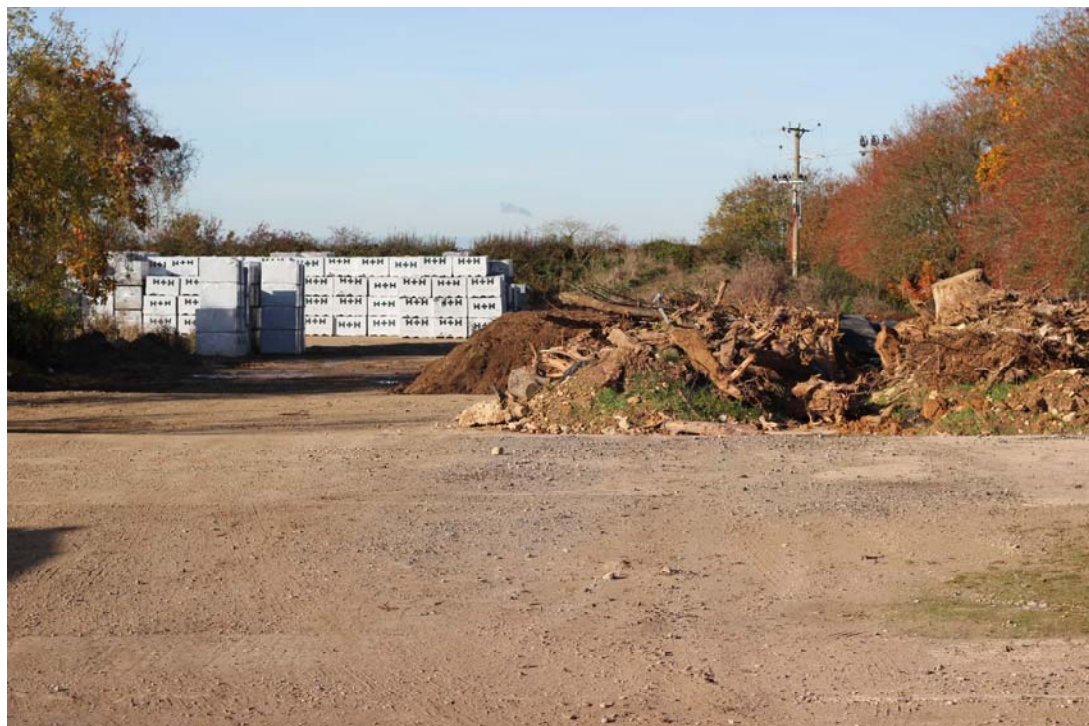
Figure 2: Looking west within entrance to Phase 9 showing restrictions to areas available for ground investigations works.

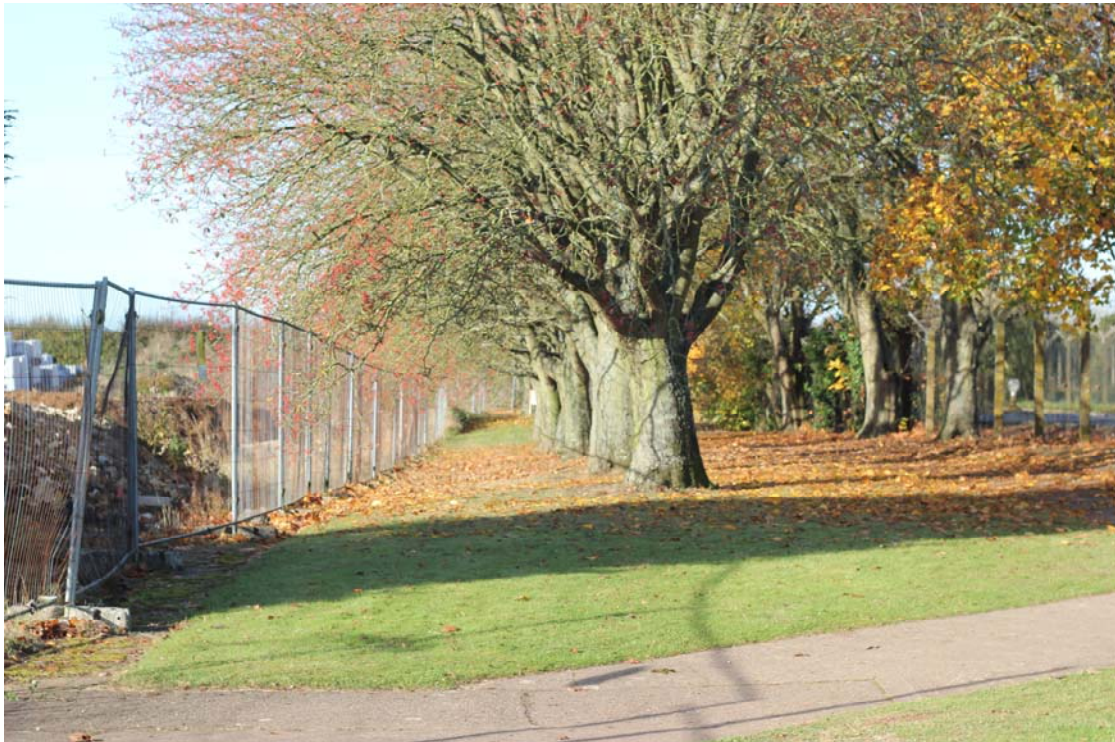
Figure 3: Looking west along the northern extents of Phase 9. No access into these areas for intrusive investigation due to trees and buried services.

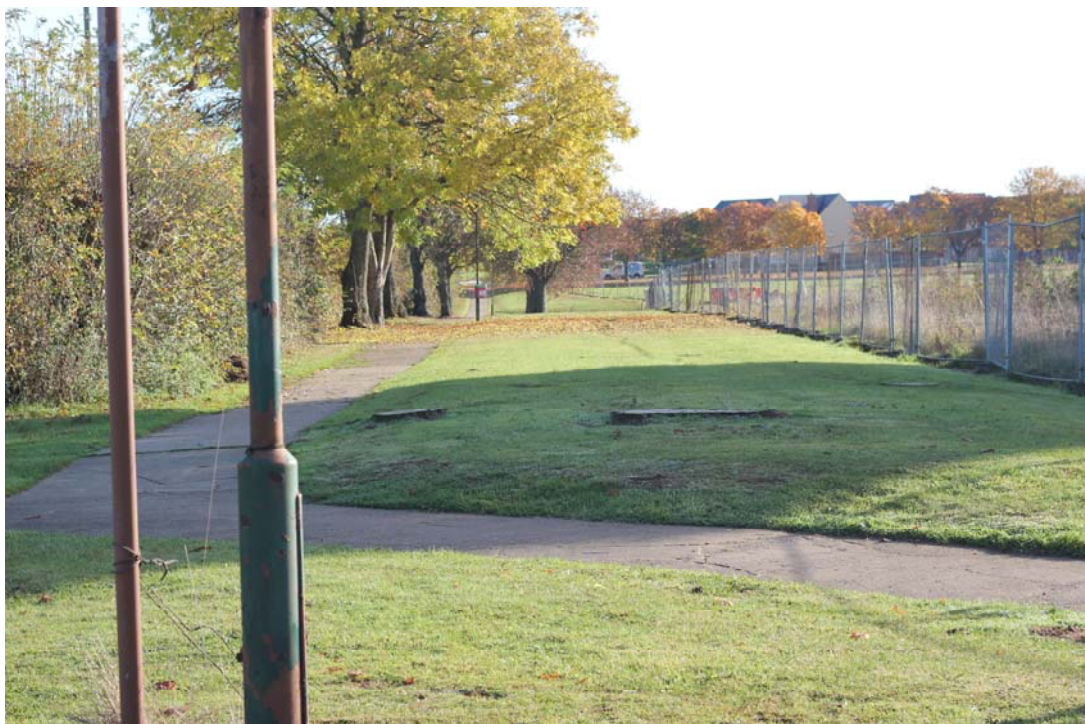
Figure 4: Looking east along the northern extents of Phase 9. No access into these areas for intrusive investigation due to trees and buried services.

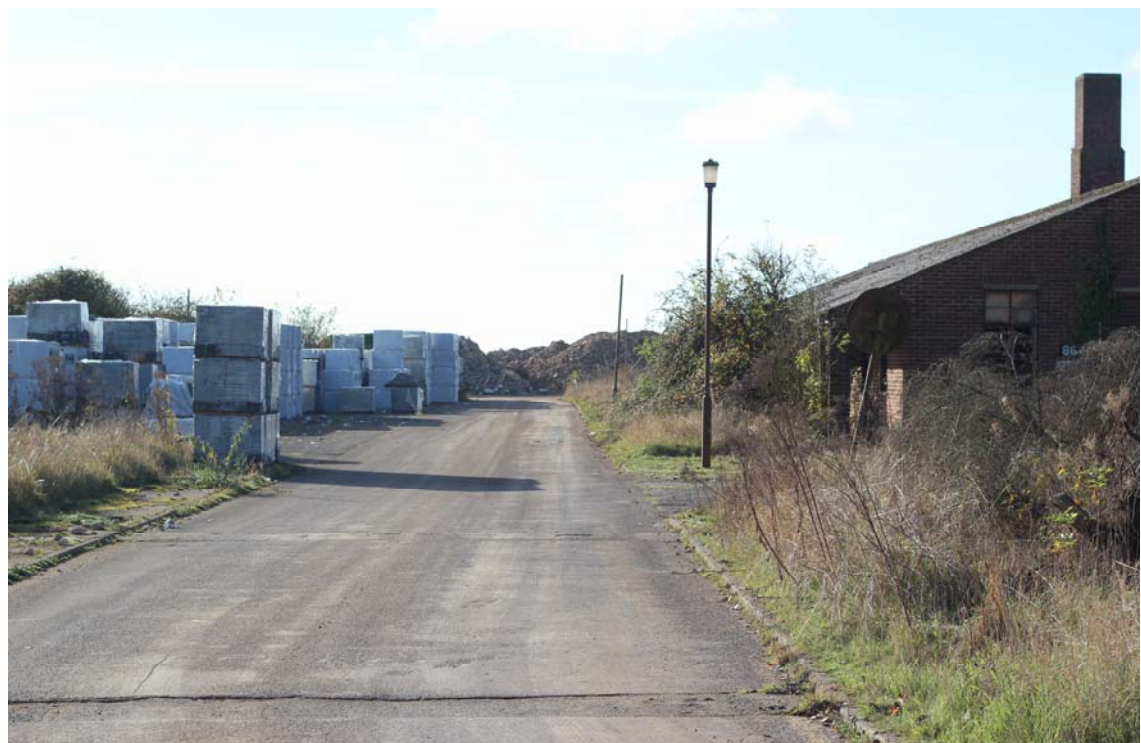
Figure 6: Looking south from Phase 9. Note, boiler house to right of shot, stockpiles breeze blocks to left of shot and concrete stockpile in distance.

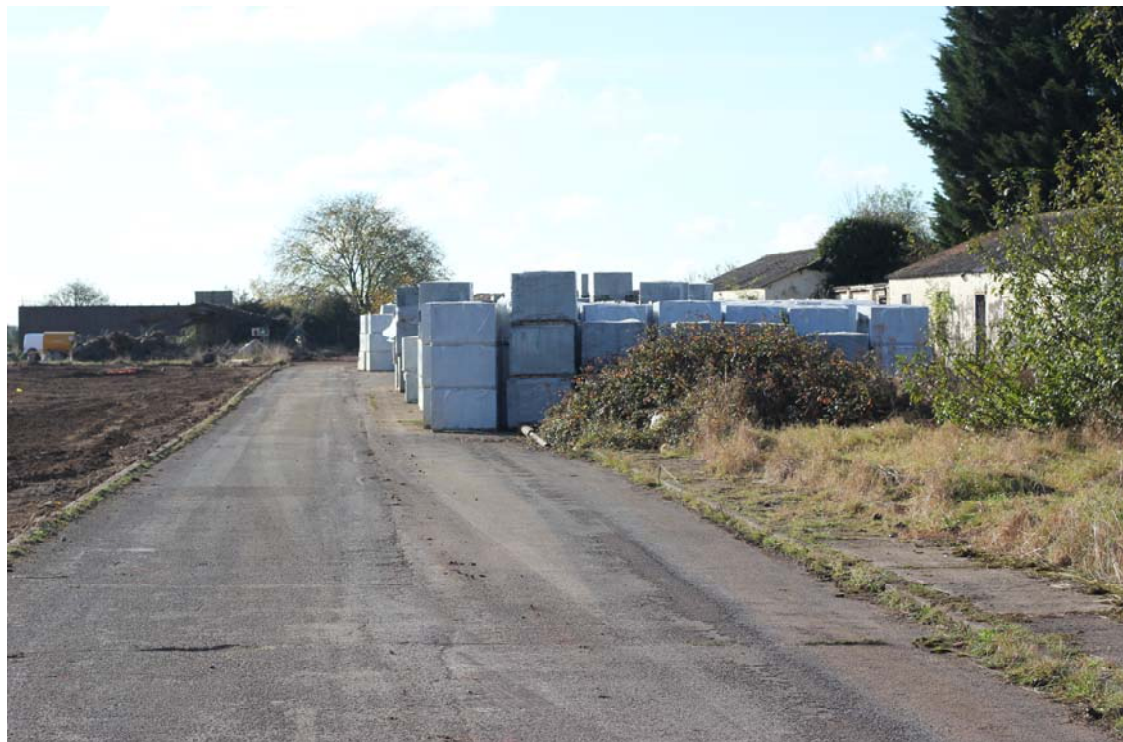
Figure 8: Looking south from Phase 9 along eastern boundary of the site. Note, stockpiled breeze blocks which restricted access for intrusive ground investigation.

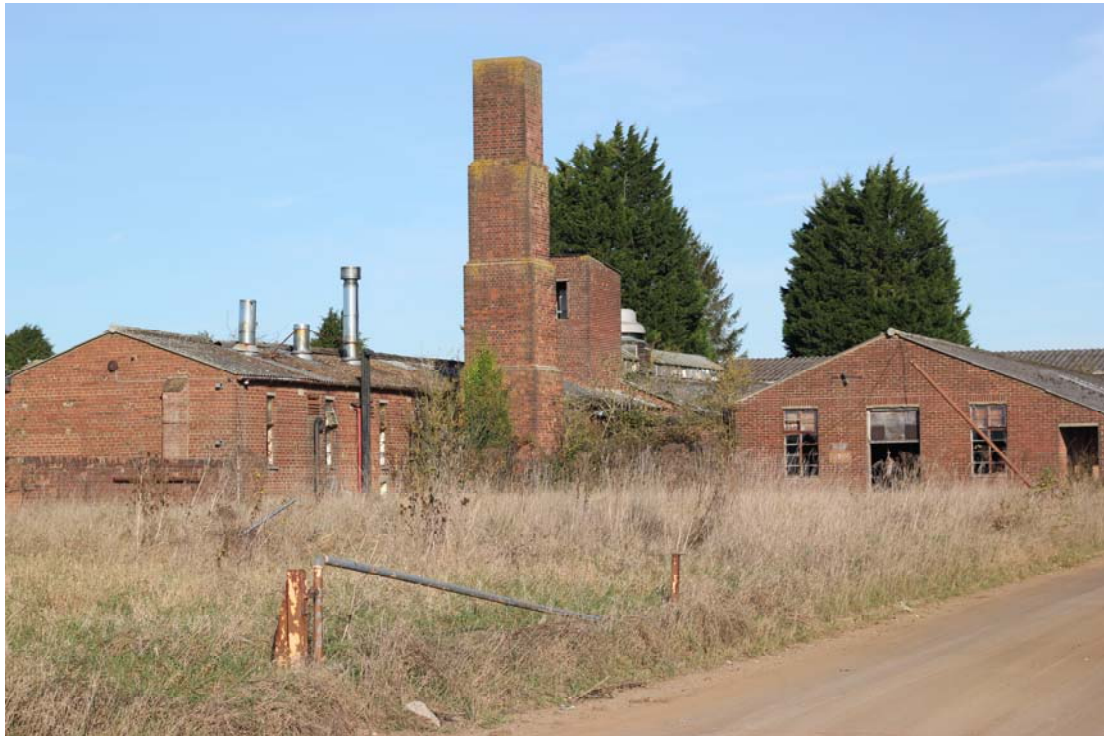
Figure 9: Looking at former boiler house on Phase 9.

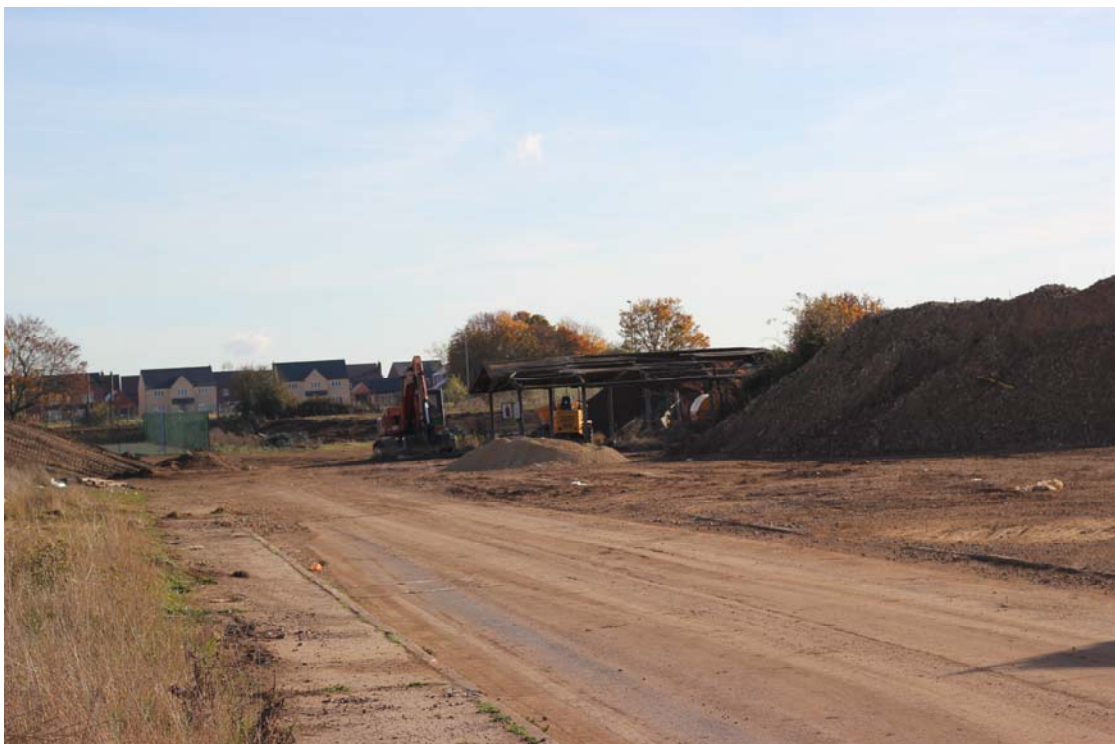
Figure 10: Looking southeast from Phase 9 towards south-eastern boundary of the phase. Note the concrete stockpile to right of shot.

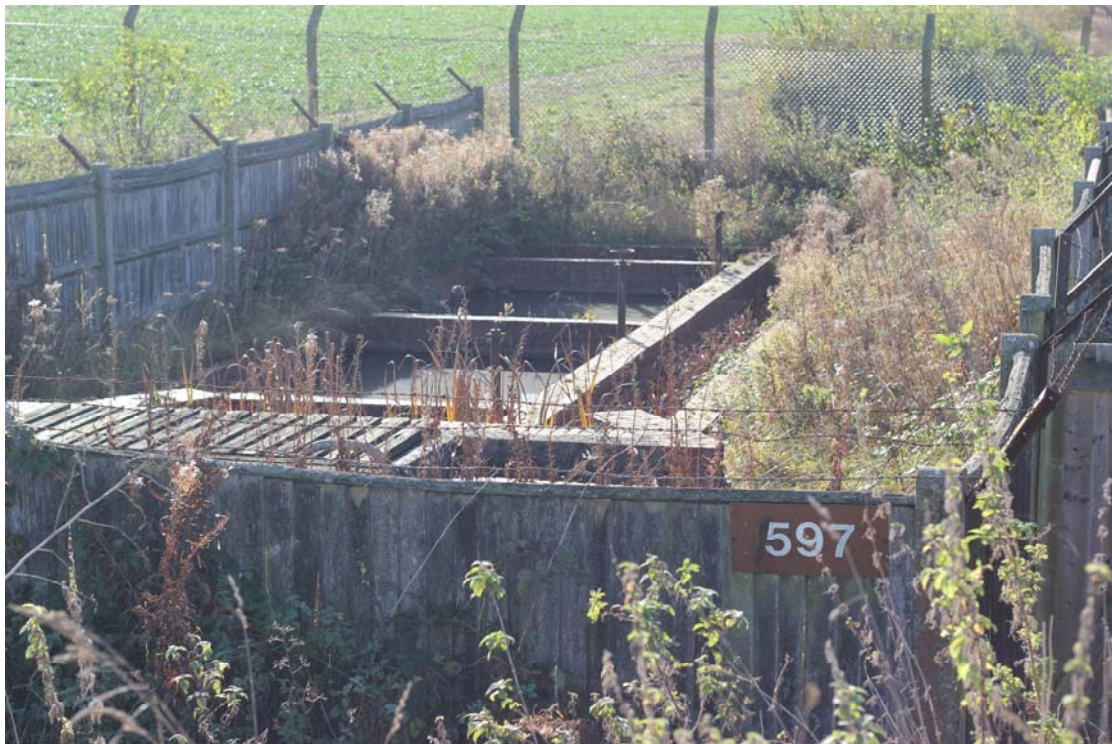
Figure 11: Looking at tanks to the southeast of Phase 9. Note, Gallos Brook located top right of shot.

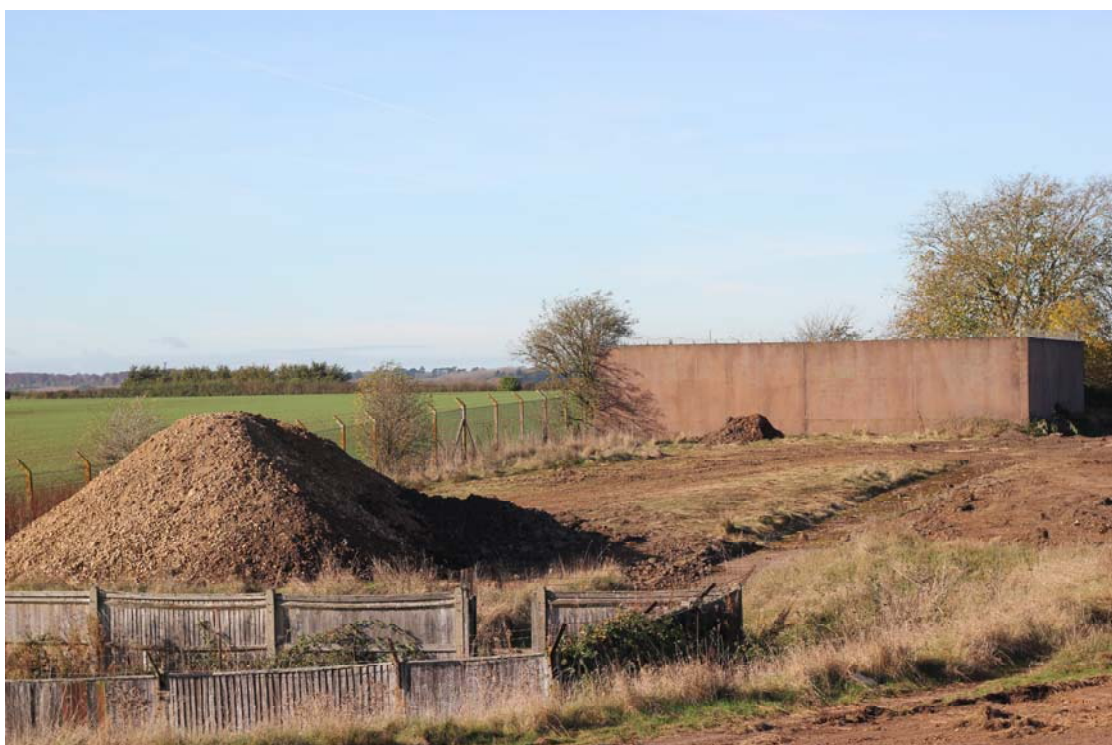
Figure 12: Looking at tanks in southeast of Phase 9. Note, tanks in the foreground and in the background of shot.

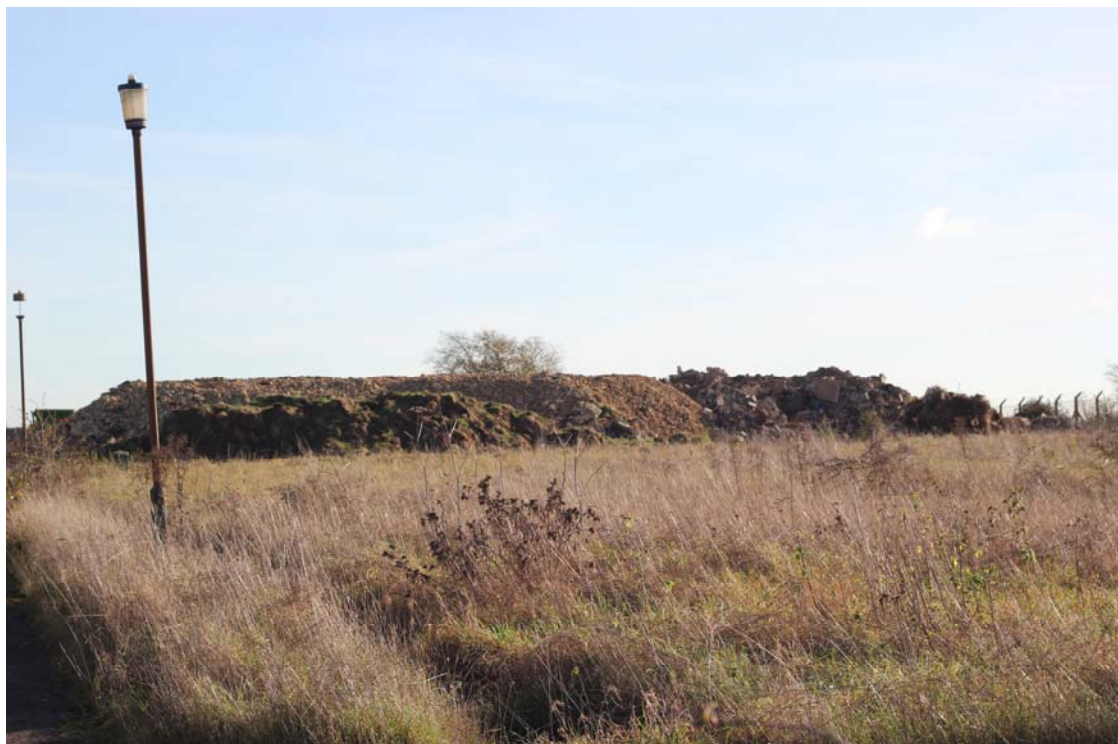
Figure 14: Looking east from Phase 9 at soil and concrete stockpiles located in the south of Phase 9.

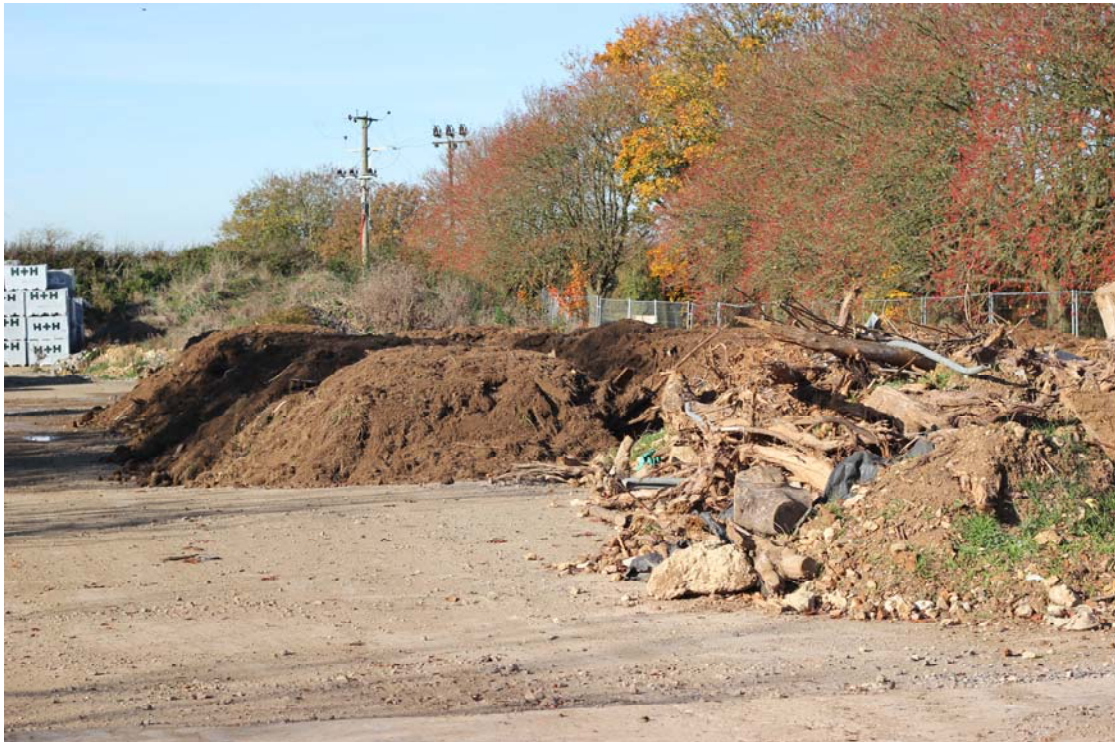
Figure 15: Looking at stockpiled material close to entrance to Phase 9.

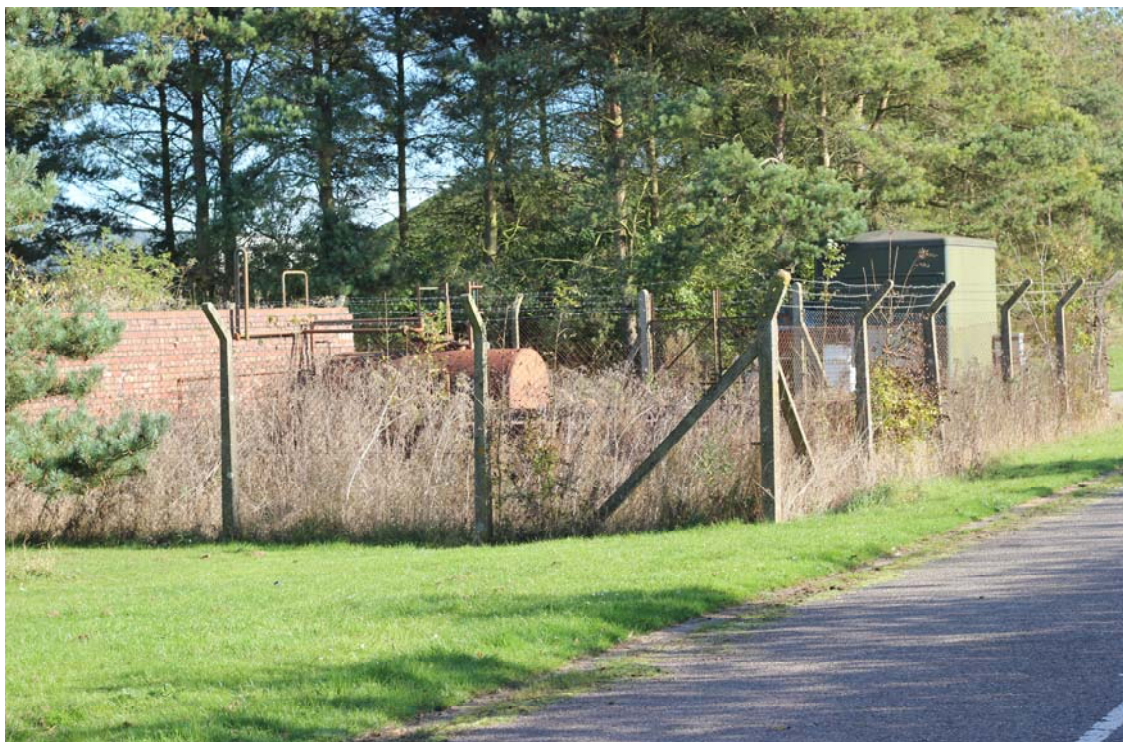
Figure 16: Looking at above ground tanks in Phase 10.

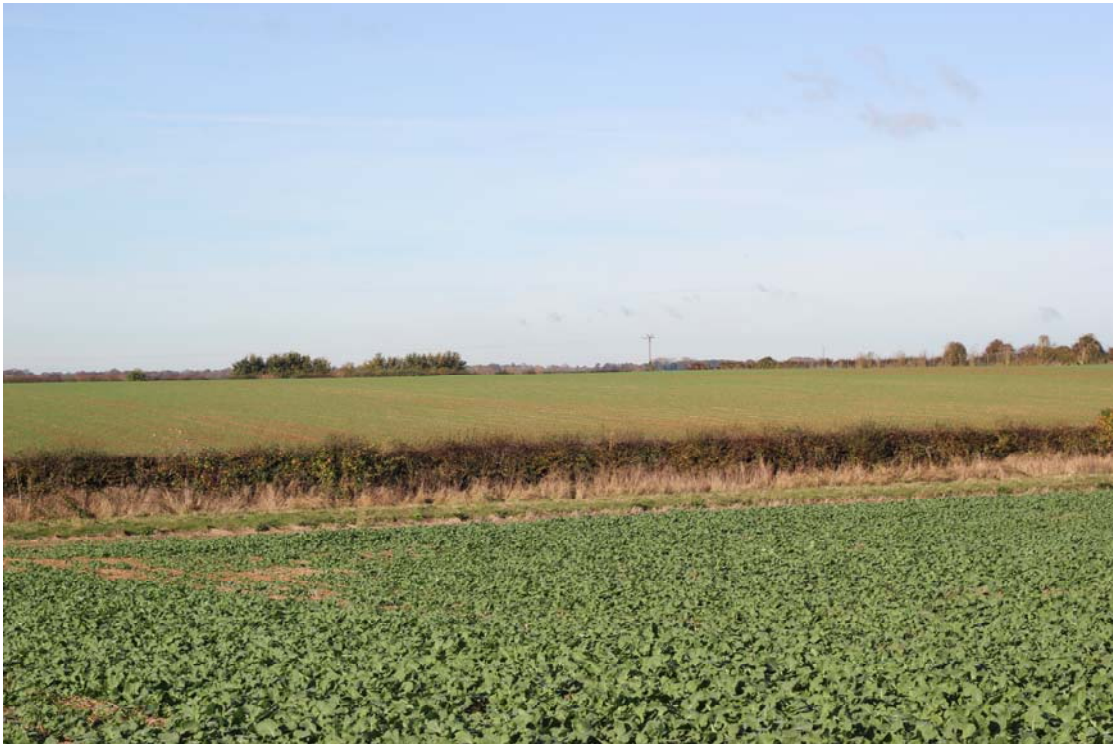
Figure 27: Looking west across Phase 16A (foreground) and Phase 16 (Background). Note, Gallos Brook separating the two phases.
