**Heyford Park
Dorchester Living: Phase 9
(Planning Consent 16/02446/F)**

**POL PIPELINE SUPPLEMENTARY SITE
INVESTIGATION**

For: Urban Regen Ltd. & Dorchester Living

January 2021

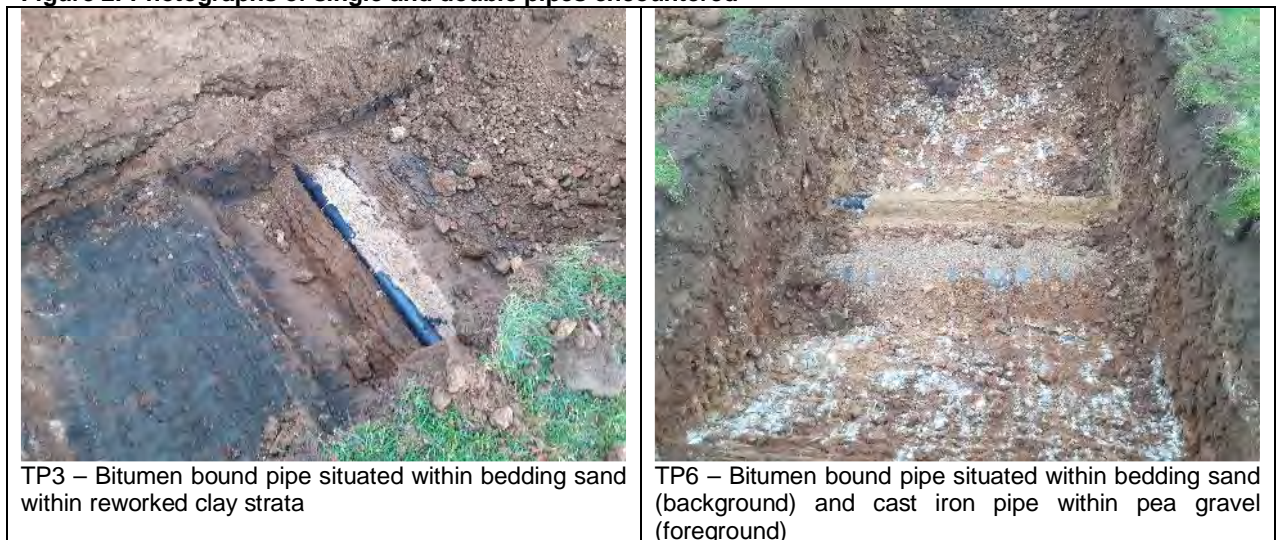
Figure 2: Photographs of single and double pipes encountered

- 4.1.10. Typically, one pipeline, consisting of a bitumen bound pipe was encountered within the entries, however several entries confirmed the presence of a second cast iron pipe running parallel to the bitumen pipe. It is assumed that both relate to the fuel pipeline although no reference is made by Vertase on multiple pipelines.

- 4.1.11. Entries where two pipelines were observed were limited to TP1 (1.5m bgl), TP5 (1.1m bgl), TP6 (1.4m bgl).
- 4.1.12. Pipes were surrounded by either a bedding sand and/or pea gravel and it was observed within TP5 (1.1m bgl) and TP10 (1.5m bgl) that a plastic marker tape was present above the pipeline. Given the presence of marker tape in only limited locations, this may suggest its more recent placement, possibly during repair work.

- 4.1.13. The pipes, where encountered appeared to be in a good condition with no cracks or breakages. A photographic record showing the pipeline within each entry is provided in Appendix A with the corresponding trial-pit logs.

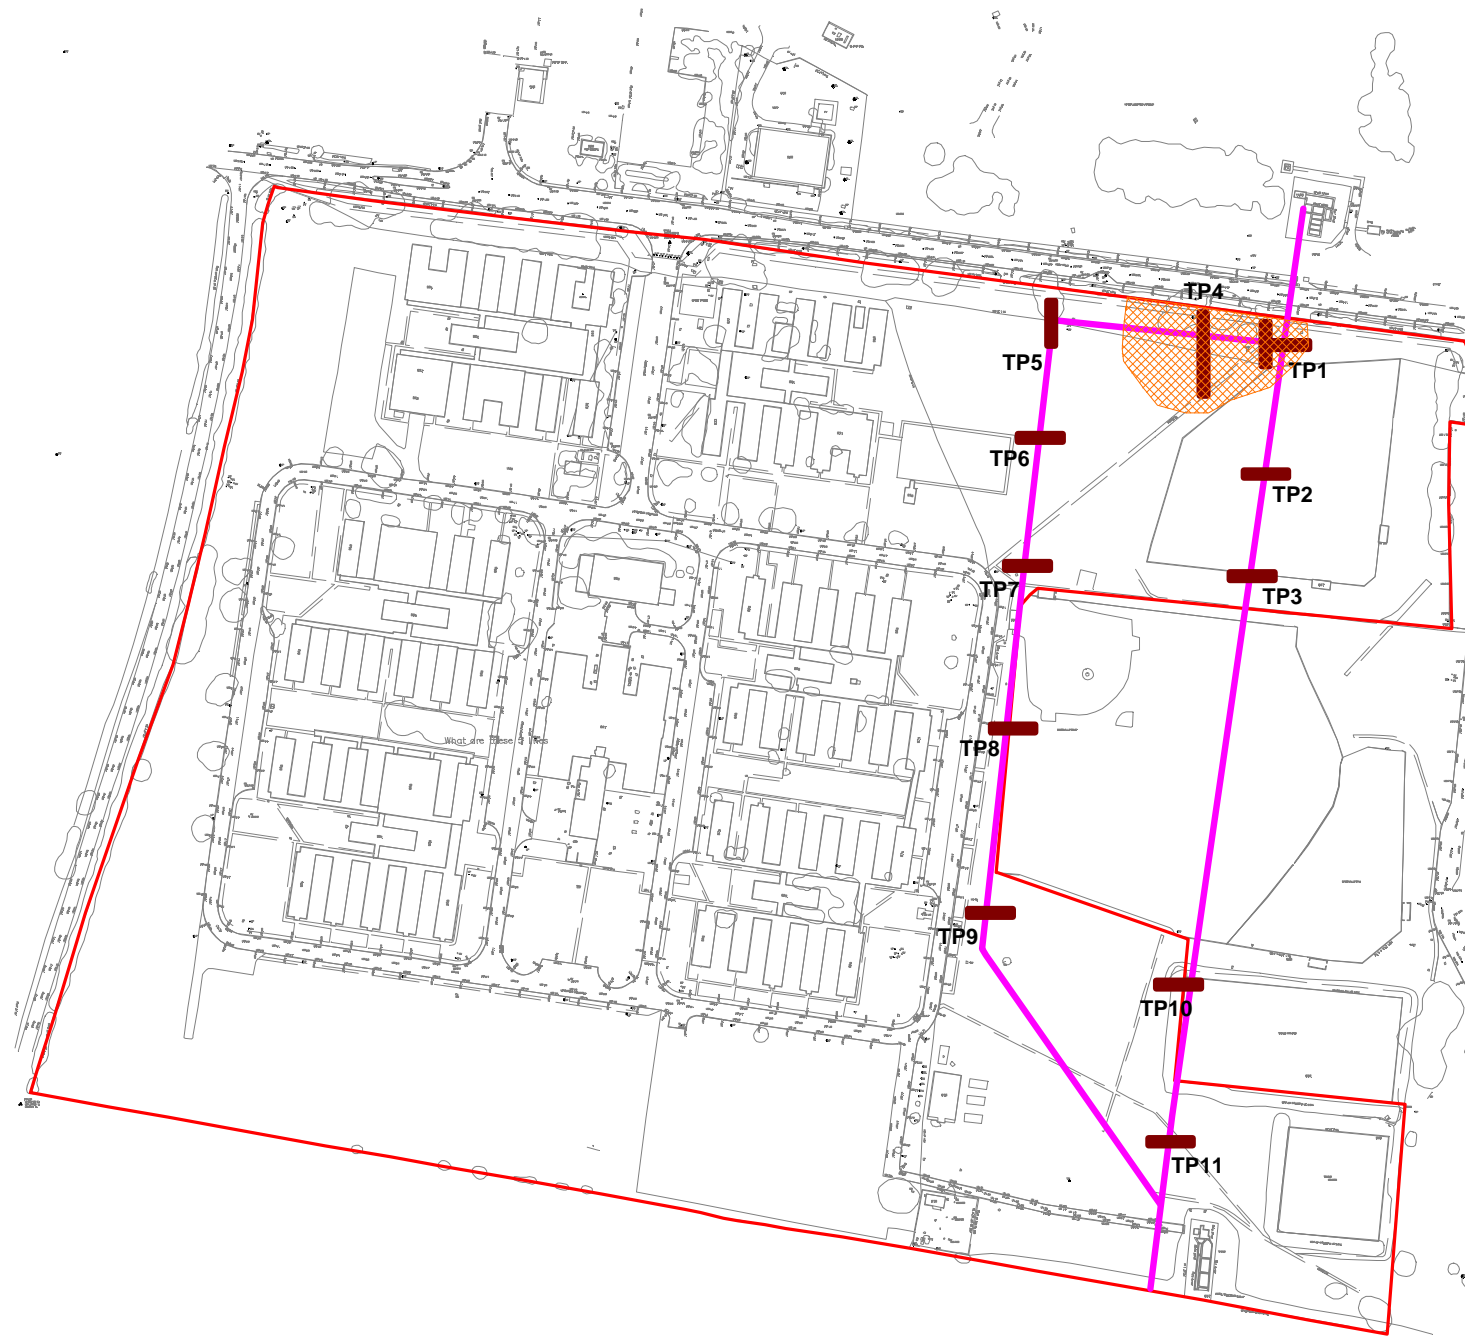
Job No: R1742d	Drg No: D02
-------------------	----------------

4.2.5. Following the presence of significant contamination indicators, TP4 was extended into a trench in a southerly direction to delineate the extent of impacted soils. The trench was extended by approximately 30m and whilst stained gravels were limited to the initial area of excavation, elevated PID readings and the presence of a grey clayey gravel layer with moderate hydrocarbon odours remained.

— Approx Line of POL pipeline

— Pipeline Trench / Extended TP

6.2.1. It is recommended that this contamination hotspot is remediated at an early stage of the remedial works within Phase 9 in accordance with the revised Remediation Strategy and that a copy of this reported is submitted to the Local Authority.

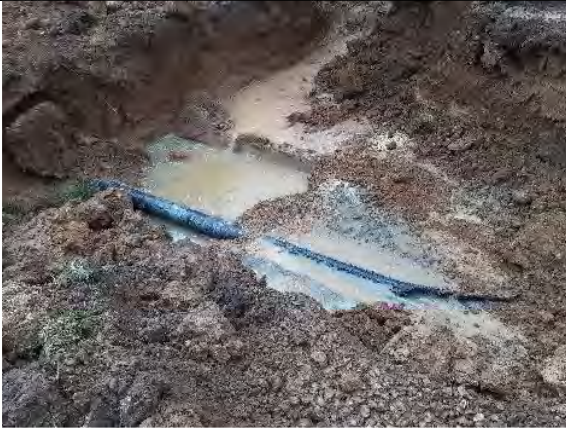
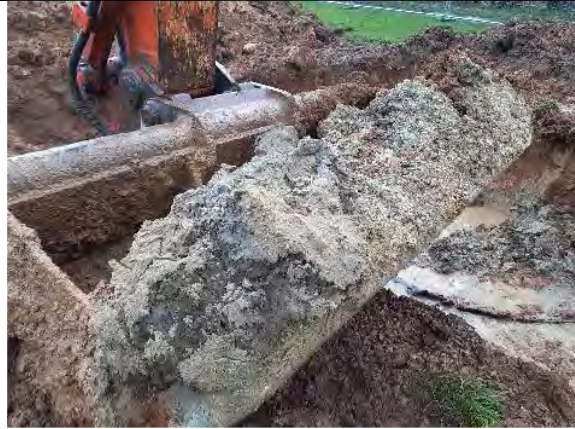
4.2.3. During the excavation of TP1 a relict manhole chamber was encountered and damaged, this resulted in the rapid ingress of perched water from the chamber into the excavation. No sheen or floating product was observed on the water. The vertical extend of the contamination could not be confirmed within this location due to ingress of water from the chamber flooding the excavation.

<p>Smith Grant LLP Station House, Station Road, Ruabon, Wrexham LL146DL Tel: 01978822367 Fax: 019788247182 www.smithgrant.co.uk email: consult@smithgrant.co.uk</p>		GROUND WATER: Rapid ingress from ruptured manhole chamber			
		REMARKS: Sidewalls stable; no sheens or staining. Slight hydrocarbon odour at 1.5m bgl Max 6.3ppm at 1.5m bgl; 2x pipes at 1.5m bgl			
		SCALE: 1:250	LOGGED BY: DW	FIGURE NO. 1

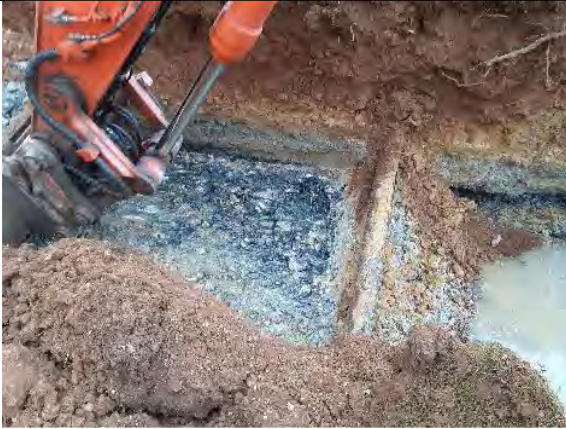
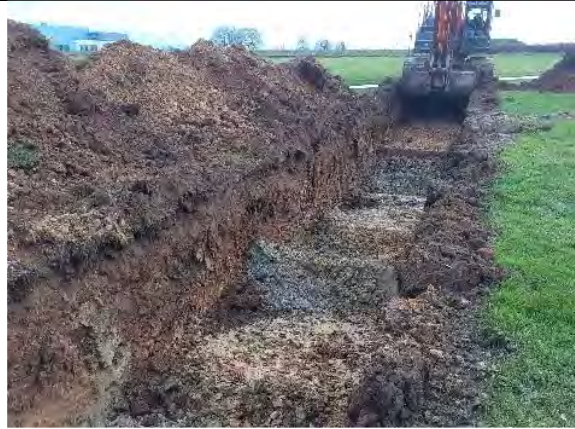
4.2.4. TP4 was excavated approximately 25m to the west of TP1 and encountered the pipeline at 1.3m bgl. Strong fuel odours were observed within the soils immediately below the pipeline with a maximum of 990 ppm recorded on the PID at 1.8m bgl. Black stained gravel was present from 1.8m to 2.3m bgl above the bedrock at 2.5m bgl.

1.9	TP4-S2	Whole Oil Fingerprint	1.6	Light grey gravelly CLAY with strong fuel odour (900 ppm) with black staining between 1.8m to 2.3m bgl on gravel

Sidewalls stable; Light grey / silvery sand with strong fuel odour at 1.6-2.5m bgl. Black staining at 1.9-2.3m bgl
PID 990ppm at 1.8m; 1x pipe at 1.3m bgl

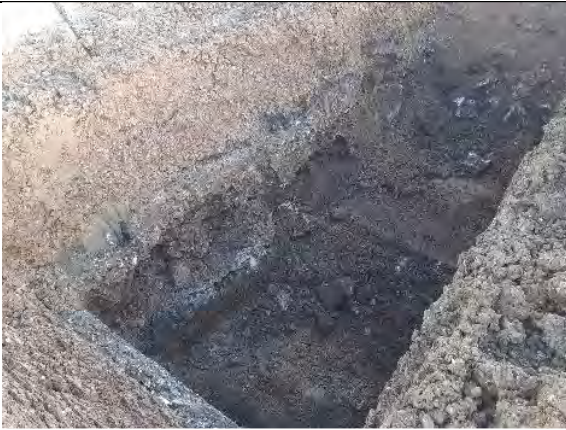
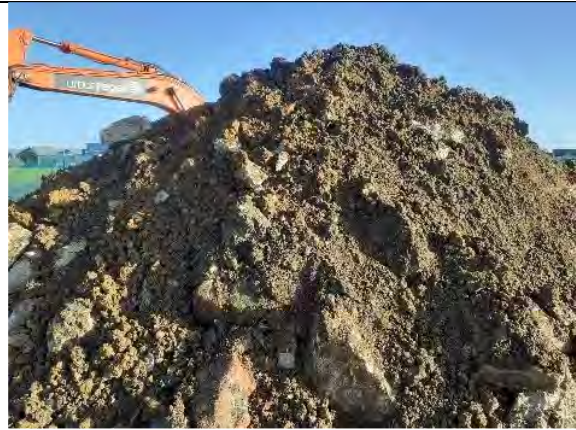
TP11

- 4.1.14. No evidence of the fuel pipeline was identified within TP11, which was excavated in line with TP10 where the pipe was located. The Vertase reporting suggests the pipeline extended in a north to south direction within this part of the site down to the southern boundary. It was observed that the made ground was particularly deep (2.5m bgl) in this location with cobbles of concrete and rebar which may suggest previous ground disturbance / preparatory works and could have also included the removal of the pipe.
- 4.1.15. The above evidence of stratigraphy is taken from discrete locations. Given the broadly similar ground conditions between many of the entries, it appears reasonable to infer that similar conditions may extend between these locations across the majority of the site, although caution should always be exercised as the nature of the ground does vary between some entries.

1.1	MADE GROUND: Dark brown clay with angular GRAVEL of limestone, rare boulder of concrete and occasional cobbles of brick	
			2.2	MADE GROUND: Boulders of concrete with rebar within a gravelly clay soil (possible buried slab/foundations)	
			2.5	Light brown sandy CLAY

REMARKS:
 Sidewalls stable; no sheens, staining or odours
 PID <0.1 ppm; pipe not encountered
