**Heyford Park
Dorchester Living: Phase 9
Remediation Earthworks Completion Report
For Urban Regen Ltd.
August 2021**

Report Ref: R1742-R23-v2

Report Title: Heyford Park, Dorchester Phase 9
Remediation Earthworks Completion Report

Client: Urban Regen Ltd

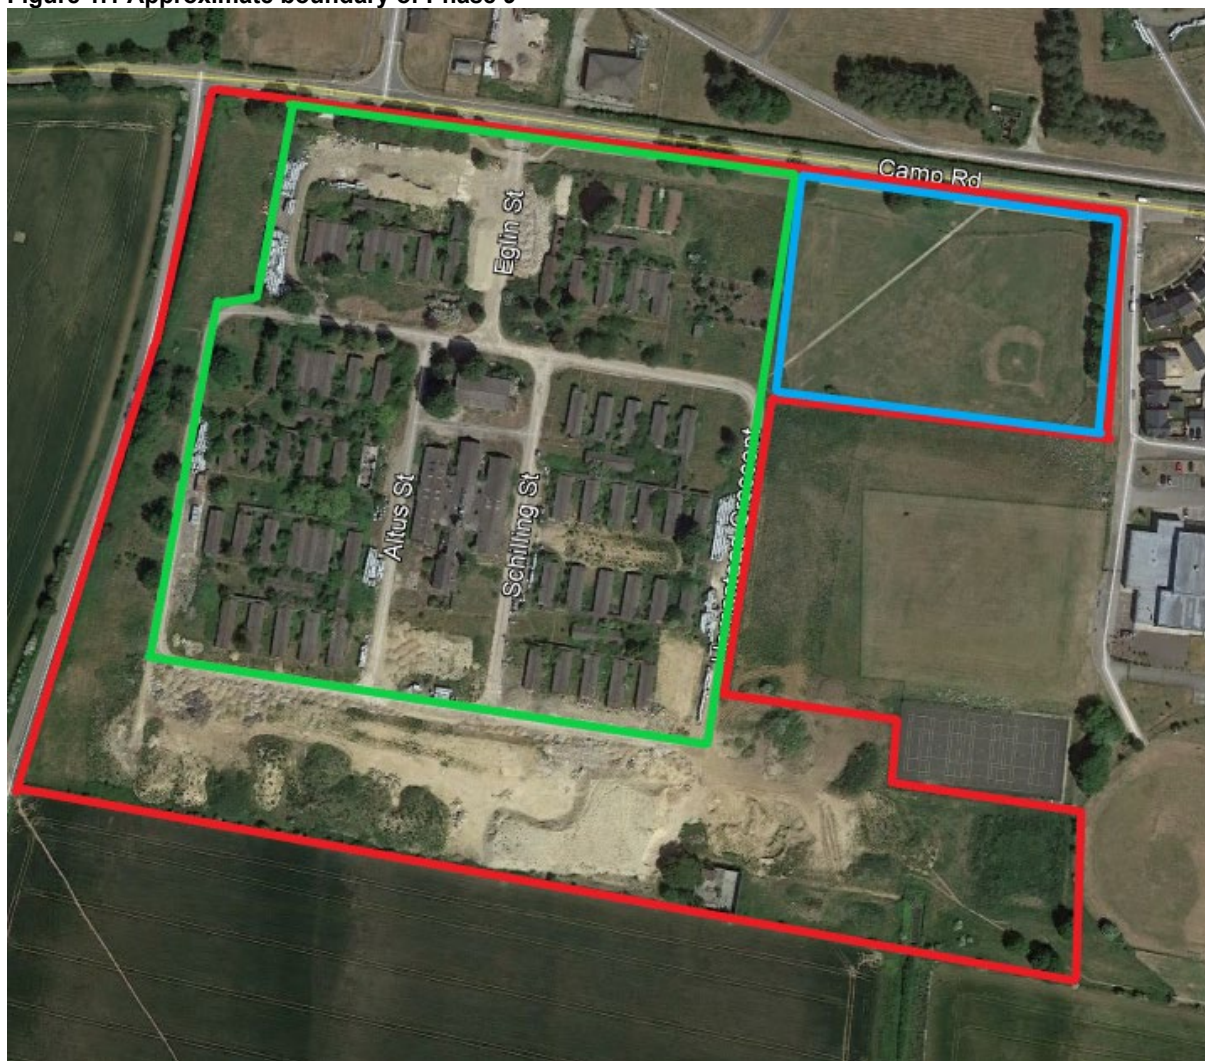
Figure 1.1 Approximate boundary of Phase 9

Red – Phase 9 area
Blue – Phase 9 Baseball Pitch (report ref. R1742b-R22)
Green – Area covered by this report (ref. R1742-R23)

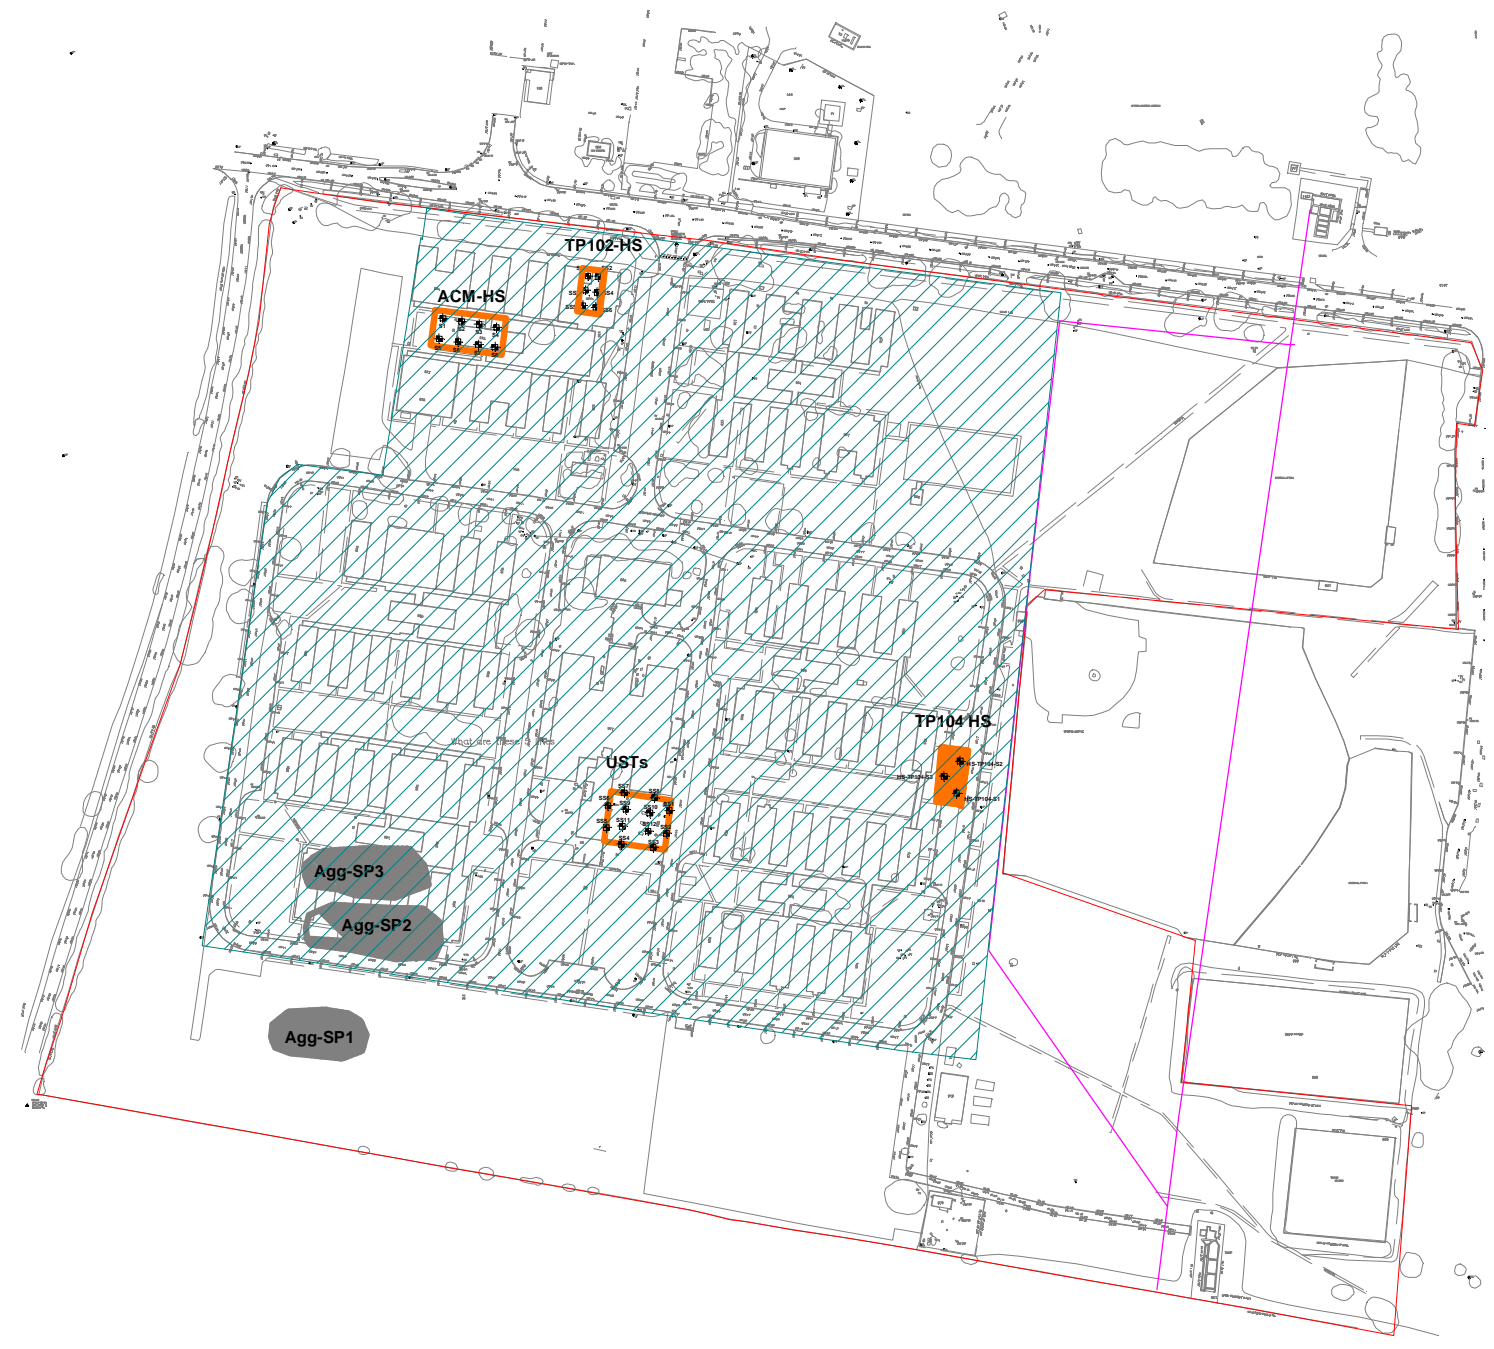
Drawing:
 Phase 9 Hotspot Investigation

— Approx Line of PDL pipeline
— Phase 9 Boundary
— Extent of UGL P19 Remedial Works Reported within R1742-R23

✦ Validation Sample

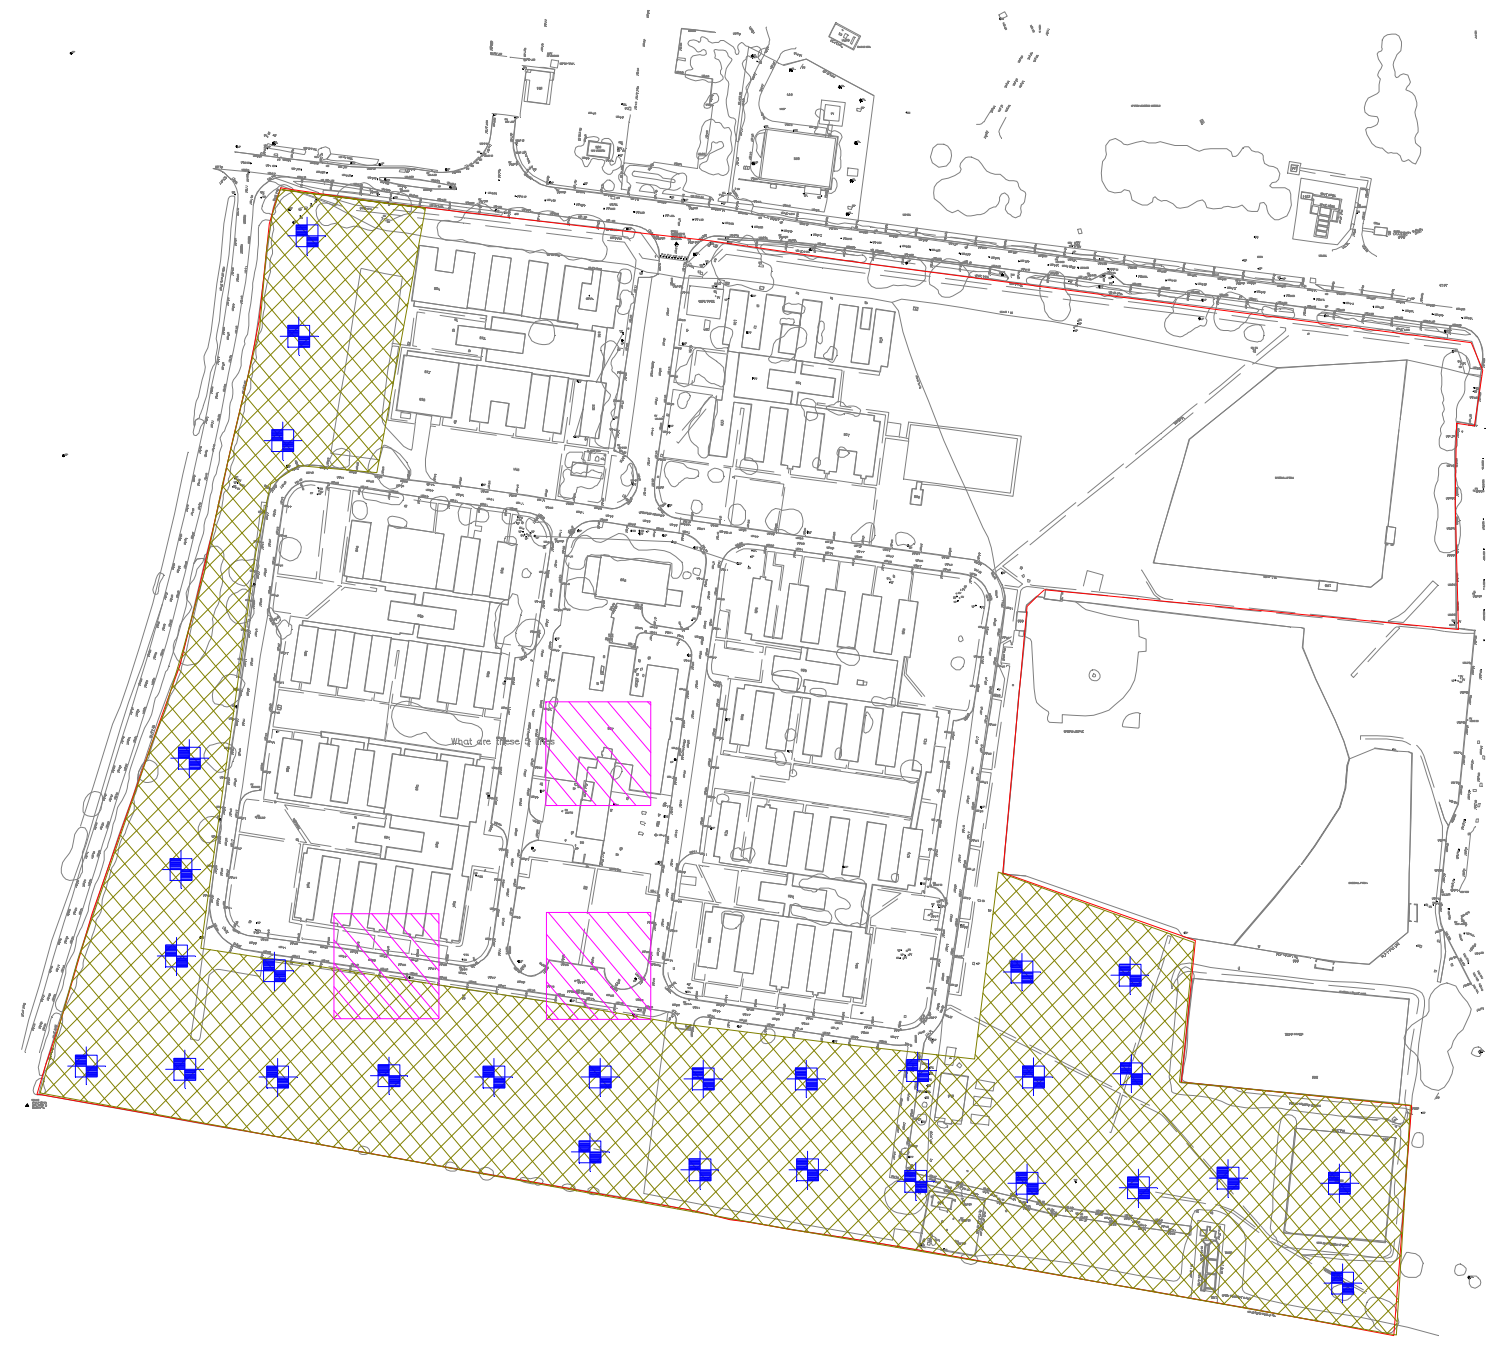
Job No: R1742b	Drg No: R23-D04
----------------	-----------------

- Phase 9 Boundary
- ▨ Remedial Works Outstanding - To be completed at a later date
- Outstanding Formation Validation - To be completed at a later date
- ▨ Precautionary surface strip from future gardens & additional PAH testing required

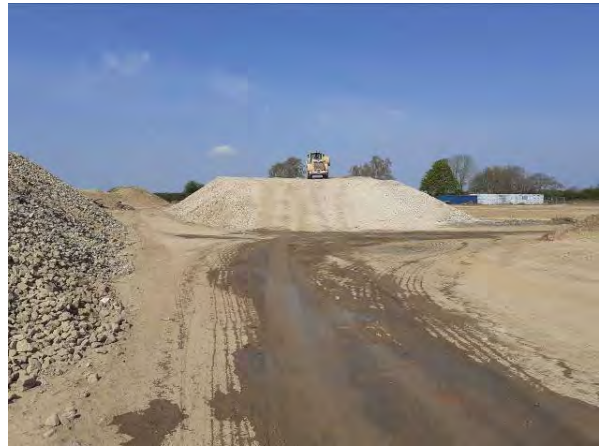
20.04.21 – Dust suppression taking place during dry conditions

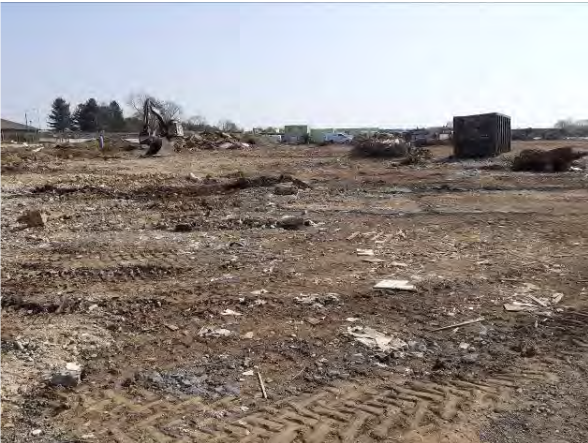
20.04.21 – Eastern view across the north of the site following building demolition and hardstanding removal but prior to regrade

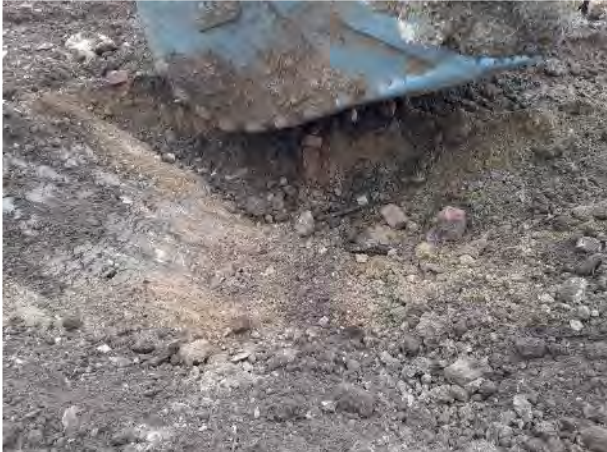
4.4.1 Following building demolition and removal of hardstanding, a localised area of ACM was observed within the surface soils by URL in the northwest of the site. Handpicking was undertaken by specialist sub-contractor Elite with all ACM double-bagged and placed in secure skips along with the ACM removed as part of the pre-demolition building strip. Following removal of surface deposits an excavator was used to carry out a shallow (0.5m turnover of soils) to allow the sub-contractor to inspect and undertake further picking, if necessary. The remediated area extended approximately 10m x 20m.

4.4.2 Following handpicking of visible ACM, SGP attended site and collected samples of the retained soils on a 1 per 5m² frequency for asbestos identification to assess whether any loose fibres remained within the soils.

<p data-bbox="114 767 768 842">28.04.21 – Excavation to 0.6m bgl and collection of sample (S1) following completion of hand-picking. No visible ACM observed</p>

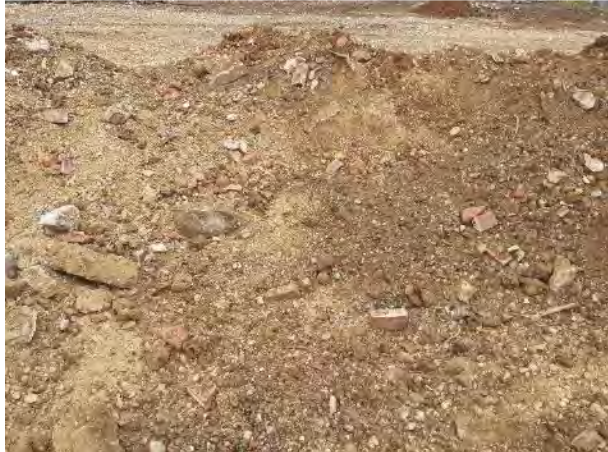
<p data-bbox="790 767 1444 842">28.04.21 - Excavation to 0.6m bgl and collection of sample (S2) following completion of hand-picking. No visible ACM observed</p>

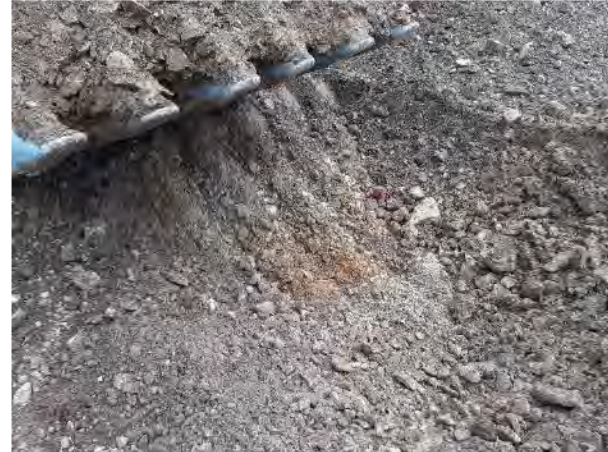
<p data-bbox="1462 767 2116 842">28.04.21 - Excavation to 0.6m bgl and collection of sample (S3) following completion of hand-picking. No visible ACM observed</p>

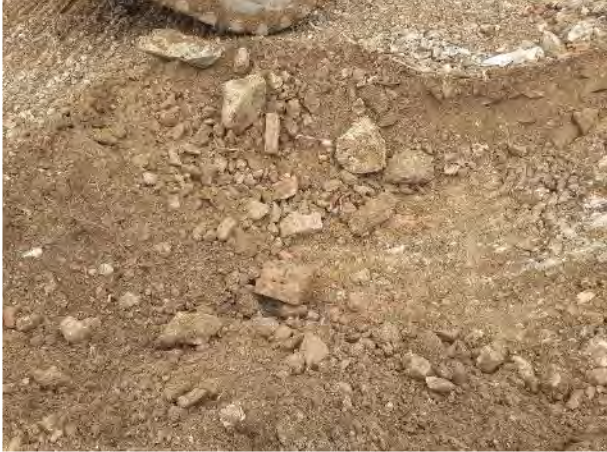
<p data-bbox="114 1305 768 1380">28.04.21 - Excavation to 0.6m bgl and collection of sample (S4) following completion of hand-picking. No visible ACM observed</p>

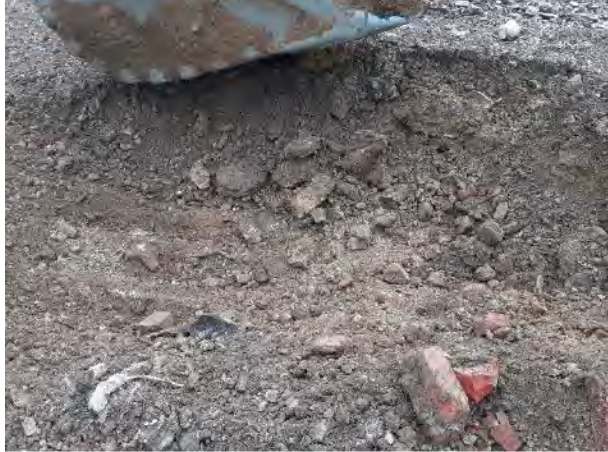
<p data-bbox="790 1305 1444 1380">28.04.21 - Excavation to 0.6m bgl and collection of sample (S5) following completion of hand-picking. No visible ACM observed</p>

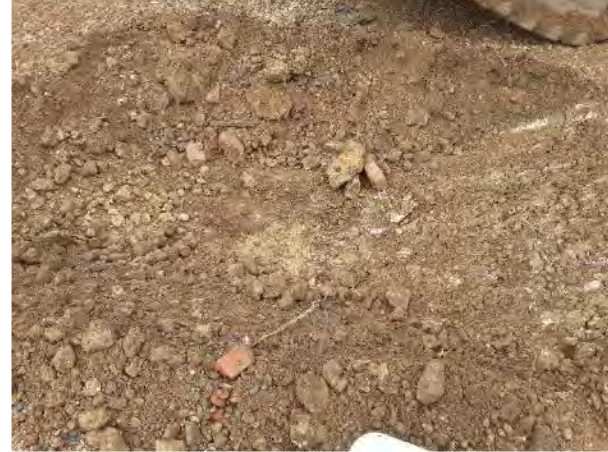
<p data-bbox="1462 1305 2116 1380">28.04.21 - Excavation to 0.6m bgl and collection of sample (S6) following completion of hand-picking. No visible ACM observed</p>

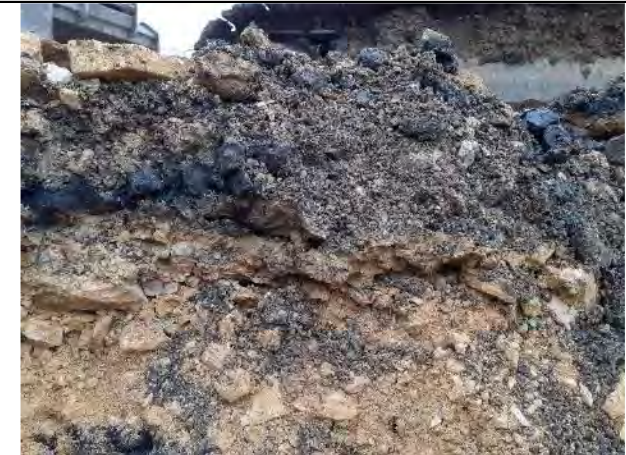
28.04.21 – Black gravel within approximate area of former aerial mast, possible former base

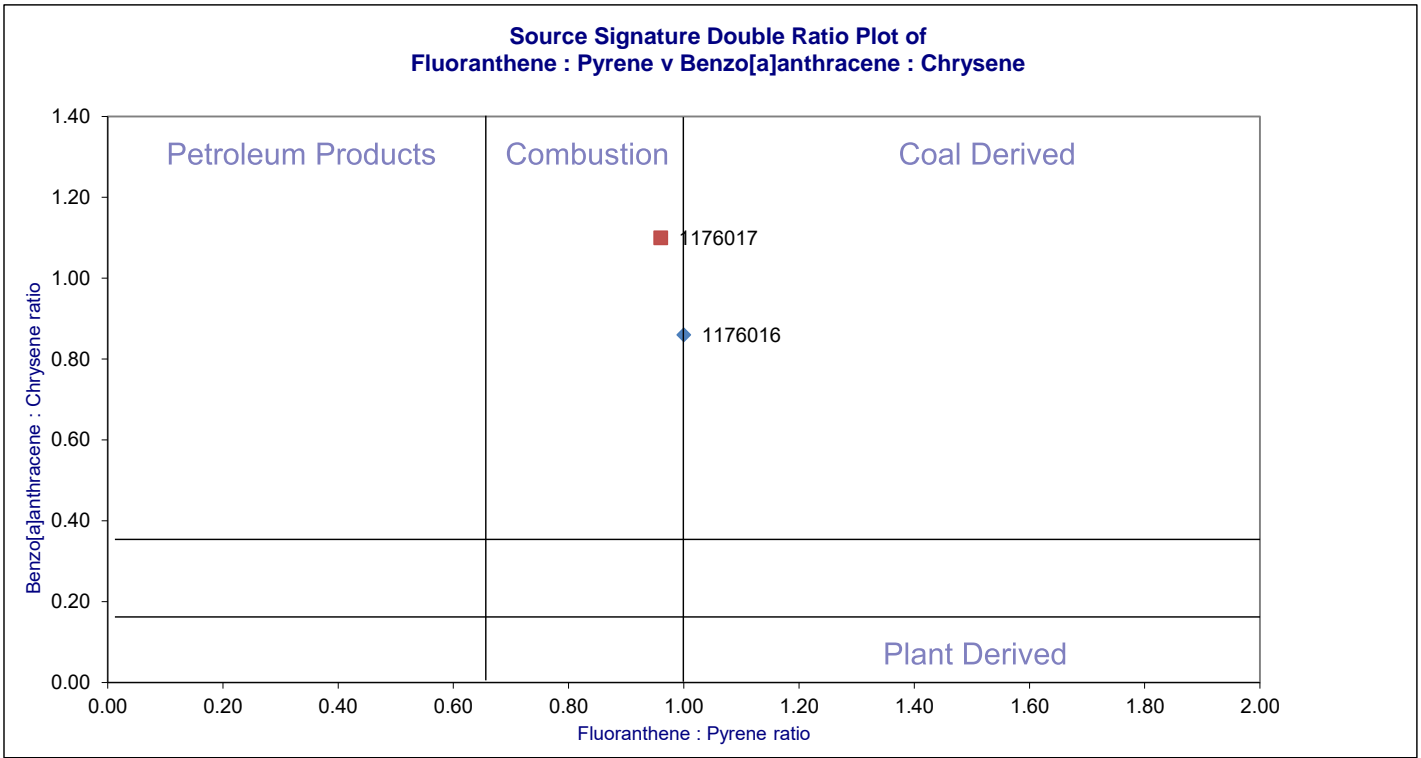
Double Ratio Plot

Sample No.	Fluoranthene	Pyrene	Benzo[a]Anthracene	Chrysene	Fluoranthene : Pyrene Ratio	Benzo[a]Anthracene : Chrysene Ratio
1176016	85	84	34	40	1.00	0.86
1176017	360	380	150	140	0.96	1.10

4.8.11 PAH ratio analysis has been undertaken to determine the probable source of the minor elevated PAHs. Source identification suggests a coal / coal tar source, a copy of the plot is included within Appendix F. It is most likely that this signature relates to very fine inclusions of broken out and removed tarmac. Small residues may remain in surface soils within these locations although no visible remains were observed during sampling. Source identification confirms a probable low bio-availability due to the sequestration of PAHs within a carbon or vitrified matrix with benzo(a)pyrene concentrations significantly below the DEFRA C4SL criteria of 5 mg/kg for garden soils.

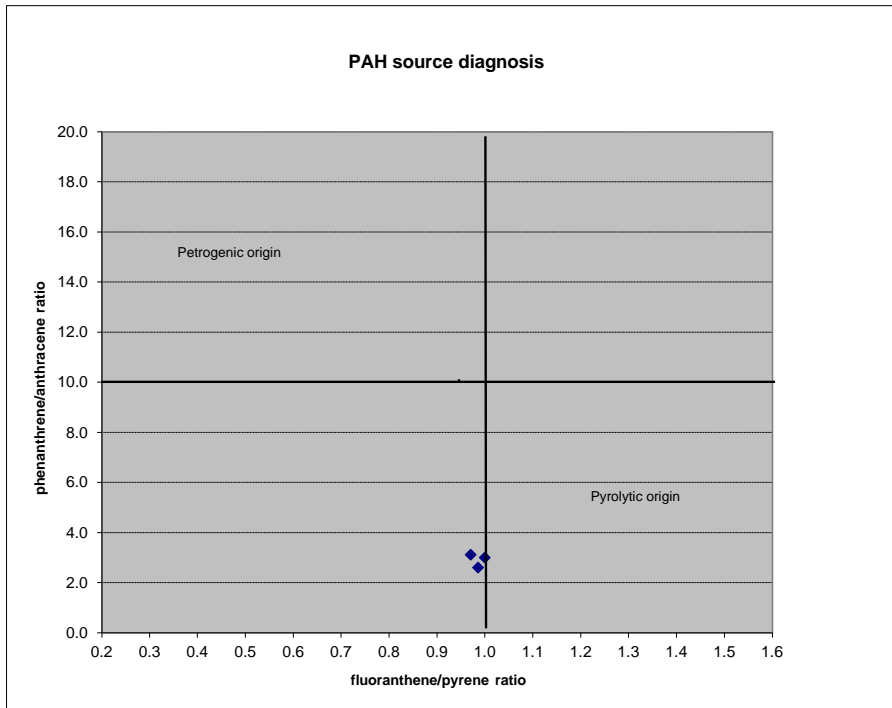
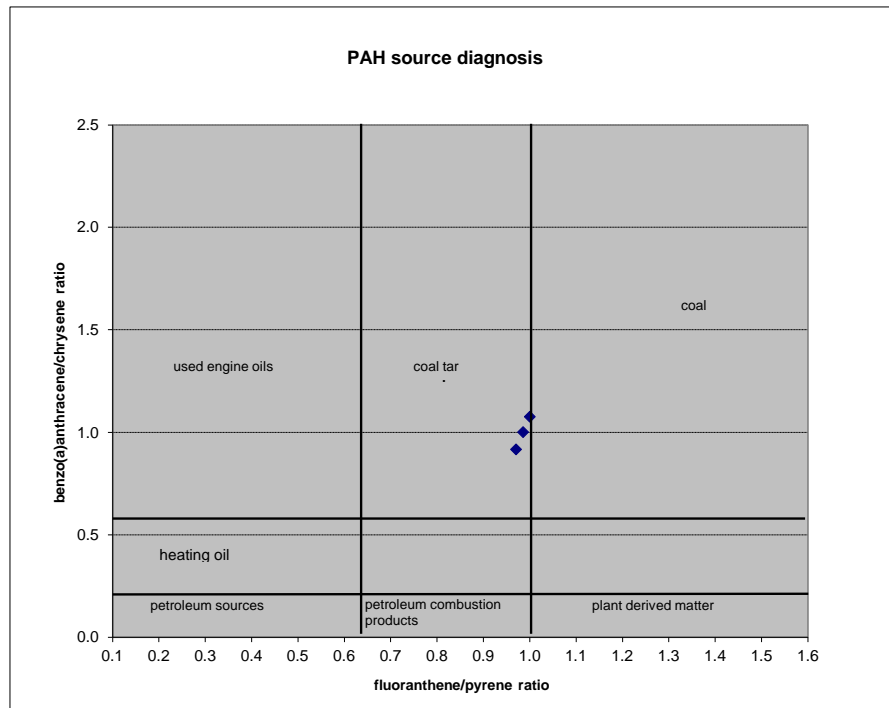
PAH Ratio Cross-Plot

phe/ant	2.597	3.111	3.000																
flu/pyr	0.986	0.970	1.000																
baa/chr	1.000	0.917	1.075
