Clifton Road, Deddington
Accurate Visual Representations
(AVR Level 1 + Shaded)

November 2020

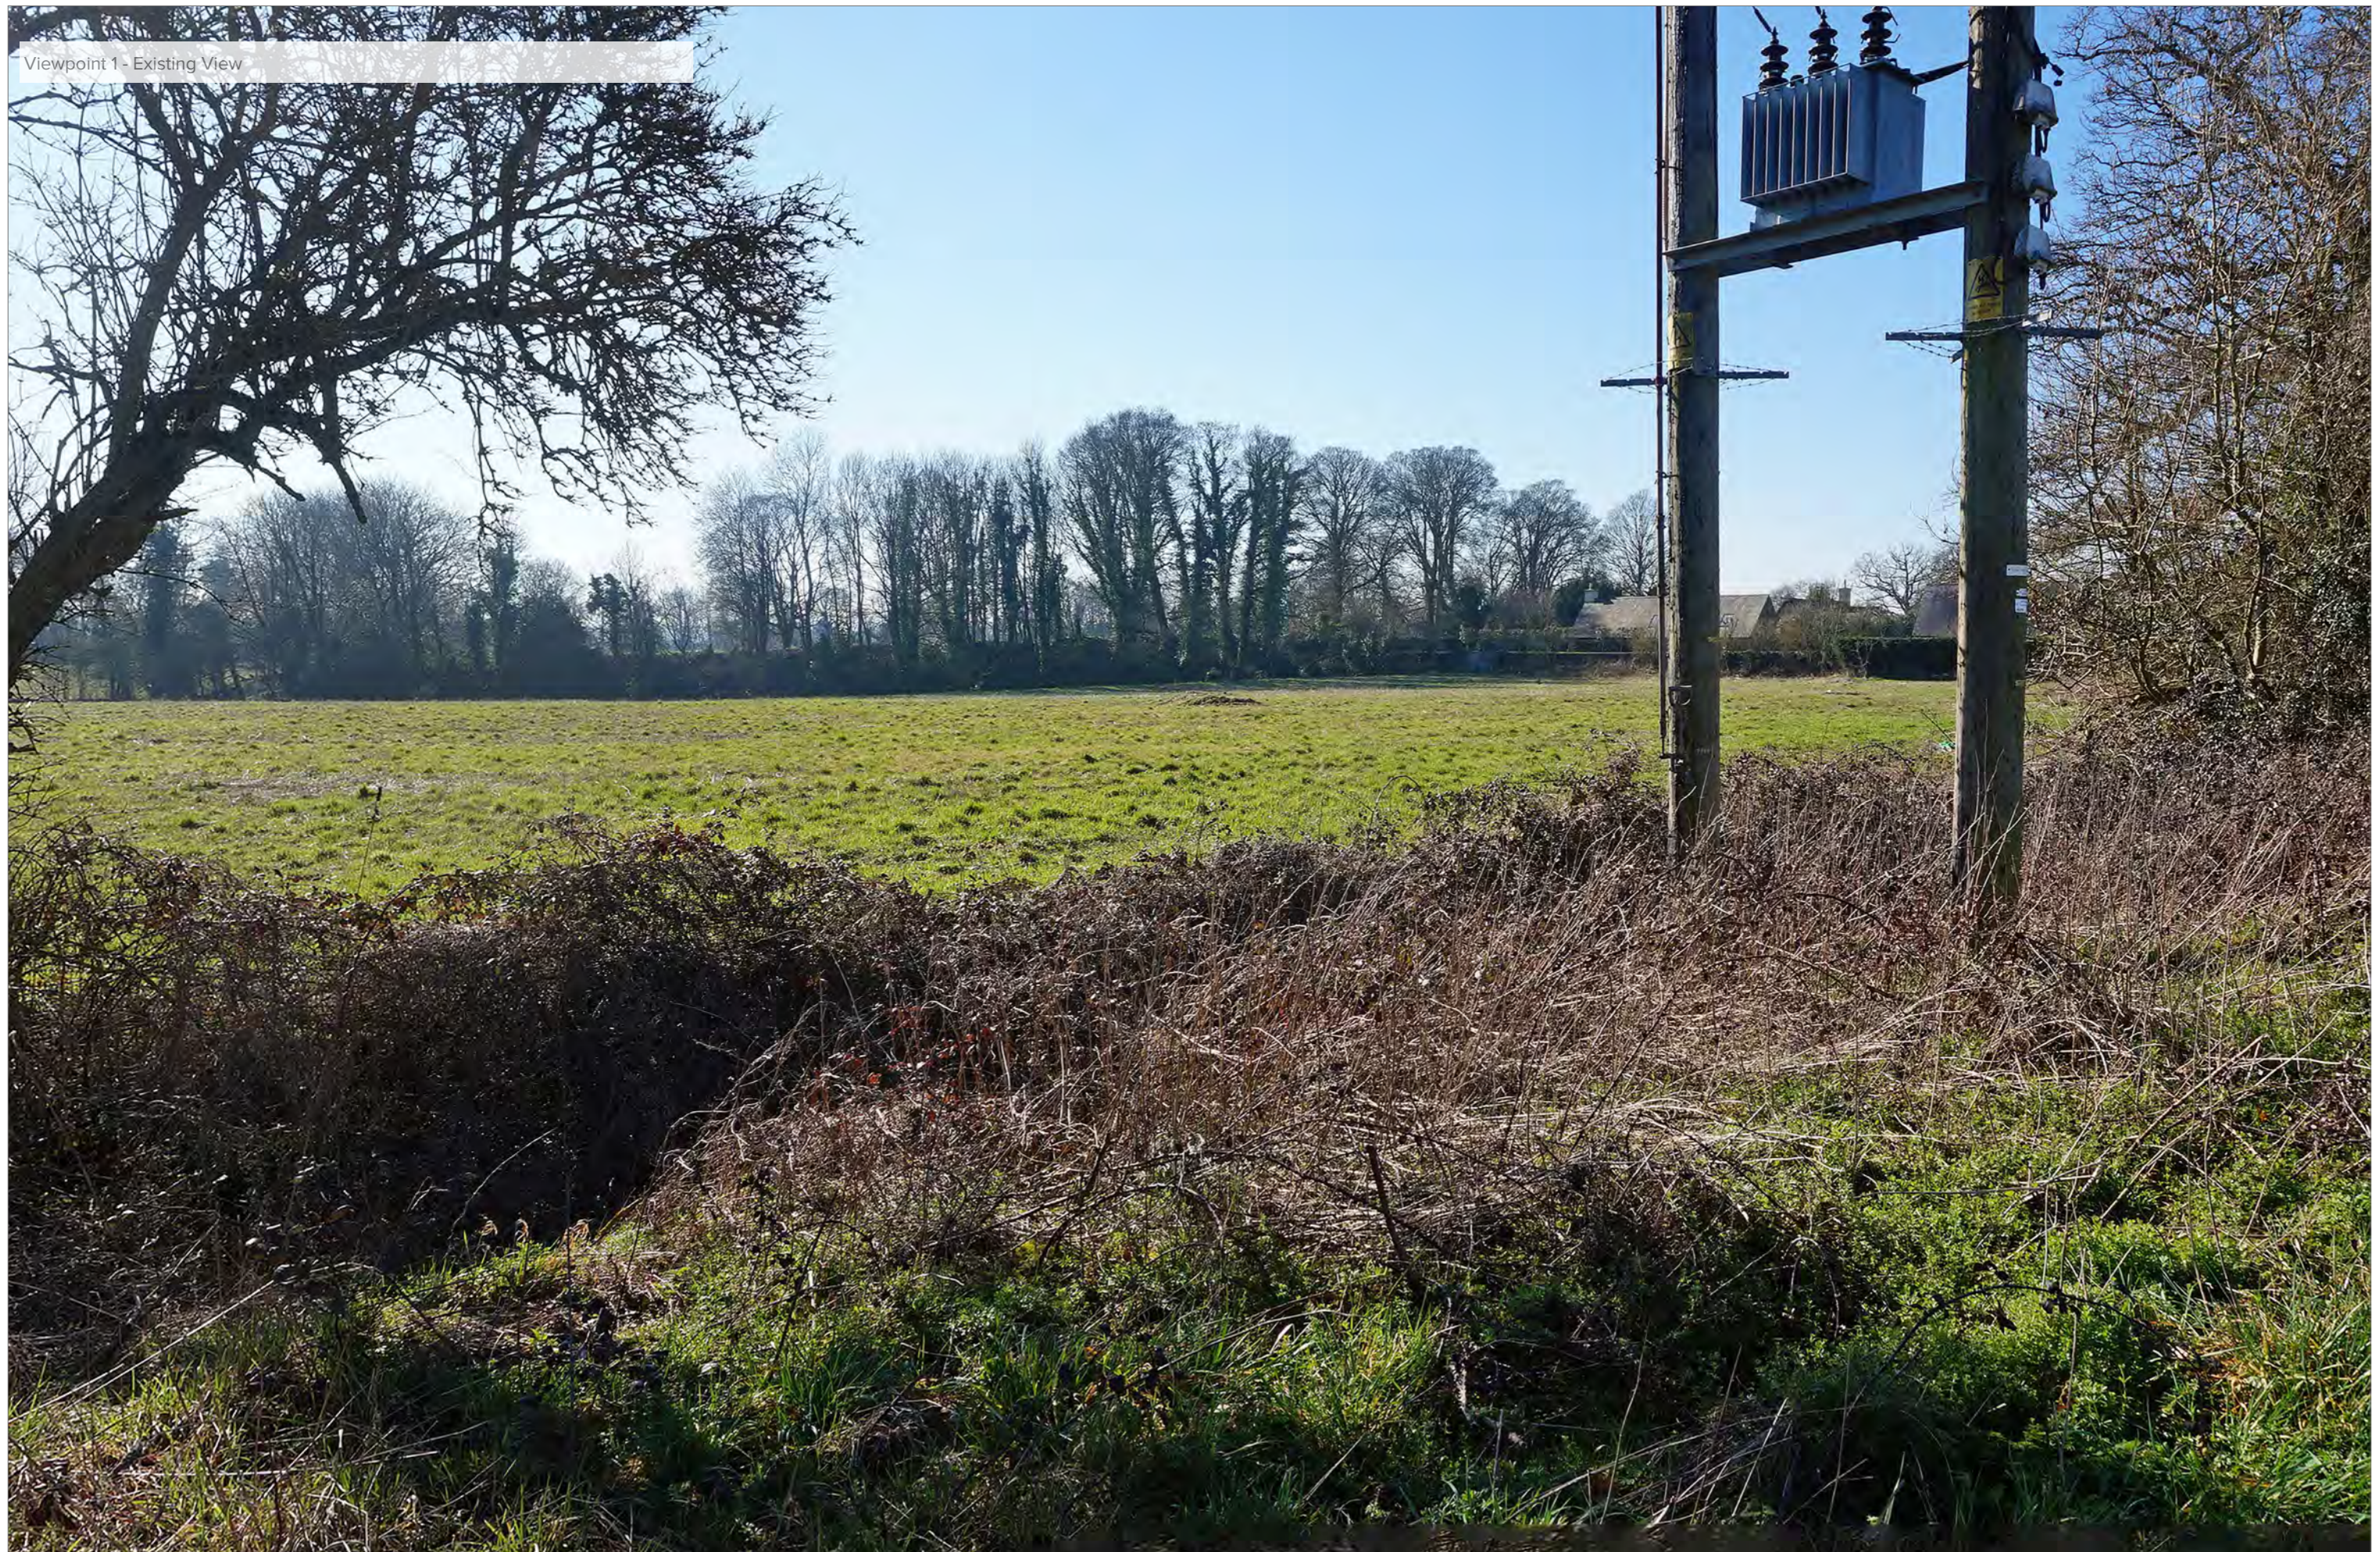
Viewpoint 1 - Existing View

Note: Photograph shot with an APS-C (x1.5 crop factor) sensor camera using a 16mm lens and is therefore equivalent to a 24mm lens in full frame format.

Viewpoint Information			
OS Grid Reference	447179.05 231783.13	Horizontal Field of View	73°
Ground Level (AOD)	124.83m	Camera / Lens	Sony a5000/16mm (24mm)
Viewer Height	1.60m	Date / Time	10/01/2020 - 09:35
Distance to Site	6.4m	Weather Conditions	5% cloud, medium visibility

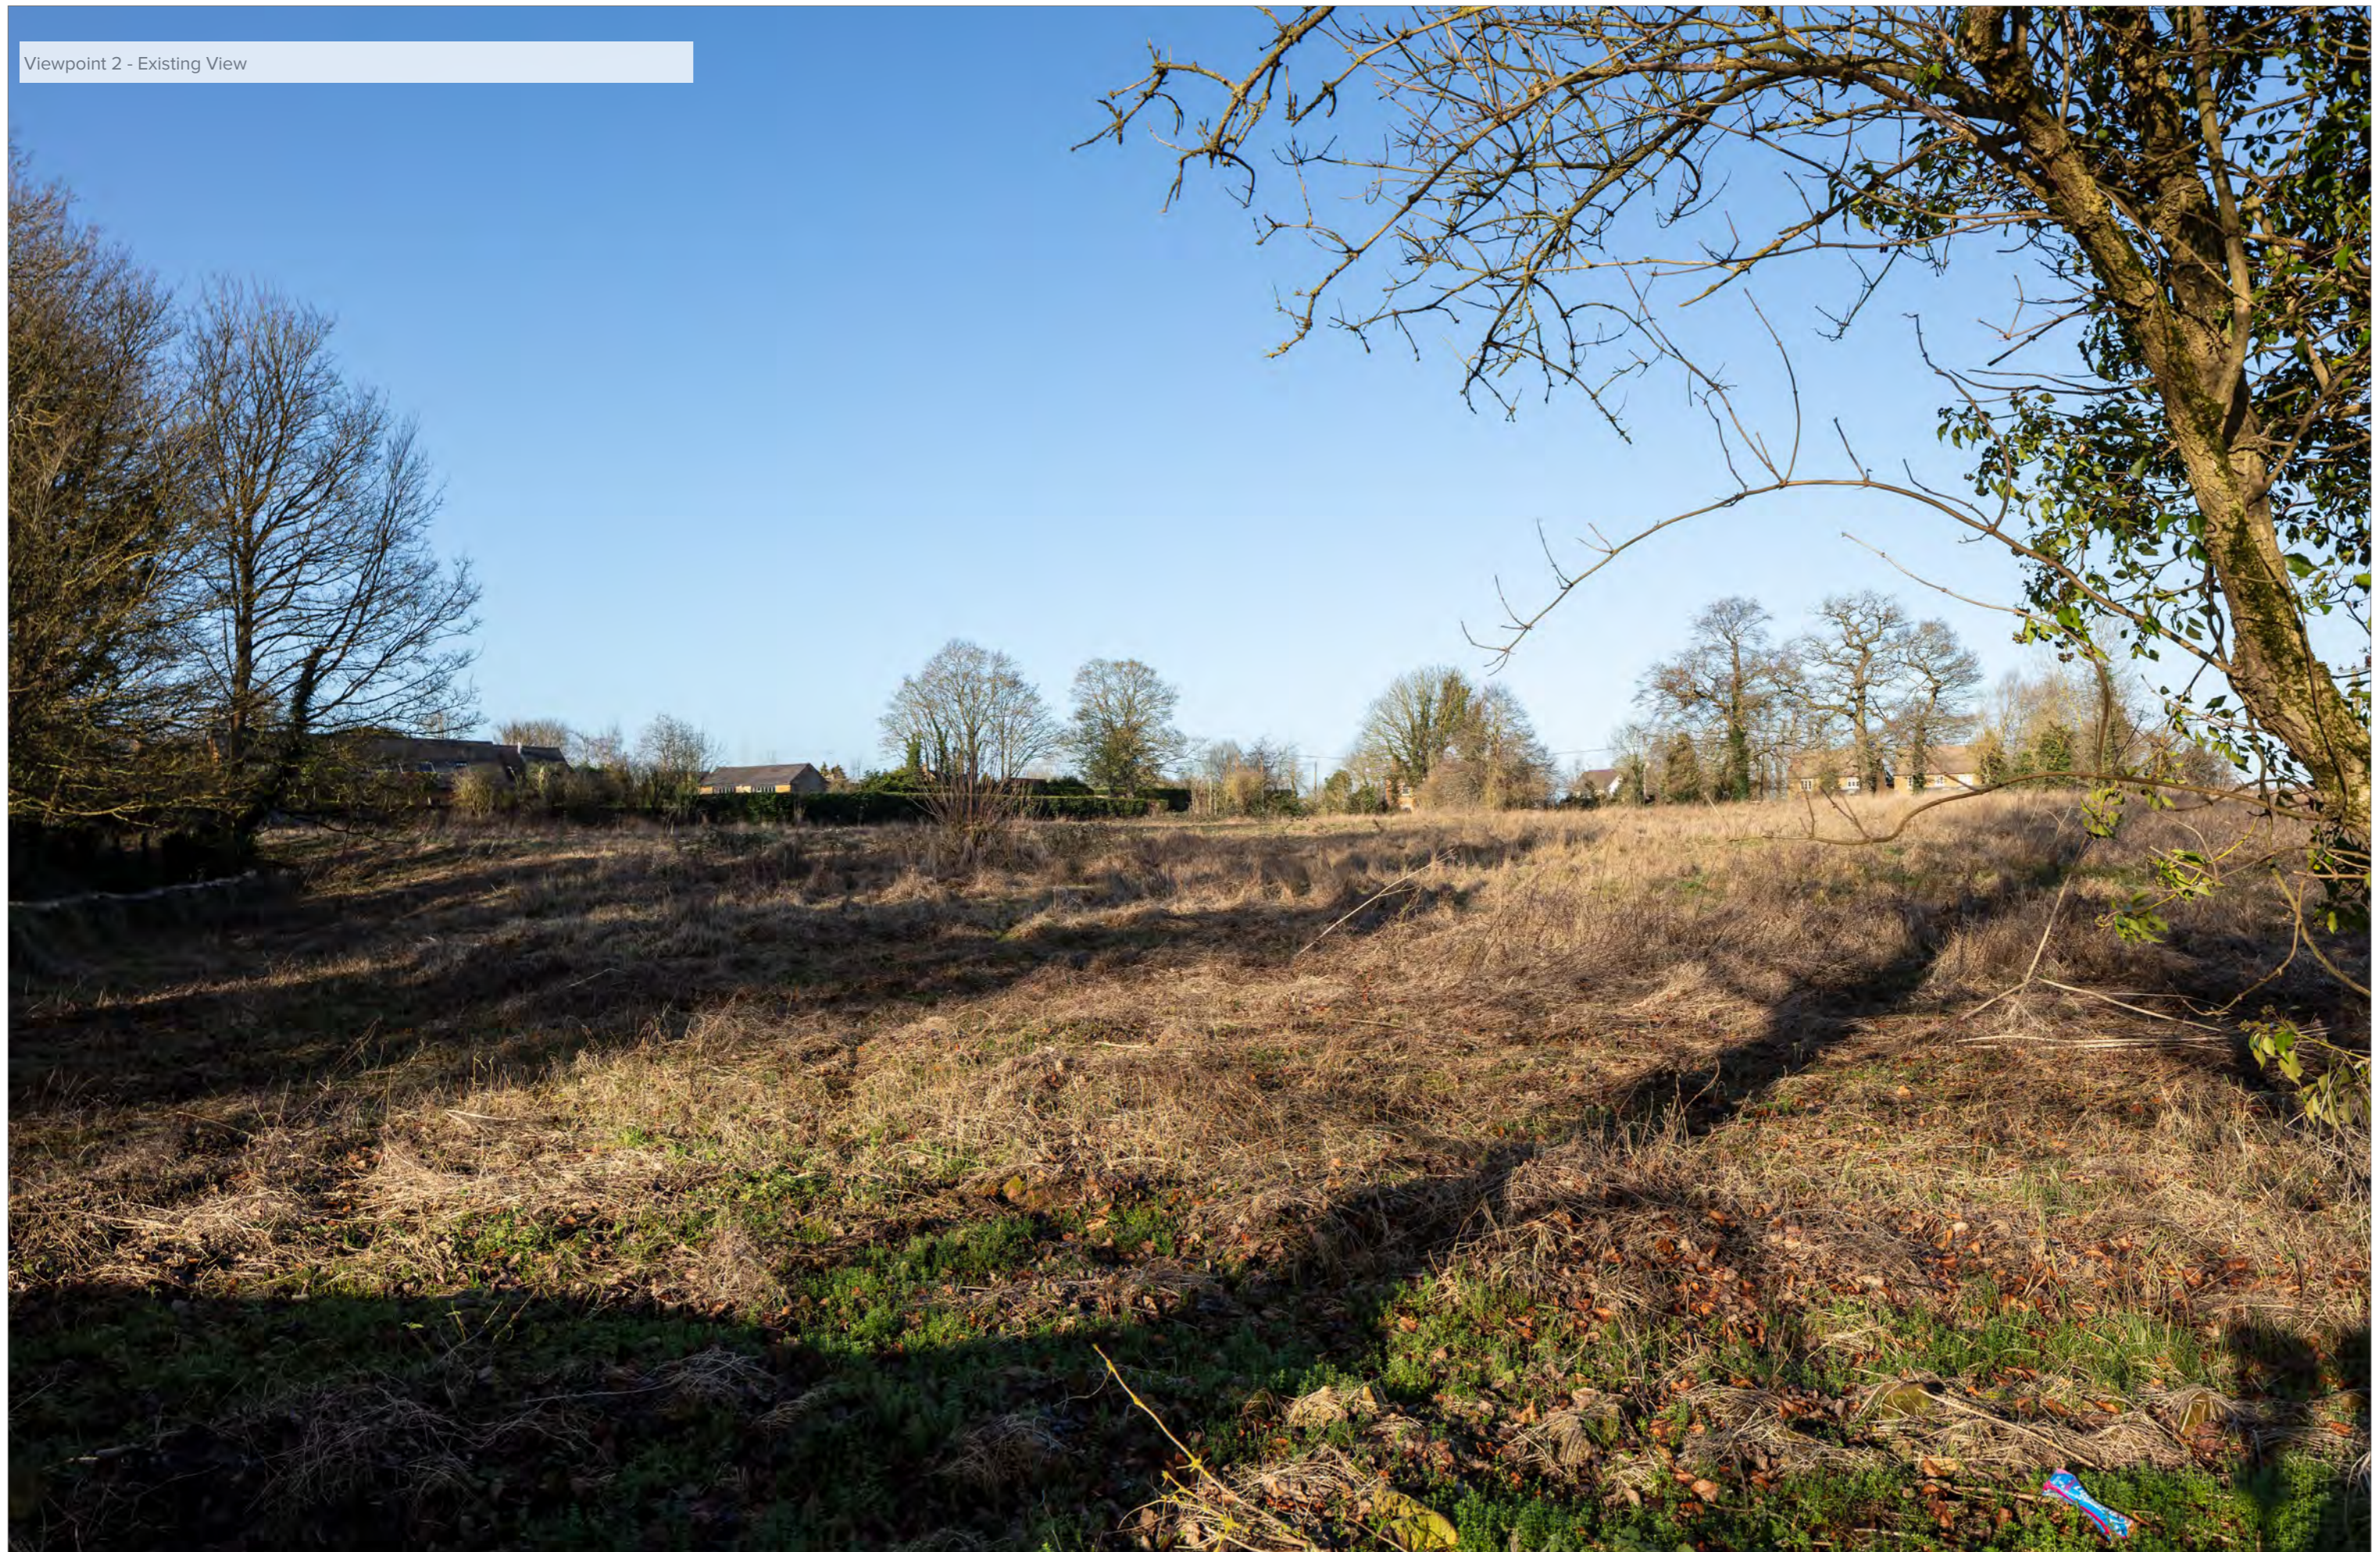
Project title: Clifton Road, Deddington
 Client:
 Drawing Title: Viewpoint 2

Viewpoint Information			
OS Grid Reference	447189.75 231646.35	Horizontal Field of View	73°
Ground Level (AOD)	120.86m	Camera / Lens	Canon 5DS R / TS-e 24mm
Viewer Height	1.60m	Date / Time	03/01/2020 - 11:51
Distance to Site	0.5m	Weather Conditions	80% cloud, good visibility

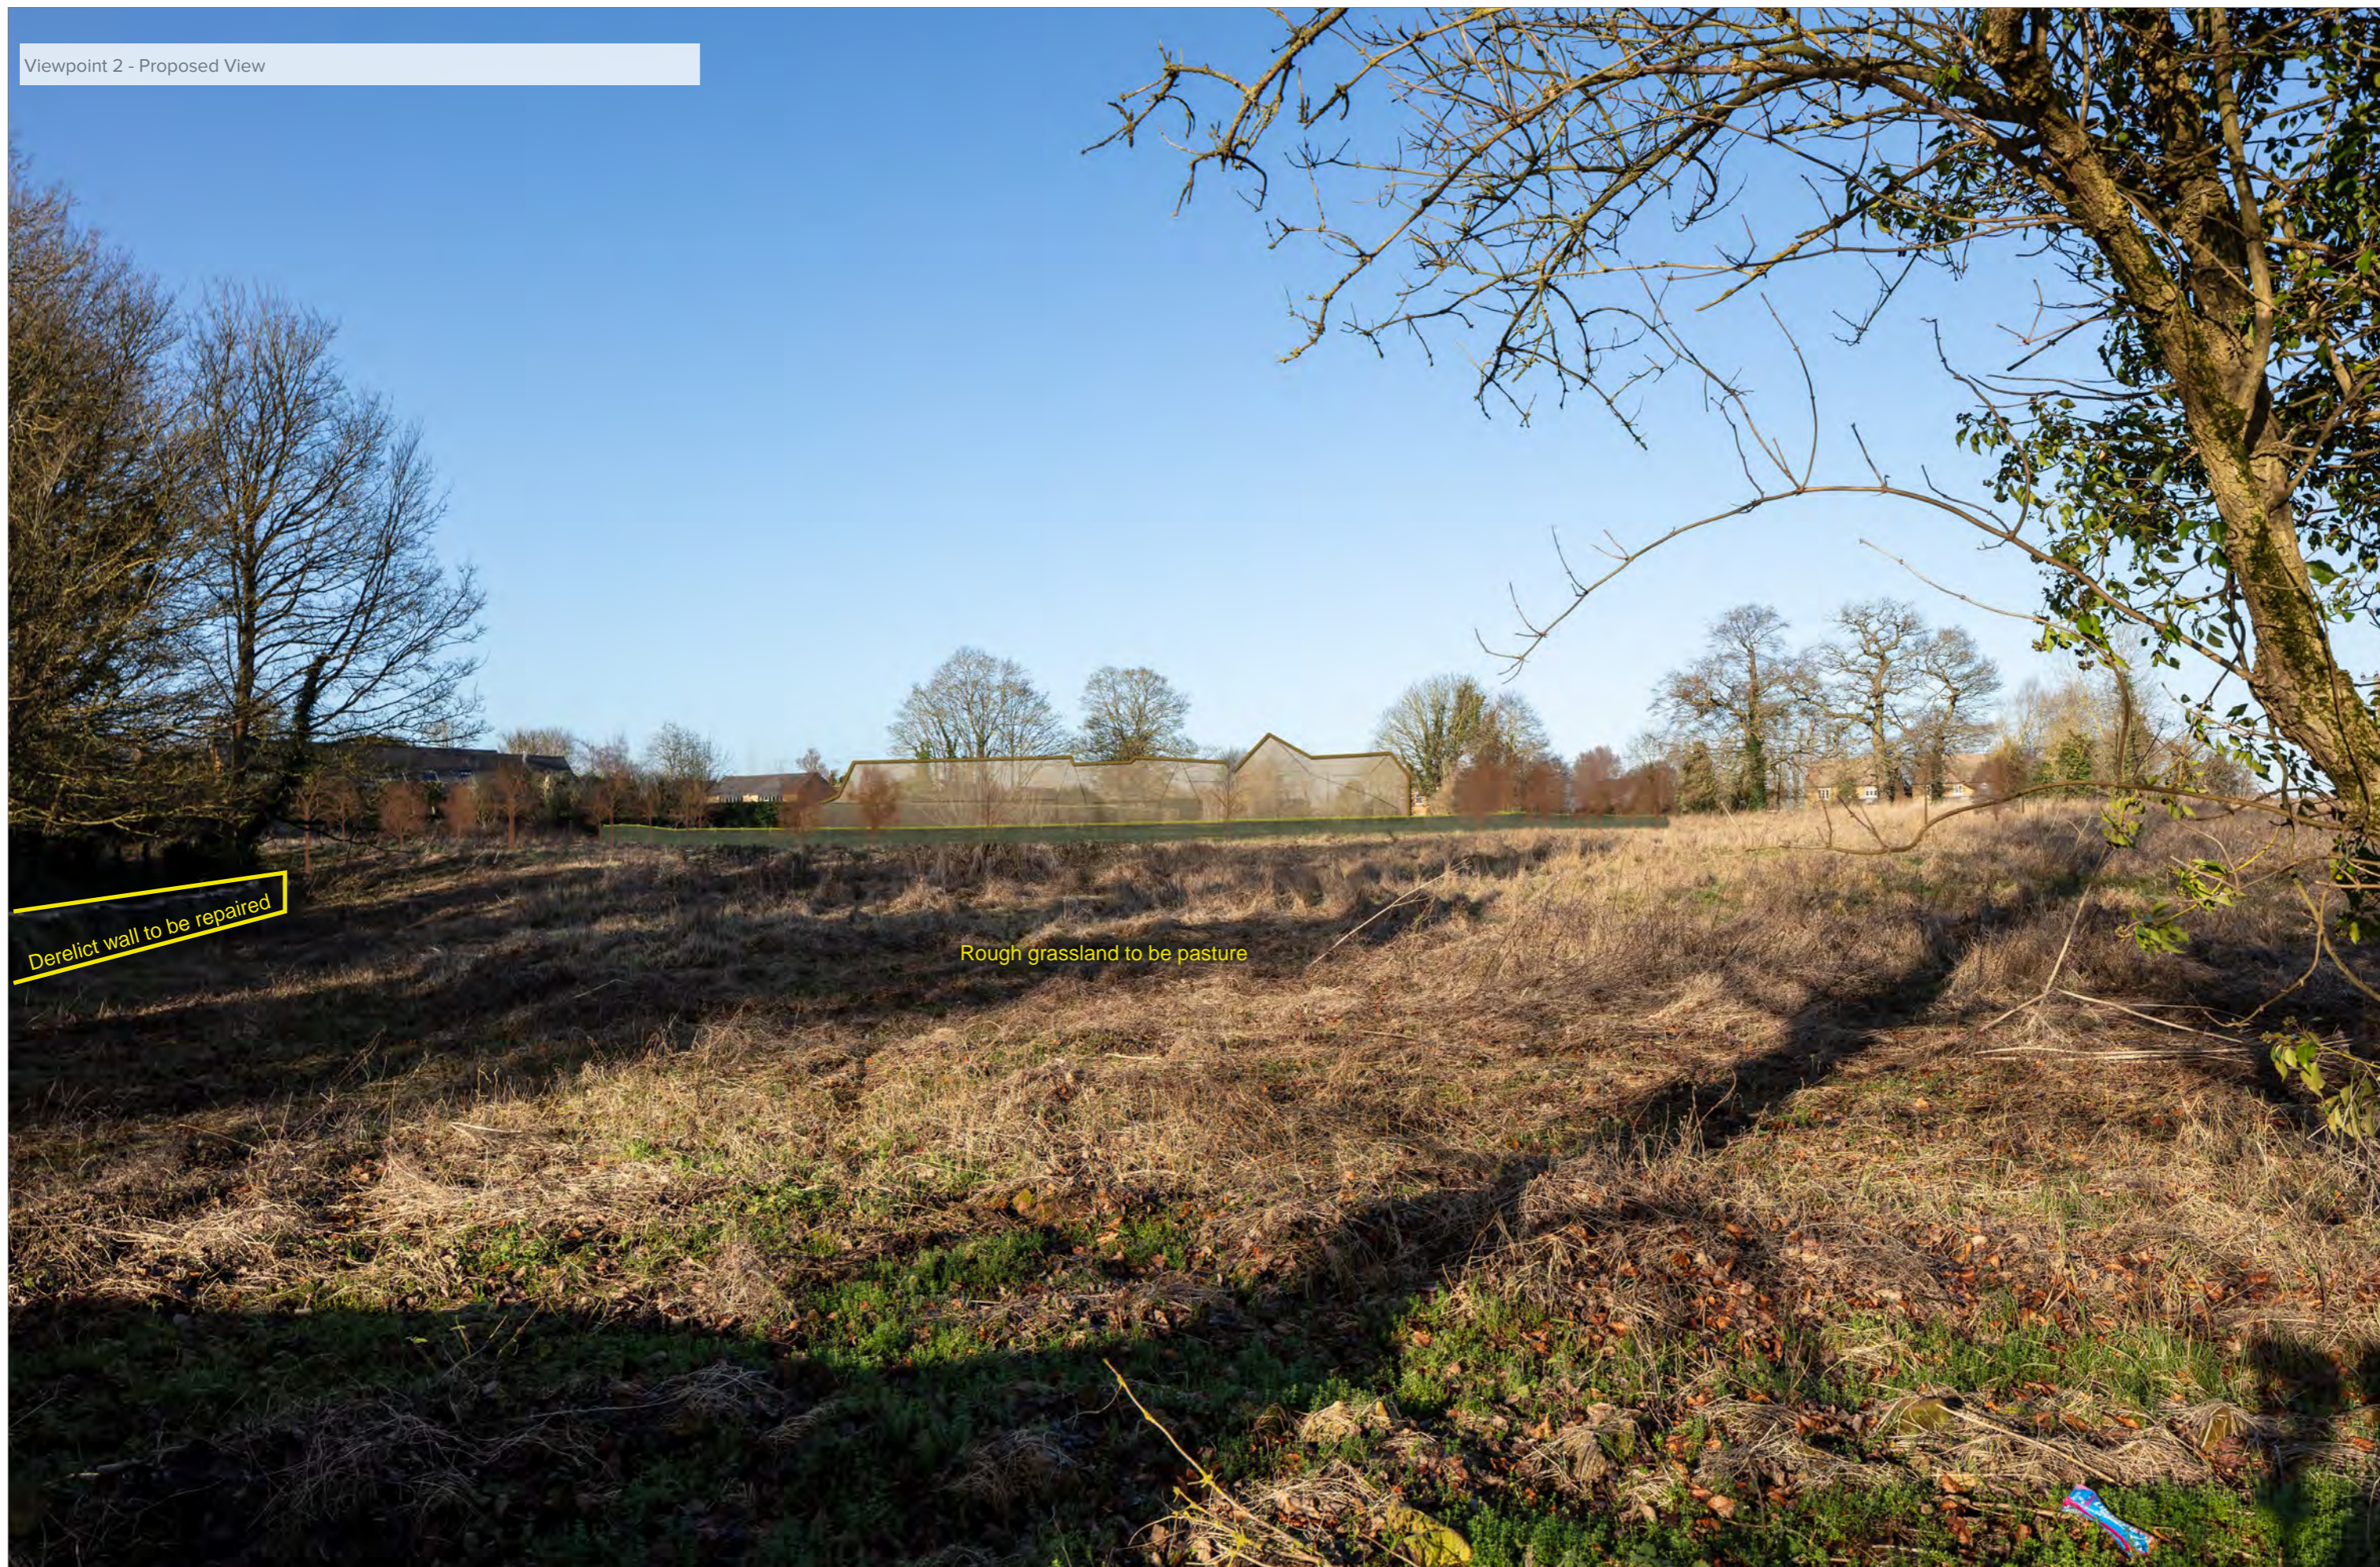
Derelict wall to be repaired

Rough grassland to be pasture

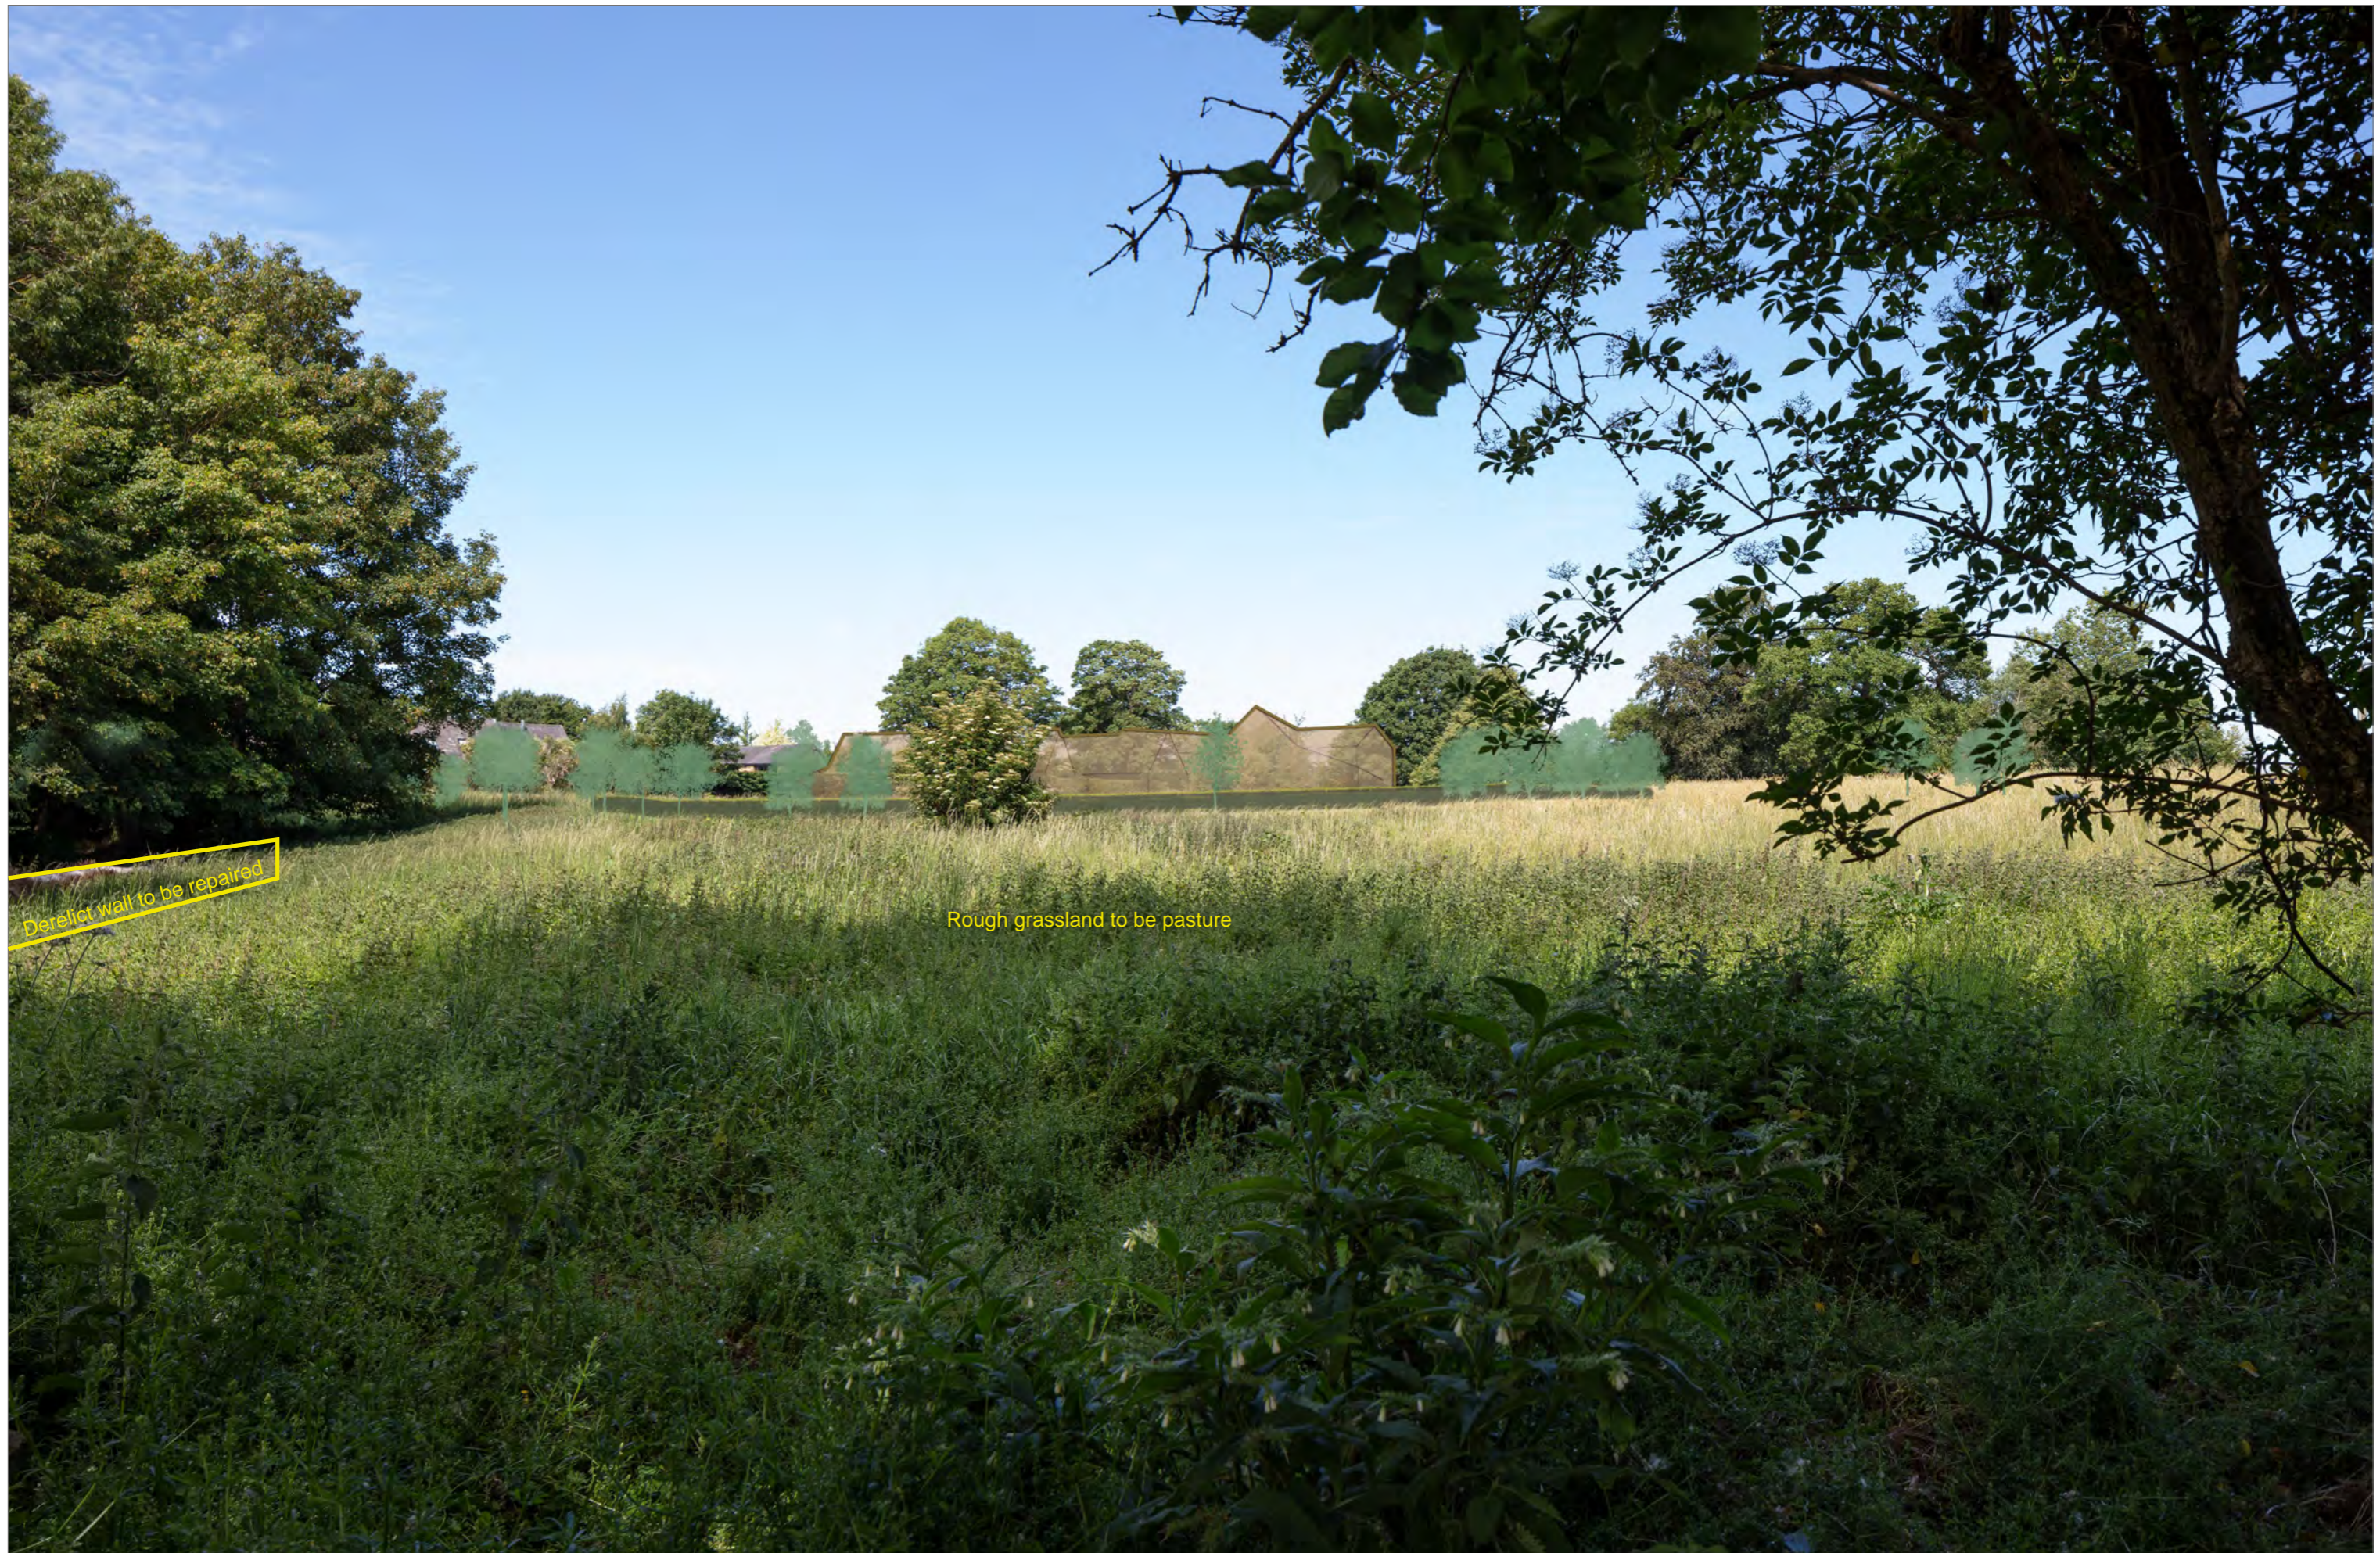
Derelict wall to be repaired

Rough grassland to be pasture

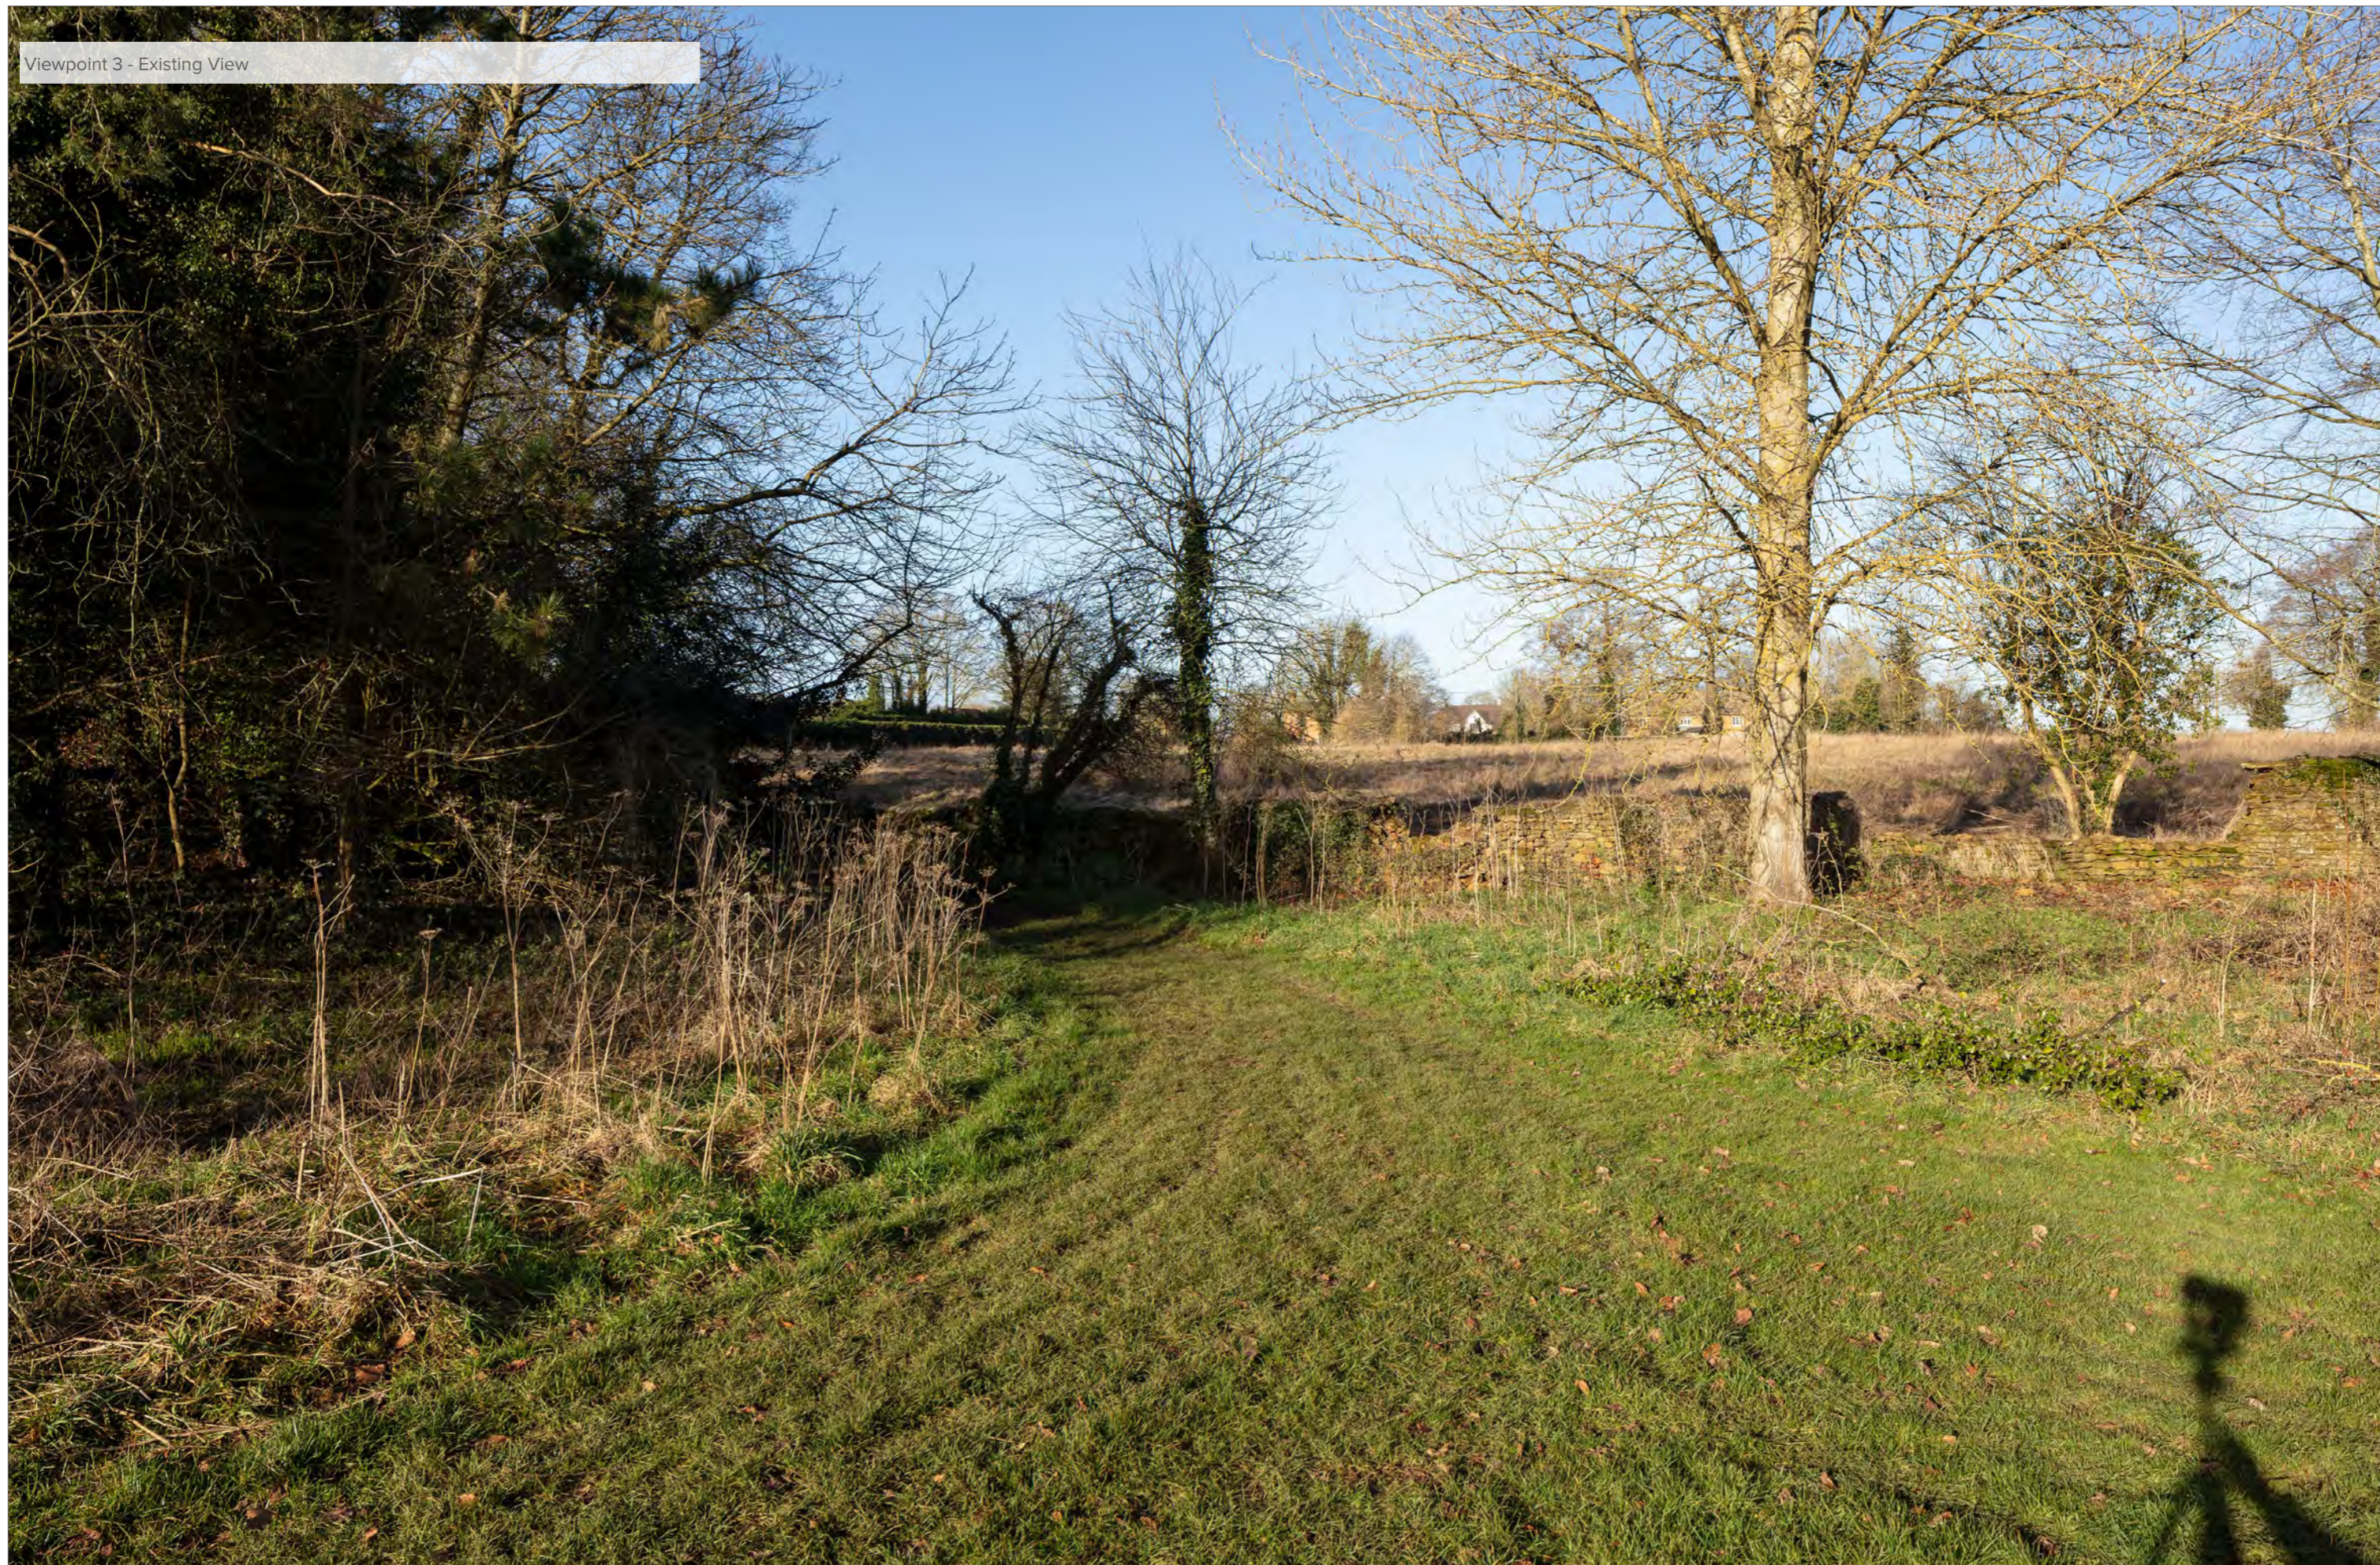
Viewpoint 3 - Existing View

Viewpoint Information			
OS Grid Reference	447193.38 231624.82	Horizontal Field of View	73°
Ground Level (AOD)	120.62m	Camera / Lens	Canon 5DS R / TS-e 24mm
Viewer Height	1.60m	Date / Time	03/01/2020 - 12:12
Distance to Site	22m	Weather Conditions	80% cloud, good visibility

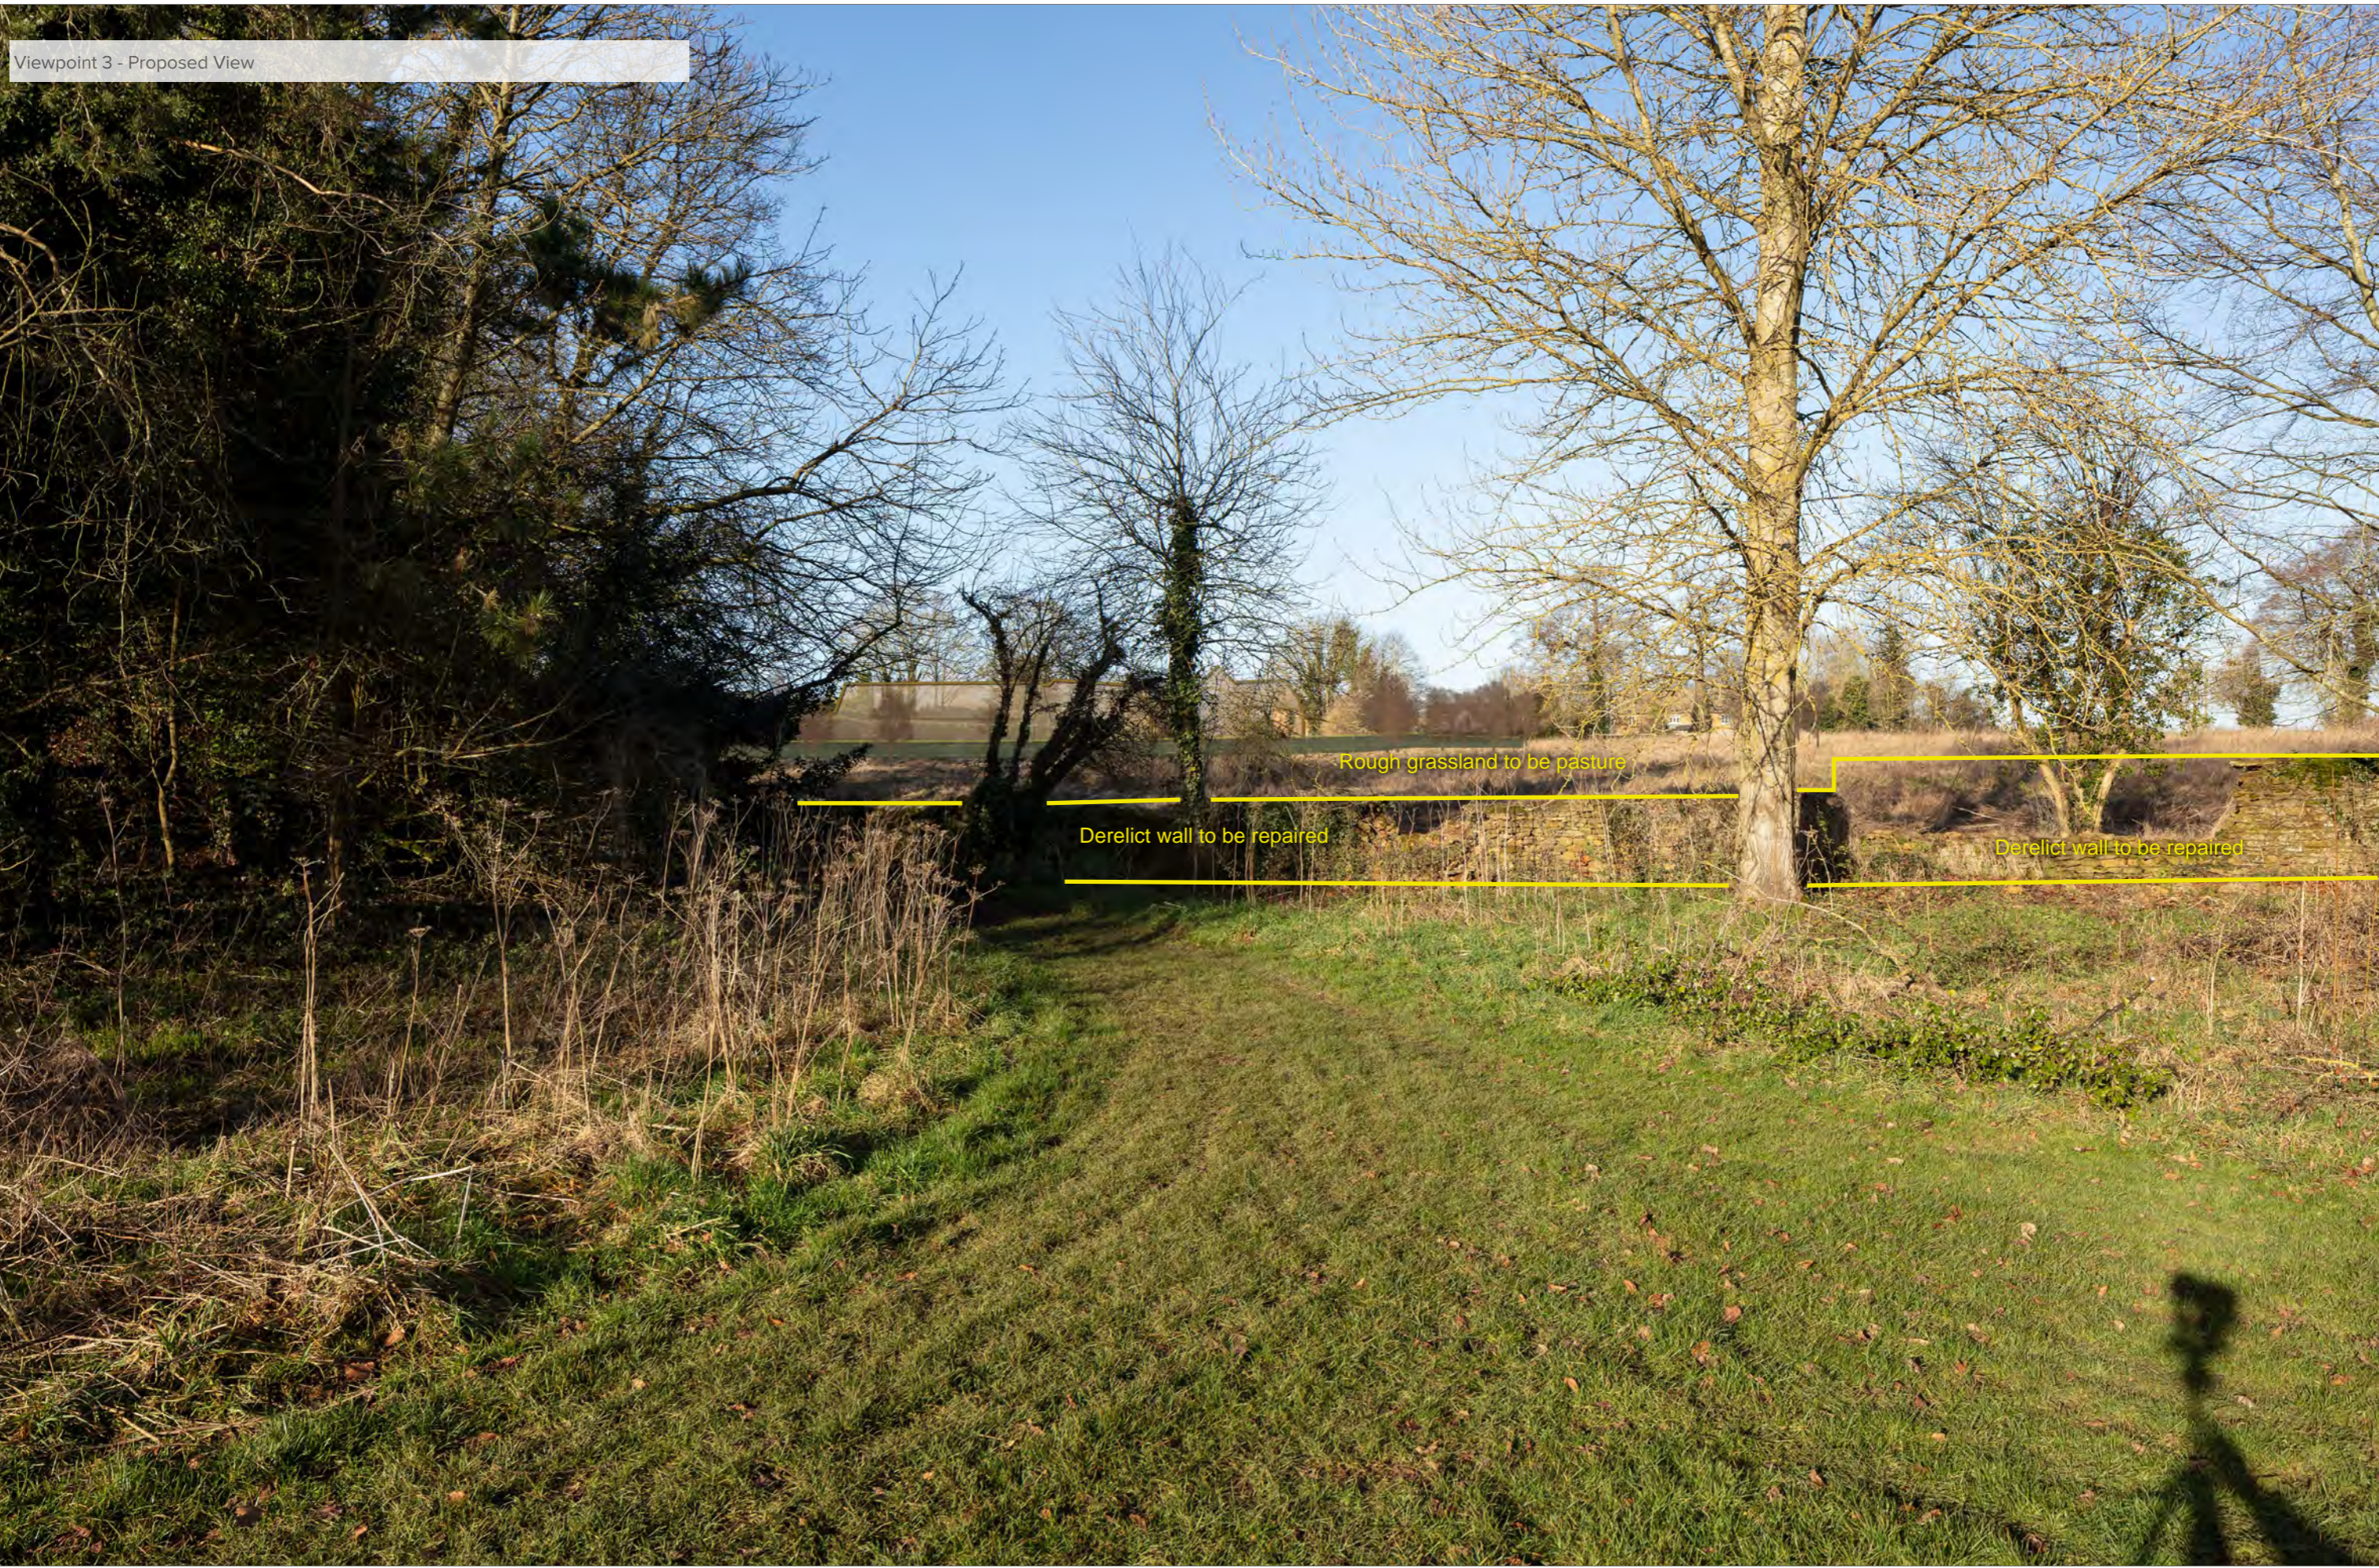
Rough grassland to be pasture

Derelict wall to be repaired
