Clifton Road, Deddington
Accurate Visual Representations
(AVR Level 1 + Shaded)

November 2020

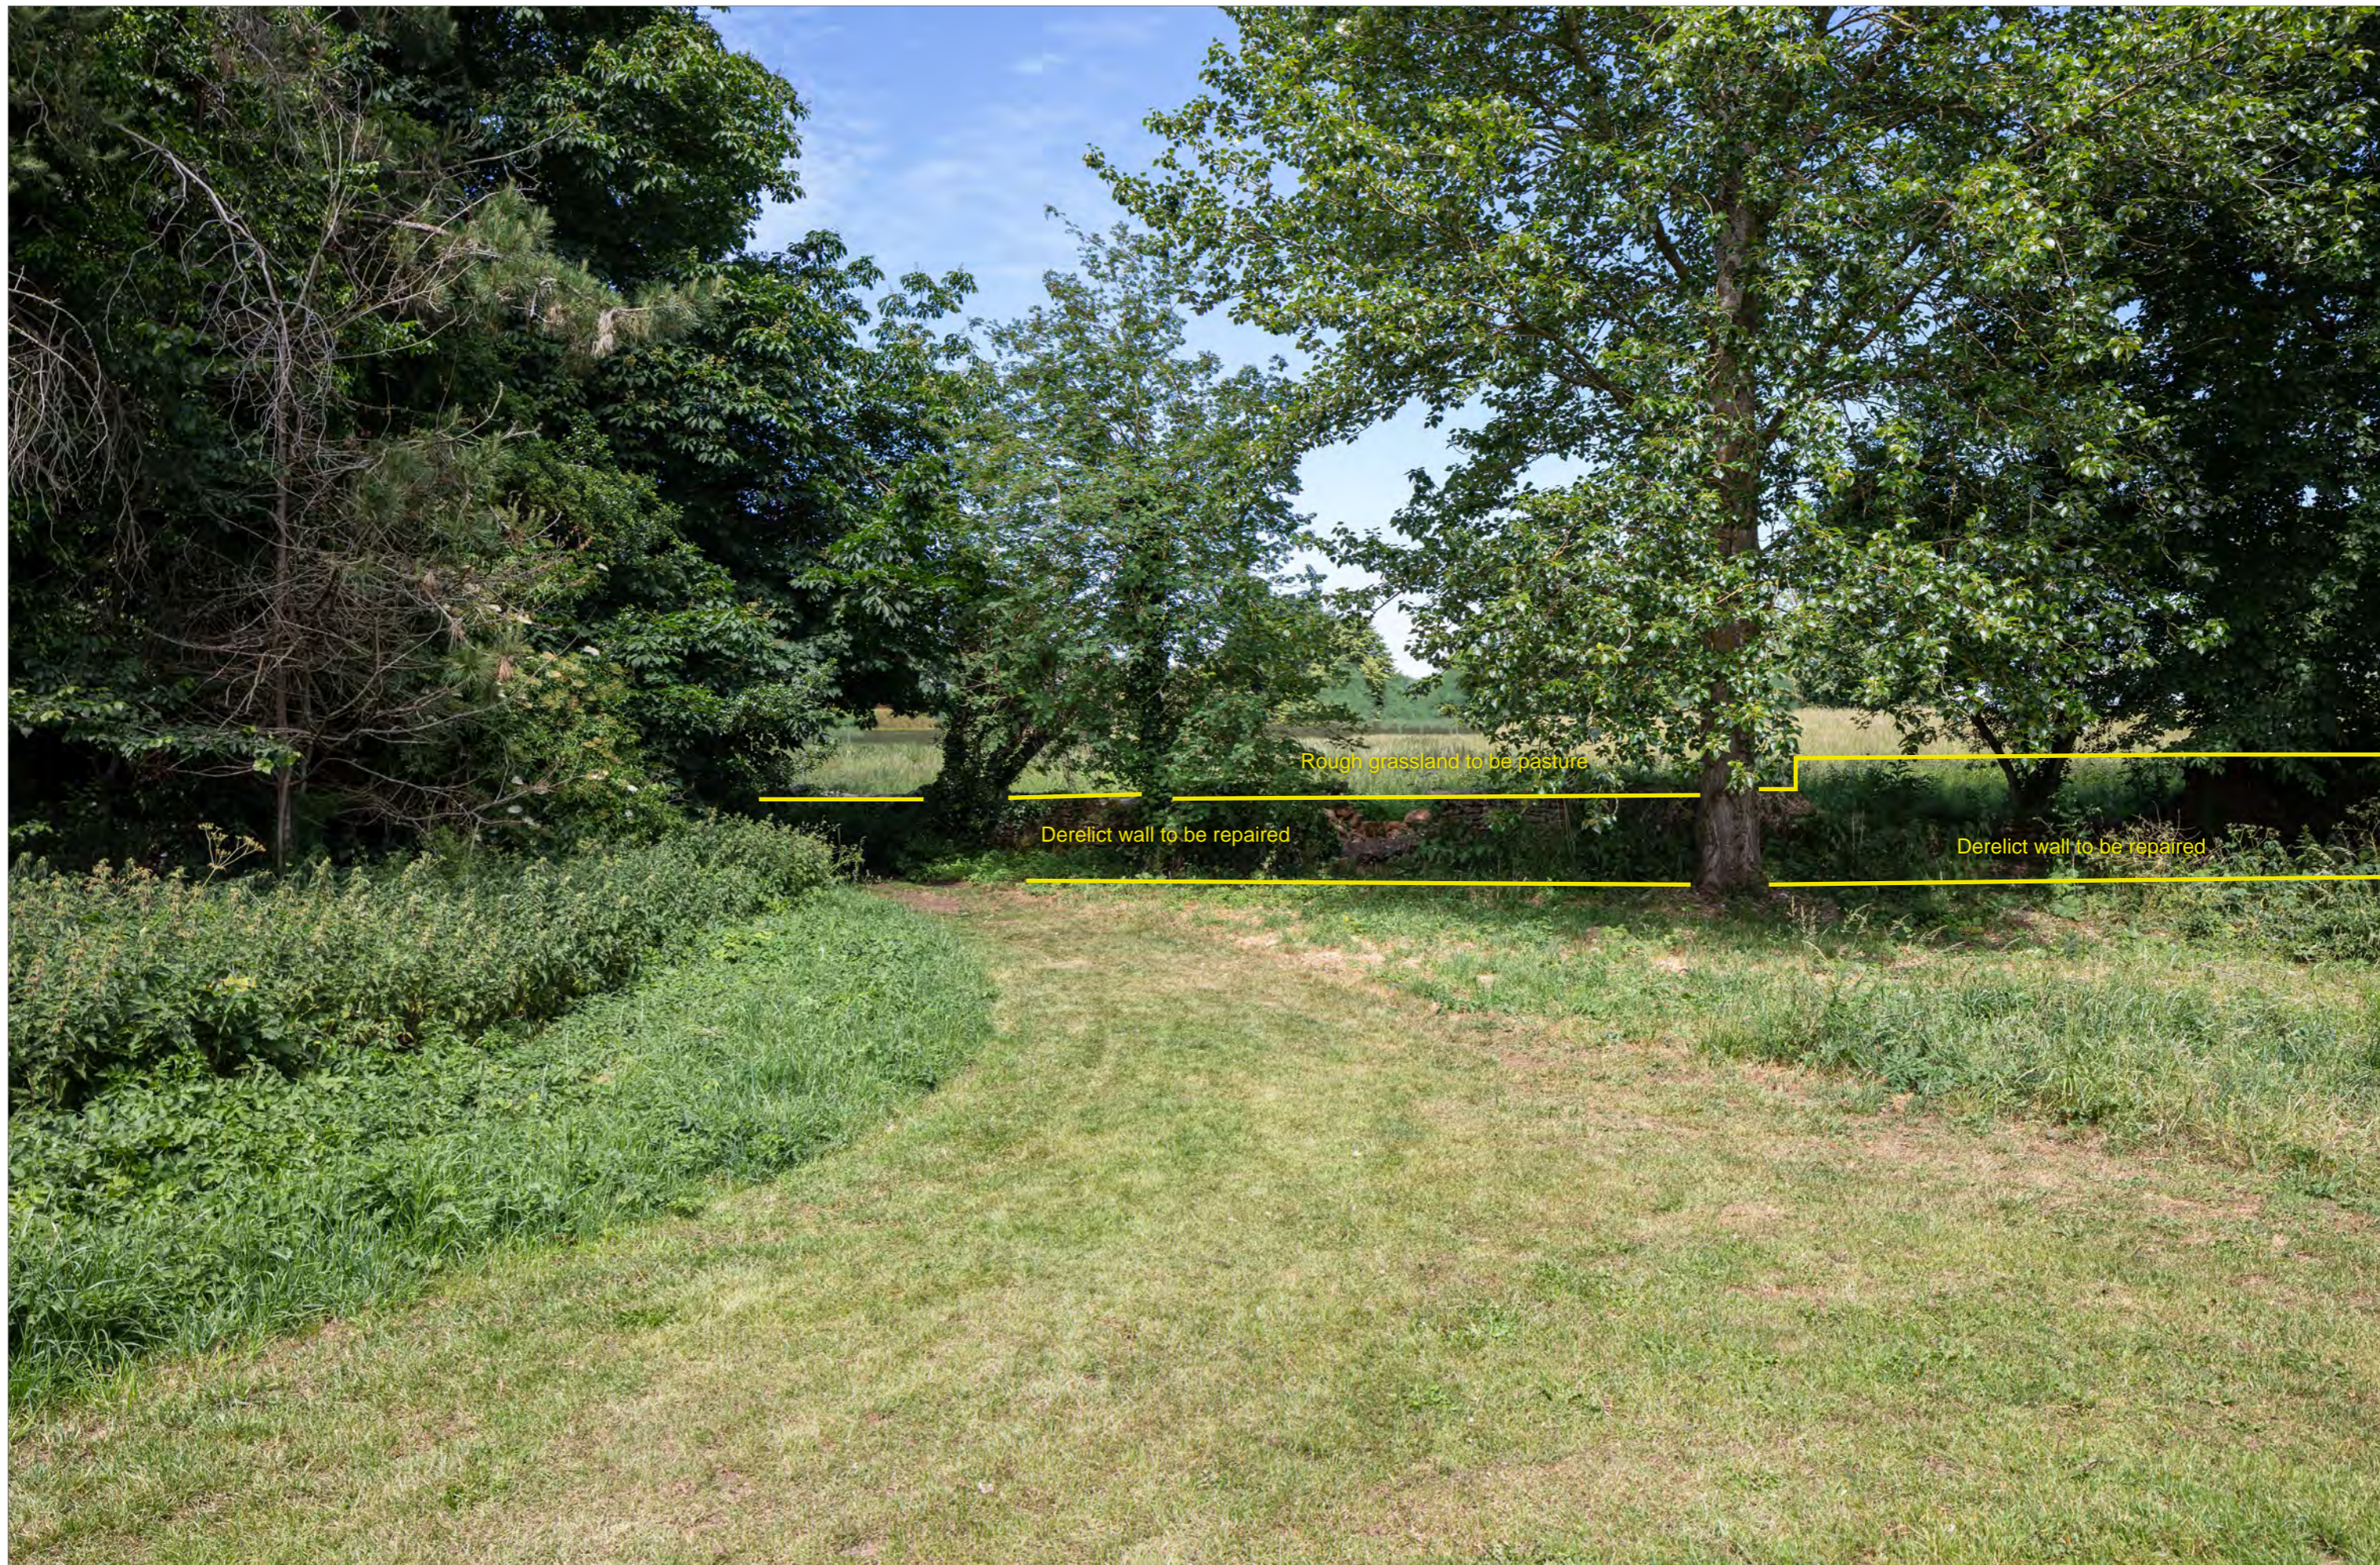
Rough grassland to be pasture

Derelict wall to be repaired
