Blue Cedar Homes Limited

# Castle Street, Deddington

Phase 1 Geo-environmental Site Assessment

DECEMBER 2018

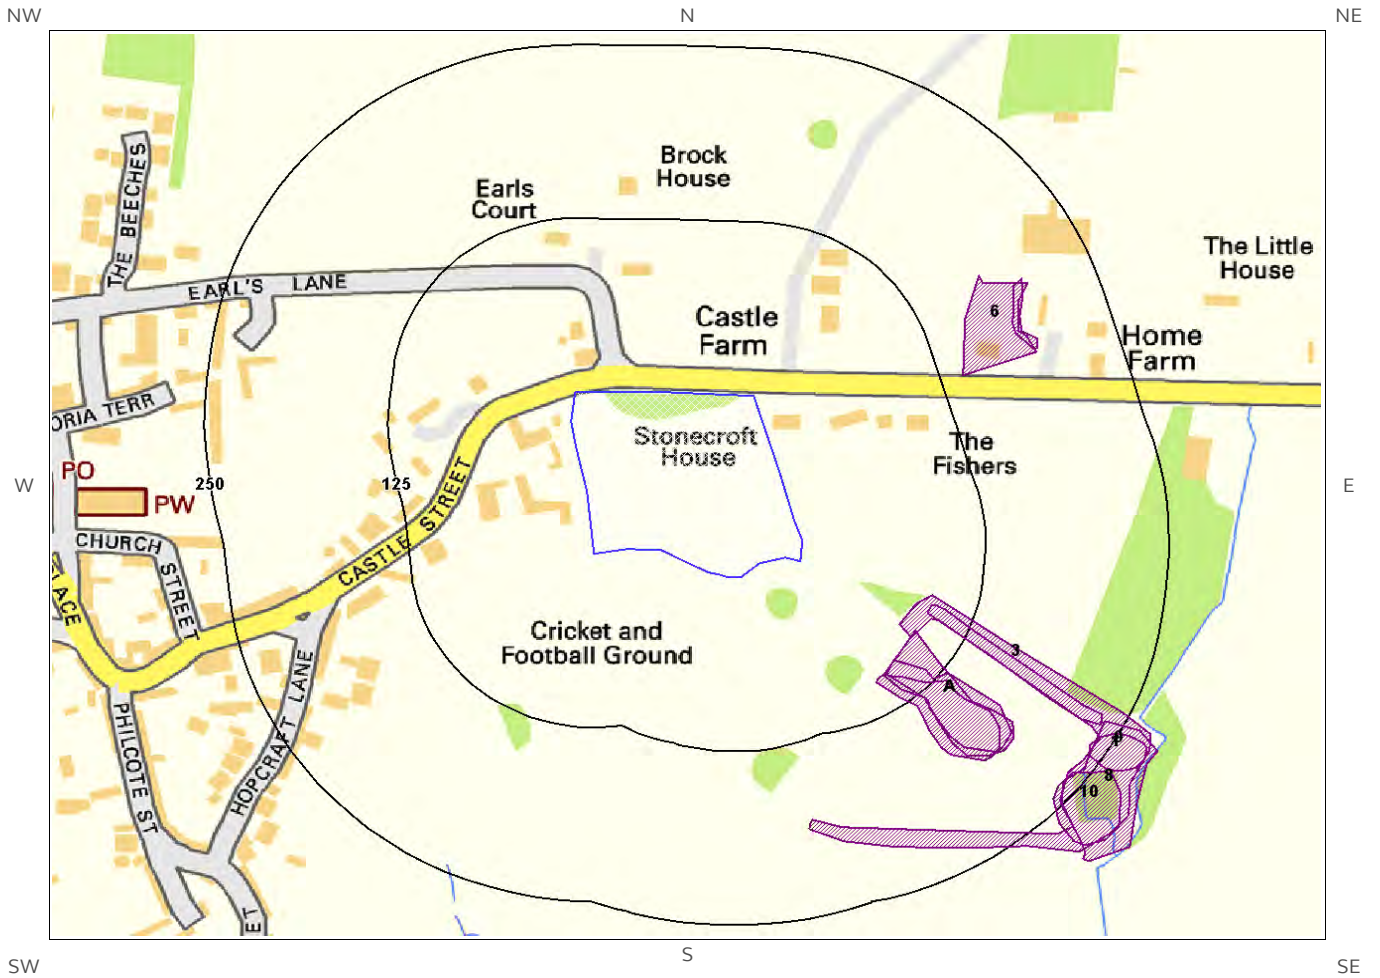
# 4 Ground Workings map

ID	Distance (m)	Direction	NGR	Commodity Produced	Pit Name	Type of working	Status
Not shown	663.0	NW	446658 232295	Ironstone	King's Spring	A surface mineral working. It may be termed Quarry, Sand Pit, Clay Pit or Opencast Coal Site	Ceased
Not shown	752.0	S	446835 230952	Sandstone	DEDDINGTON	A surface mineral working. It may be termed Quarry, Sand Pit, Clay Pit or Opencast Coal Site	Ceased
Not shown	761.0	S	446911 230920	Clay & Shale	Deddington	A surface mineral working. It may be termed Quarry, Sand Pit, Clay Pit or Opencast Coal Site	Ceased
