Clifton Road, Deddington, Banbury
Proposed Section 278 Works (Option 2)

Road Safety Audit Stage 1

on behalf of Blue Cedar Homes Ltd

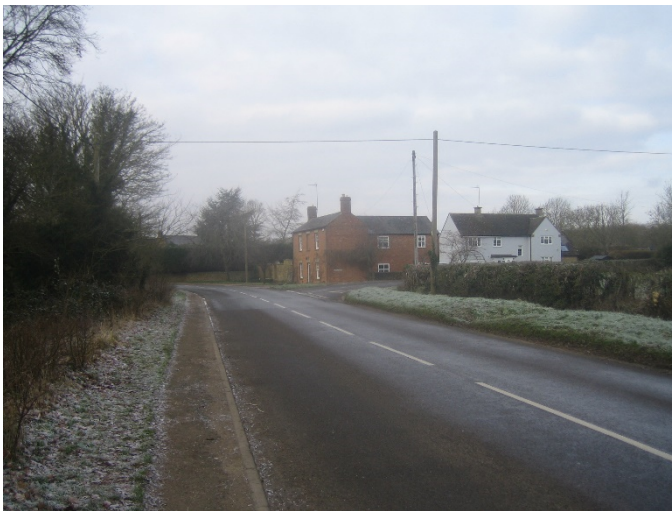
Location – Proposed new access junction

Summary: Potential pull-out type vehicle collisions

At the proposed new access junction, visibility to the left for drivers of vehicles emerging from the development could be restricted by vegetation in the verge. Restricted visibility could lead to a vehicle pulling out into the path of an oncoming eastbound vehicle.

RECOMMENDATION

Adequate visibility splays should be kept free of obstruction, including vegetation and, to ensure that visibility splays remain free of obstruction in the future, the Highway Boundary should be located behind visibility splays.

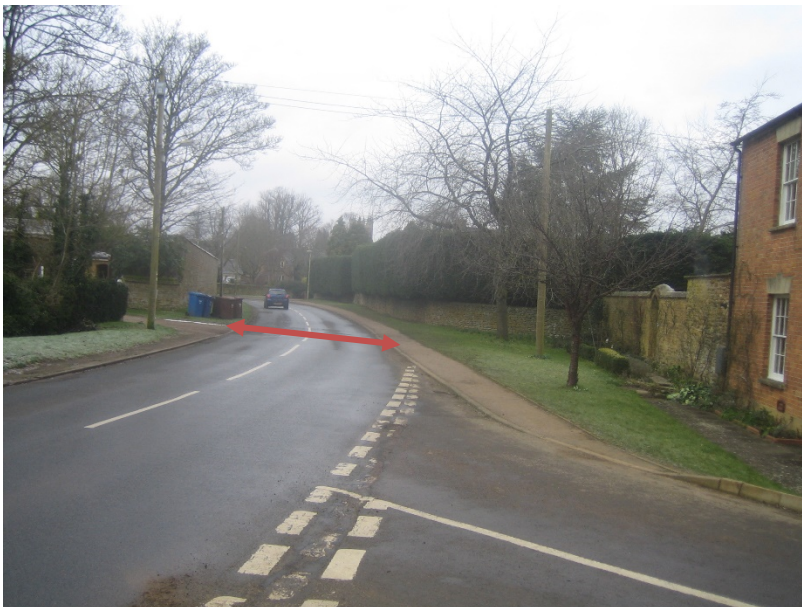
Location – Proposed new uncontrolled pedestrian crossing on Clifton Road

Summary: Potential hazard for pedestrians

The proposed uncontrolled crossing is located on a private driveway access on the south side of Clifton Road. Locating a pedestrian crossing on a private drive could result in conflict between crossing pedestrians and vehicles using the driveway, and lead to collisions between pedestrians and vehicles. This could be exacerbated by pedestrians being required to look for vehicles approaching from three different directions.

RECOMMENDATION

The proposed new crossing should be located further to the east away from the driveway, immediately to the west of the remodelled junction with Earls Lane.

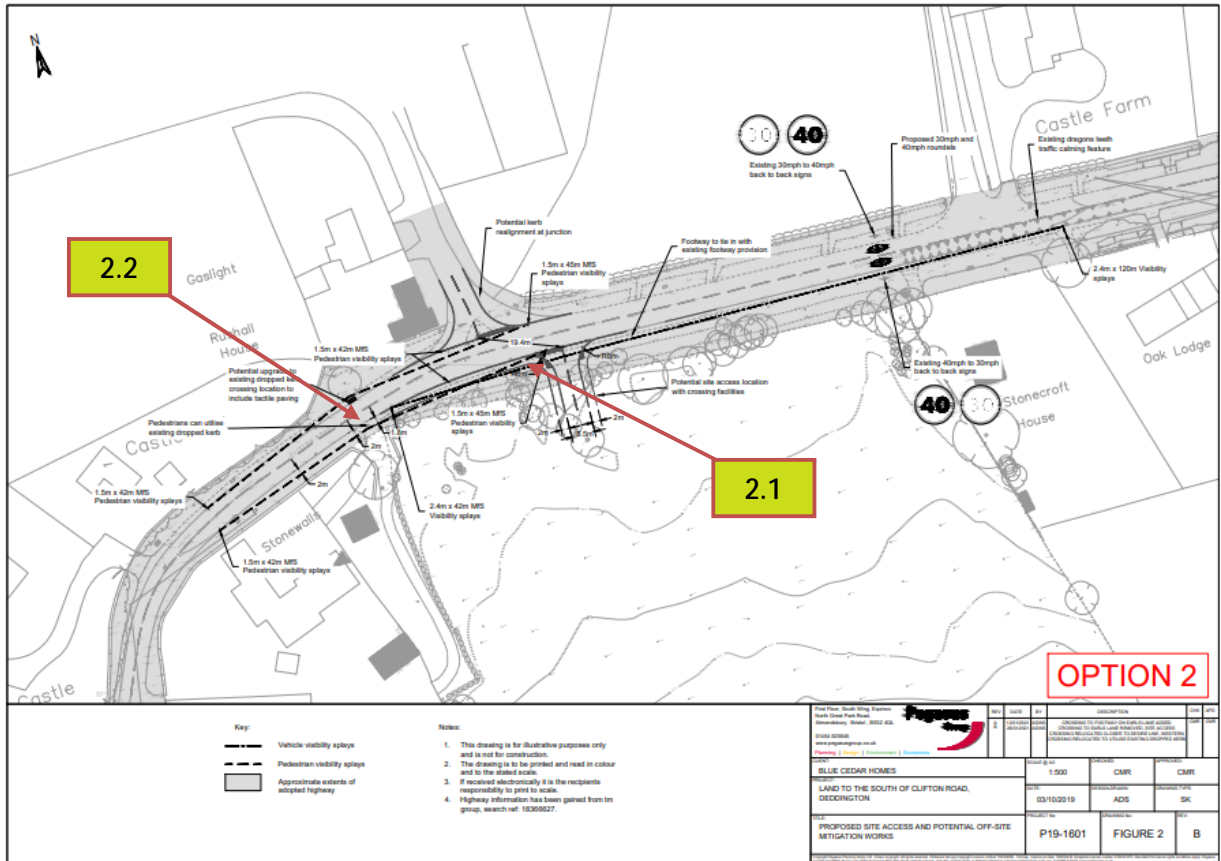
Location of Problems

- 1.5 All of the problems described in this report are considered by the audit team to require action in order to improve the safety of the scheme and minimise accident occurrence. Comments and recommendations are indicated on the plan in **Appendix B**.
