FEBRUARY 2021 | P19-1601

DESIGNERS REPONSE TO STAGE 1 ROAD SAFETY AUDITS

THE POPLARS, LAND SOUTH OF CLIFTON ROAD, DEDDINGTON

ON BEHALF OF BLUE CEDAR HOMES LIMITED

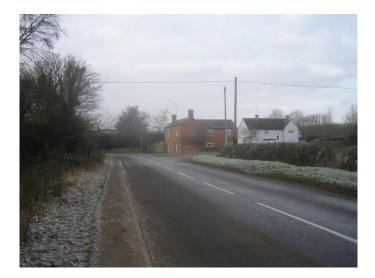
Location – Proposed new access junction

Summary: Potential pull-out type vehicle collisions

At the proposed new access junction, visibility to the left for drivers of vehicles emerging from the development could be restricted by vegetation in the verge. Restricted visibility could lead to a vehicle pulling out into the path of an oncoming eastbound vehicle.

Adequate visibility splays should be kept free of obstruction, including vegetation and, to ensure that visibility splays remain free of obstruction in the future, the Highway Boundary should be located behind visibility splays.

Noted. Junction visibility splays are in excess of what is typically sought for the locally measured speeds (dimensions as shown on the drawings) and the fact that they are in publicly maintainable highway land means that they will be able to remain free of obstruction.

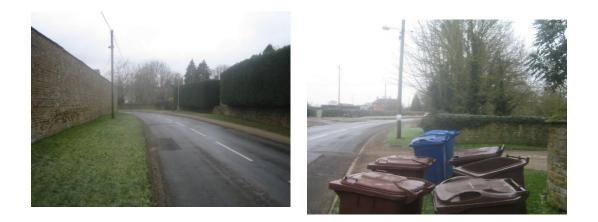
Location - Proposed new uncontrolled pedestrian crossing on Clifton Road

Summary: Potential hazard for pedestrians

The proposed uncontrolled crossing is located quite close to a bend in the road, and intervisibility between vehicle drivers and pedestrians on the south side of the crossing could be restricted by a high wall. For pedestrians crossing from the south side, visibility to their right could also be restricted by a boundary wall. These potential visibility restrictions could lead to pedestrians stepping out into the path of oncoming vehicles on Clifton Road.

The proposed new crossing should be located further to the east, immediately to the west of the remodelled junction with Earls Lane.

Noted. The design has been updated to incorporate this recommendation. P19-1601_001_SK Figure 2 Rev C shows the relocated crossing position with suitable pedestrian visibility splays in excess of what is required for the locally measured speeds (dimensions as shown on the drawing) and is included at **Appendix D**.

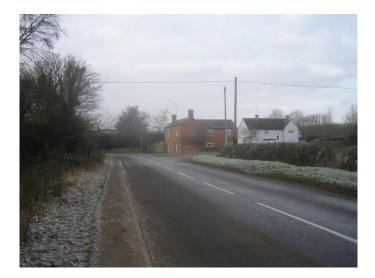
Location – Proposed new access junction

Summary: Potential pull-out type vehicle collisions

At the proposed new access junction, visibility to the left for drivers of vehicles emerging from the development could be restricted by vegetation in the verge. Restricted visibility could lead to a vehicle pulling out into the path of an oncoming eastbound vehicle.

Adequate visibility splays should be kept free of obstruction, including vegetation and, to ensure that visibility splays remain free of obstruction in the future, the Highway Boundary should be located behind visibility splays.

Noted. Junction visibility splays are in excess of what is typically sought for the locally measured speeds (dimensions as shown on the drawings) and the fact that they are in publicly maintainable highway land means that they will be able to remain free of obstruction.

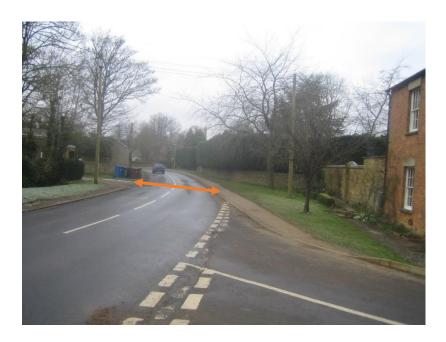
Location - Proposed new uncontrolled pedestrian crossing on Clifton Road

Summary: Potential hazard for pedestrians

The proposed uncontrolled crossing is located on a private driveway access on the south side of Clifton Road. Locating a pedestrian crossing on a private drive could result in conflict between crossing pedestrians and vehicles using the driveway, and lead to collisions between pedestrians and vehicles. This could be exacerbated by pedestrians being required to look for vehicles approaching from three different directions.

The proposed new crossing should be located further to the east away from the driveway, immediately to the west of the remodelled junction with Earls Lane.

Noted. The design has been updated to incorporate this recommendation. P19-1601_001_SK Figure 2 Rev C shows the relocated crossing position with suitable pedestrian visibility splays in excess of what is required for the locally measured speeds (dimensions as shown on the drawing) and is included at **Appendix D**.

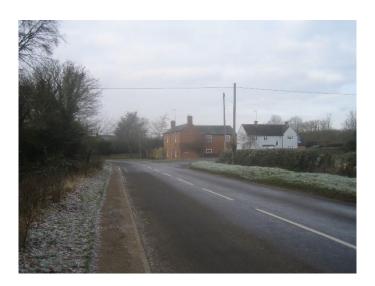
Location - Proposed new access junction

Summary: Potential pull-out type vehicle collisions

At the proposed new access junction, visibility to the left for drivers of vehicles emerging from the development could be restricted by vegetation in the verge. Restricted visibility could lead to a vehicle pulling out into the path of an oncoming eastbound vehicle.

Adequate visibility splays should be kept free of obstruction, including vegetation and, to ensure that visibility splays remain free of obstruction in the future, the Highway Boundary should be located behind visibility splays.

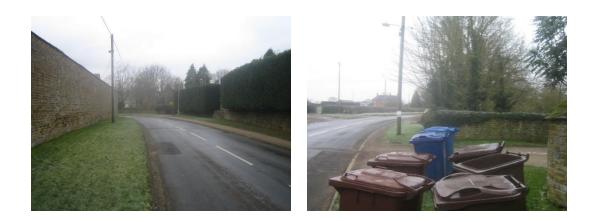
Location - Proposed new uncontrolled pedestrian crossing on Clifton Road

Summary: Potential hazard for pedestrians

The proposed uncontrolled crossing is located quite close to a bend in the road, and intervisibility between vehicle drivers and pedestrians on the south side of the crossing could be restricted by a high wall. For pedestrians crossing from the south side, visibility to their right could also be restricted by a boundary wall. These potential visibility restrictions could lead to pedestrians stepping out into the path of oncoming vehicles on Clifton Road.

The proposed new crossing should be located further to the east, immediately to the west of the remodelled junction with Earls Lane.

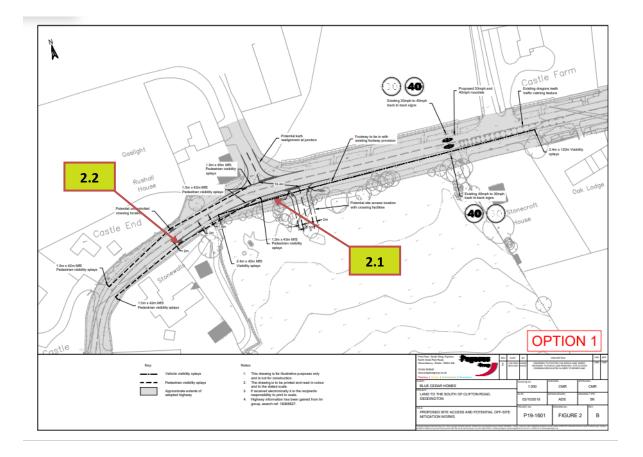
Location of Problems

- 1.5 All of the problems described in this report are considered by the audit team to require action in order to improve the safety of the scheme and minimise accident occurrence. Comments and recommendations are indicated on the plan in **Appendix B**.

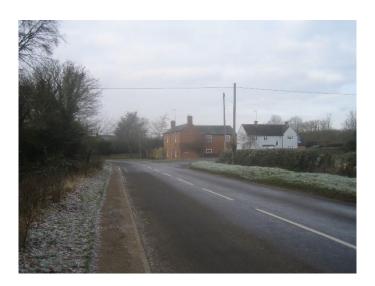
Location - Proposed new access junction

Summary: Potential pull-out type vehicle collisions

At the proposed new access junction, visibility to the left for drivers of vehicles emerging from the development could be restricted by vegetation in the verge. Restricted visibility could lead to a vehicle pulling out into the path of an oncoming eastbound vehicle.

Adequate visibility splays should be kept free of obstruction, including vegetation and, to ensure that visibility splays remain free of obstruction in the future, the Highway Boundary should be located behind visibility splays.

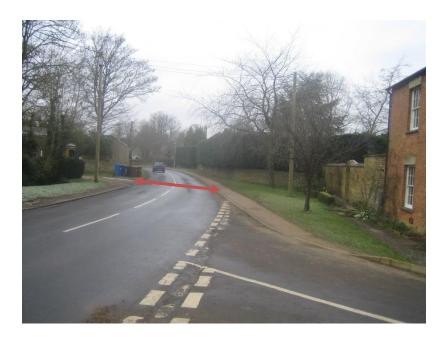
Location - Proposed new uncontrolled pedestrian crossing on Clifton Road

Summary: Potential hazard for pedestrians

The proposed uncontrolled crossing is located on a private driveway access on the south side of Clifton Road. Locating a pedestrian crossing on a private drive could result in conflict between crossing pedestrians and vehicles using the driveway, and lead to collisions between pedestrians and vehicles. This could be exacerbated by pedestrians being required to look for vehicles approaching from three different directions.

The proposed new crossing should be located further to the east away from the driveway, immediately to the west of the remodelled junction with Earls Lane.

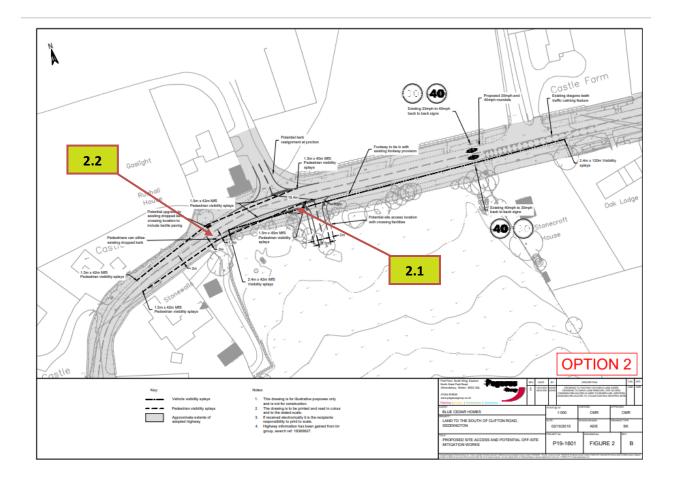
APPENDIX B

- 1.5 All of the problems described in this report are considered by the audit team to require action in order to improve the safety of the scheme and minimise accident occurrence. Comments and recommendations are indicated on the plan in **Appendix B**.
