Banbury MX and Motocross Scrambling Site, Wroxton OX15 6EU

EXPERT WITNESS STATEMENT OF CHRISTINE DIANE COX BA MA MCIFA FSA

Evidence from dated aerial photographs, satellite imagery and visualised Lidar data regarding the extent and configuration of the facility

Planning Reference 20/02126/CLUE

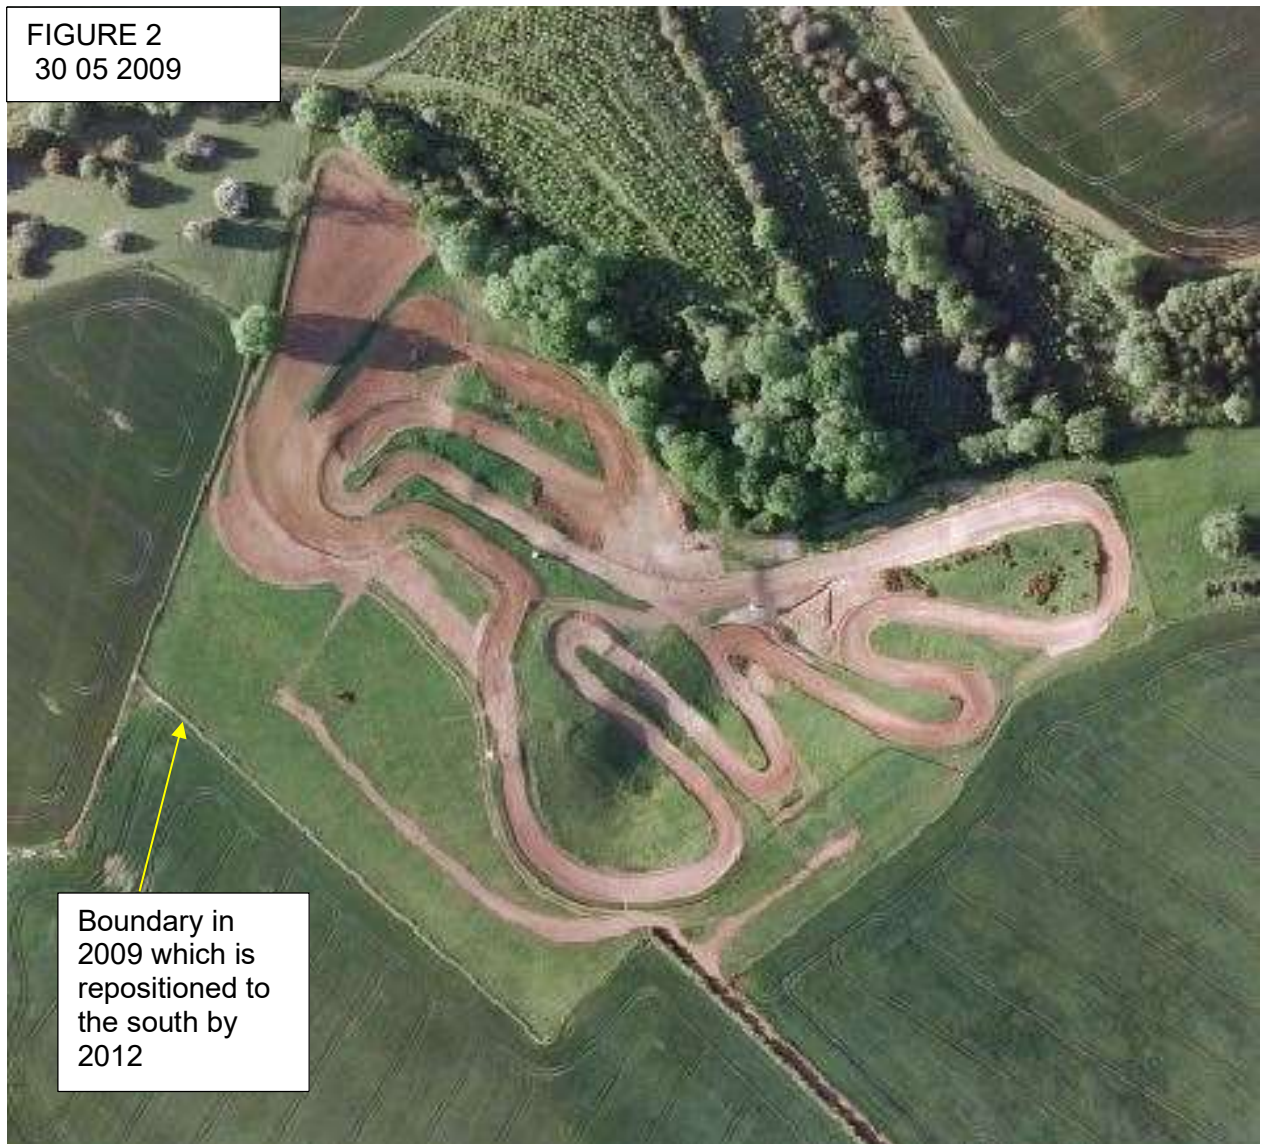
5.4 **Figure 2: Baseline 30 05 2009**

- 5.5 This image shows the track in 2009. There is a further image available, which I have examined, captured by Getmapping plc, who date their survey to between 2009 and 2013, which appears at Google Earth on a 2009 date. It shows the same configuration as this image which was supplied and firmly dated by Blueky Mapshop. I have used this image as a baseline for this assessment because it is firmly dated and georeferenced by the supplier.

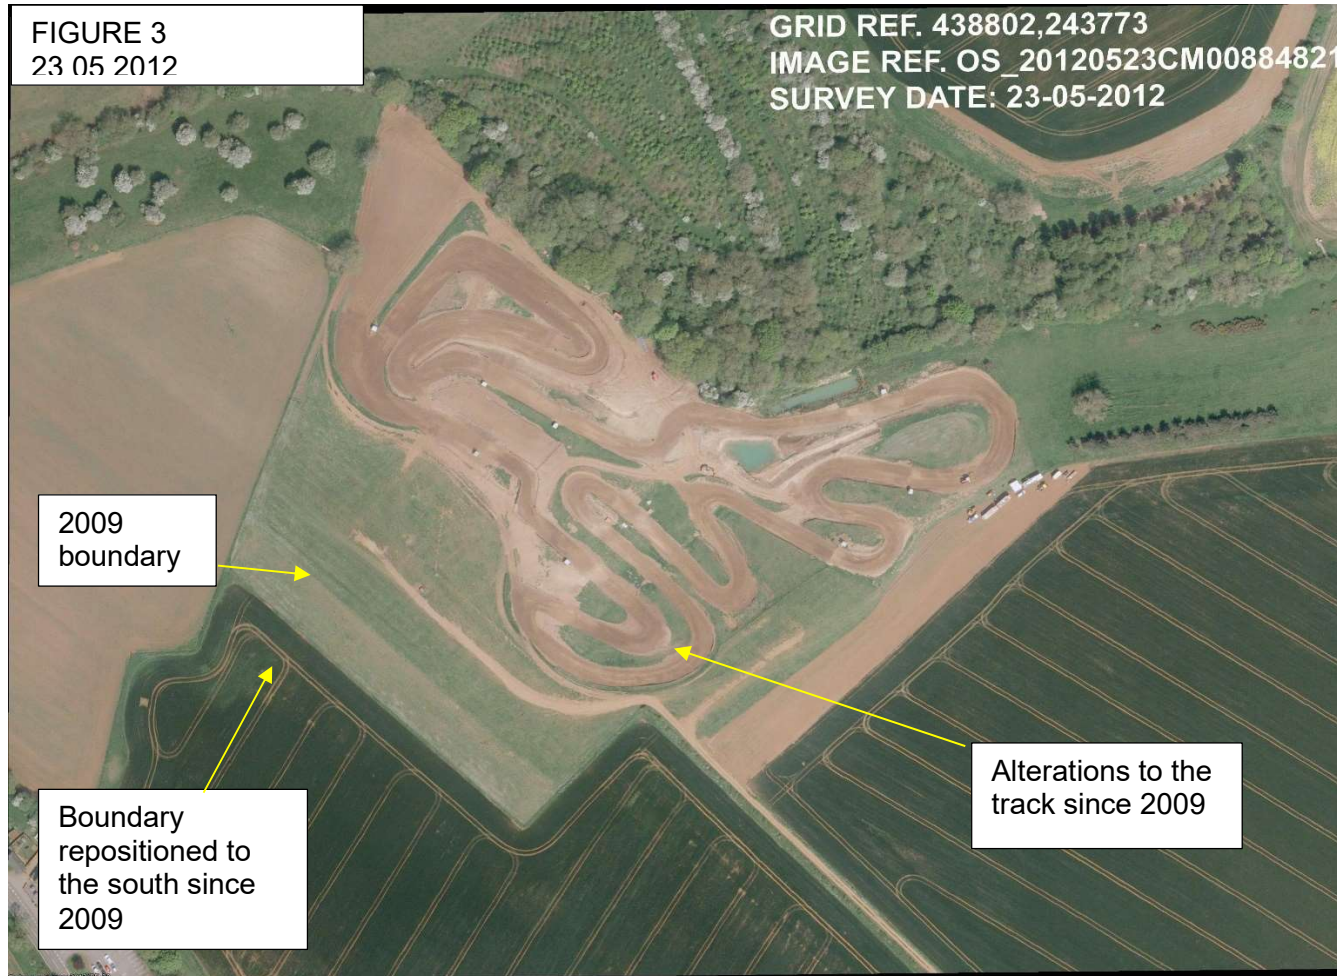
5.6 **Figure 3: 23 05 2012**

5.7 This image is clear, but is not georeferenced by the supplier therefore I consider the 2009 and 2014 images to provide more reliable geolocation information for comparison of the track configuration on the ground. It shows that the southern boundary has been repositioned since 2009 and some substantial alterations have been made to the south eastern part of the track.

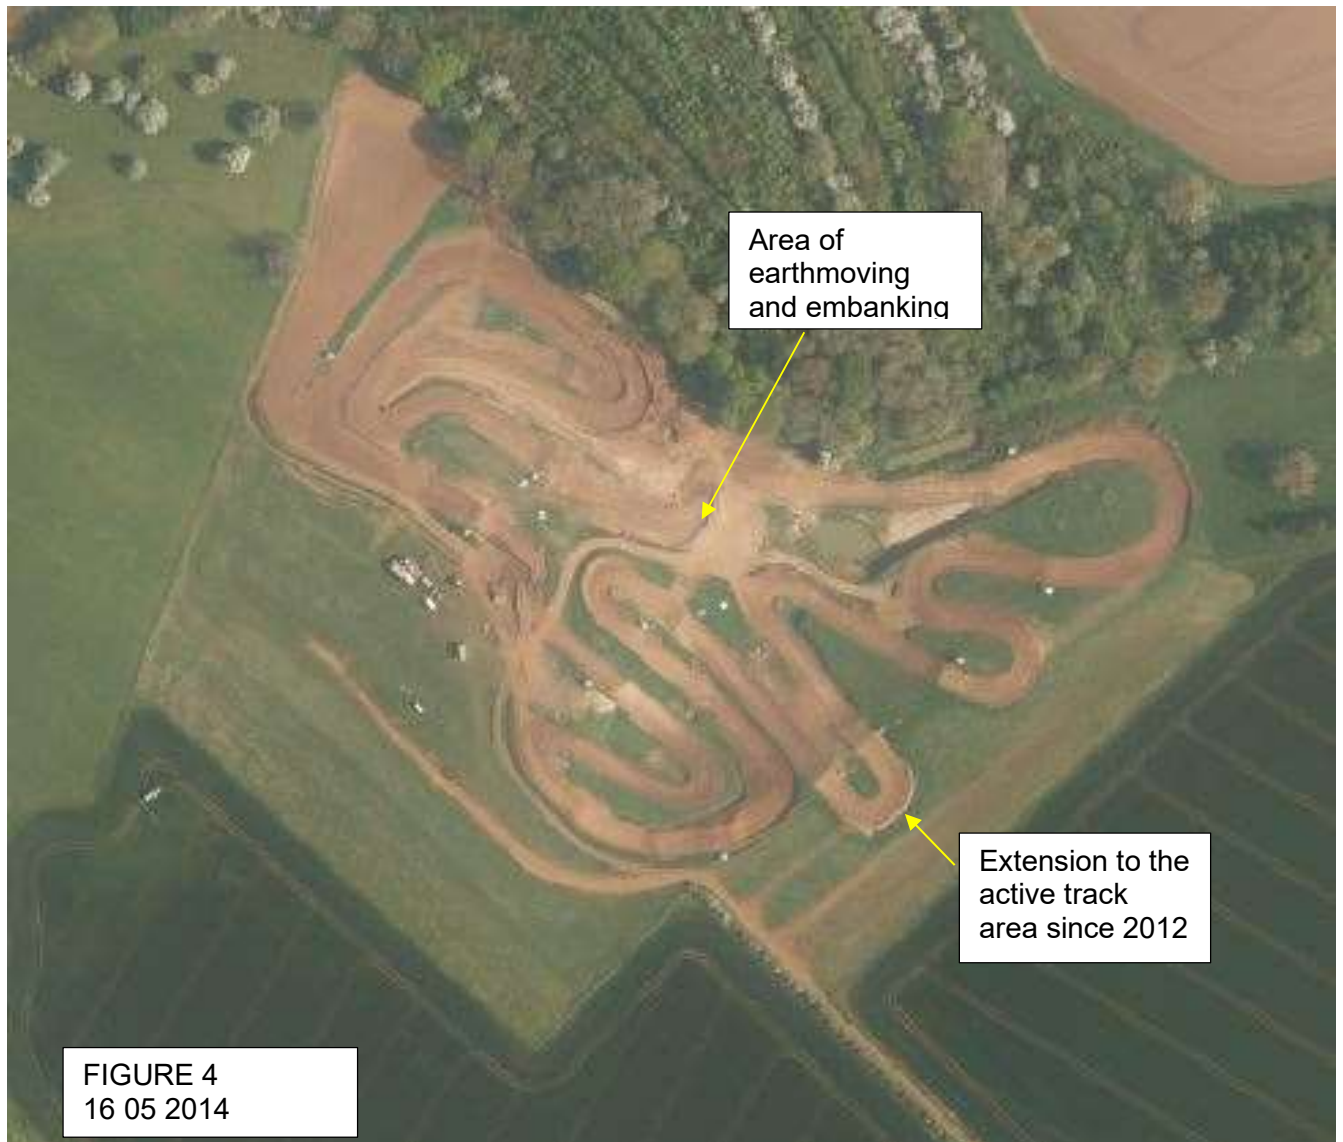
5.8 **Figure 4: 16 05 2014**

- 5.9 Works are ongoing in 2014 and an area of earthmoving and embanking is indicated. The shadows are soft and diffused, and the image does not allow for an accurate assessment of any topographic features.

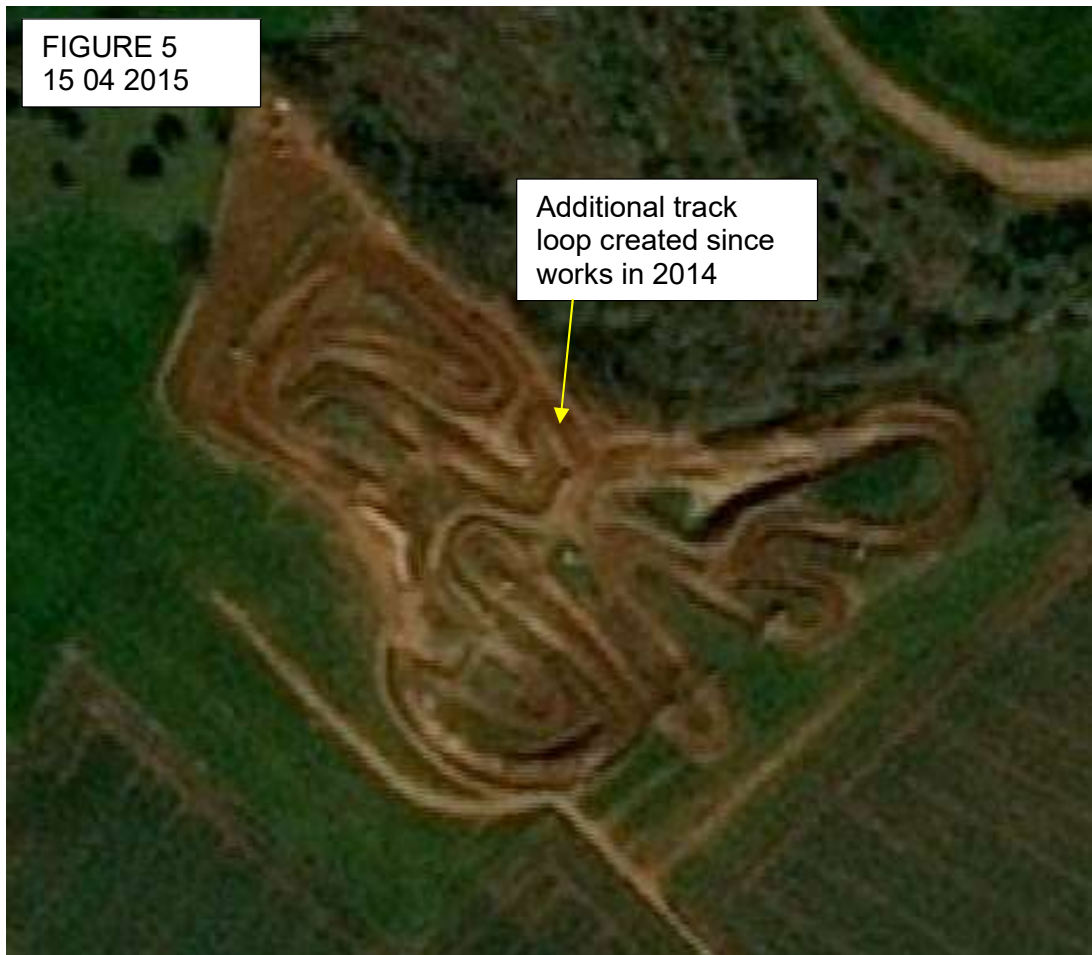
5.10 **Figure 5: 15 04 2015**

- 5.11 This satellite image lies towards the edge of the captured area and the resolution is not optimal. It does however show that the works which were ongoing in 2014 have completed a further loop to the track by 2015 which is indicated below.

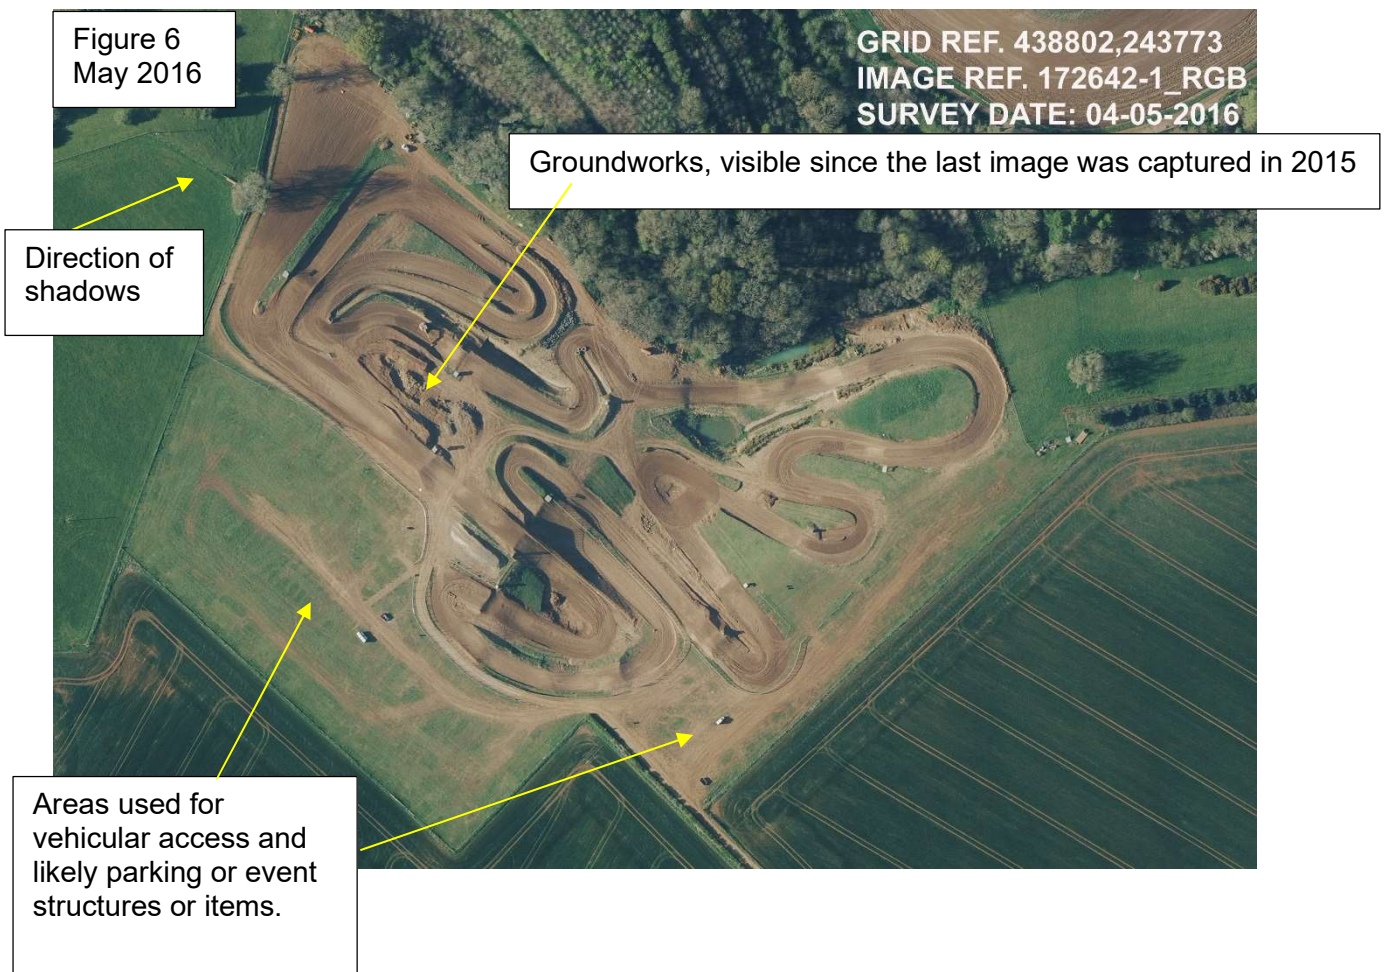
5.12 **Figure 6: 04 05 2016**

5.13 This image shows the site clearly, and indicates that there are some works ongoing in the site centre, since 2015, and that the periphery of the site indicates that there has been increased access and a recent event/meeting which has caused marks in the grass to the south of the track area. The long shadows indicate the presence of sharply edged, likely recently constructed platforms and some likely jumping ramps.

5.14 Works are ongoing in May 2016 to extend and landscape the track and associated features and areas.

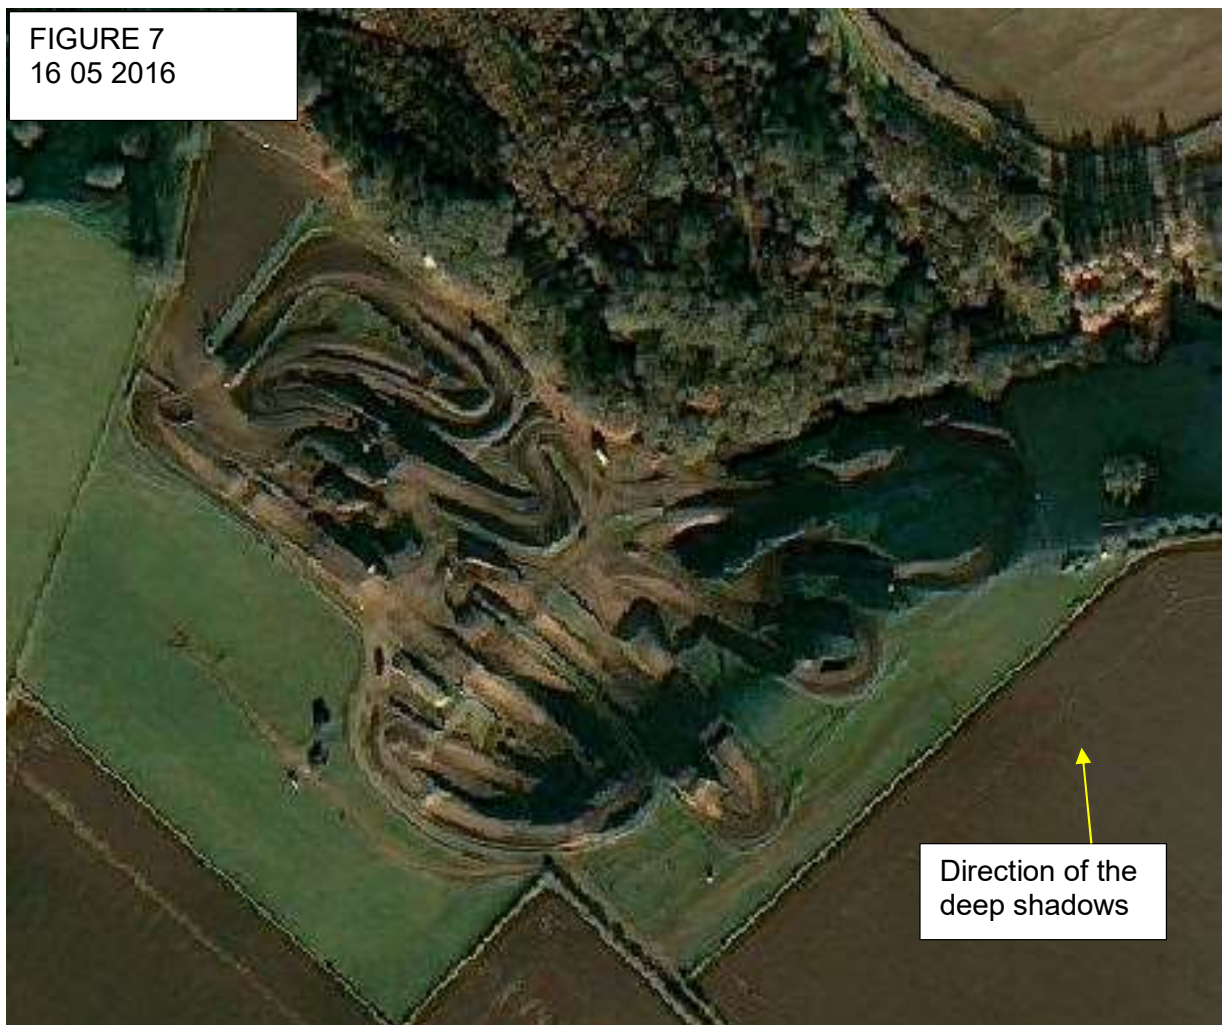
5.16 **Figure 7: 05 12 2016**

5.17 This satellite image was captured in winter, is of high contrast and the light is low angled, creating very deep shadows. This low light angle emphasises the topographic features – the jumps, banks and hollows, which are present on the site by 2016, *via* the shadows which they cast on this occasion. Unfortunately there is no stereo pair to this image and no way to derive accurate topographic modelling from it. However, it is an excellent visual illustration of the site topography in December 2016 which was photographed under active modelling in May 2016. The layout remains the same as in February 2015, with an ongoing visible development to this layout since 2012.

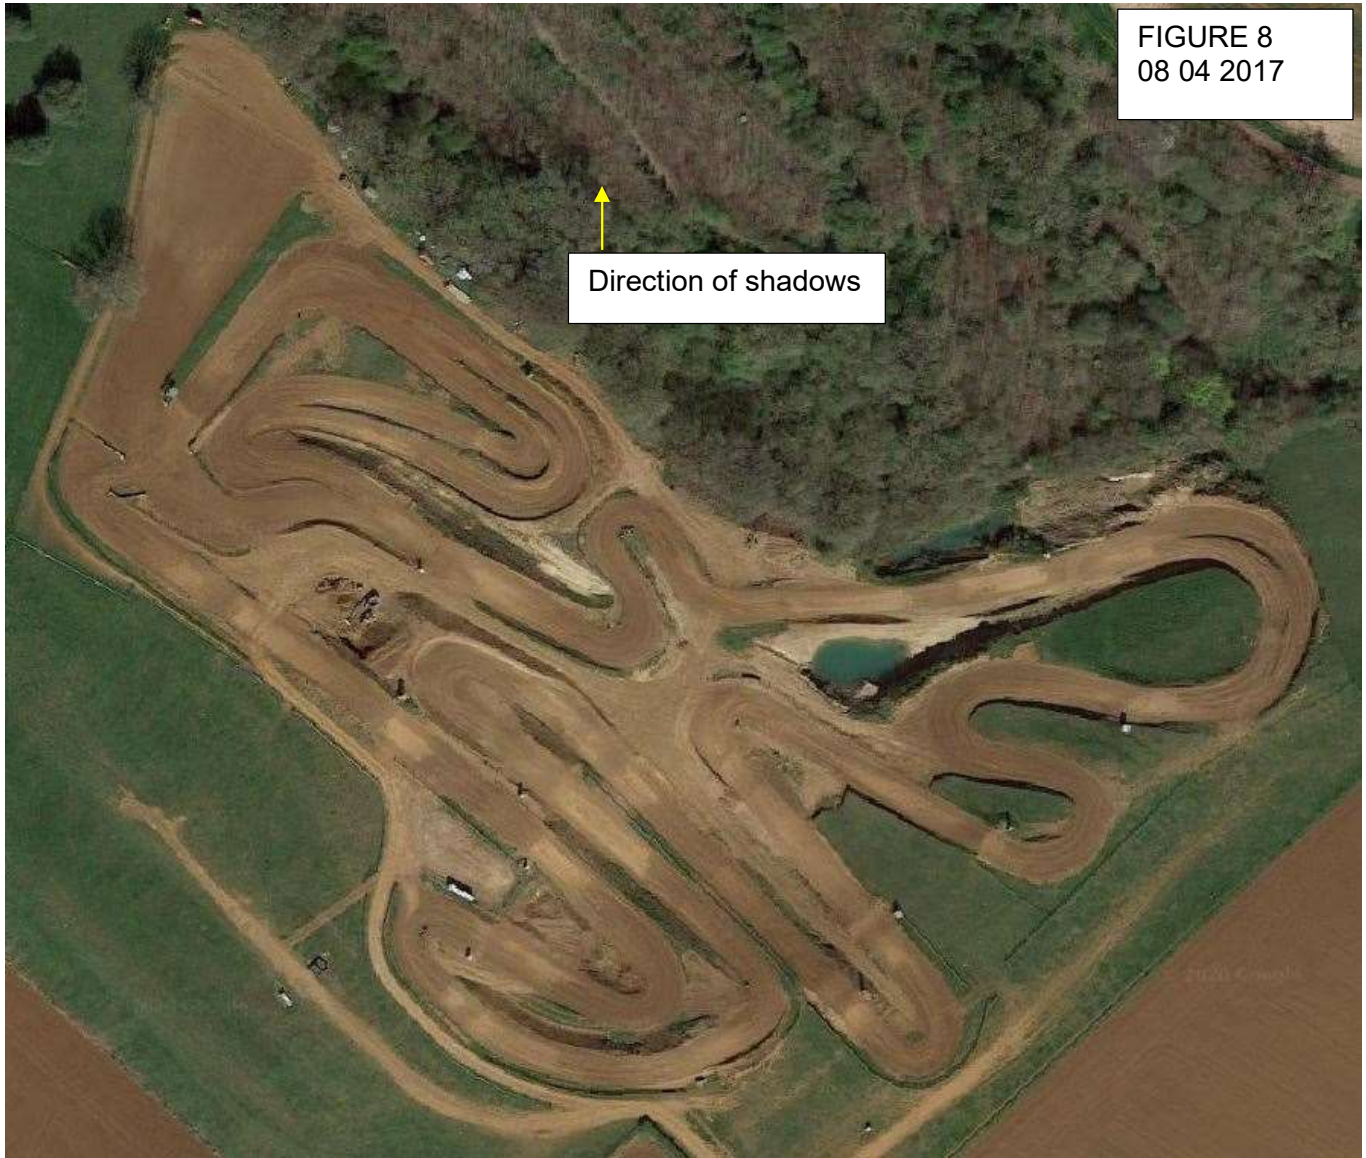
5.18 **Figure 8: 08 04 2017**

5.19 This image is very clear and shows the same topographic and configuration features, in different lighting conditions, as were present in 2015 and 2016. The track is not deeply shadowed, despite there being shadows cast by trees and fences, and the earthworks not so prominently visible as in 2016.

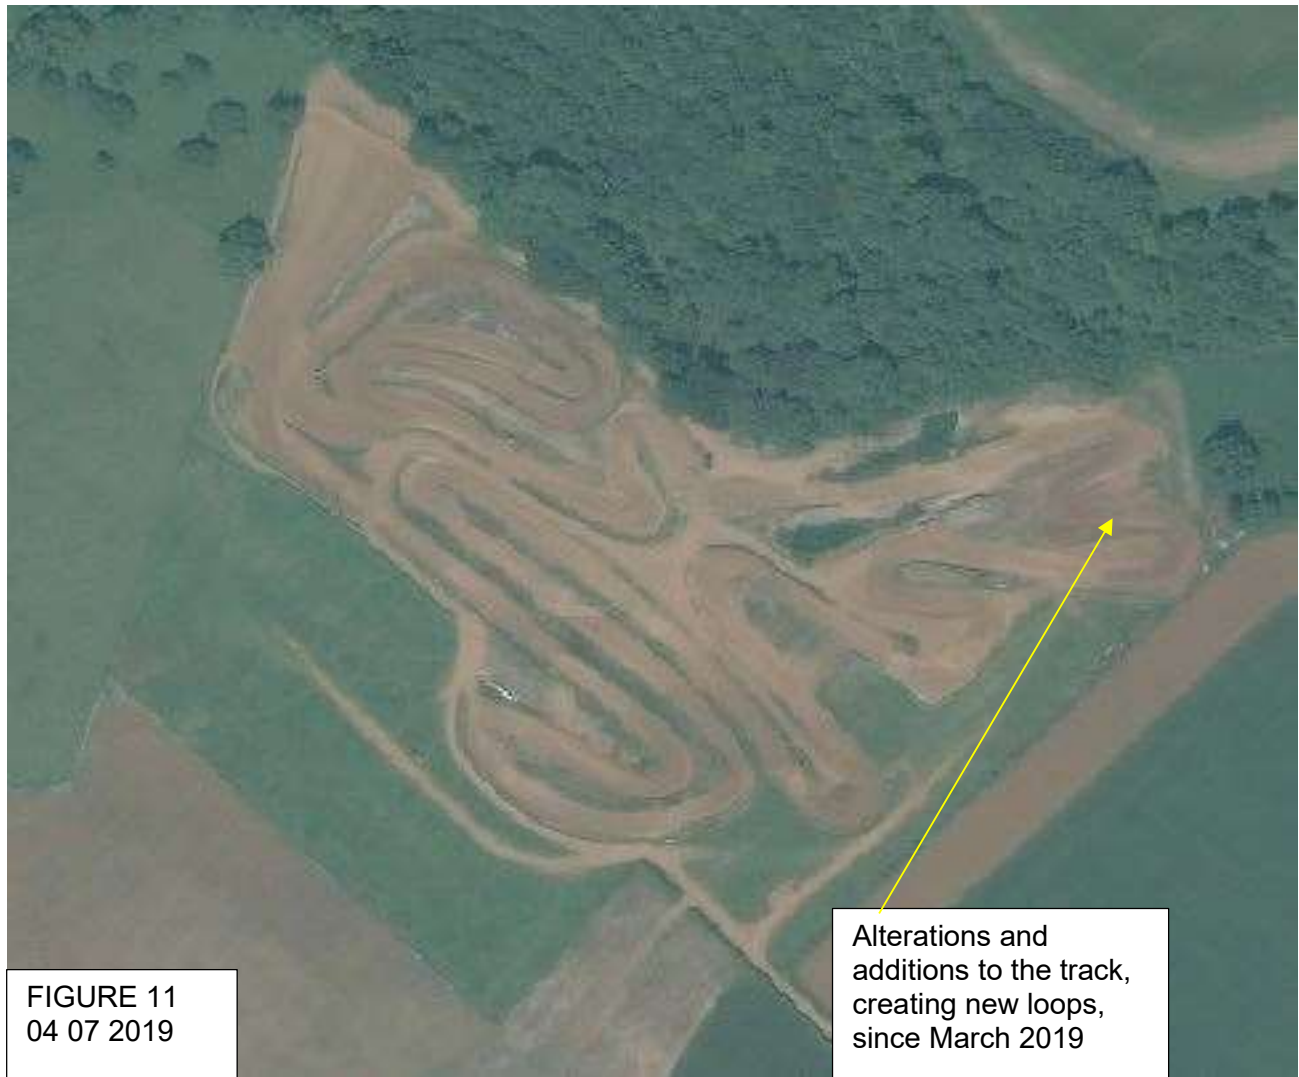
5.29 **Figure 11: 04 07 2019**

5.30 **This satellite image taken in rather flat lighting conditions in July 2019 shows two new loops under construction as an alteration from a single loop present in March 2019. Figure 11a shows a blended image with July 2019 at 80% transparency over the visualised Lidar DTM, which indicates the area of alteration between March and July.**

Alterations and additions to the track, creating new loops, since March 2019

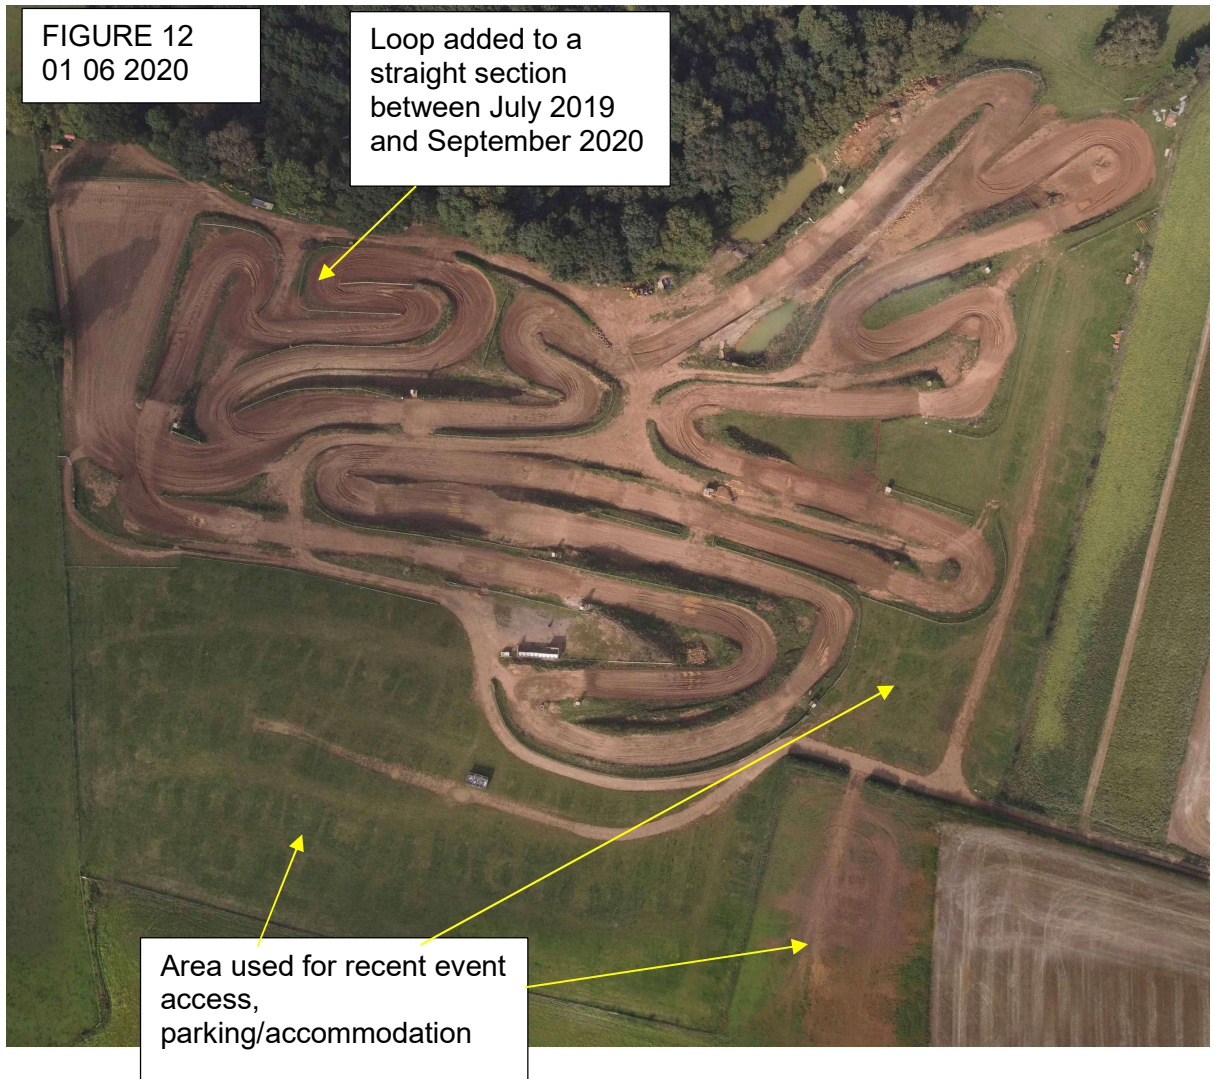
5.33 **Figure 12: 01 09 2020 date**

5.34 this image was captured *via* a drone survey in September 2020. It shows the configuration of the track at that date following works between March and July 2019. An alteration had taken place since July 2019, with the creation of a further loop in the north west sector of the site. The light toned marks on the grass to the south and south east of the site indicate the recent presence of parking or other facilities for a likely event, which lasted long enough to affect the growth of the grass in areas which were covered by structures, items or vehicles.

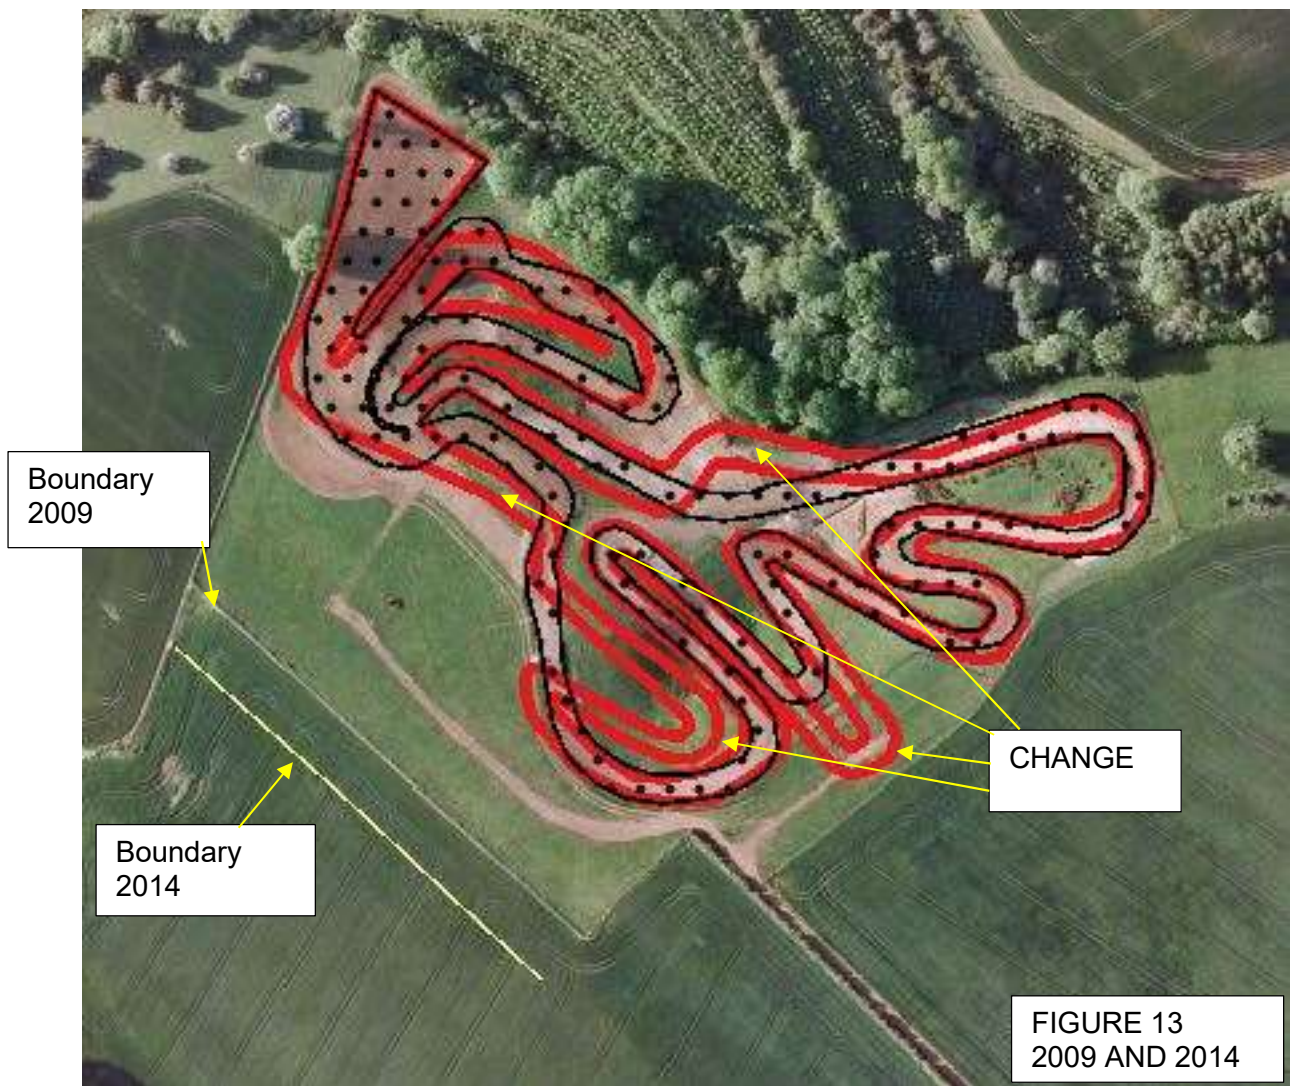
5.35 Figure 13: The track in 2009 and 2014

5.36 This figure shows the extent of the track in 2009 and 2014. It was created by digitising the extent of the track and the north western entrance way at both dates. The difference in the position of the southern boundary in 2009 and 2014 is also indicated.

5.37 The track at both dates is shown against the 2009 image to indicate changes in 2014, which are the addition of loops to the track as indicated and the moving of the southern boundary which took place between 2009 and 2012.

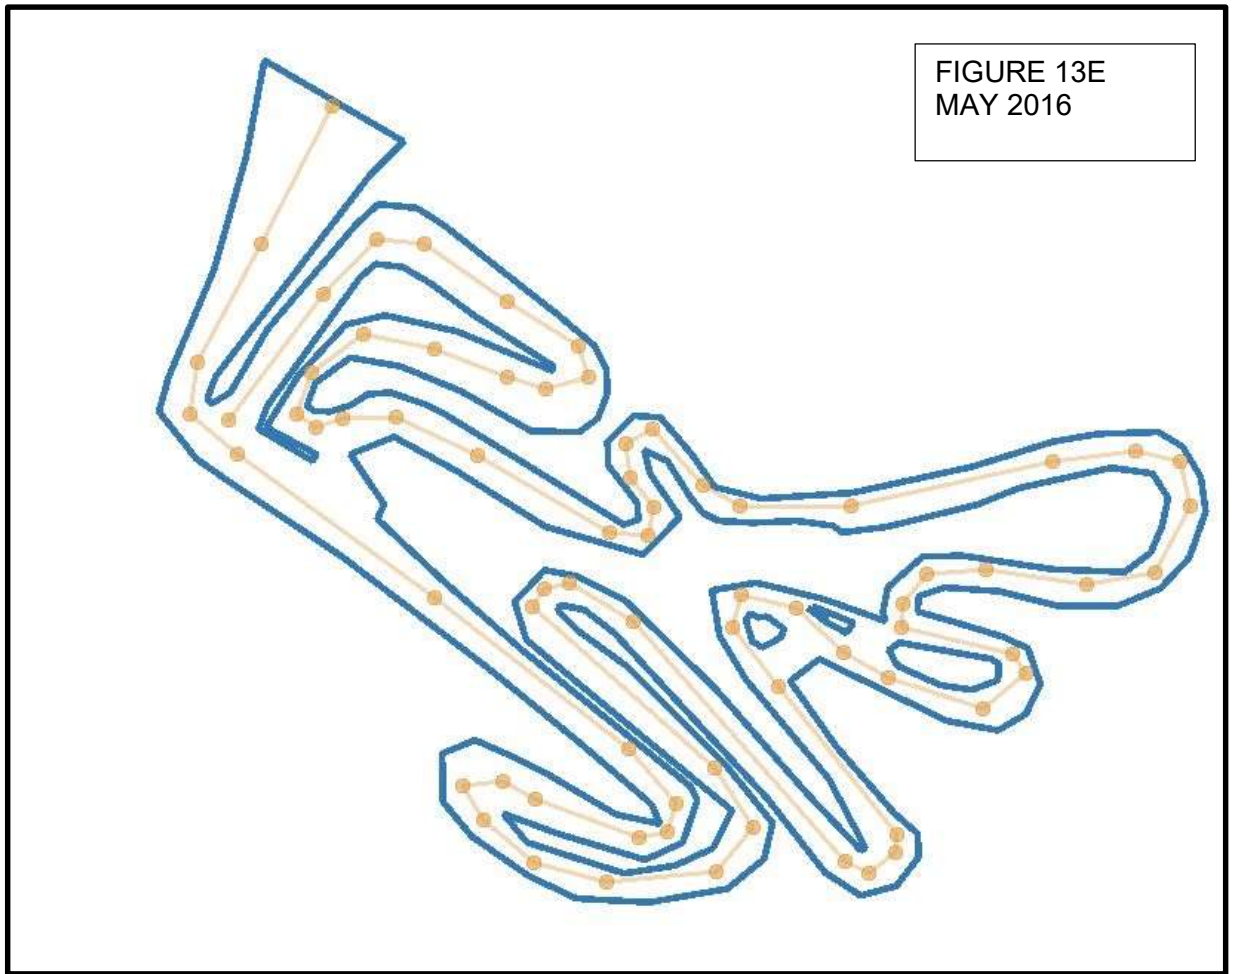
5.43 **Figure 13E May 2016**

5.45 The above figures demonstrate considerable change in the track layout between 2014 and 2019, and ongoing relandscaping works in May 2016.

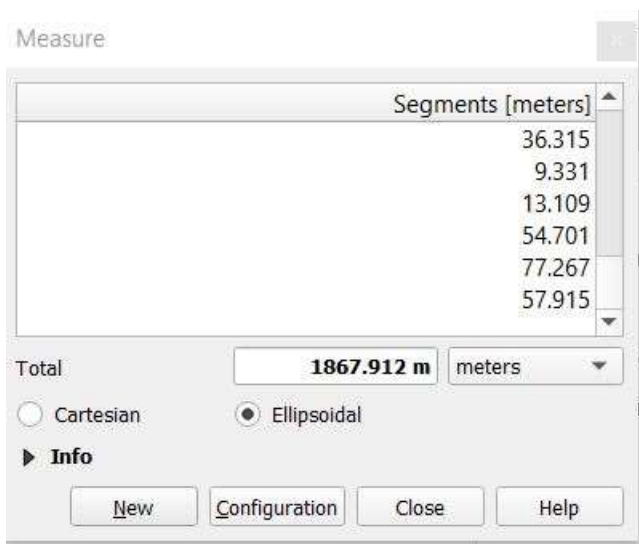
5.49 **Figure 14B 2019 length result.** There is a small length of track unmeasured in this diagram which adds approximately 34m to this measurement if it is to be counted as 'track'.

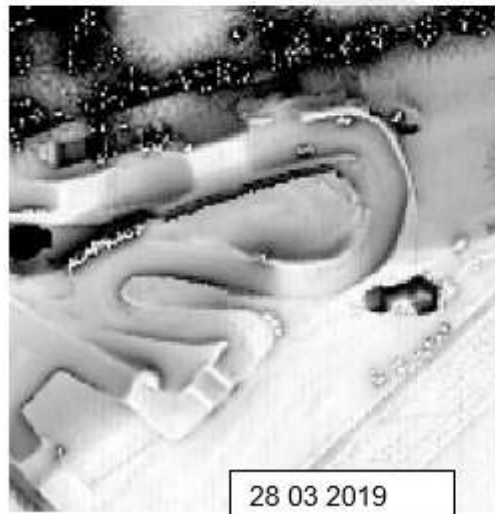
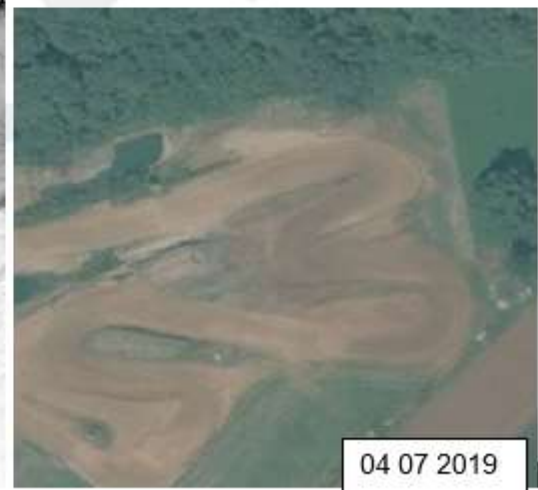
Changes between March and July 2019, after Figure 11

These images were blended to show the change to the north east loop in the track between 29 03 2019 and 04 07 2019.

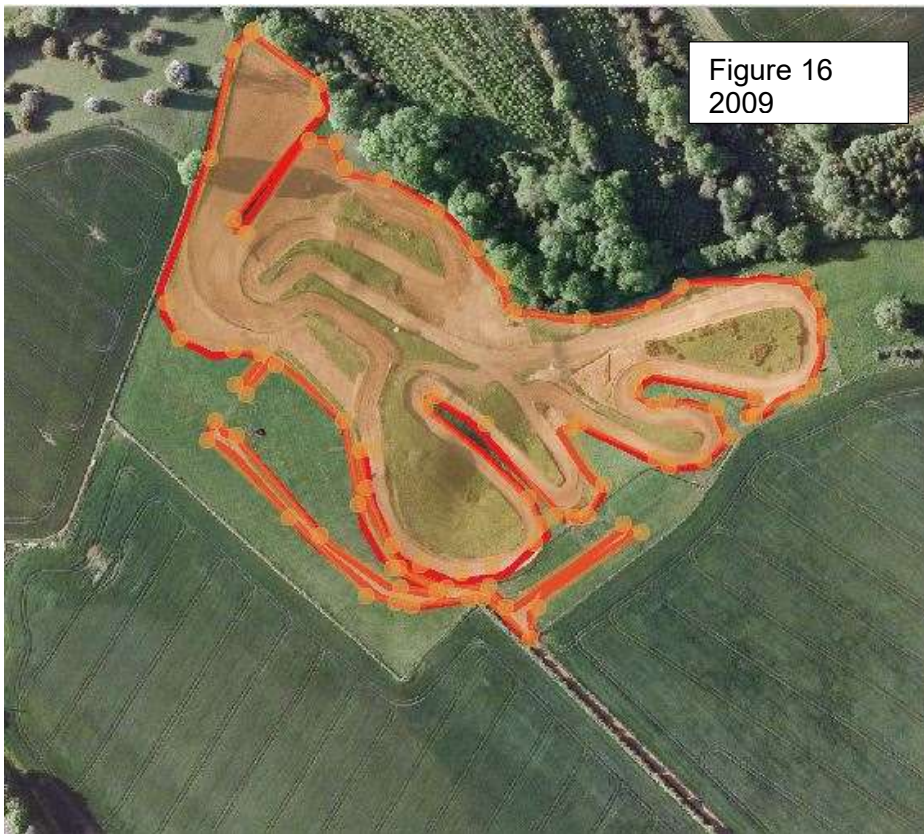
5.57 **Figure 16 2009 the area of the track and all associated bare earth features**

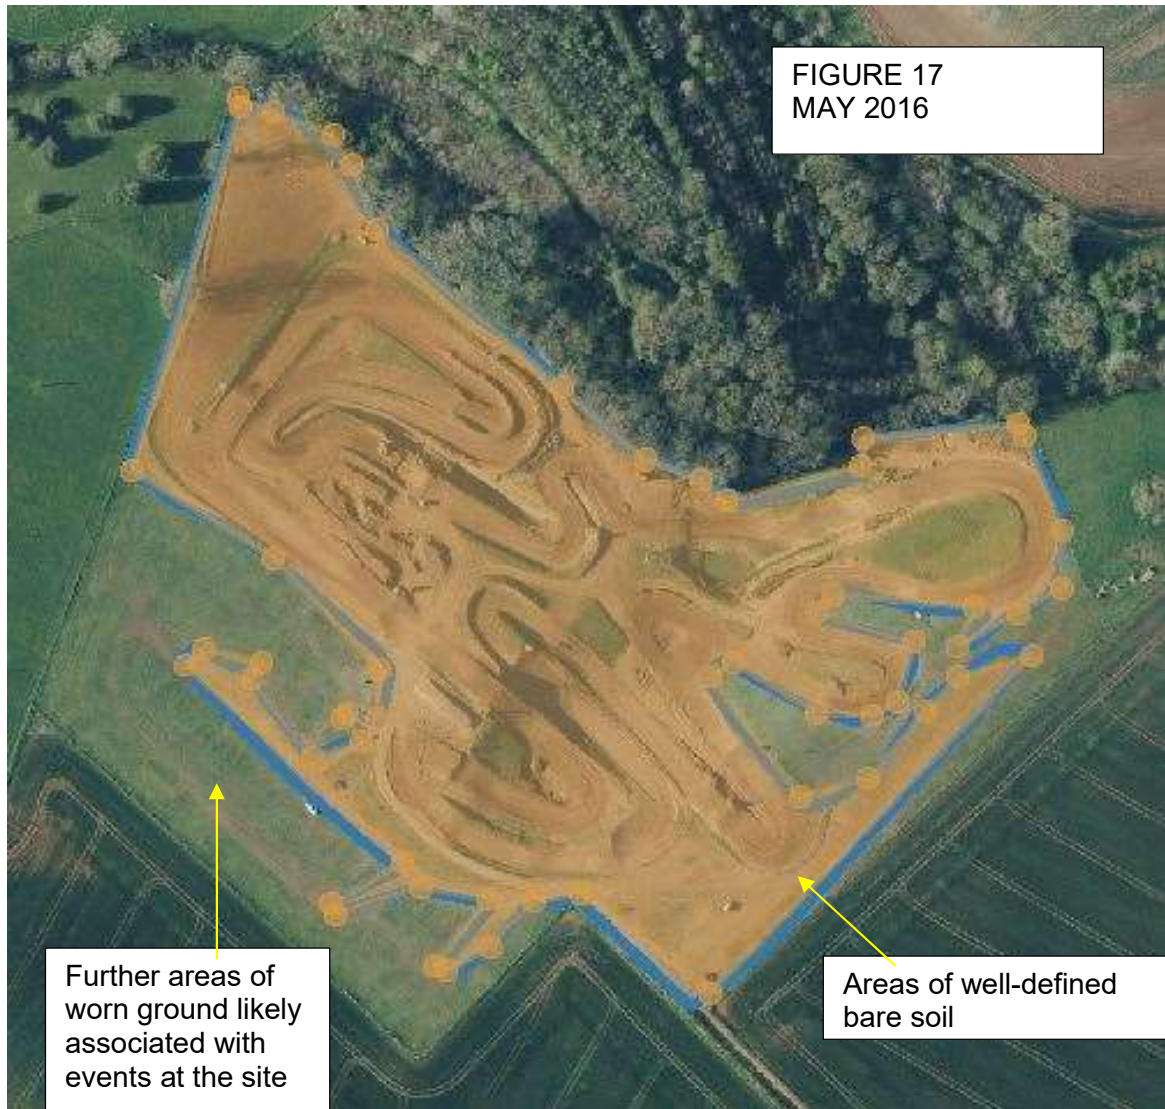
5.60 **Figure 17 4th May 2016, the area of the track and all associated bare earth features.**
