**Planning Application Ref: 21/00517/F
Land Drainage Issues in Relation to Your Recent Consultee
Comments**

Evidencing watercourse mismanagement and silting up

– Photographs January 2023

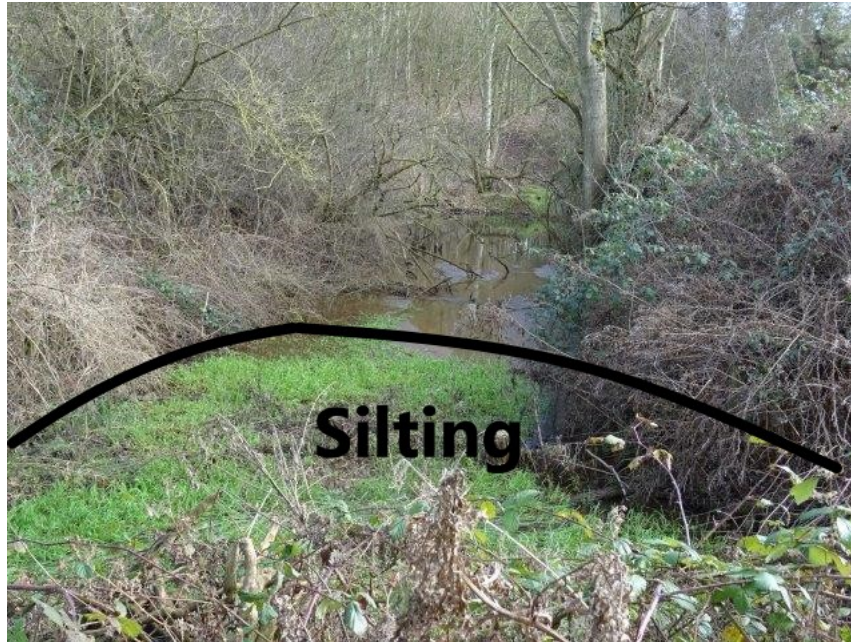
This photo is taken from the bridge on the public footpath at the foot of the start of the MX racetrack. The image shows the much-enlarged pond dug out of the brook, without our or anyone else's consent. As previously explained by us, this pond has been used to irrigate the race track to settle the dust on race days. An enormous gallonage is pumped out using old slurry tankers vacuuming out in excess of 1500 gallons per tanker load to dampen the track. This water extraction is massively above the legal limit to abstract without a licence.

The much enlarged pond in the brook has now not been used for irrigation purposes for some three years. Hence, the pond is now very choked with silt, which has been washed into the brook from the bare race track. The silted areas have grass rooting and growing on them, severely impeding the flow of the brook.

If, in the interim, between races and events, the former track had been reseeded and reverted to agricultural use, as the applicant claimed, this massive soil run-off would have been minimised. However, it seems that the land, its watercourse and their welfare have been, first, exploited and then neglected.

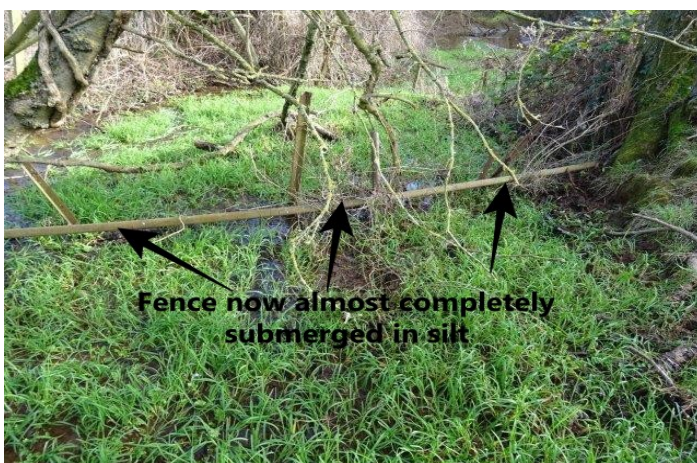
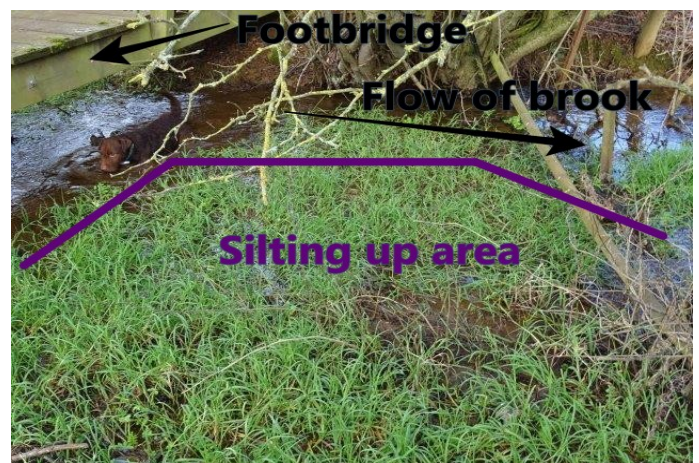
The two images below show where, today, the fence has been almost completely submerged by silt and the bank of silt under the public footbridge access point.
