Our ref: R1742B-L07  
Your ref:

**Upper Heyford – Dorchester Phase 9 – Basketball Pitch  
Supplementary Site Investigation**

Project:  Heyford Park, Upper Heyford	
Drawing:  Phase 9 - Basketball Pitch Insitu Validation Samples	
Drawn:  DW	Checked:  BJT
Date:  06.08.18	Scale:  1:500 @ A3
Job No:  R1742b	Drg No:  R1742b-L07-D01

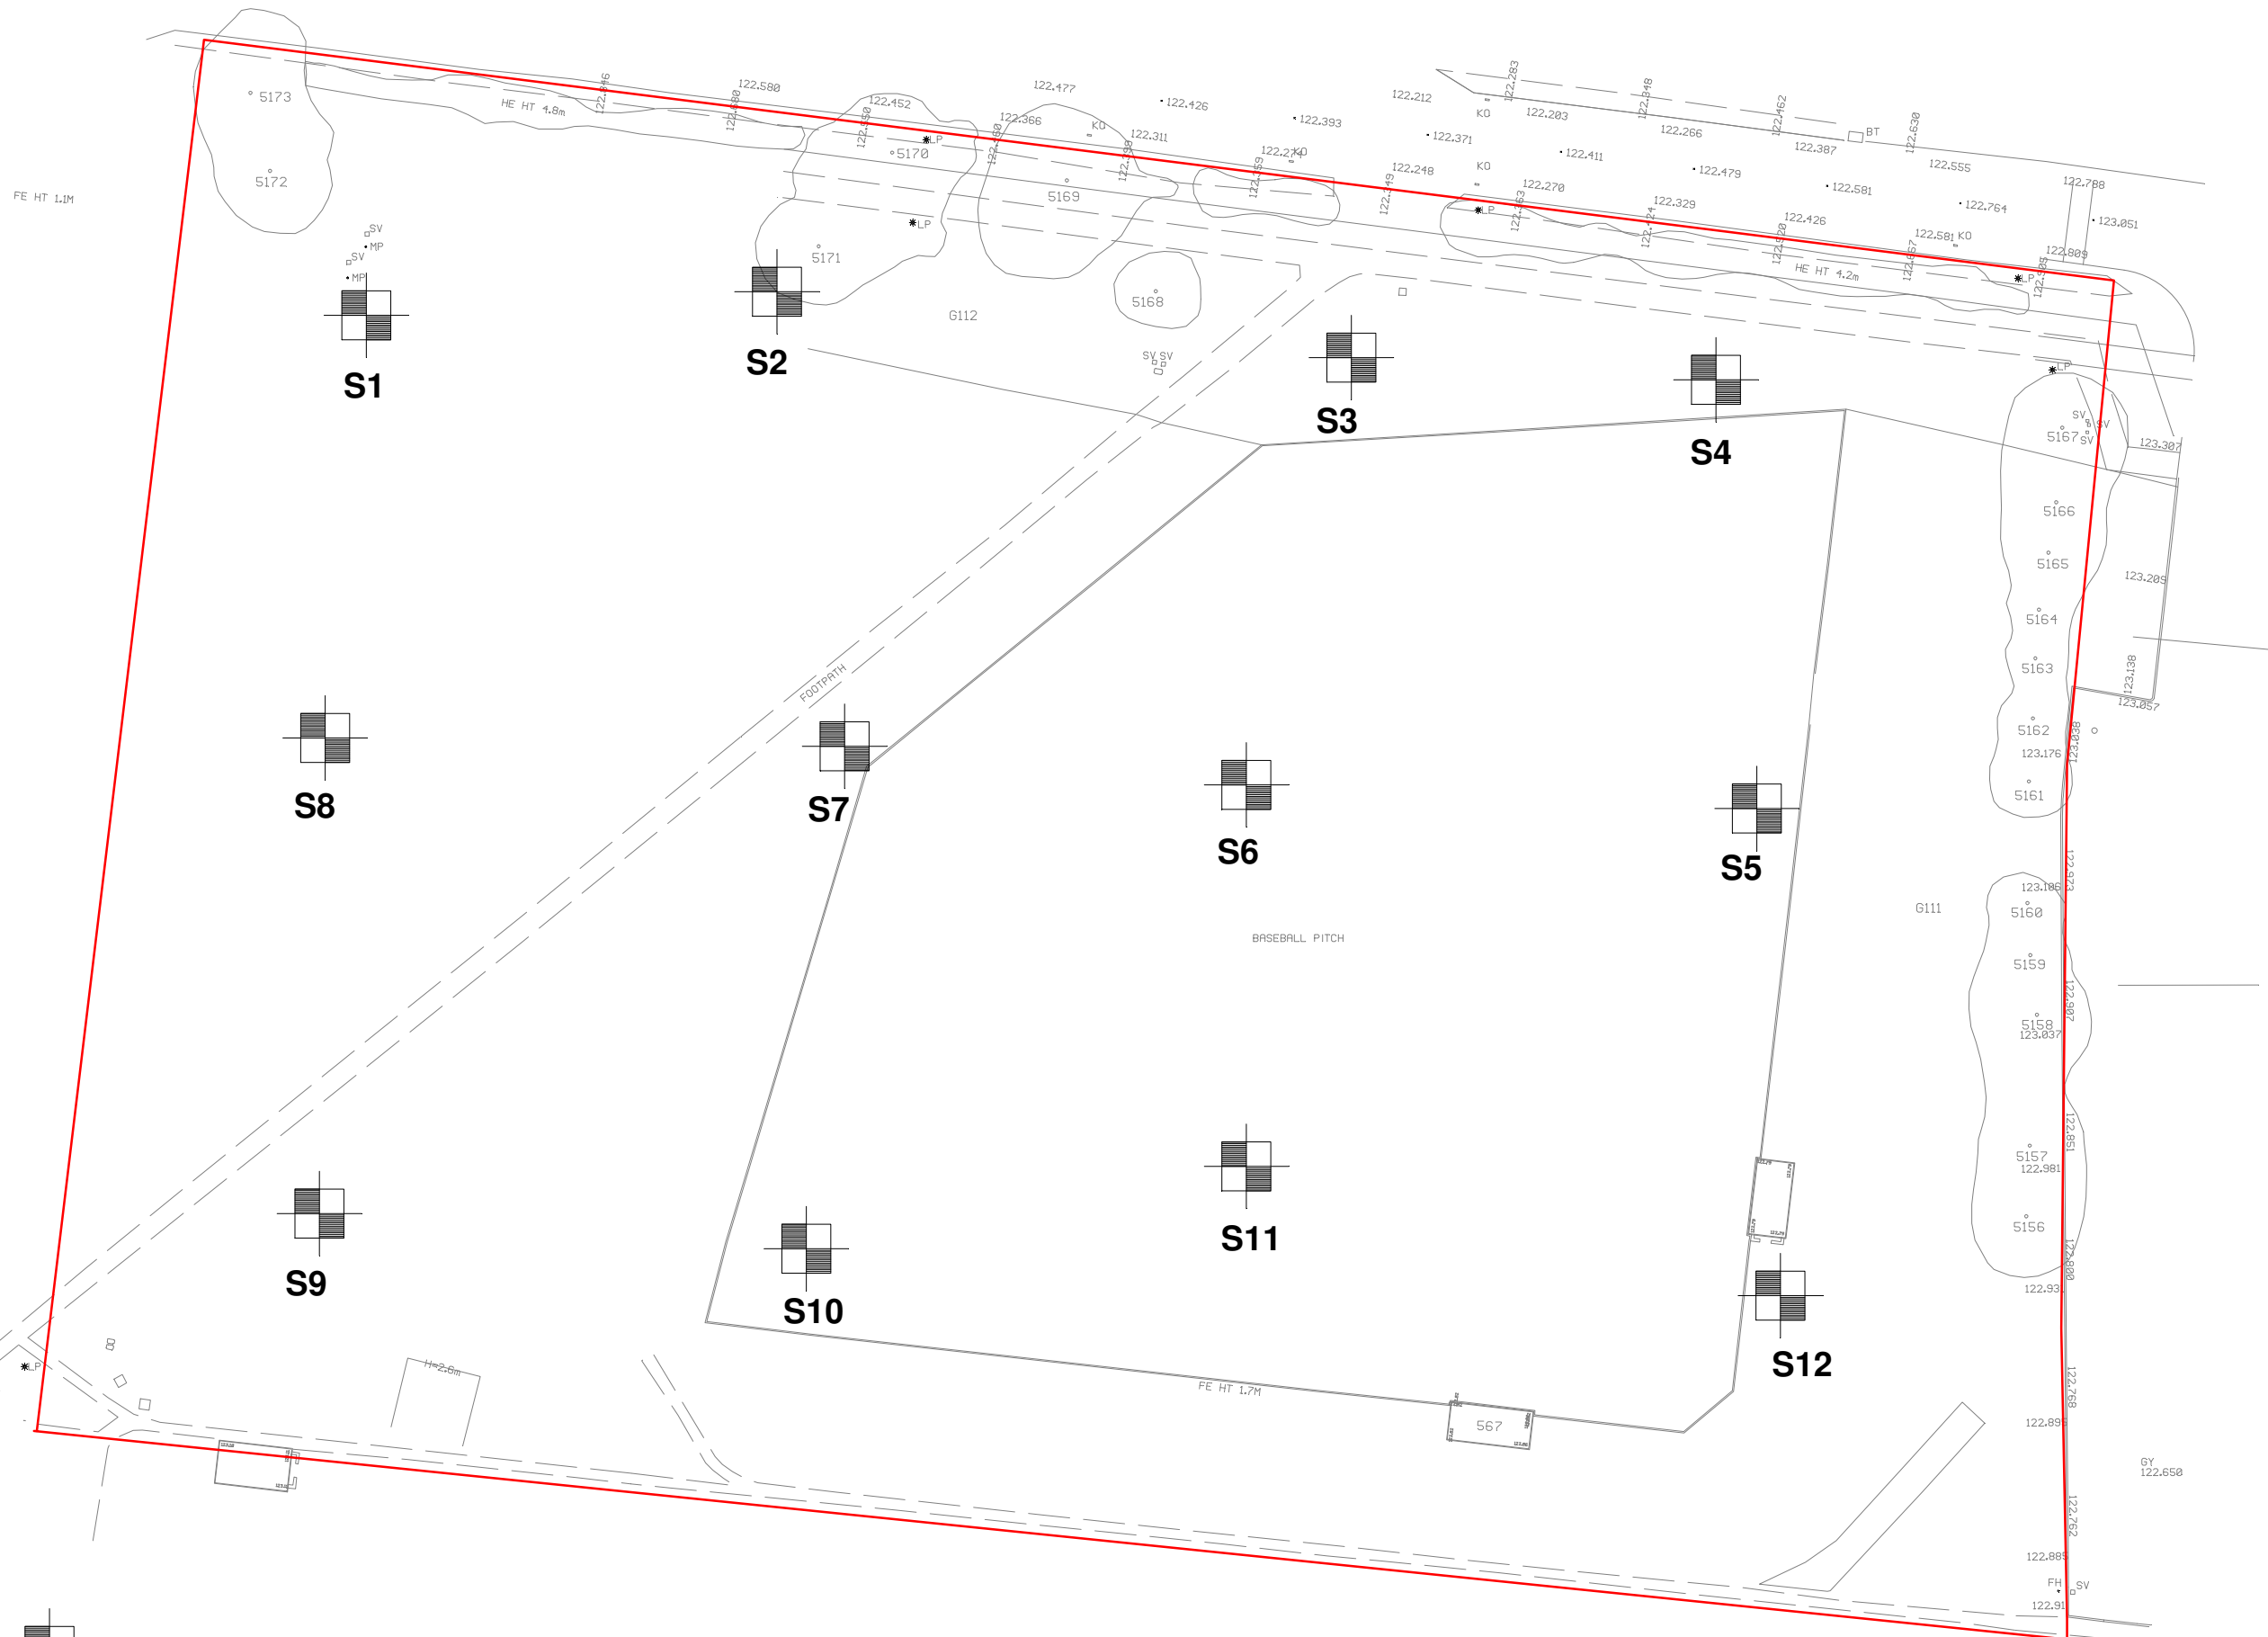
Sampled soils generally comprised of a dark brown clay soil with coarse gravel of limestone although inclusions of brick fragments (S5, S6, S11 and S12) and tarmac (S7 and S11) were observed. No inclusions of ash, slag or clinker were observed but it is noted that Hydrock reported ash within 2 locations. A plan detailing the validation entries with Hydrock's trial-pits is provided in Drawing D01.

**Insitu Sample**
