Additional Ground Investigation & Remediation Strategy

Hempton Road, Deddington

BRD3567-OR3-A

March 2021

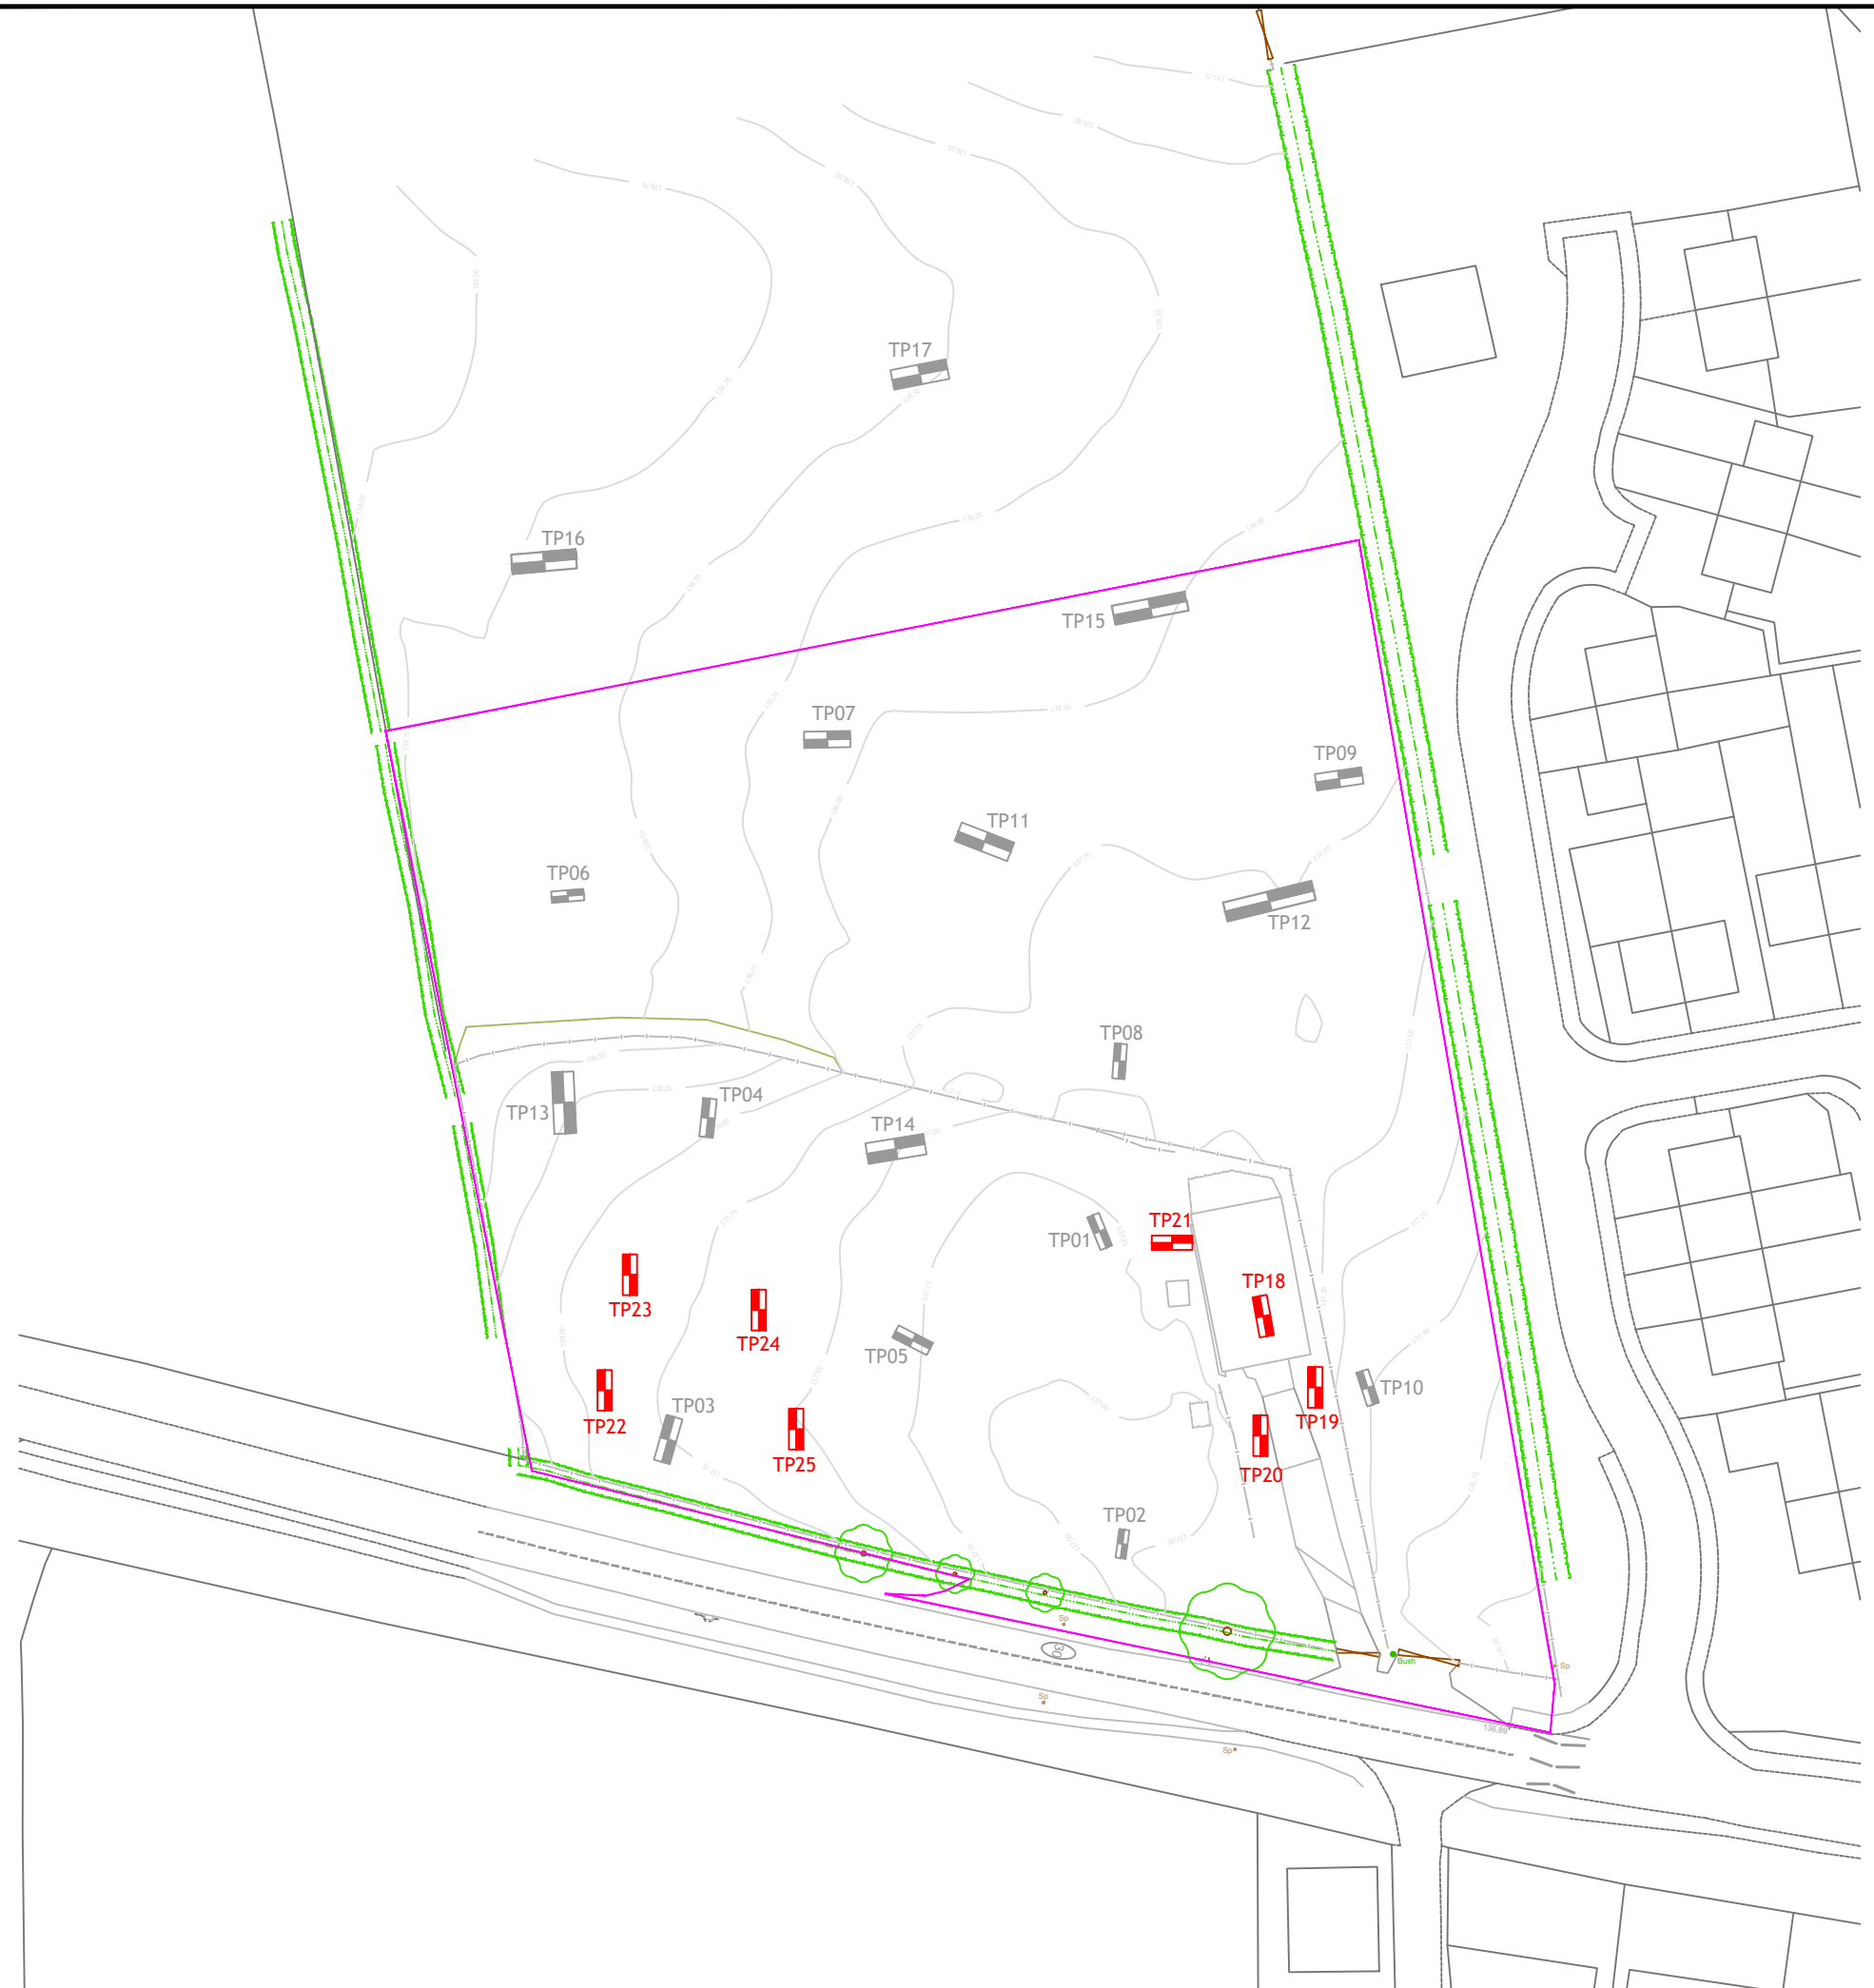
Drawing Number	Rev
BRD3567-OD1	B

- BRD Trial Pit Locations (2021)
- BRD Trial Pit Locations (2019)
- Site Boundary (Approximate)
