**2021 Updated Bat Survey Report for
Crockwell Farm,
Manor Road, Great Bourton,
Banbury, OX17 1QT**

Cotswold Wildlife Surveys

15th April 2016 and 6th, 8th & 24th September 2019 and 29th March 2021

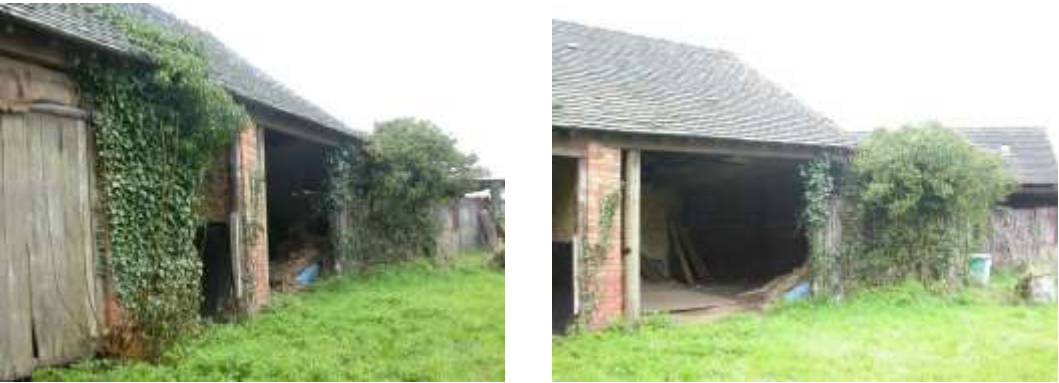
<p style="text-align: center;">Figs. 5 & 6 Garage block</p>

Building Name	Description	Figures
Garage block	<p>The garage block was a brick building with a pitched tiled roof (Figs. 5 and 6). This was generally sound throughout, with just a few slipped tiles on the roof verge. There were no suitable gaps for roosting bats and the brickwork was sound throughout. The front was open to the inside of the building.</p> <p>Internally the garage block was open to the underside of the roof which was unlined (Figs. 7 and 8). The building was brightly illuminated through the open front and was very heavily cobwebbed. The open nature of the building also made it very cold and quite drafty.</p>

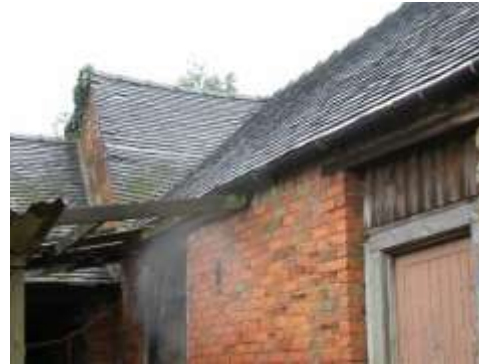
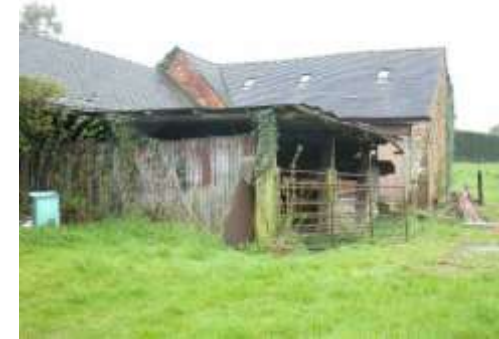
Figs. 9 & 10 Storage barn and lean-to

The storage barn was a brick building with a pitched tiled roof (Figs. 9 and 10). This was generally sound throughout, with just a few slipped tiles on the roof verges and ends. There were no suitable gaps for roosting bats and the brickwork was sound throughout. There was also a small, corrugated metal lean-to on the north elevation which was highly unsuitable for roosting bats.

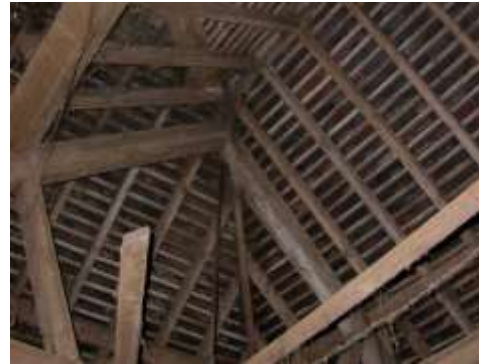
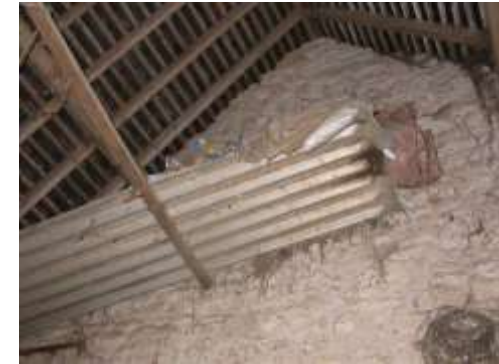
Figs. 11 & 12 Interior of storage barn

Internally the garage block was open to the underside of the roof which was unlined (Figs. 11 and 12). The building was quite brightly illuminated and was very heavily cobwebbed. The open nature of the building also made it very cold and quite drafty.

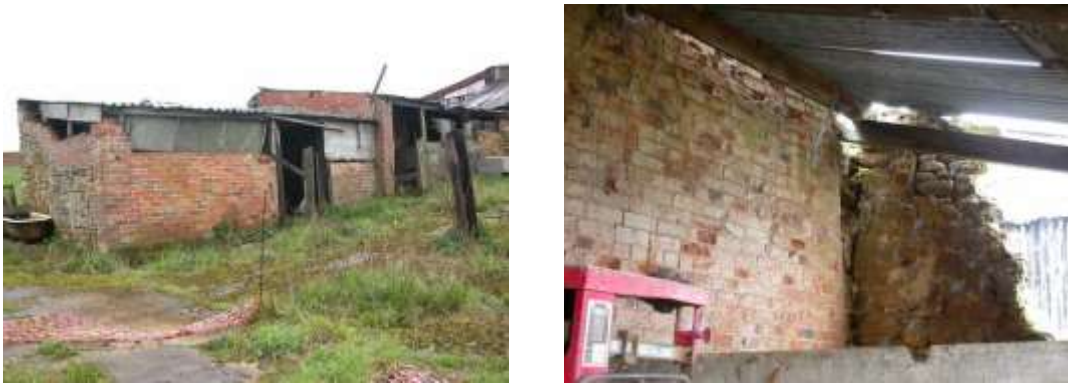
<p>Pigsty</p>	<p>The pigsty consisted of two adjoining brick structures with a sloping corrugated metal roof (Figs. 13 and 14). The walls were in a very poor state of repair, with areas which had collapsed. However, despite this, there were no suitable crevices for roosting bats.</p> <p>Internally the pigsty was cold and damp due to the poor state of repair and gaps and holes in the roof.</p>

<p>Figs. 13 & 14 Pigsty</p>
<p>Derelict barn</p>	<p>On the western side of the stable block were the remains of a derelict barn which had since collapsed (Fig. 15). There were several timber posts left, but these held no suitable roosting features for bats.</p>

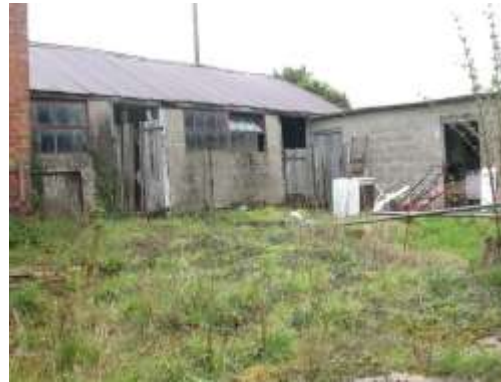
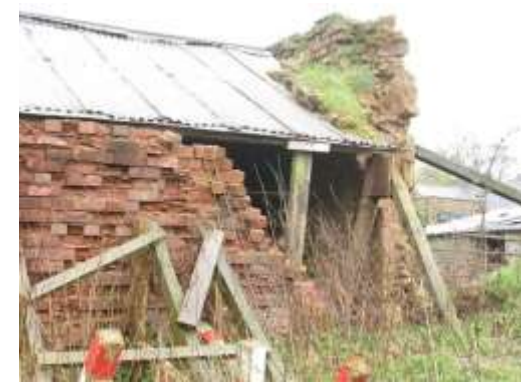
Figs. 16 & 17 Stable block

The stables were a combination of block, brick and stone (Fig. 16), with the rear brick wall having collapsed in one corner (Fig. 17). The roof was covered with corrugated metal sheets, which had some gaps between the panels and along the ridge.

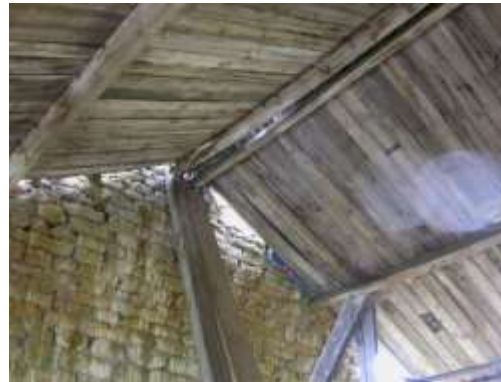
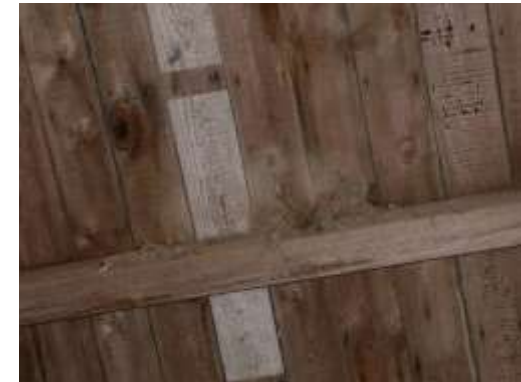
Figs. 18 & 19 Timber sarking lined roof of stable block

The building was lined with timber sarking, the boards tightly fitting. On one of the beams an old Swallow's nest was noted. The walls were in a poor state of repair and there were no suitable crevices for roosting bats.

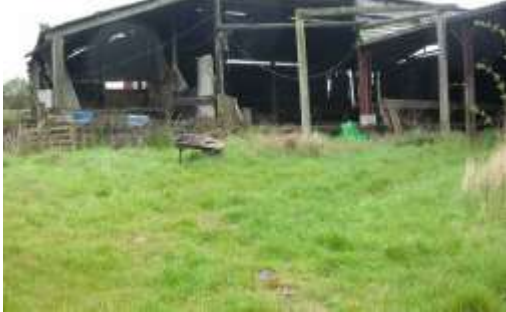
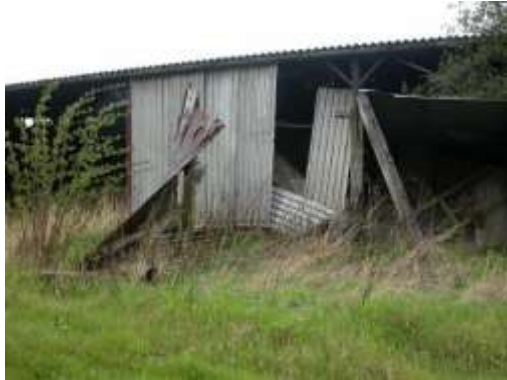
<p>Figs. 18 & 19 Open barn</p>

Open barn	<p>The open barn was a large structure which had been extended several times (Figs. 18 and 19). It had a timber and metal frame, with a corrugated metal roof and walls in places. There were a number of skylights in the roof, which along with the open sides made the barn very brightly illuminated (Figs. 20 and 21).</p> <p>The open barn was generally highly unsuitable for roosting bats, given the bright interior and exposed nature. However, some of the timber rafters were made from two boards, separated by blocks (Fig. 22). The latter were recessed creating deep, triangular shaped gaps. These appeared suitable for bats and in one of the gaps a single Brown Long-eared Bat was found (Figs. 22 and 23 overleaf).</p>

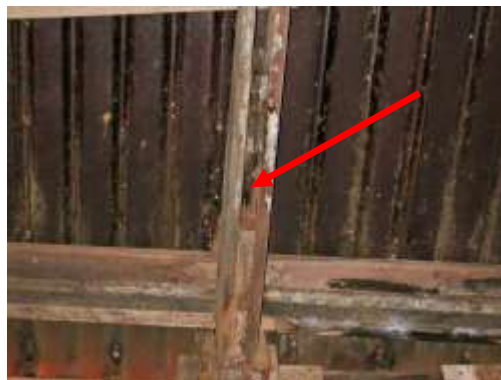
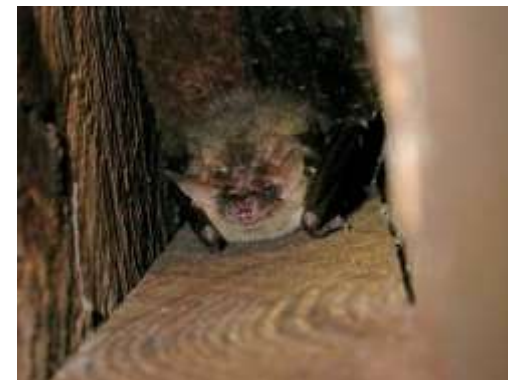
Despite the number and style of buildings, none of the barns or other structures contained any features suitable for roosting bats apart from the large, open barn at the

northern end of the site, in which a Brown Long-eared Bat was found roosting within a timber rafter gap.

Figs. 22 & 23 Roosting Brown Long-eared Bat in gap in rafter (arrowed)

As the proposed works will result in the loss of the Brown Long-eared Bat hibernation site, appropriate mitigation will be needed, along with a licence from Natural England consenting to the loss of the roost.

It is therefore suggested that a large timber garden store, with an open front, is erected at the northern end of the site, potentially straddling the two gardens.

The structure will contain two Schwegler 1FF bat boxes (one in each gable end) to act as hibernation/roosting sites, whilst it will also provide a replacement nest site for the Swallows.

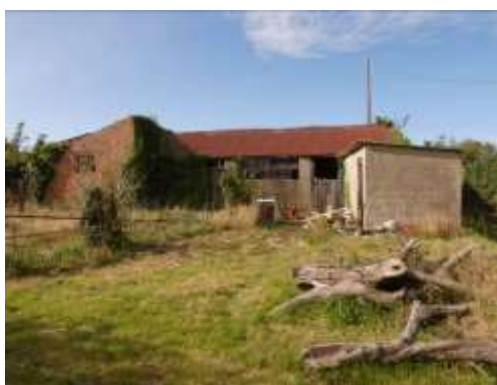
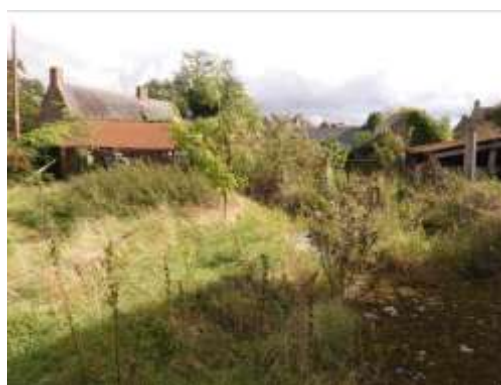
Figs. 24 & 25 Farm in September 2019

The site was virtually unchanged since 2016, although it was more overgrown with vegetation (Figs. 24 and 25).

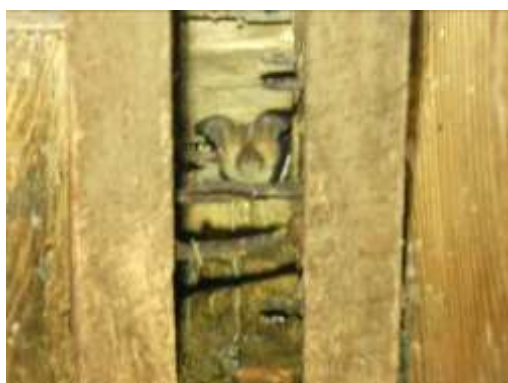
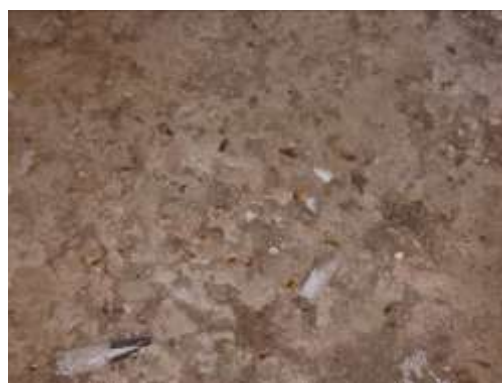
A roosting Brown Long-eared Bat was again present in a rafter gap in the open barn, but a different gap to 2016 (Fig. 26).

Figs. 26 & 27 Roosting Brown Long-eared Bat (L) and moth wings (R)

There were no signs of activity by other bat species, but a small cluster of moth wings and a couple of droppings was evidence of a Brown Long-eared Bat feeding perch in the garage block (Fig. 27).

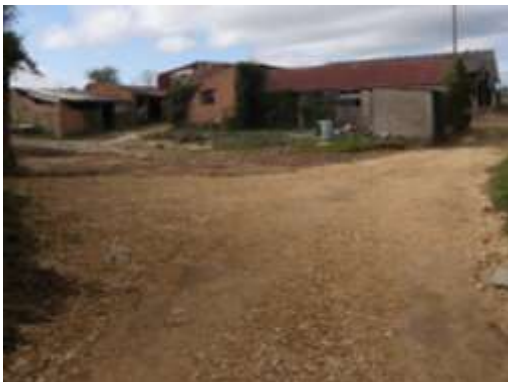
Fig. 28 Stables

Apart from some tidying up and new stone in the entrance, there were no changes to the buildings. The stables (Fig. 28), pigsty (Fig. 29) and derelict barn (Fig. 30) were still in a dilapidated state.

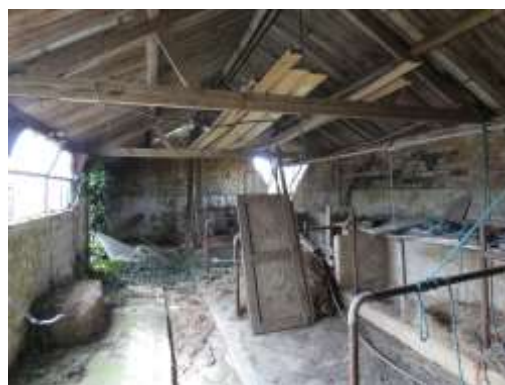
Fig. 31 Interior of stables

The interiors of the buildings were heavily cobwebbed and dusty (Fig. 31), with no suitable roosting features.

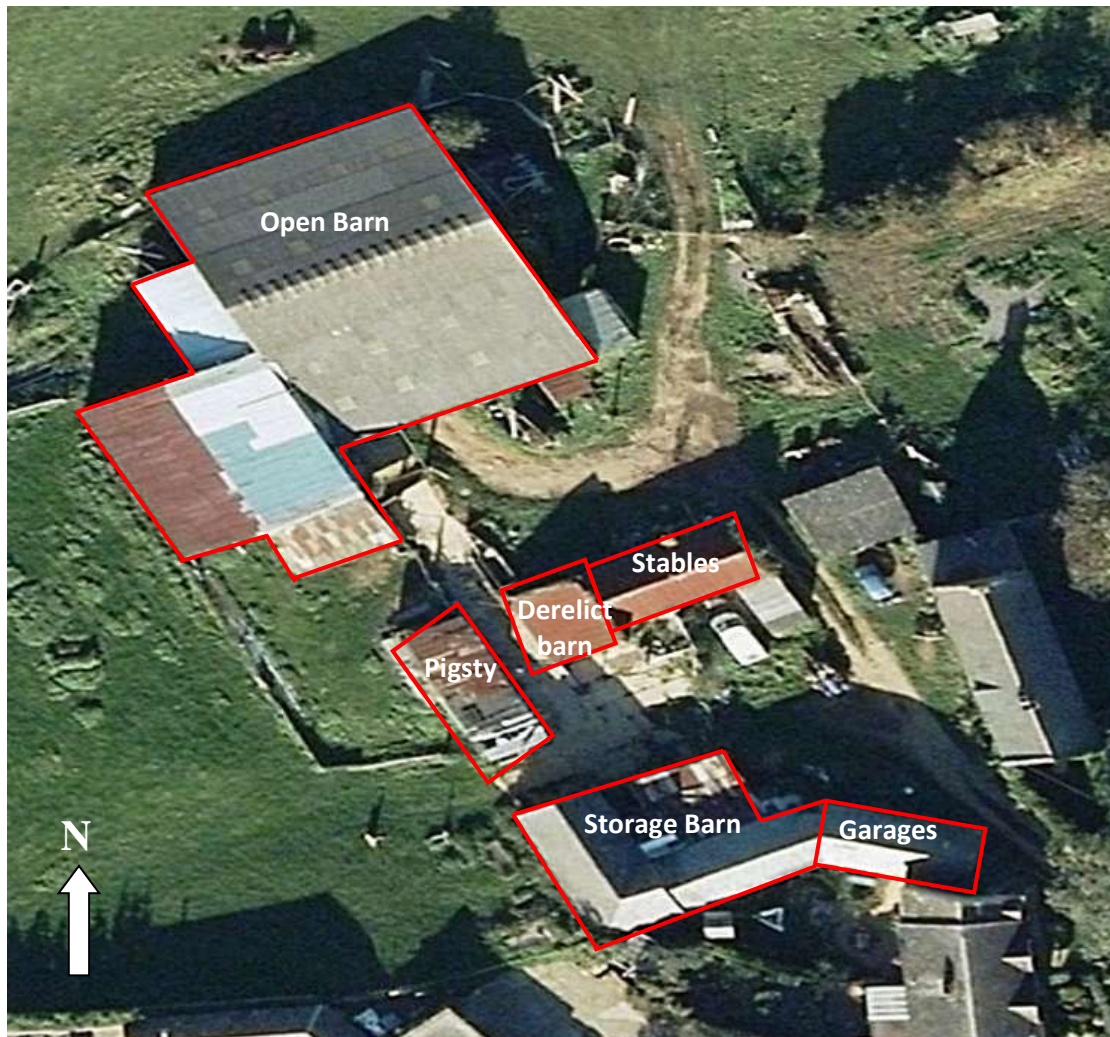
Appendix 2: Site layout

The layout of the site is shown in the aerial photograph in Appendix 2.
