Crockwell Farm, Great Bourton, Oxfordshire

Construction of a new dwelling to replace disused and derelict former farm outbuildings

Heritage Statement

Graham Keevill BA (Hon) FSA MCIfA
Keevill Heritage Ltd
for Crockwell Farm LLP
August 2021 (revised)

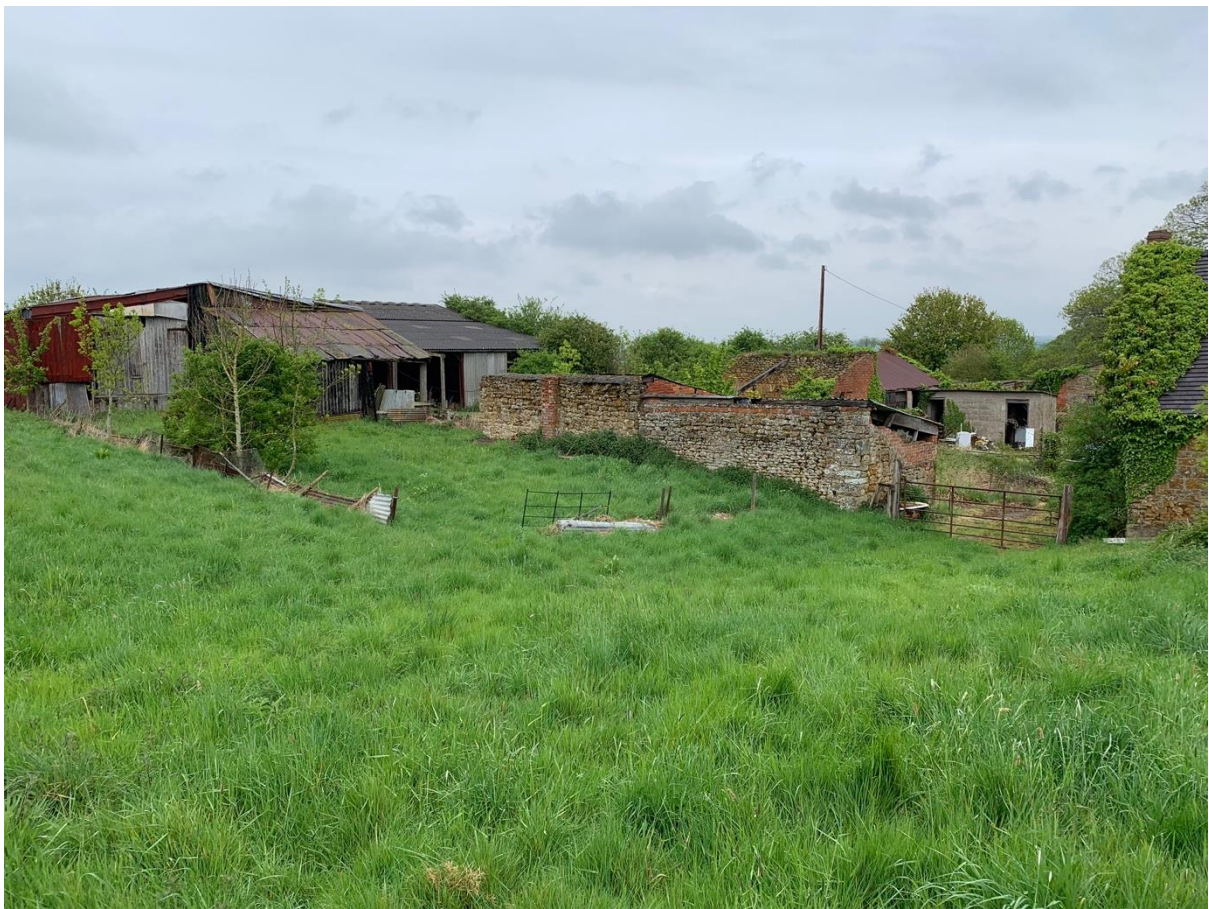
Figure 1: The central area of Crockwell Farm, showing the derelict and disused buildings to be replaced by the new dwellings. The large steel-framed barns to the left do not form part of this application.

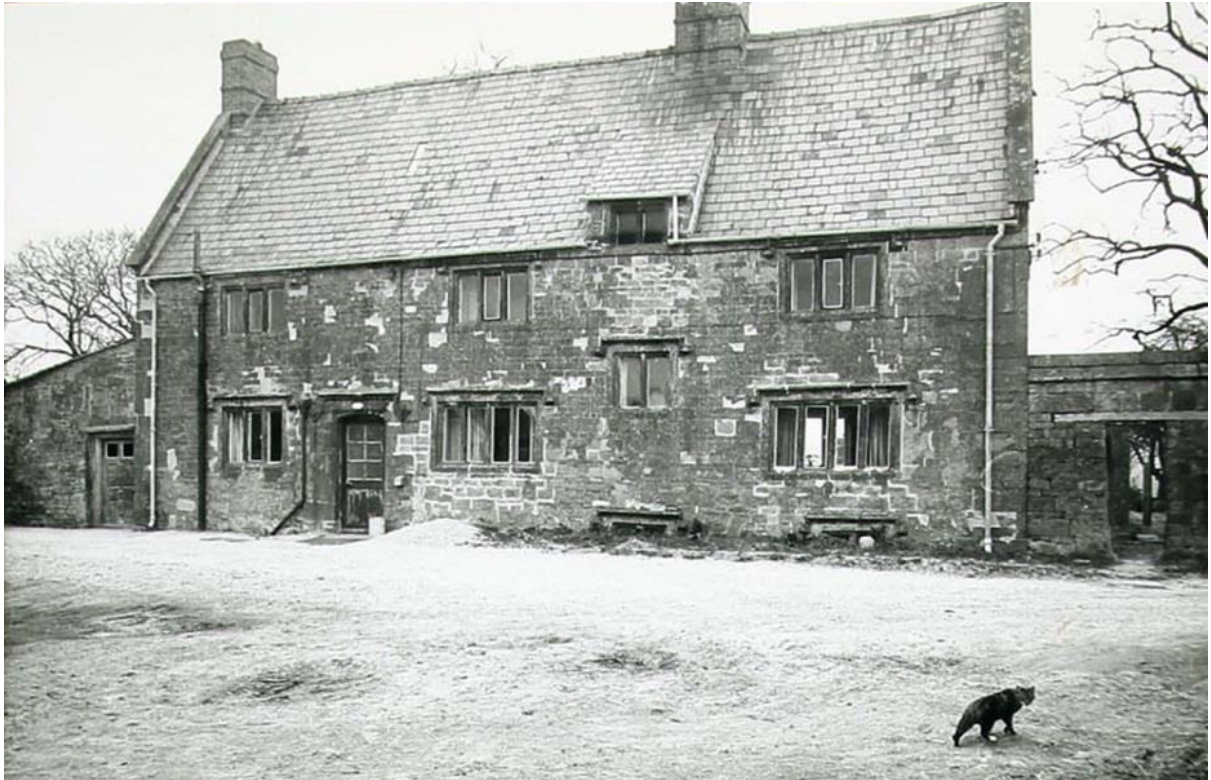
Figure 4: A photograph of the farmhouse in 1964 from the Red Boxes. Contrast with Figure 5.

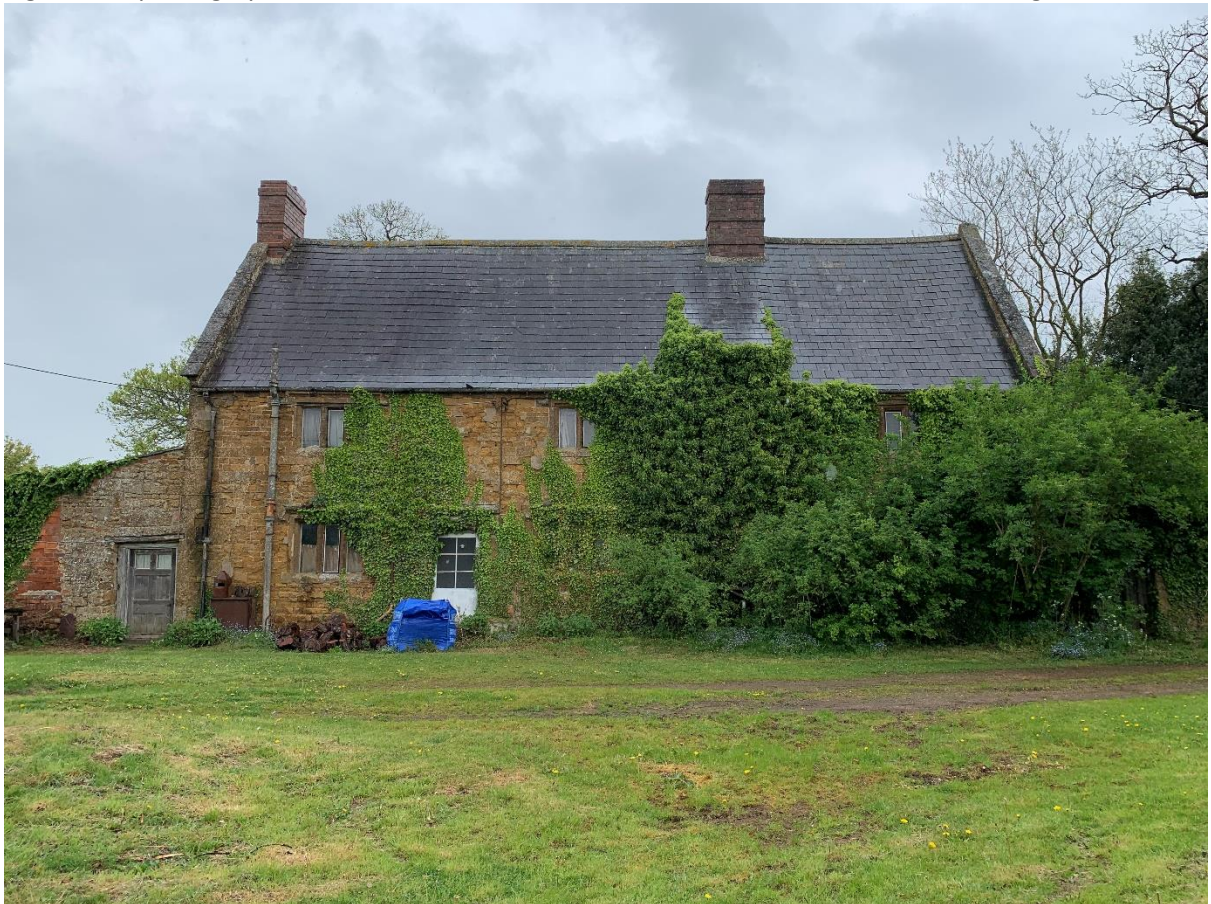
Figure 5: Crockwell Farmhouse in 2020.

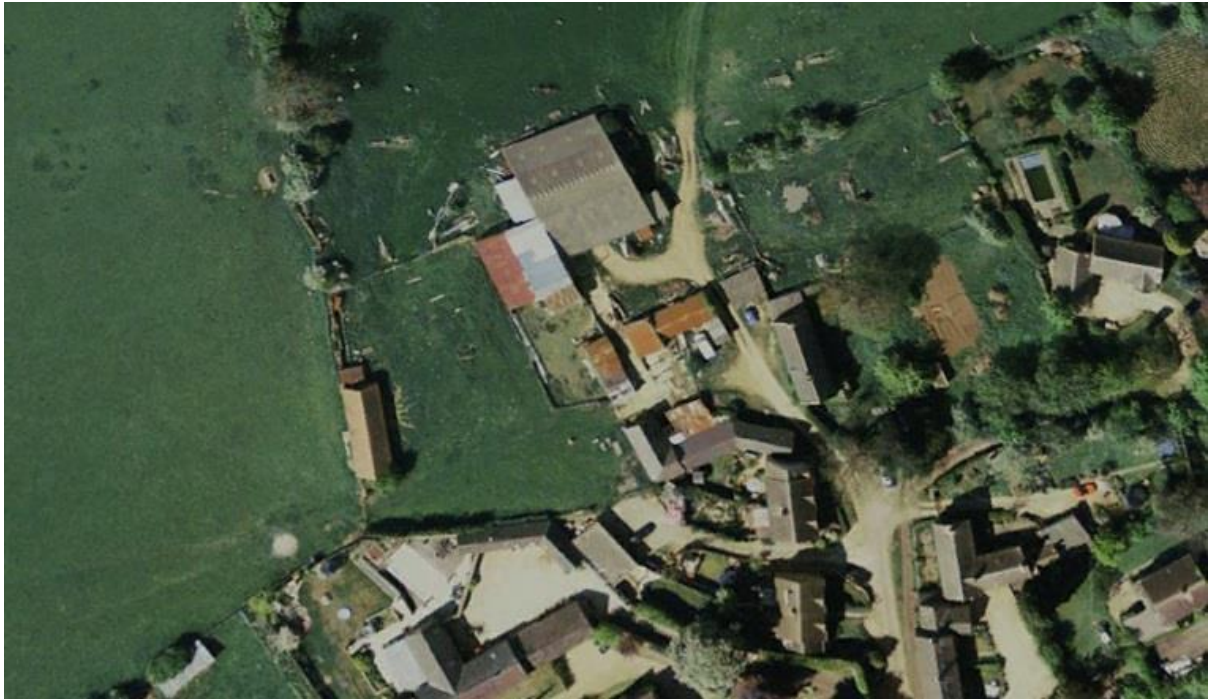
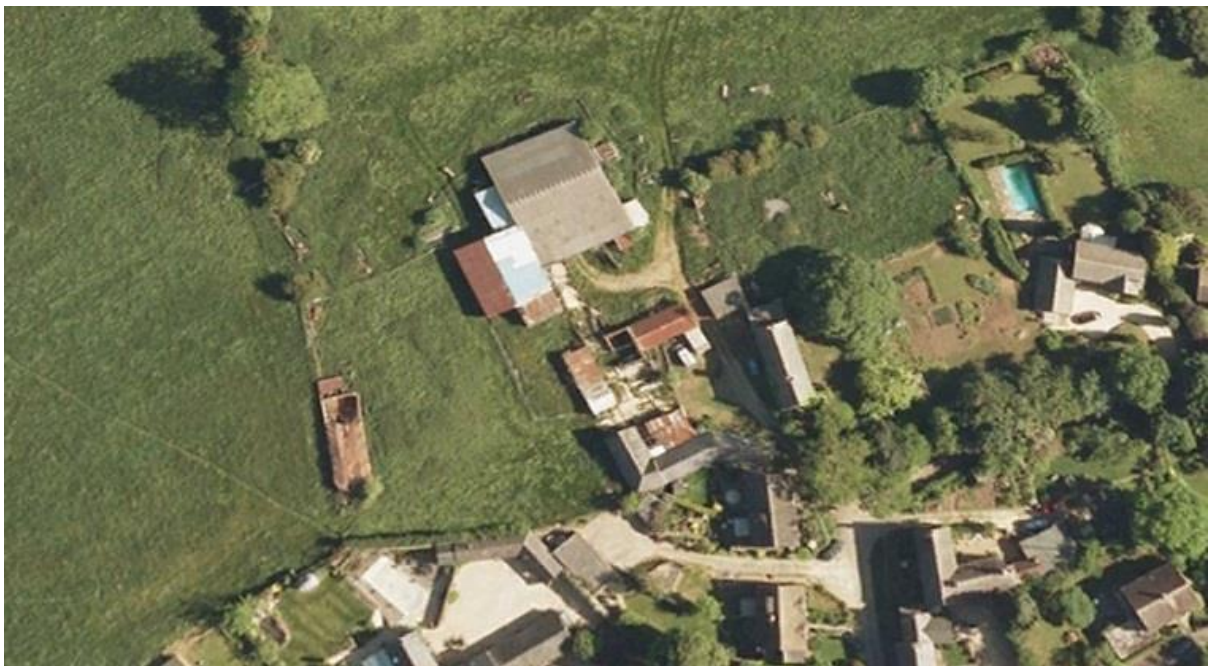
Figure 13: Google Earth aerial photograph from 2007 (top), with all buildings still broadly intact and roofed at this stage, and 2009 with building 6 now roofless. Compare these images with Figures 9-12 for the form of buildings 9 and 10.

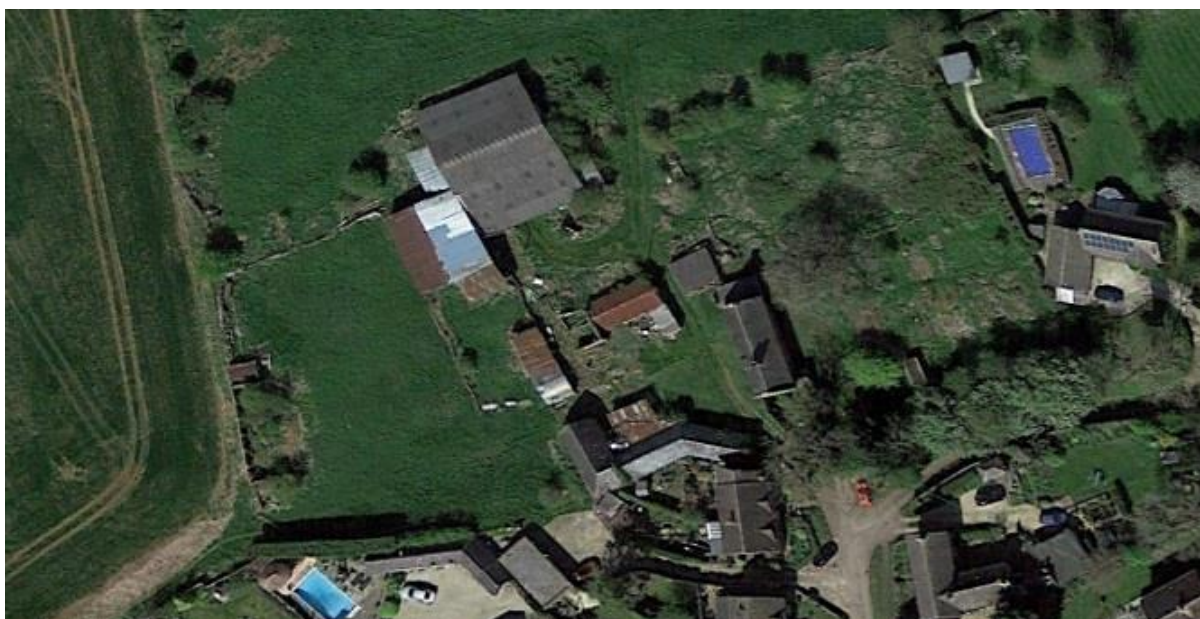
Figure 14: Google Earth images from 2017 shows a further decline in the abandoned outbuildings. Not only has building 6 lost its roof, but building 11 was also completely unroofed and the interior had been invaded by greenery.

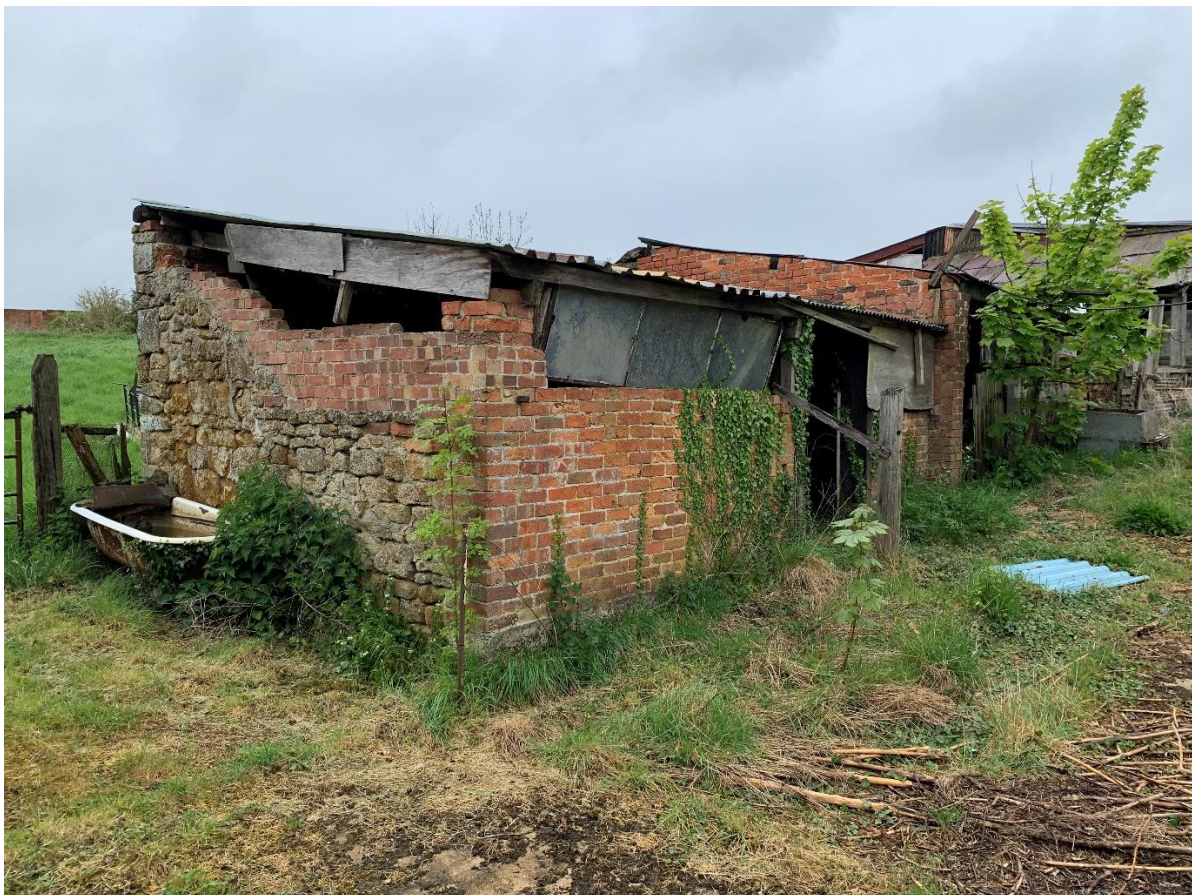
Figure 15: Building 5 looking north-west. The ironstone end wall may be of 19th-century date. All the rest is modern. Including the roofs.

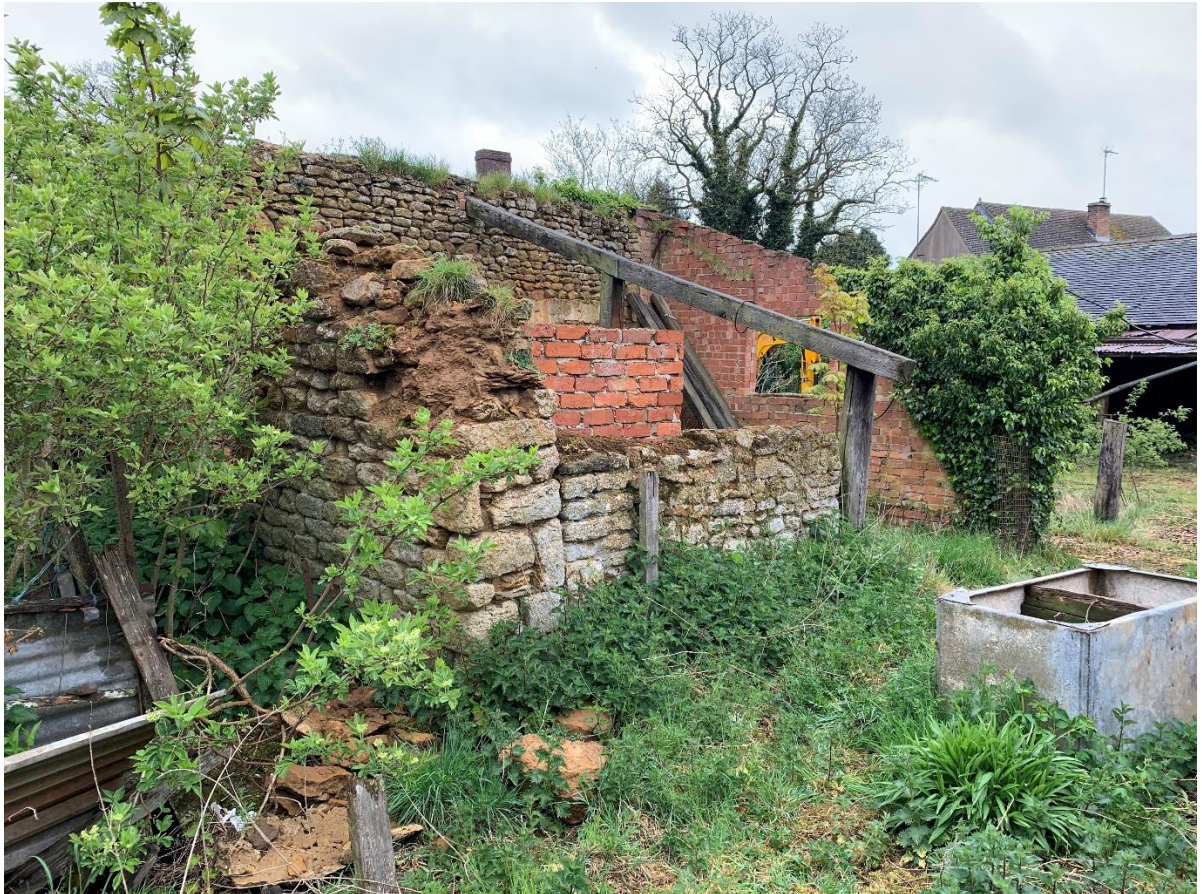
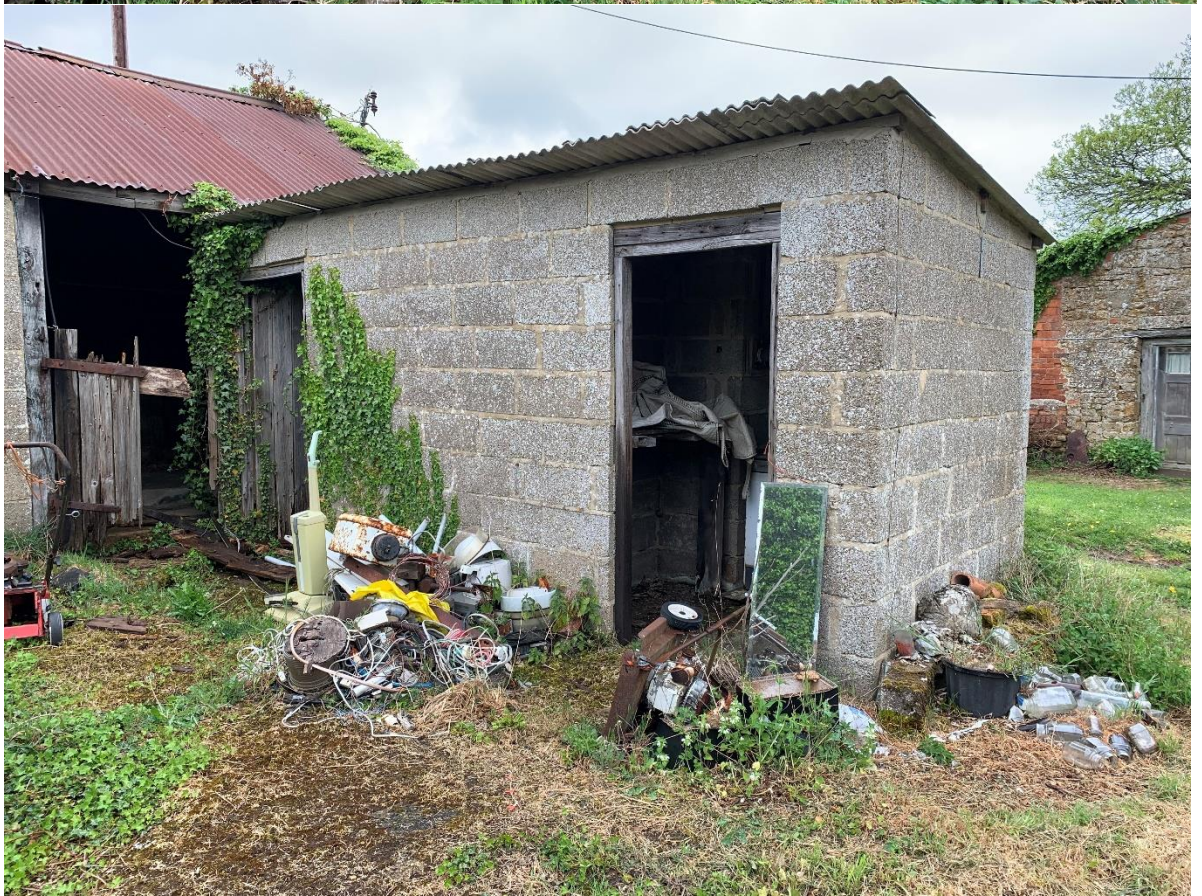
Figure 16: Building 6 (top) looking south-east, and buildings 7 and 8 looking north-west. The former's condition has deteriorated since 2016 – compare with the same view in Soden 2016, figure 12.

Assessment during the site visit in 2020 confirmed that the condition of buildings 5-8 had continued to deteriorate since Iain Soden's report of 2016. The 2019 case officer's comments that conversion of the buildings was unlikely to be feasible or viable therefore still apply, and if anything the situation is worse now (August 2021). Parts of buildings 5 and possibly building 6 might pre-date the 1 July 1948 cut-off for curtilage listing. Buildings 7 and 8 certainly post-date this. They cannot be defined as non-designated heritage assets, and therefore the NPPF tests do not apply to them. Planning permission 19/00250/OUT already allows for the demolition of buildings 5-8. It is therefore concluded that the required demolitions are not a planning issue.

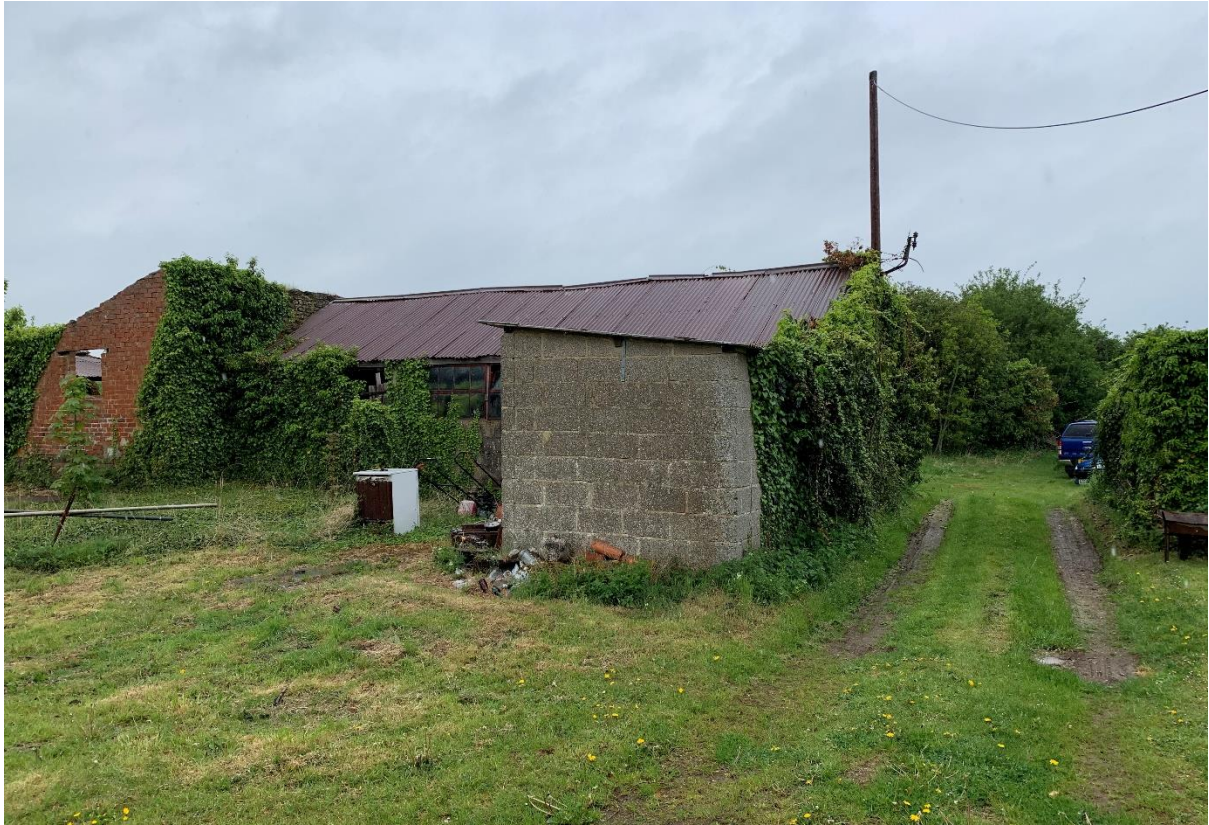
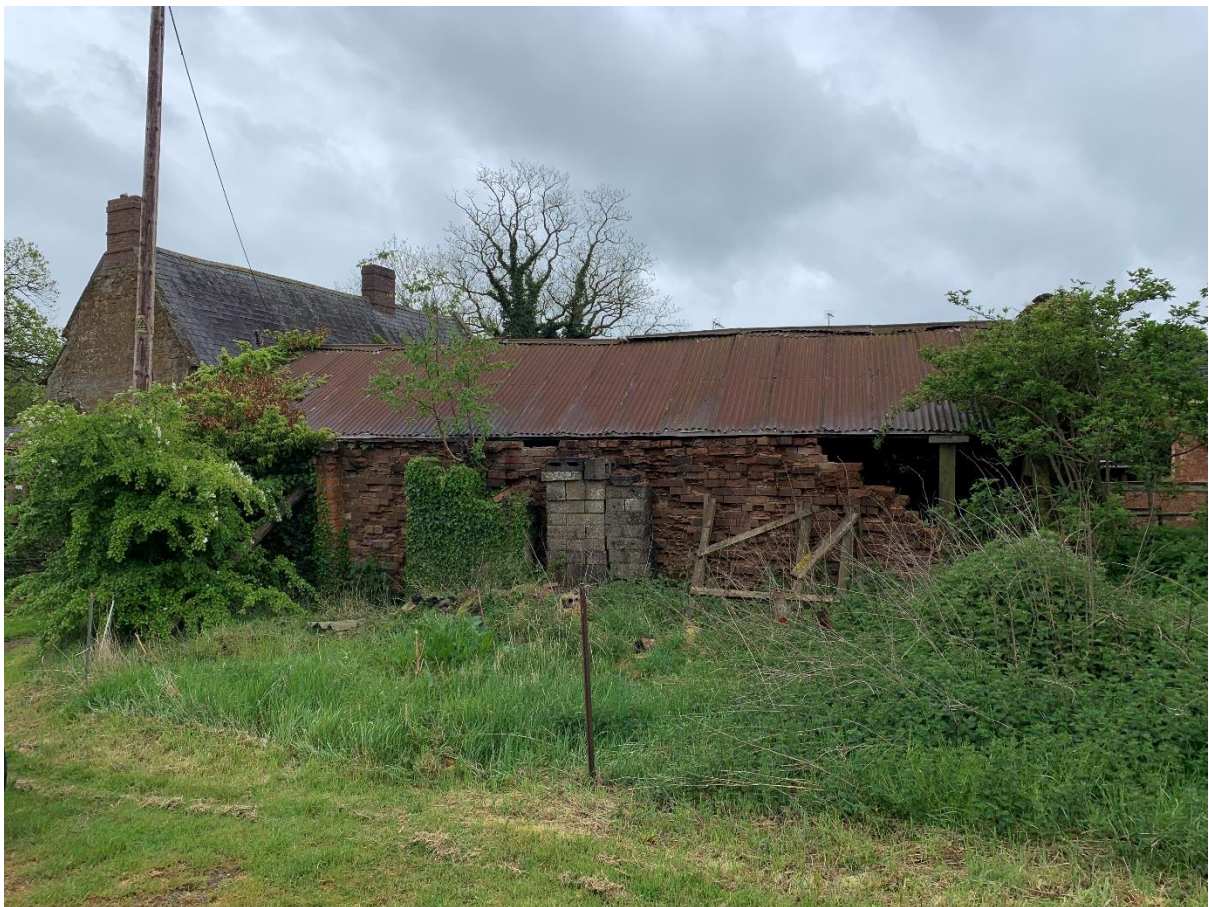
Figure 17: Buildings 7 and 8 looking south-east (top), and the rear wall of buildings 7, which is in very poor condition.

The very poor condition of buildings 5-8 is **visually intrusive** upon the setting of the listed farmhouse. The materials, character, function and ‘design’ of buildings 7 and 8 are also harmful to the setting of the farmhouse. The secluded and isolated nature of the farmyard, however, means that the buildings do not have any effect or impact on other nearby listed buildings (Manor Farmhouse and The Friars). Equally, their removal would have no negative impact on any of the nearby listed buildings and would enhance Crockwell Farm.

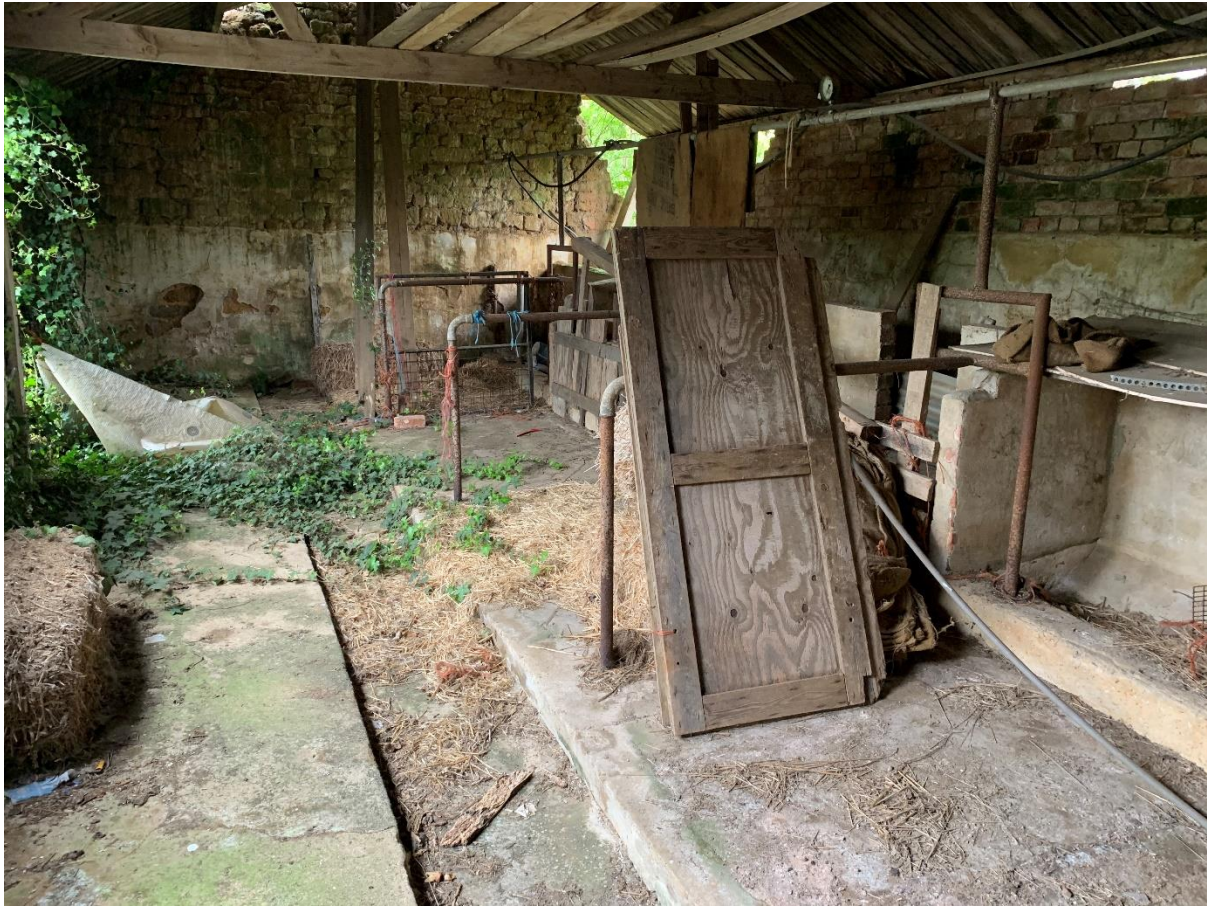
Figure 18: The interior of Building 7 looking west, with the end wall of building 6 at its rear.
