**Document:** Desk Study Report

**Project:** Bicester Health Care Hub

**Reference No:** GN23319\_DS

**Date:** February 2021

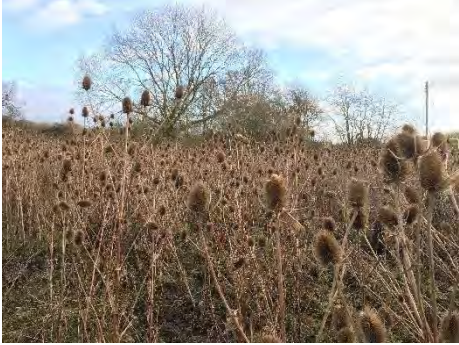
<p><b>Photograph 3 Looking northeast from the southwest corner.</b></p> </div> <div style="text-align: center;">

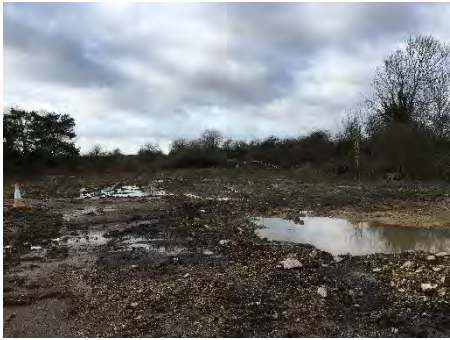
<p><b>Photograph 4 Looking northeast towards the eastern portion of the site.</b></p> </div> </div>
<p style="writing-mode: vertical-rl; transform: rotate(180deg);">Existing Buildings / Structures</p>	<p>There were no buildings or structures present on site at the time of the walkover. Three pipes were observed towards the northern boundary (see Photograph 5 below). Additionally, a manhole cover was noted towards the southwest of the site, the cover could not be lifted.</p> <div style="display: flex; justify-content: space-around; align-items: flex-end;"> <div style="text-align: center;">

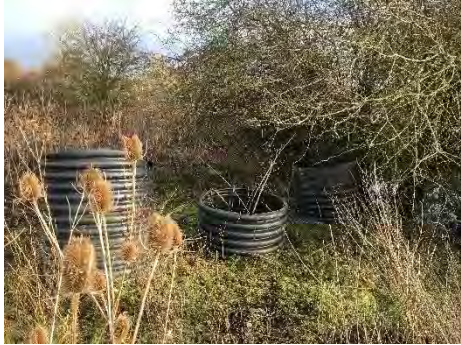
<p><b>Photograph 5 Showing the three large diameter plastic pipes located close to the northern boundary</b></p> </div> <div style="text-align: center;">

There were three large waste plastic pipes noted as present towards the northern boundary of the site and a manhole cover located along the southwest which could not be lifted. No buildings were present on site having been demolished, litter was present frequently with tall teasles and brambles present in the centre of the site. There was one main access road into the site which consisted of a asphalt road (Graven Hill) running north off Anniversary Avenue, with the site entrance secured with a gate.

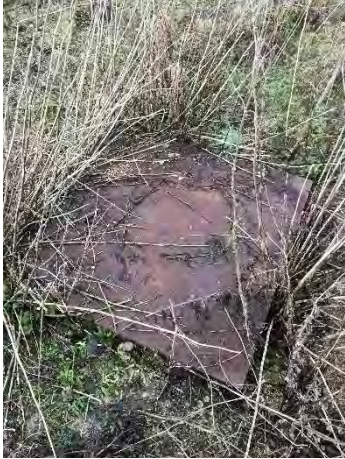
<p><b>Photograph 6 Showing cover located along the southwest portion of the site.</b></p> </div> </div> <p>The western boundary of the site had pooled water present running to the sewer in the southwest corner.</p> <div style="display: flex; justify-content: space-around; align-items: flex-end;"> <div style="text-align: center;">

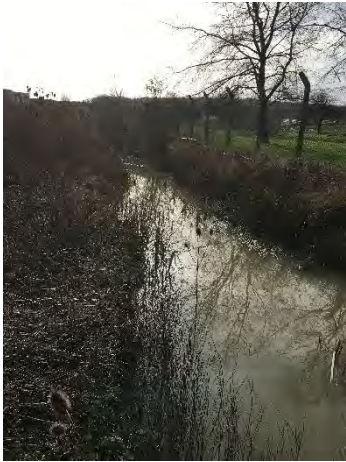
<p><b>Photograph 7 Showing the full drainage ditch forming the western boundary, looking from the northwest corner towards the south.</b></p> </div> <div style="text-align: center;">

Surface Water	<p>Water within a drainage ditch was noted along the western boundary. In addition, pooling surface water was present on hardstanding located in the eastern portion of the site.</p>

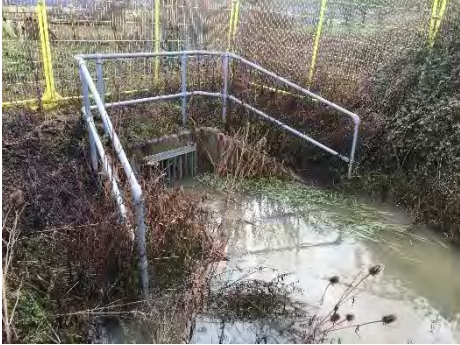
<p><b>Photograph 8 Showing the culvert headwall located in the southwest corner.</b></p> </div> </div>

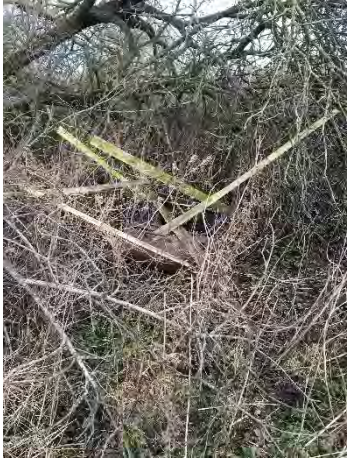
<p><b>Photograph 9</b> Example of litter present on site.</p> </div> <div style="text-align: center;">

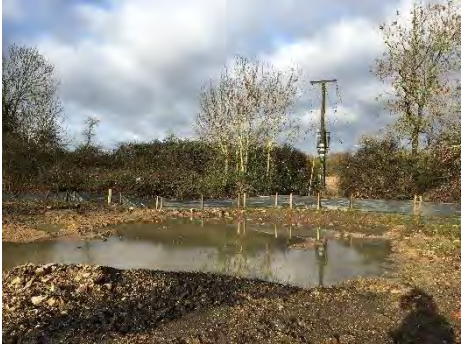
<p><b>Photograph 30</b> Showing pooling water towards the north eastern boundary of the site.</p> </div> </div>
Above / Below Ground Tanks	<p>There were no above or below ground tanks observed on site during the walkover.</p>
Services	<p>Overhead power cables present and had partially fallen down and were trailing on the ground.</p> <div style="display: flex; justify-content: space-around; align-items: flex-end;"> <div style="text-align: center;">

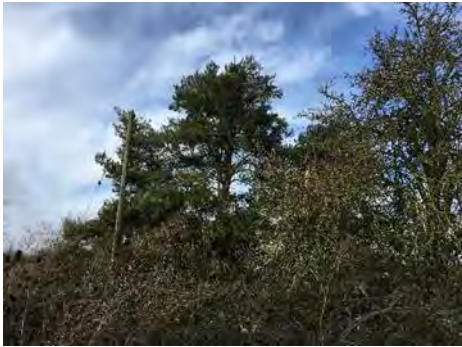
<p><b>Photograph 11</b> Overhead cable trailing on the ground noted at the western portion of the site.</p> </div> <div style="text-align: center;">

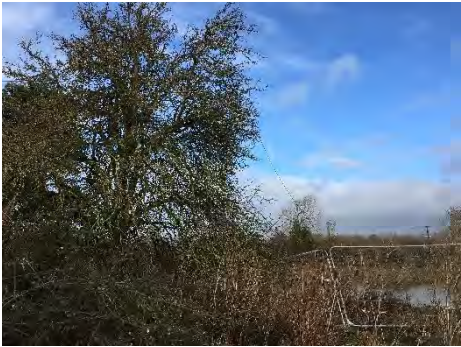
<p><b>Photograph 12</b> Overhead cable trailing on the ground noted at the western portion of the site.</p> </div> </div>

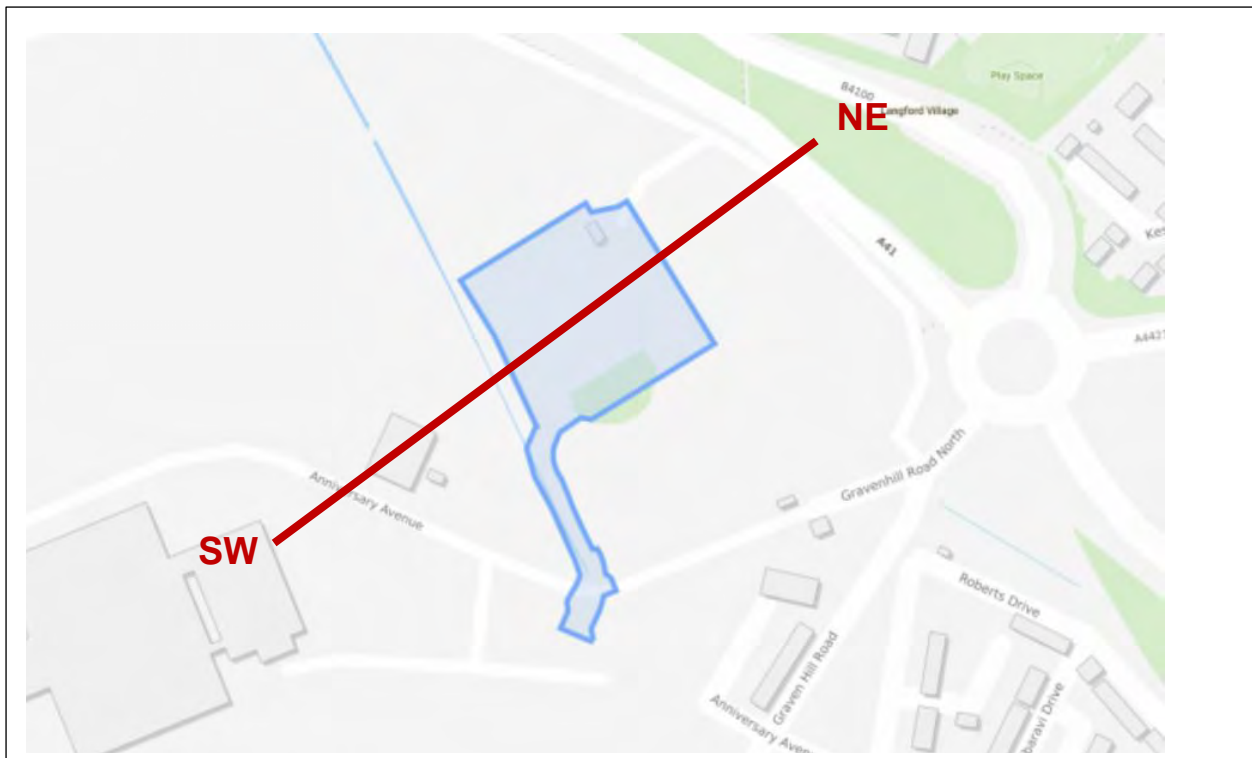
Figure 3.4.1 Trend Line of the Schematic Cross-Section

In order to identify potential pollutant linkages, a schematic section has been included below as Figure 3.4.2, with Figure 3.4.1 showing the trend line for the section.
