**Bat Survey Report for
Lane Head, Sibford Gower,
Oxfordshire, OX15 5RT**

3rd June 2021

Lane Head, Sibford Gower – Bat Survey Report

Report Number: 4047-CWS-01

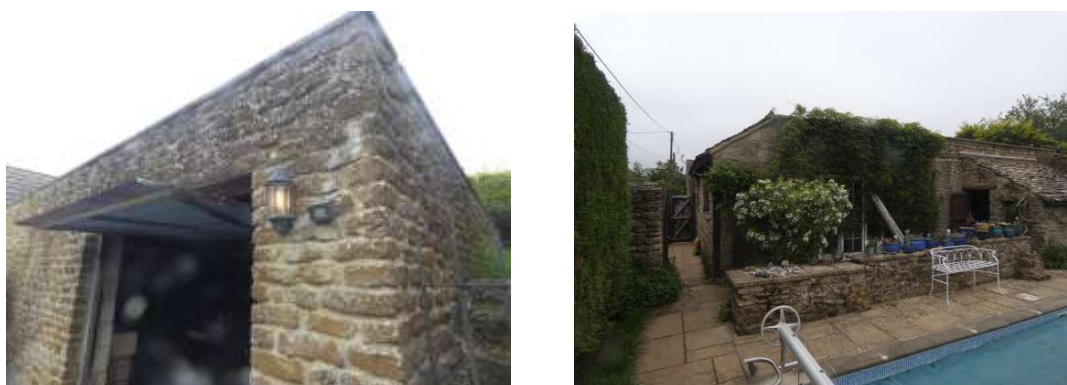
Figs. 1 & 2 Garage (L) and store (R)

The survey site comprised a large, flat roofed garage (Fig. 1) and an adjacent flat roofed store. Part of the latter included a short section of mono-pitched roof covered by stone tiles.

A small, stone lean-to with a mono-pitched stone tiled roof adjoined the east elevation of the store (Fig. 2).

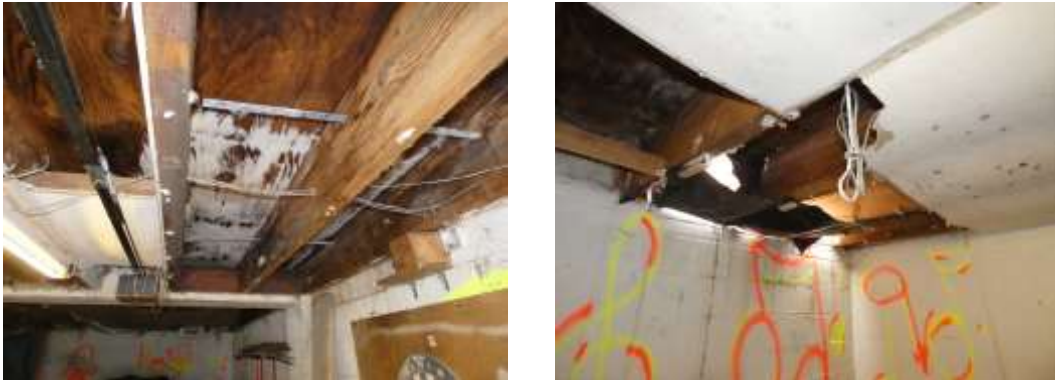
Figs. 13 & 14 Interior of garage

Internally the garage roof was in poor condition, with holes in the ceiling where the dryboard had become waterlogged and dropped off (Figs. 13 and 14). The whole structure was damp and cobwebbed and not suitable for bat roosting.

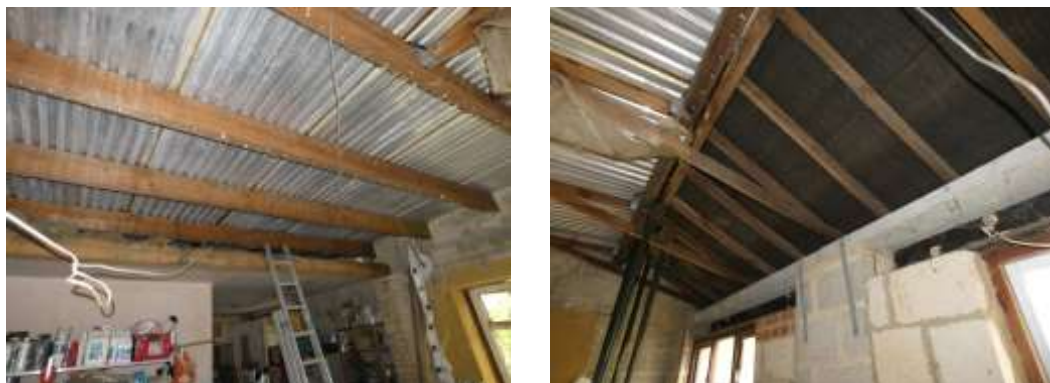
Figs. 15 & 16 Interior of store

Except for the stone tiled section at the front, which was lined with tarred felt, the roof of the store was unlined and open to the underside of the corrugated metal sheets (Figs. 15 and 16).

Despite a thorough search, no evidence of bat activity was found, and the building was considered to be unsuitable for bat roosting.

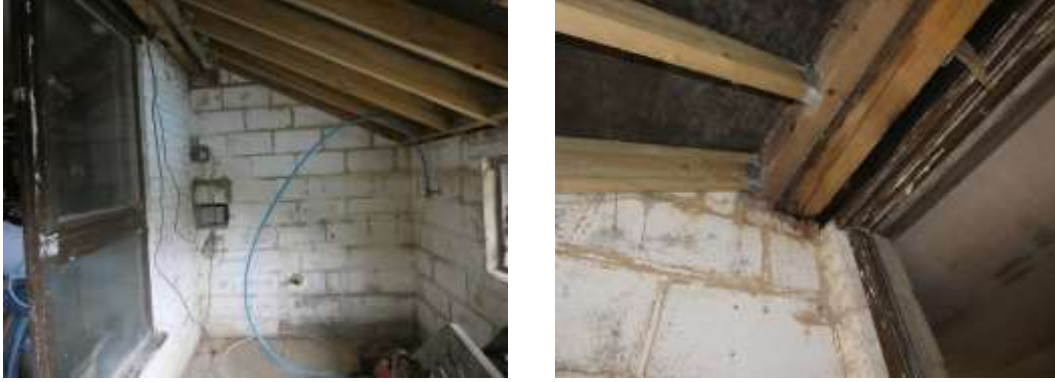
Figs. 17 & 18 Interior of stone lean-to

The adjoining lean-to was open to the tarred felt lined roof, this intact and un-torn and quite heavily cobwebbed (Figs. 17 and 18). The eaves were closed and the window casements and door frame were tightly fitting. There was no bat access to the interior of the lean-to, and no evidence of bat use was found.
