**Tappers Farm, off Oxford Road,
Bodicote, Banbury, OX15 4BN**

GROUND INVESTIGATION – BRE365 INFILTRATION TESTING

Green Square Group

September 2021

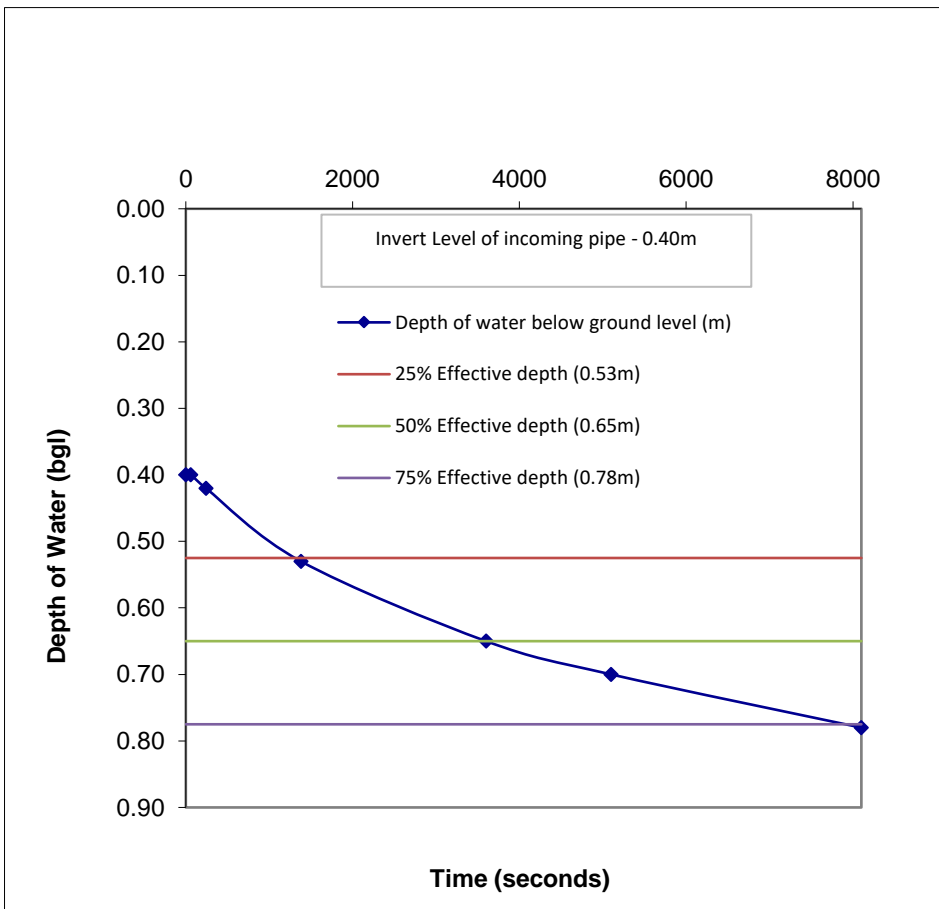
Infiltration Test to BRE365 - SA1 TEST 1

Location: SA1 **TEST 1**
Weather: Bright and sunny
Engineer: TN
Date: 16/08/2021

Strata Tested Marlstone Rock Formation

$$f = \mathbf{1.31E-05} \text{ m/s}$$

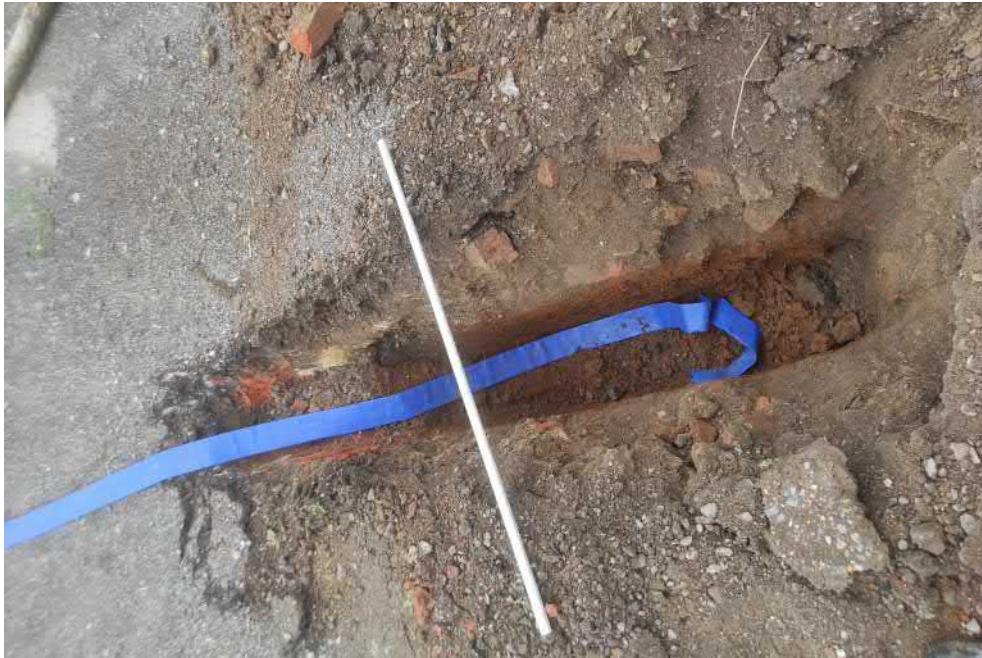
Photograph of trial pit SA1.

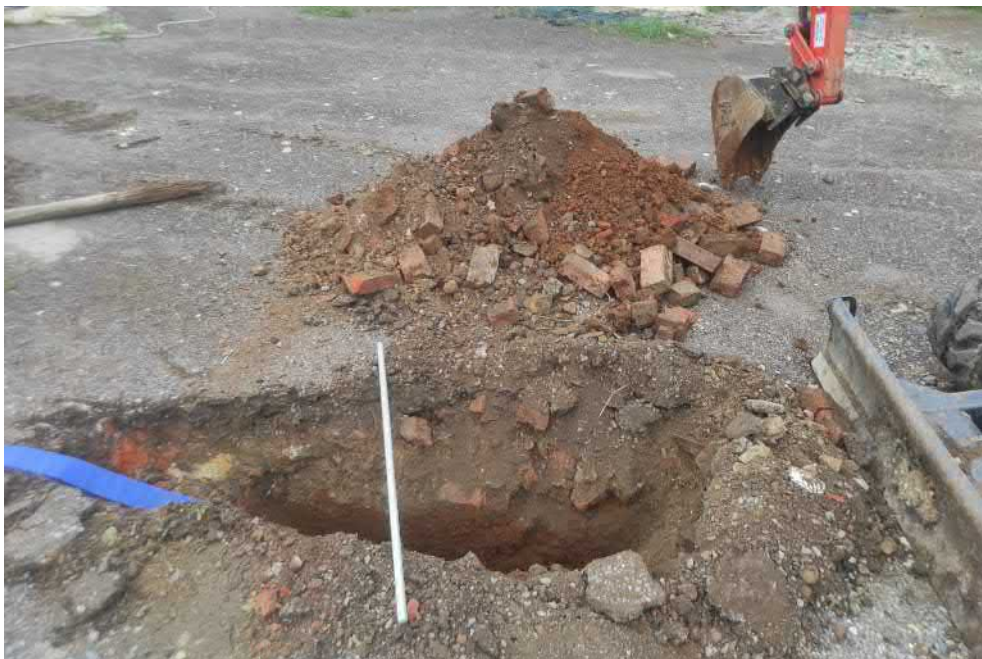
Photograph of arisings from trial pit SA1.

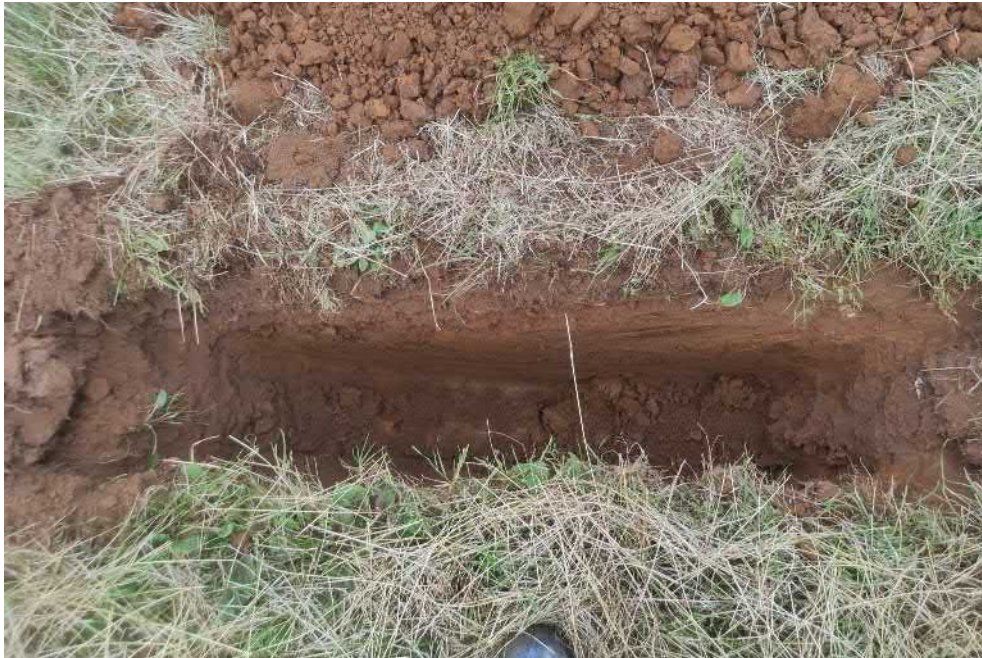
Photograph of trial pit SA2.

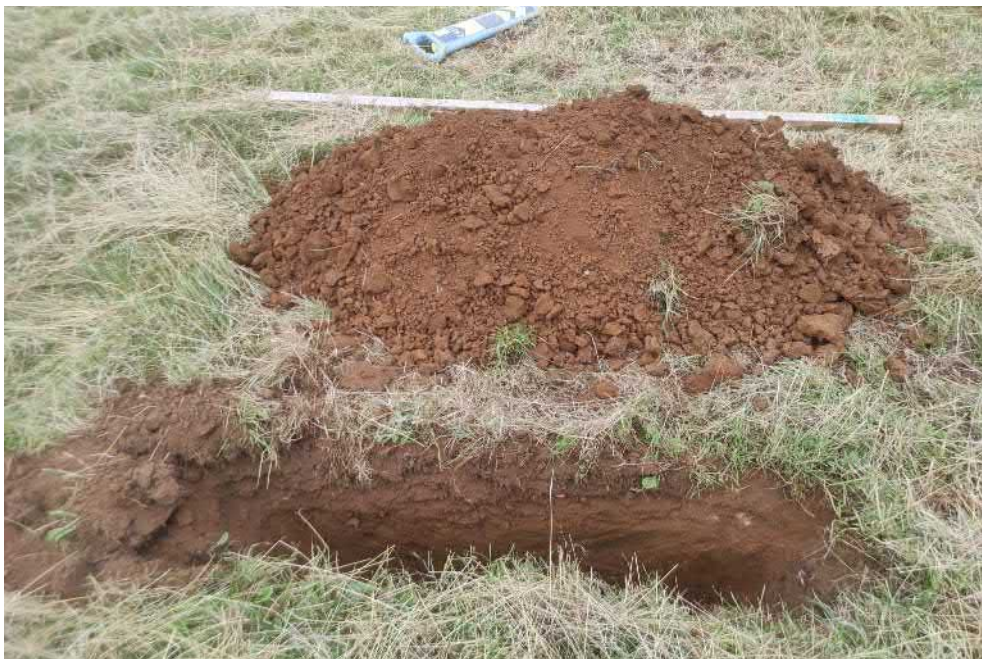
Photograph of arisings from trial pit SA2.

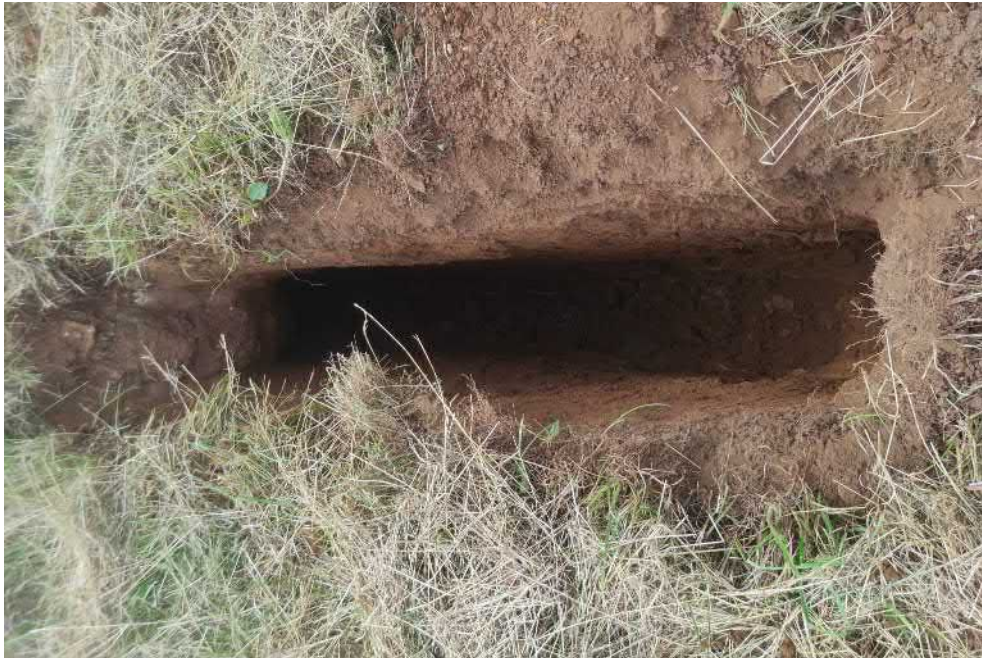
Photograph of trial pit SA3.

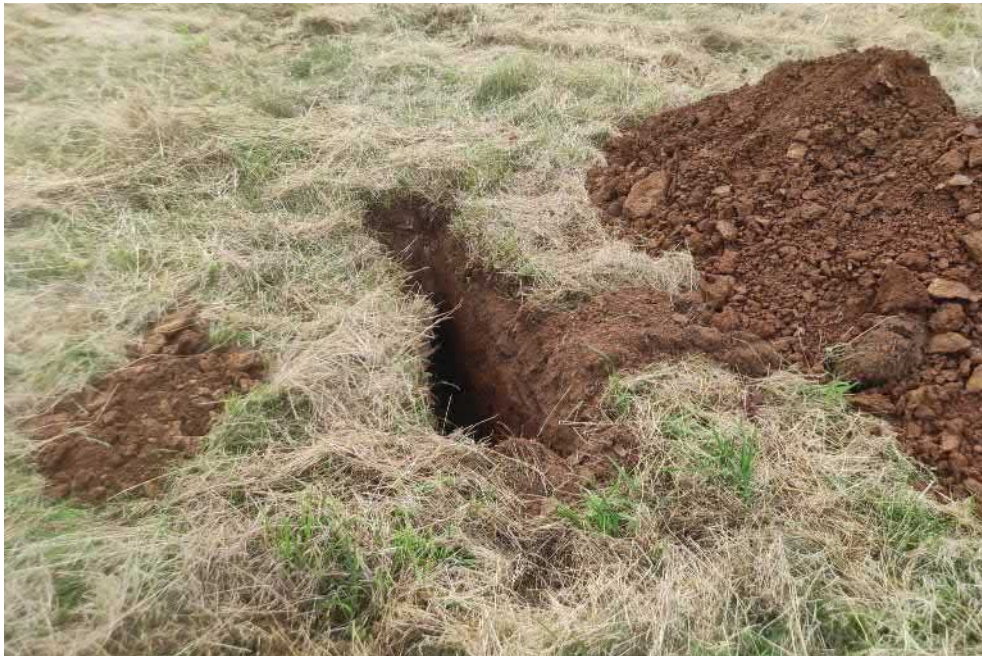
Photograph of arisings from trial pit SA3.

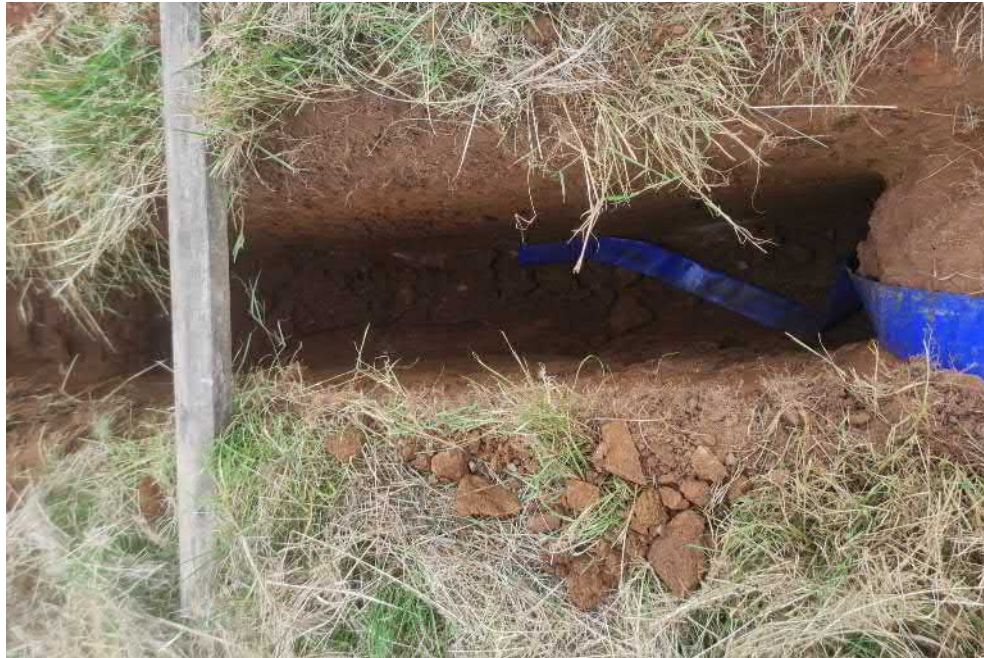
Photograph of trial pit SA4.

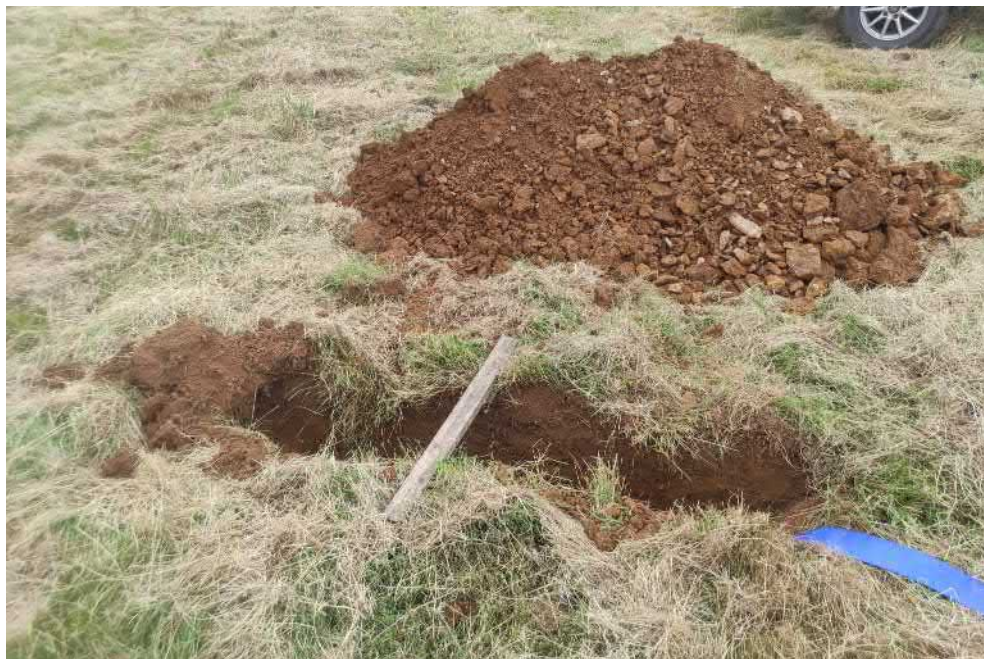
Photograph of arisings from trial pit SA4.

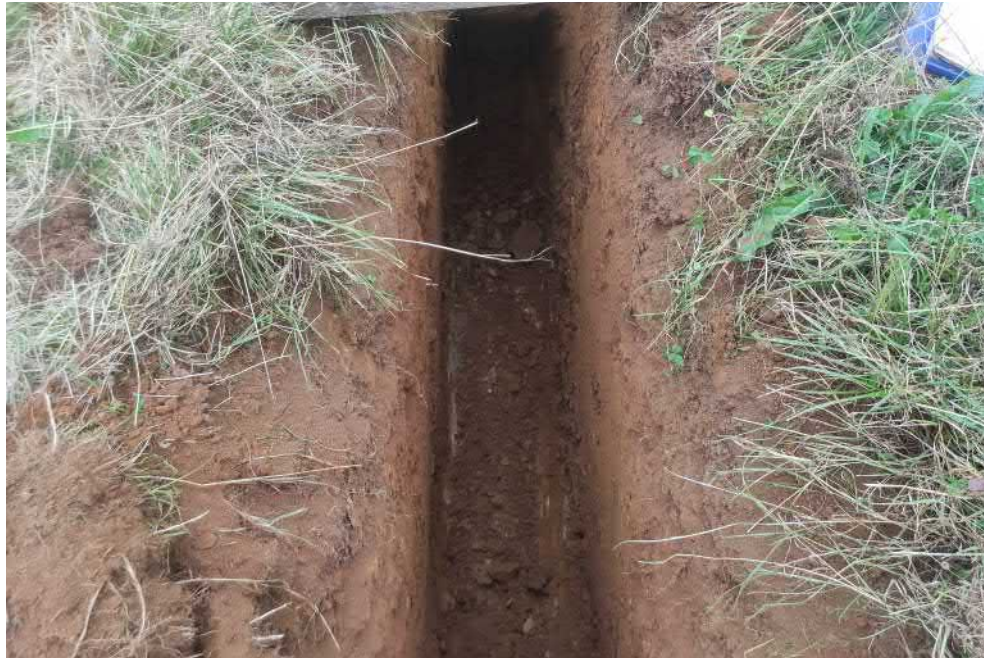
Photograph of trial pit SA5.

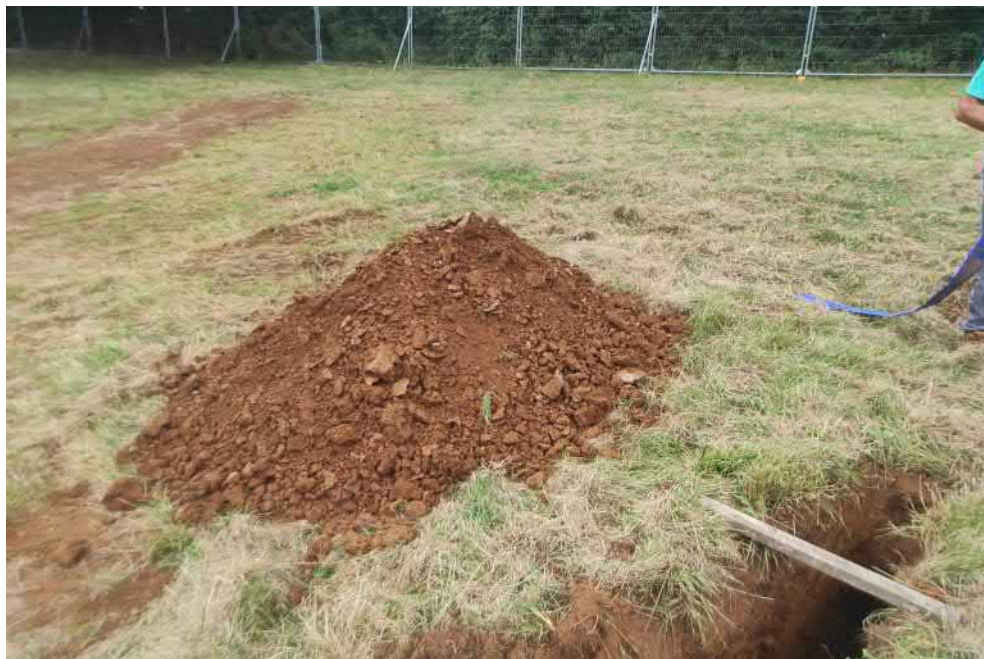
Photograph of arisings from trial pit SA5.

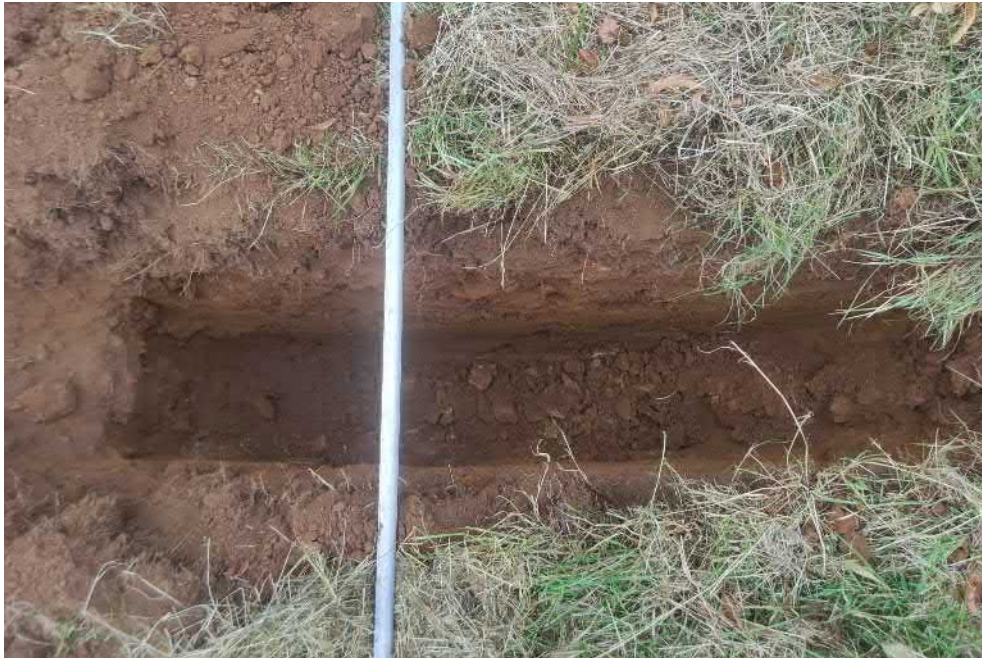
Photograph of trial pit SA6.

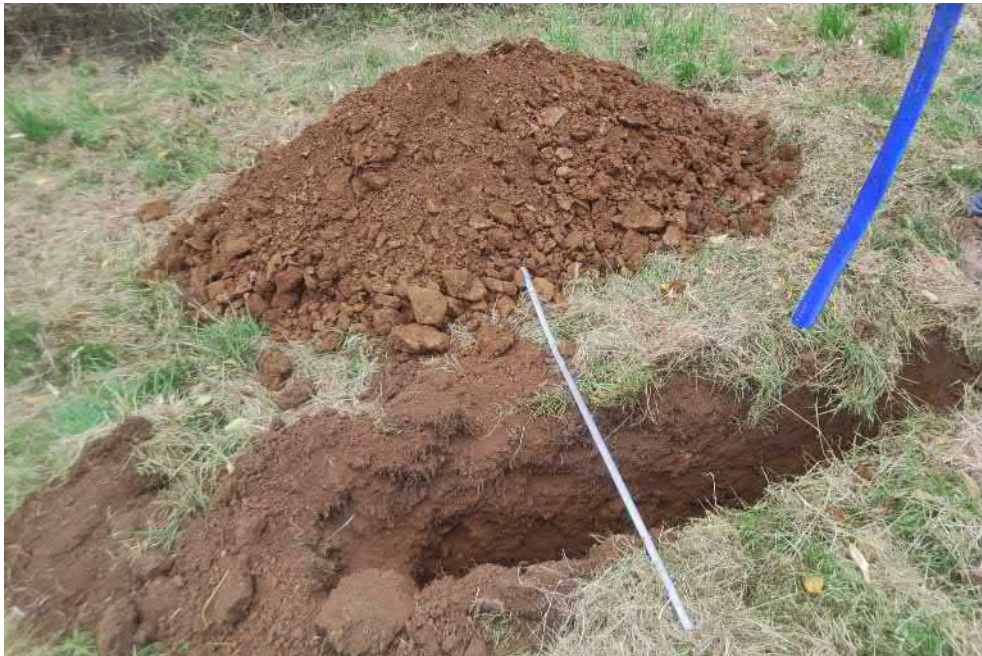
Photograph of arisings from trial pit SA6.

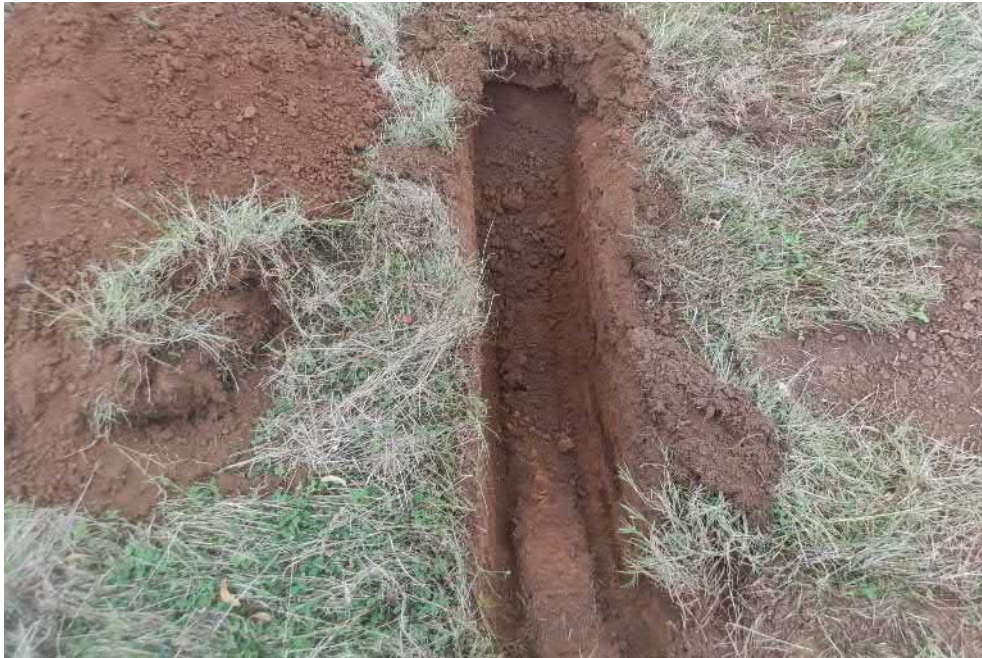
Photograph of trial pit SA7.

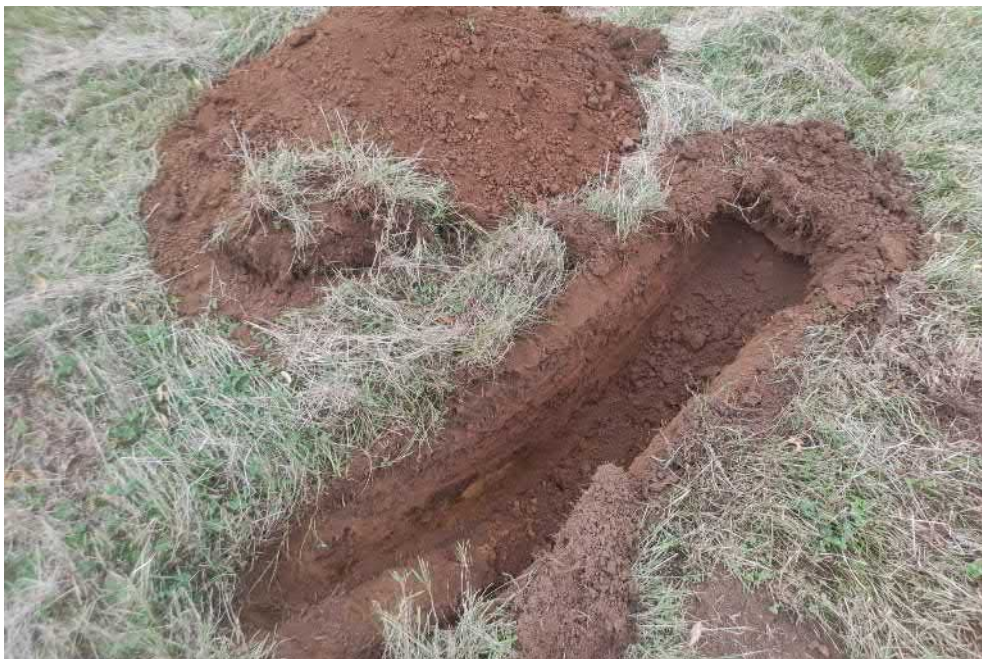
Photograph of arisings from trial pit SA7.

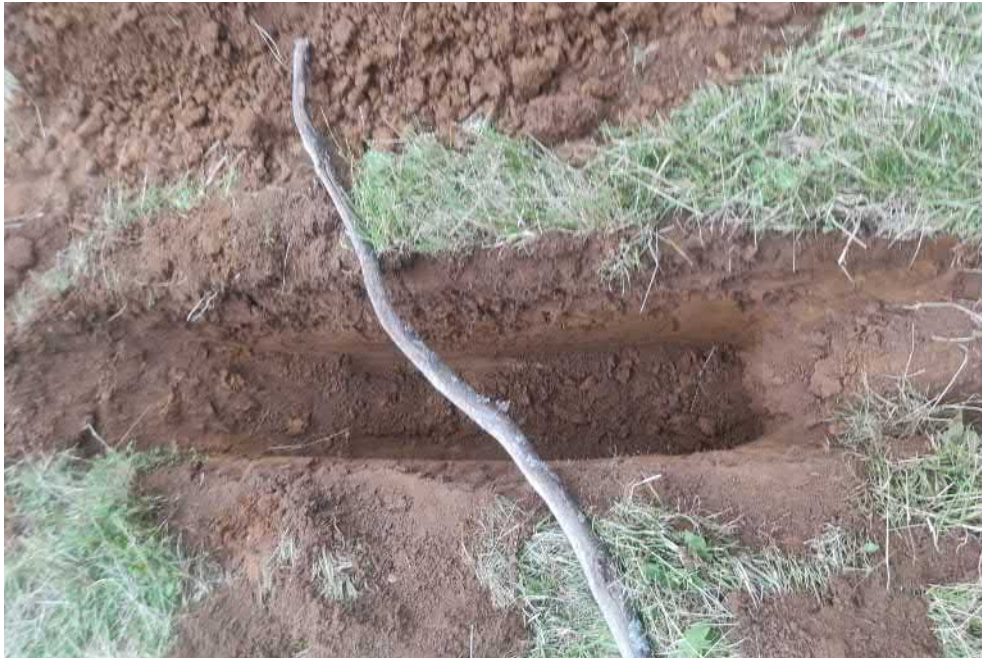
Photograph of trial pit SA8.

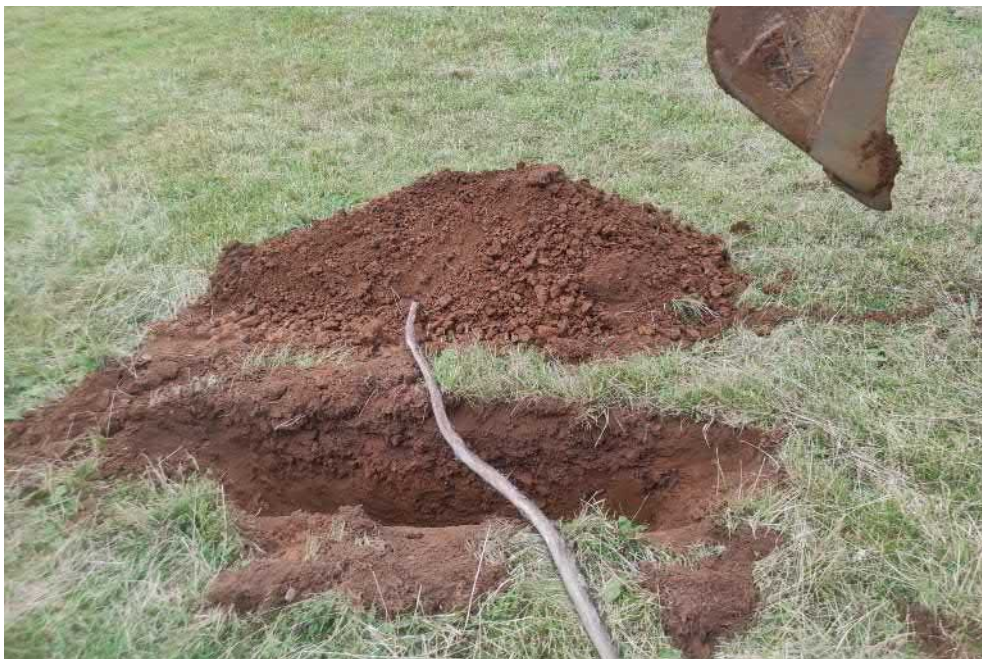
Photograph of arisings from trial pit SA8.
