BS5837:2012 ARBORICULTURAL IMPACT ASSESSMENT & METHOD STATEMENT

LAND AT TAPPERS FARM,
OXFORD ROAD, BODICOTE, BANBURY,
OXFORDSHIRE, OX15 4BN

GREENSQUARE HOMES LTD

Focus Environmental Consultants

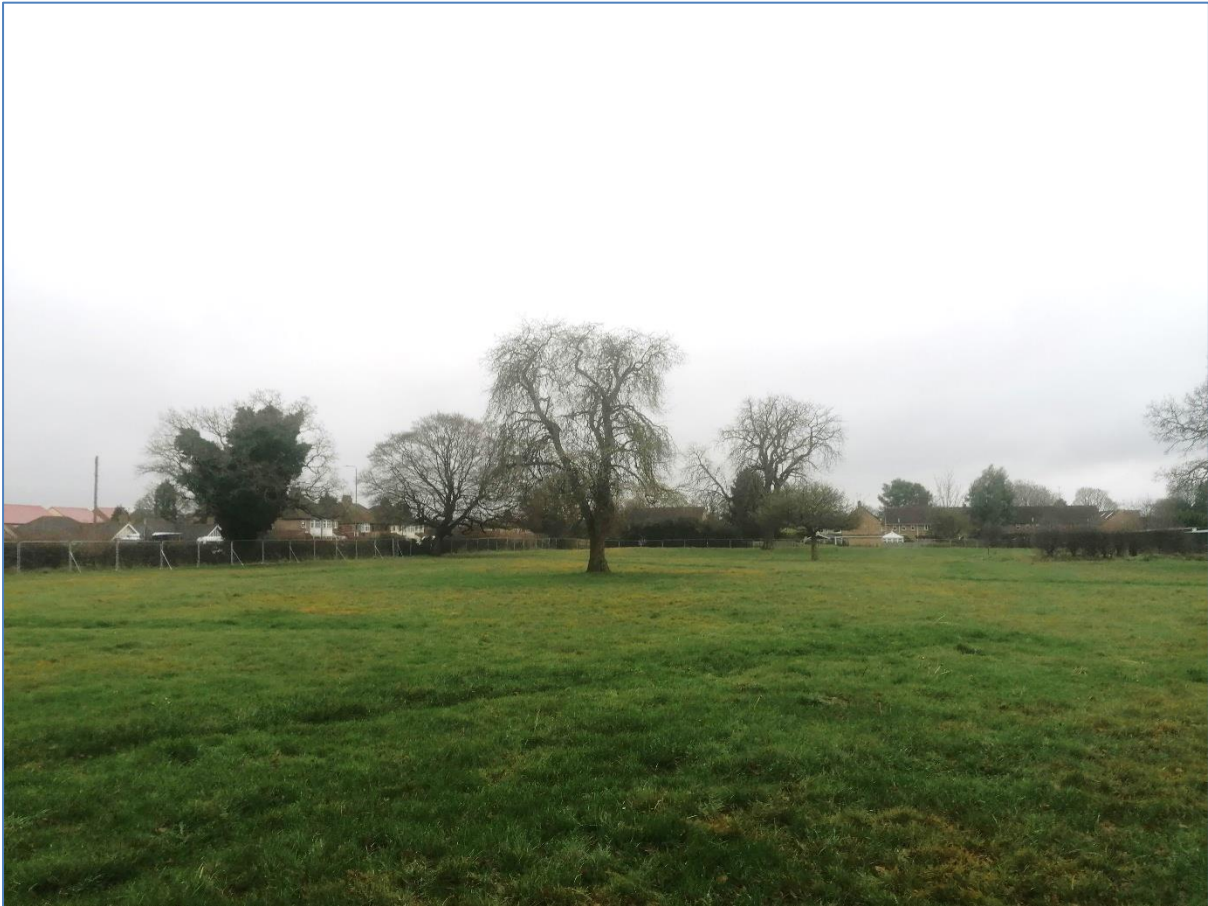
Plate 8: central location and reduced form of T8.

Aesculus x carnea is not a long-lived species and given the life stage of the tree and structural defects noted on the stem and within the crown, it is unlikely that the tree has more than 10 years useful life expectancy remaining. As such, extensive redesigning of the site to retain the tree within a public open space is likely to result in a dead or partially collapsed tree within a focal position of the site within 10 years.

Furthermore, the loss of the tree will not have a significant impact on the character and appearance of the wider area, and therefore the proposed development seeks to remove and replace the tree to improve the quality of the layout of the site and provide an improved replacement TPO tree for future generations.

The loss of the horse chestnut tree T8 has been specifically considered within the landscape proposals, with a clear stem *Liquidambar* tree (14 – 16cm girth, 4.5 – 5m height) planted as a specimen tree within public open space south of Plot 43 to provide internal visual amenity benefits. Given the proximity to the front garden of Plot 43 and concerns this may present future requests for crown management, the replacement TPO has been presented west of the site entrance, the walnut tree (*Juglans regia* 14 – 16cm, 4.5 – 5m) which has ample room from adjacent plots and is located within a prominent position framing the site entrance.

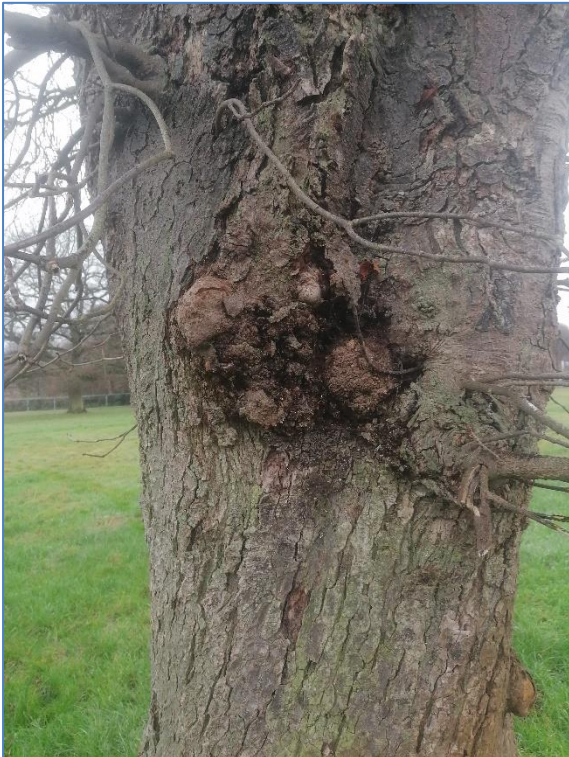
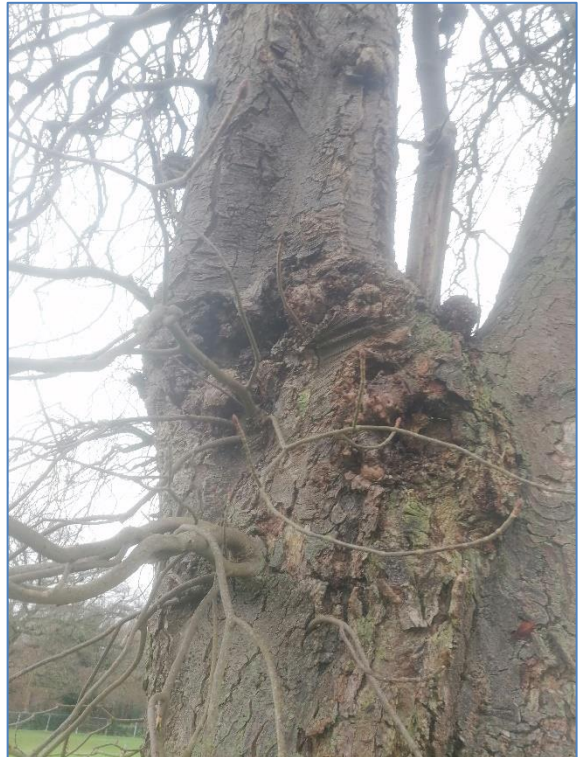
Close inspection of the tree found basal damage and decay from livestock impacts, bark necrosis and major stem canker formation on the main stem, seven large diameter target cankers on co-dominant stems and the scaffold limbs of the tree; two of which were at the base of major stem of scaffold limbs unions.

Plates 11 & 12: target cankers at the base of and within acute angle co-dominant stem attachments on T8.

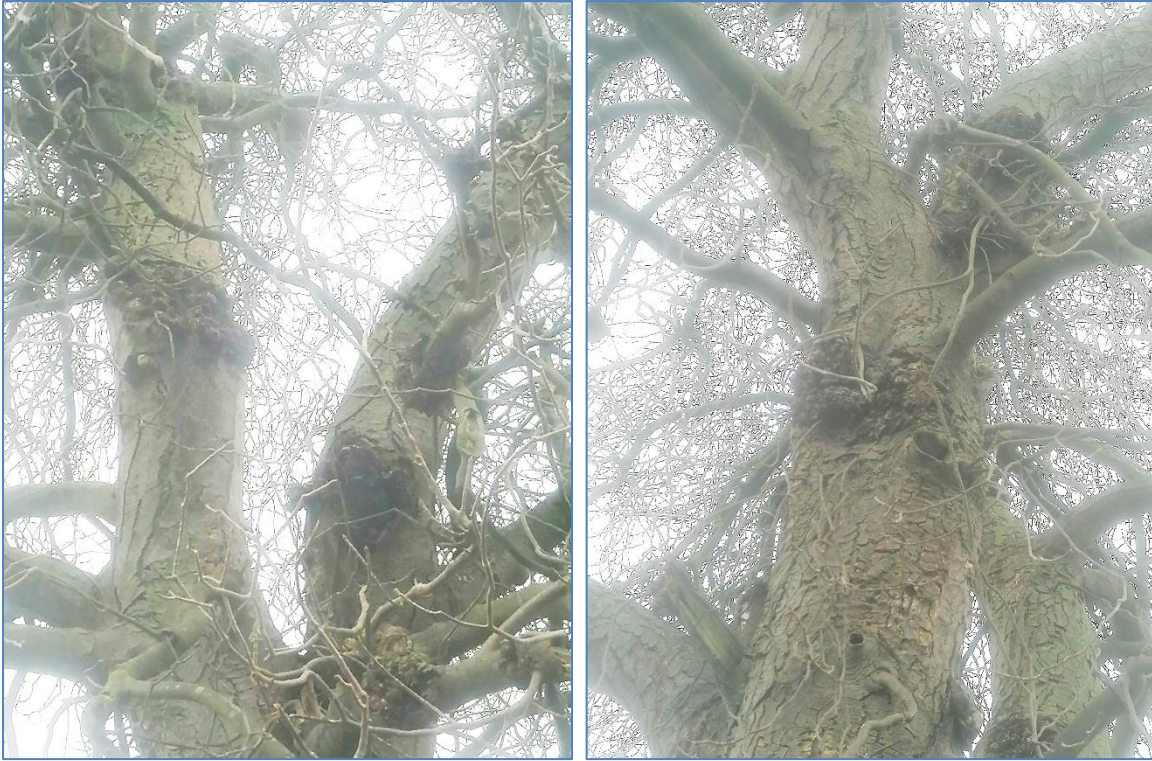
Plates 13 & 14: further cankers and structural defects noted within the crown of T8.

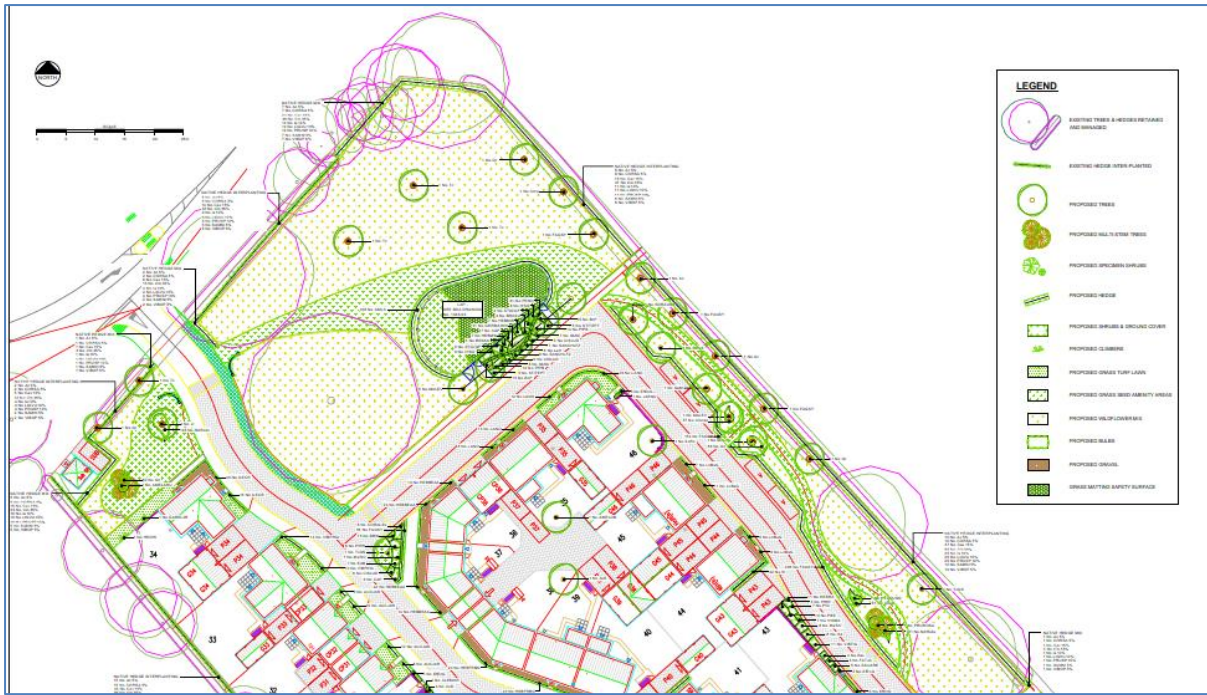
Plate 18: extract from the landscape plan showing proposed planting to the north of the site.

The proposed tree planting strategy includes 44 heavy or extra heavy standard trees (12 – 16cm girth, 4 – 6m height) which will have an instant impact on the site.

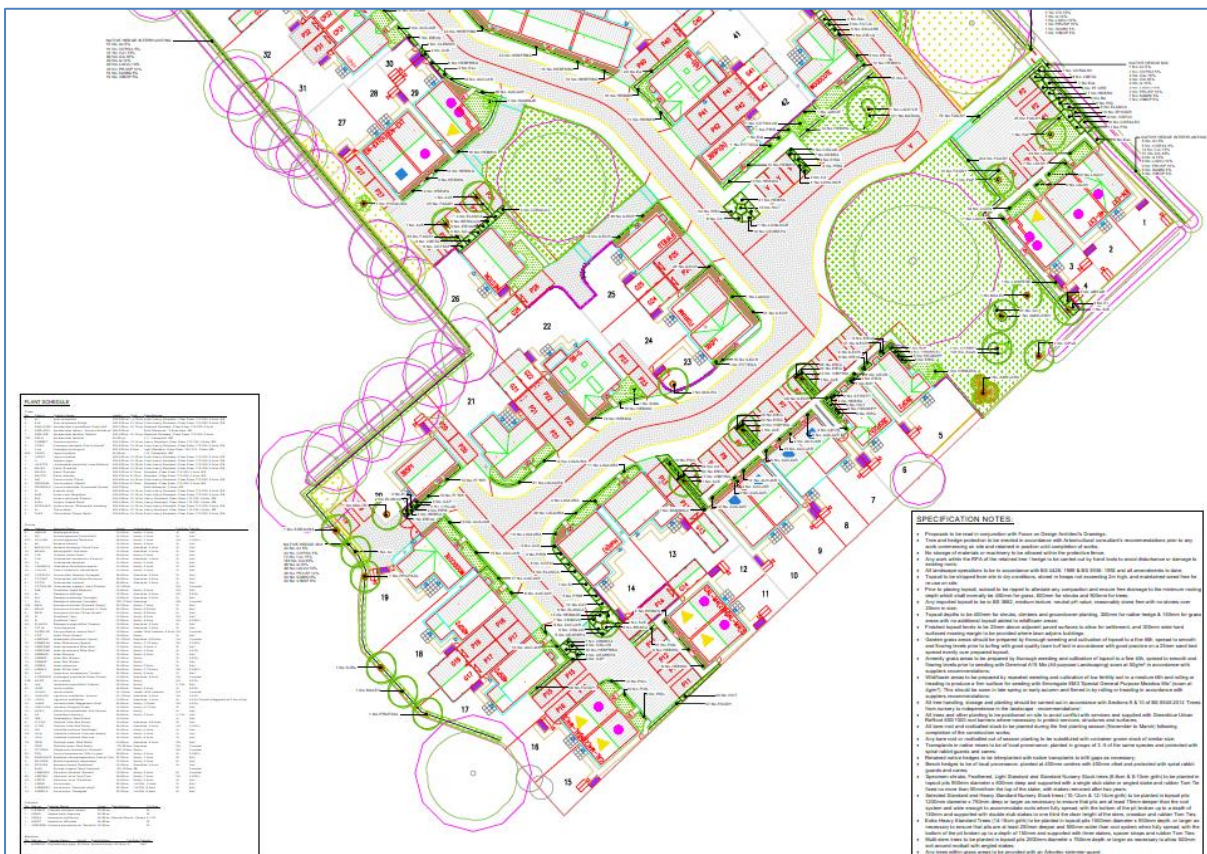
Plate 19: extract from the landscape plan showing the south of the site. Full detail may be found within the landscape submission by Bridges Design Associates Ltd.

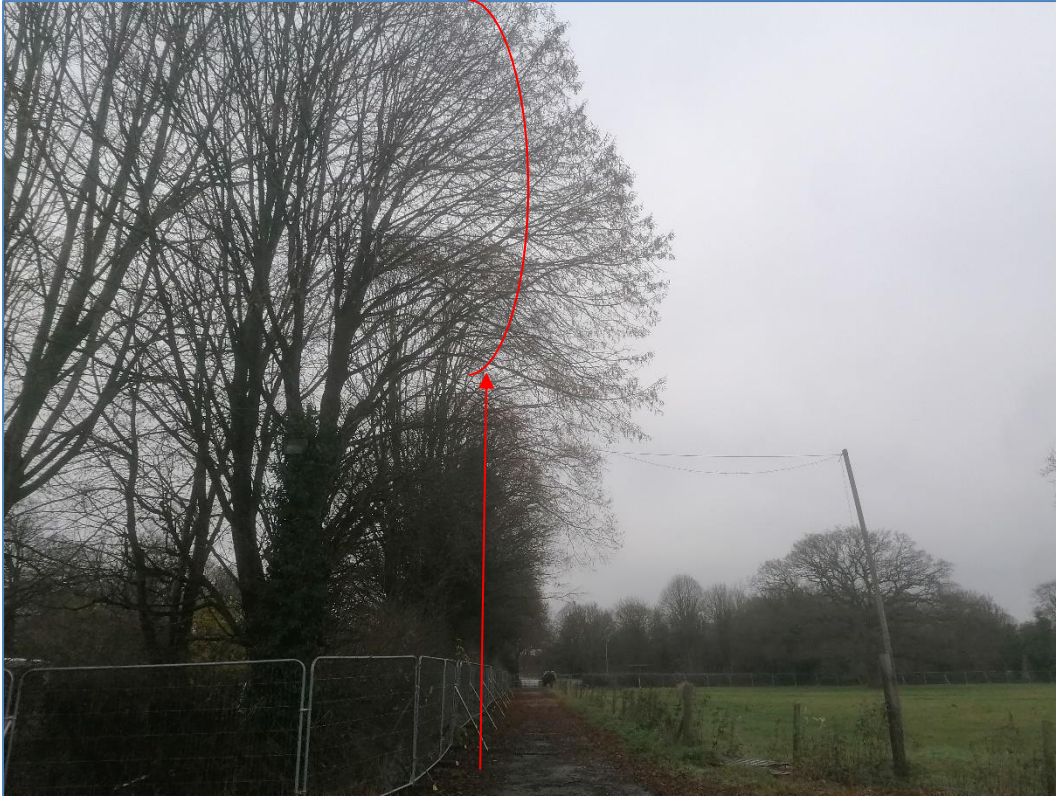
Plate 20: proposed 4m vertical clearance over site and 2m crown reductions to formalise boundary trees T18 – T35.

The offsite lime trees T18 – T35 will be crown lifted to 4m over the site (the majority have already been lifted to this height). Branch tips within the upper canopy will be reduced back to 3.5m from the tree stems (an average crown reduction of circa 2m) to formalise the boundary, reduce shading / overhang of private amenity spaces and allow future cyclical management. The pruning specification is in line with both British Standard 3998: 'Tree Work Recommendations', and common law rights.

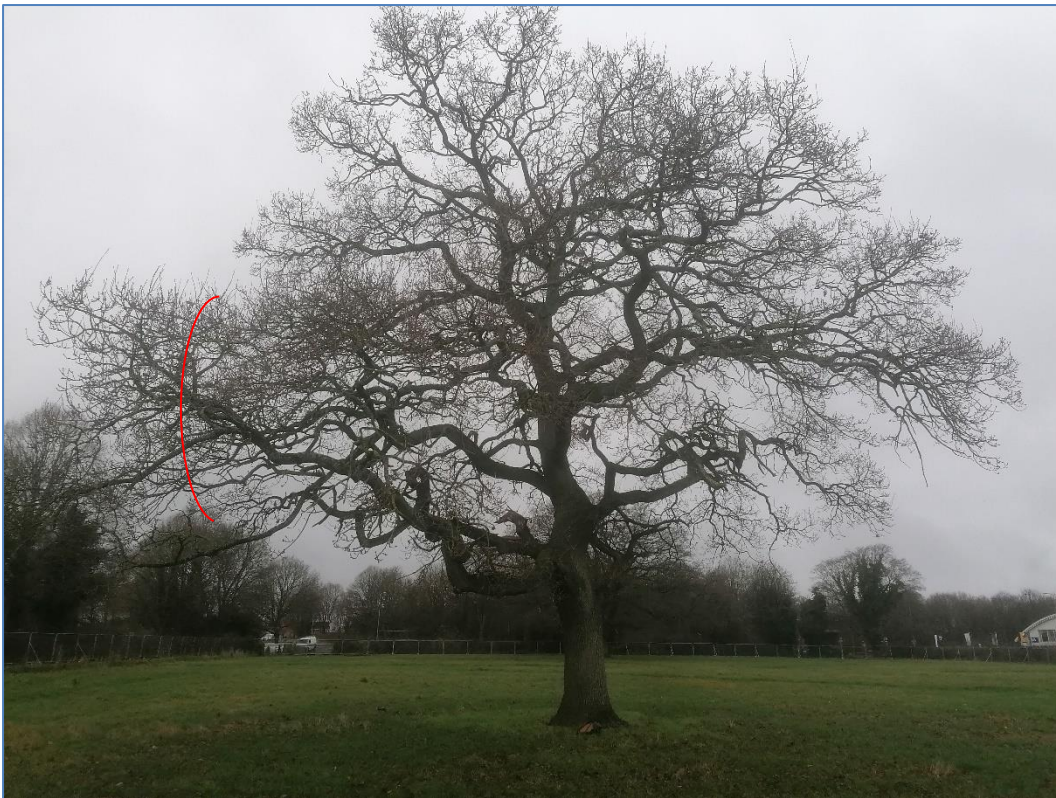
Plate 21: 2m crown reduction of extended lower lateral to balance form of T7.

The oak tree T7 will have the western aspect of the crown reduced by 1.5 – 2m, depending on the most suitable branch junction, by pruning the extended lowest lateral limb which extends beyond the crown extent and will be managed to balance and the form of the tree within the proposed amenity space.

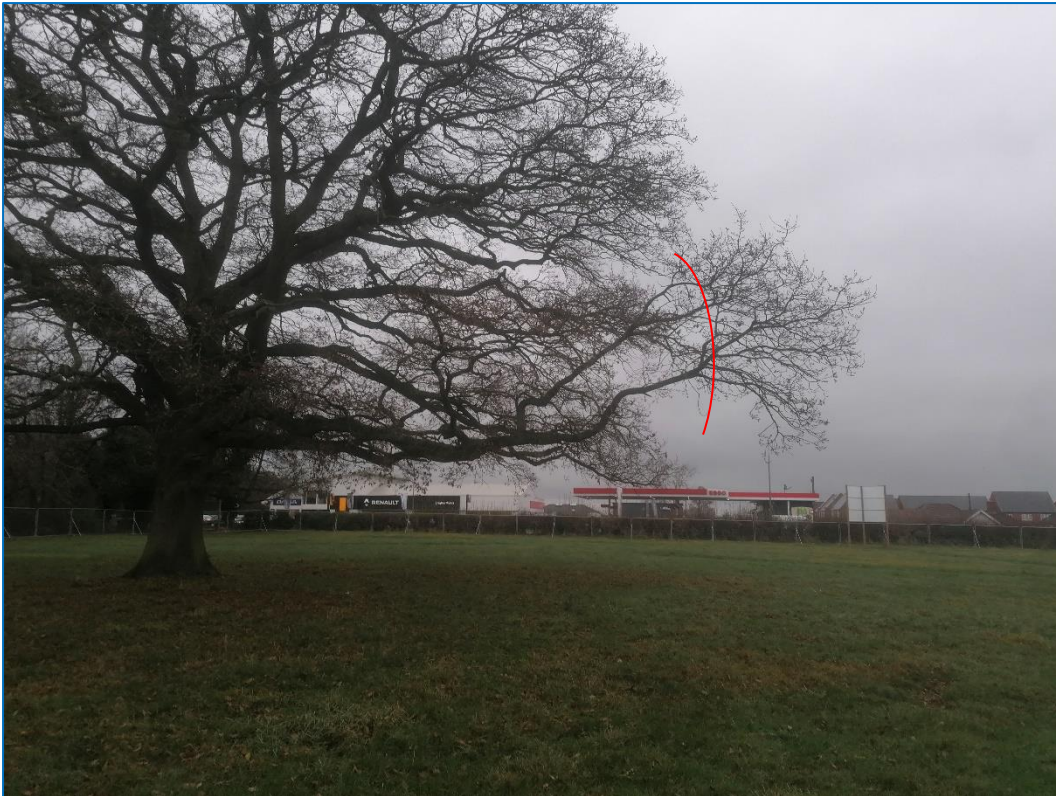
Plate 22: 2m crown reduction of extended lower lateral to balance form of T9.

The extended lower lateral limb of T9 will also be reduced by 2m on the southern aspect of the crown to balance the form of the tree and provide clearance from the proposed road.

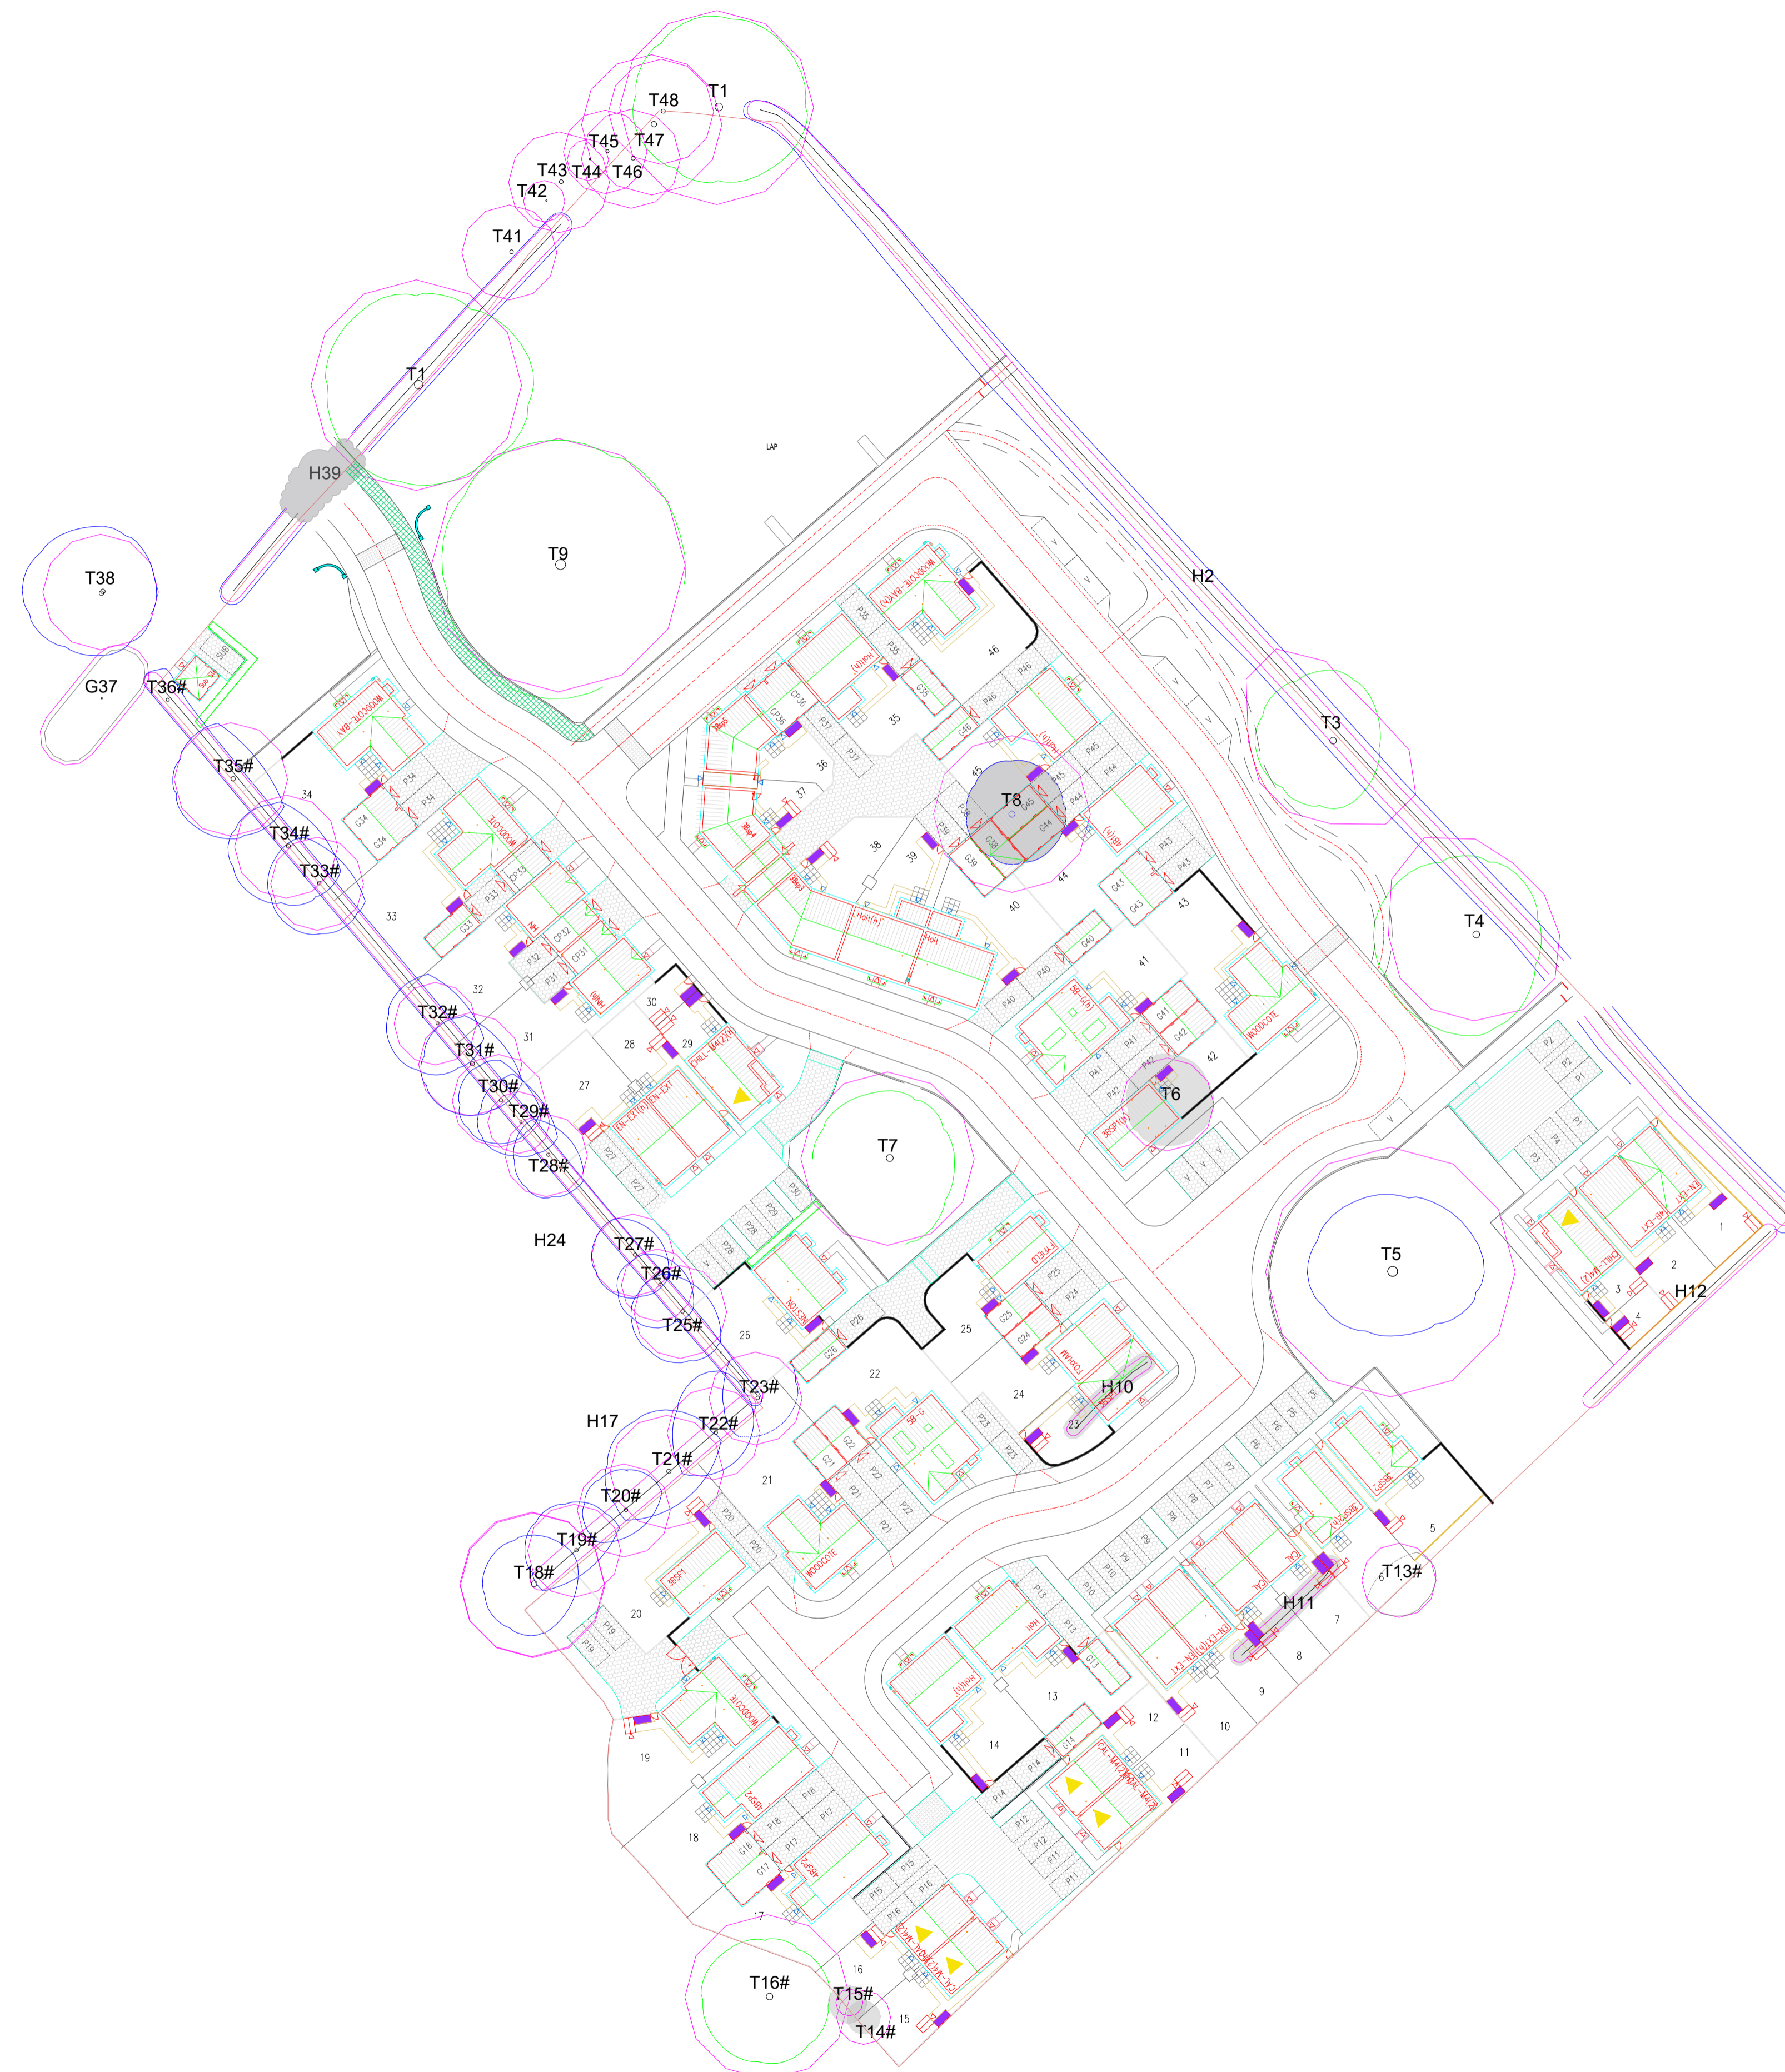
Proposed Layout and Tree Removals

**Trees to be removed shown shaded**

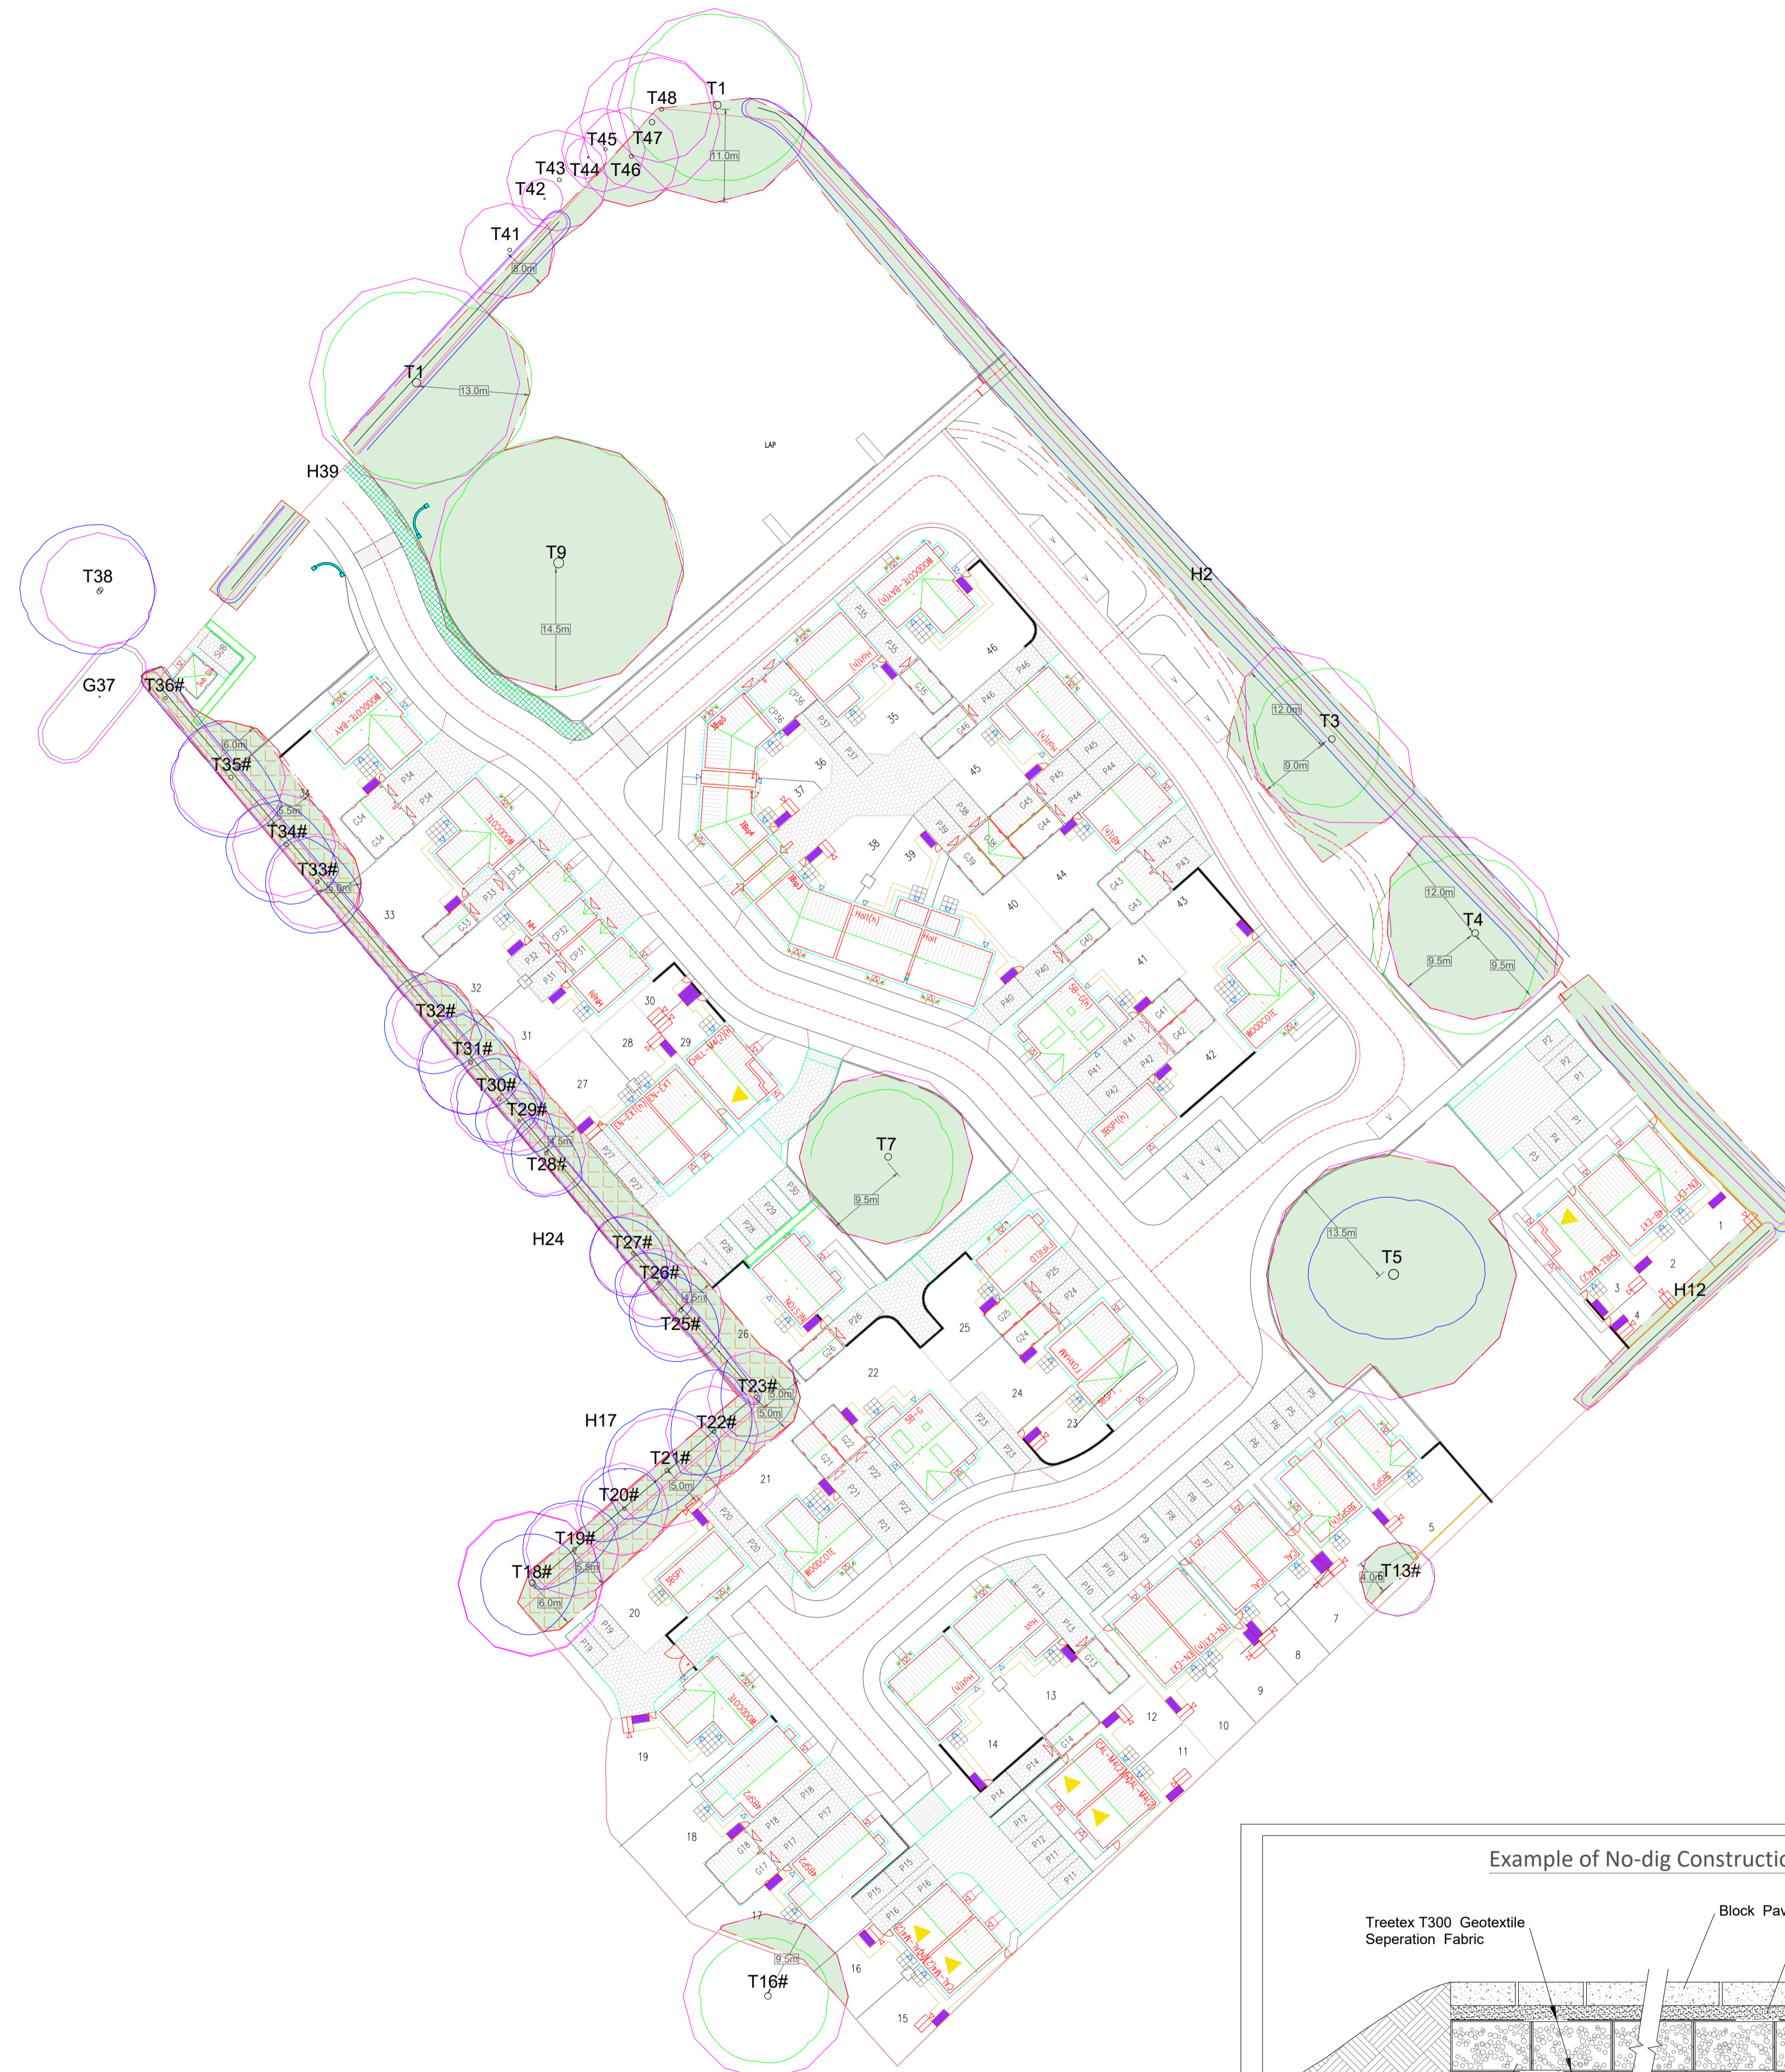
Tree Protection Plan

- Position of protective fencing and tree protection zones.
- CelliWeb or other Low impact path with porous surfacing, tree protective fencing adjusted to install at landscaping stage.
- Existing hard surfacing be completed in a sympathetic manner. A machine mounted mechanical breaker will be used to break up the hardstanding surfaces. The machine will be positioned either outside of the RPAs or upon the existing hardstanding, working its way backwards so that it does not need to move over areas of newly exposed ground. A machine no larger than two-tonnes with a flat edged bucket will then be used to carefully scrap away the broken up debris and remove it from the RPAs taking care to not disturb any of the soil below.

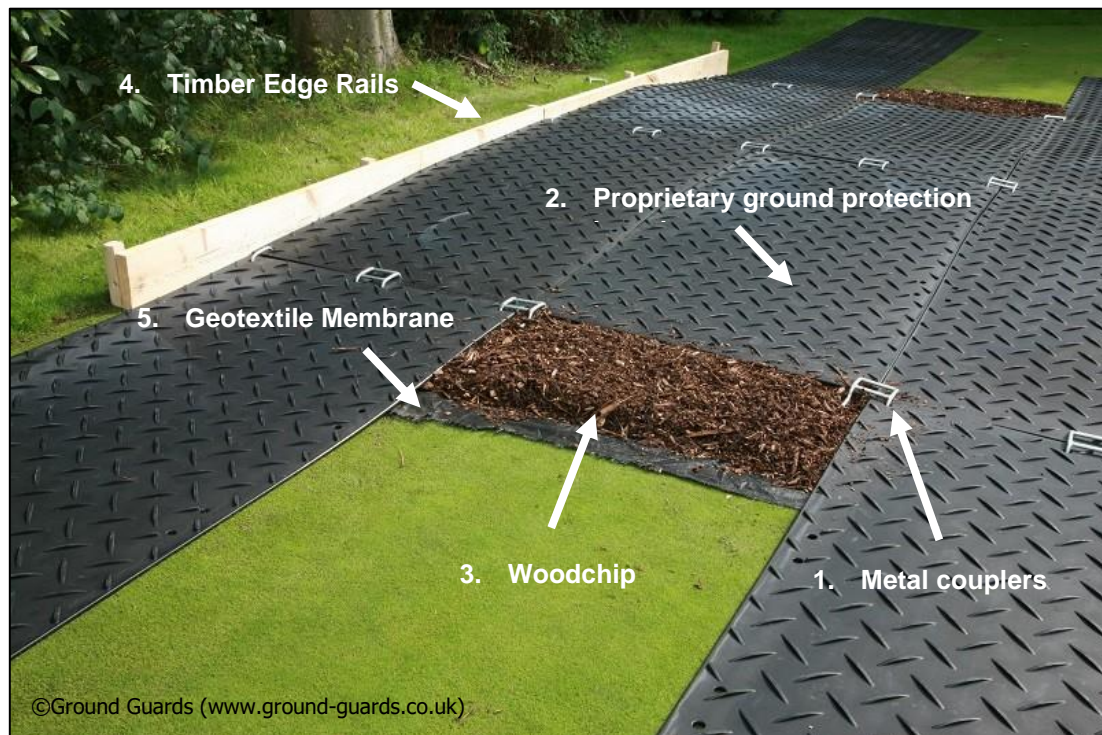
5.5.4 Temporary Ground Protection

Temporary ground protection will be capable of tolerating pedestrian-operated plant up to a gross weight of 2 t. Machinery of a weight greater than 2 t will be prohibited from moving over these areas.

1. Timber edge rails at 200 mm high x 50 mm wide will be secured to the ground with timber stakes. Timber stake dimensions will be 50 x 50 x 500 mm and will be positioned at 1 m spacings. Timber edge rails will be installed at both sides of the ground protection's specified position.
2. A geotextile membrane will be laid on the ground between the timber edge rails.
3. A layer of woodchip at a depth of 150 mm will be laid upon the geotextile membrane.
4. Proprietary ground protection boards at 1200 mm wide x 2400 mm long will be laid upon the woodchip. A single row of boards will be used to cover the areas specified for 1.2 m wide temporary ground protection. Two rows of boards laid next to each other with no gaps between will be required in areas specified for 2.4 m wide temporary ground protection.
5. The ground protection boards will be secured together using metal couplers.

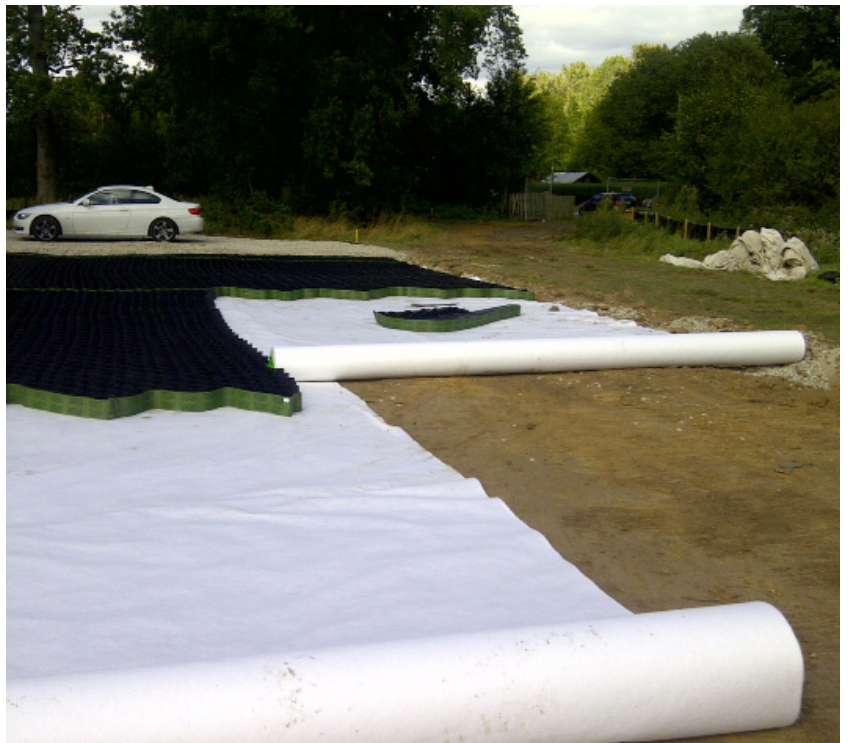
Harcourt Aboretum

The Treetex[®] geotextile used in the CellWeb TRP[®] system has two functions. Treetex[®] separates the sub base aggregates from the soil beneath and it traps oil within its structure and allows it to degrade aerobically within the pavement construction. The structure, thickness and weight of Treetex[®] creates the perfect environment for this to happen. Most importantly tests prove that Treetex[®] will absorb 1.7 litres of oil per square metre, this is 4 times more effective than standard geotextiles.

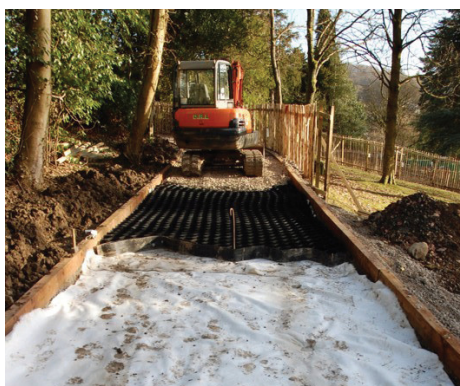
Fallbarrow Park, Windermere:
CellWeb TRP® Installation

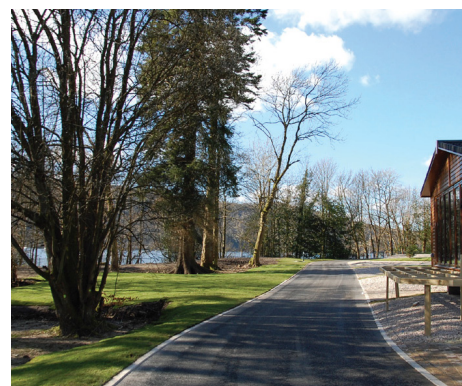
Fallbarrow Park, Windermere:
Completed CellWeb TRP® Installation
