PHASE I AND PHASE II INVESTIGATION

LAND OFF FEWCOTT ROAD, FRITWELL, OXFORDSHIRE. OX27 7QA

Prepared for: Cala Homes (Chiltern) Ltd

Report Reference: BC195 RE001 31st January 2021

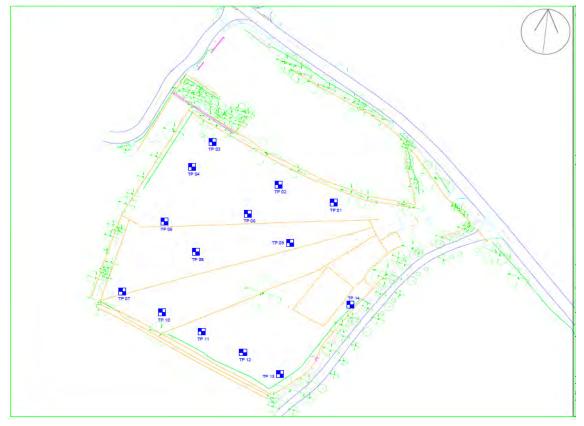
The investigation comprised 14No. mechanically excavated trial pits denoted TP1-TP14 (incl.) to a maximum depth of 2.50m. Their locations are presented on the drawing overleaf.

Made Ground was encountered in TP7 and TP10 – TP14 (incl.) to a maximum depth of 1.80m in TP13. The thickest sequences of Made Ground were encountered along the south western boundary of the site. This raised area was associated with the line of the foul sewer.

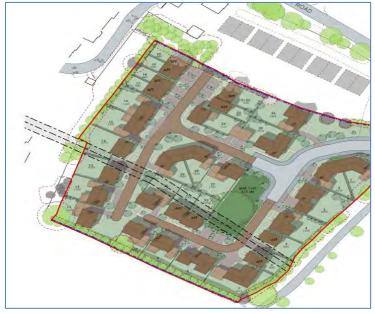
Line of sewer crossing east-west across the site.

We understand that the existing foul sewer is being decommissioned and replaced slightly further to the north. The proposed new route is denoted on the Exploratory Hole Location Plan and the drawing entitled Preliminary Drainage Strategy in Appendix A. This will require disturbance of asbestos contaminated soil and thus a licensed asbestos contractor will be required to oversee this work.

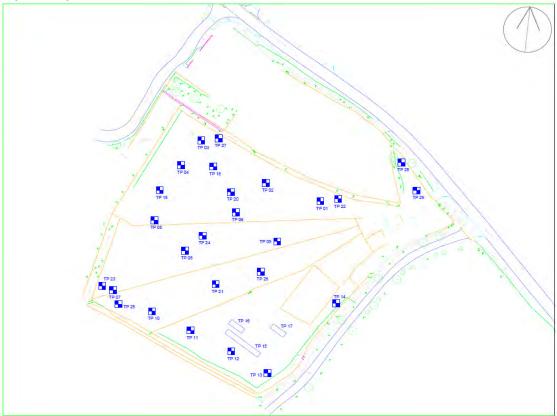
Exploratory Hole Location Plan 4th March 2016.

The findings of the Desk Top Study are reproduced in Section 4 – 8 (incl.) below. Supplementary intrusive fieldwork was carried out on 4th March 2016 and comprised 15No. mechanically excavated trial pits denoted TP15-TP29 using a JCB 3CX. TP15, TP16 and TP17 comprised of trial trenches excavated in a northwest-southeast orientation. Their locations are presented on the drawing below:-

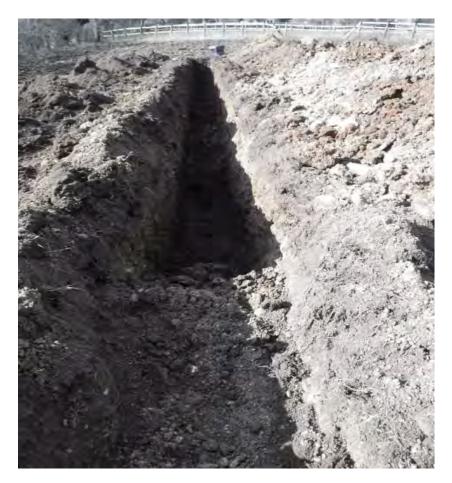
Trial Trench TP15 looking North West

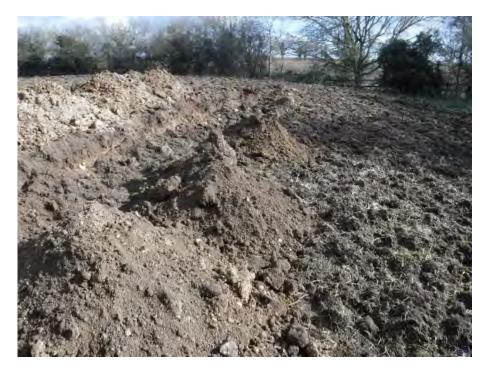
Trial Trench TP15 looking South East

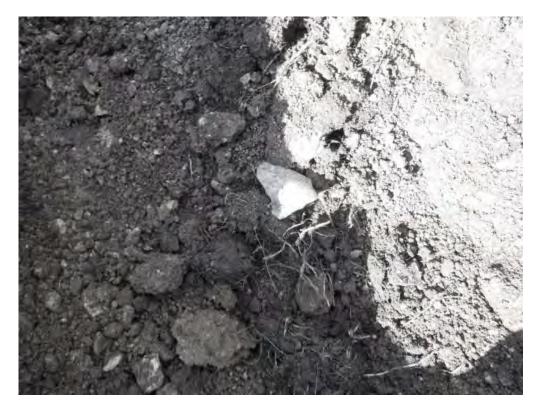
In trial trench TP15, rare fragments of ACM were observed. However 3No. tubs of soil matrix were submitted to analysis for asbestos at depths of 0.50m, 0.70m and 0.90m bgl from various lengths along the pit extending in a south-easterly direction. Asbestos fibres were not recorded.

In trial trench TP15, during the supplementary contamination investigation, rare fragments of ACM were observed. 3No. tubs of soil matrix were submitted to analysis for asbestos at depths of 0.50m, 0.70m and 0.90m bgl from various lengths along the trench extending in a south-easterly direction. Asbestos fibres were not recorded.

Suspected ACM - Trial Trench TP15

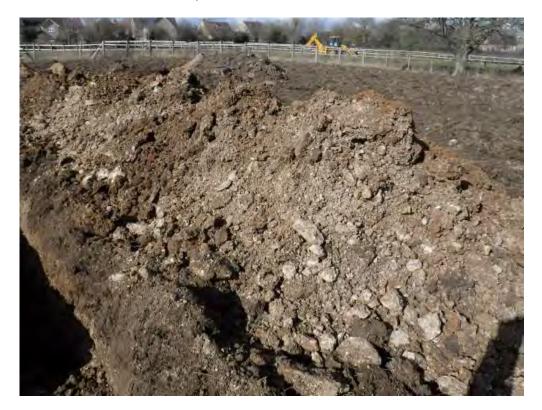
Trial Trench TP15 stockpiled arisings

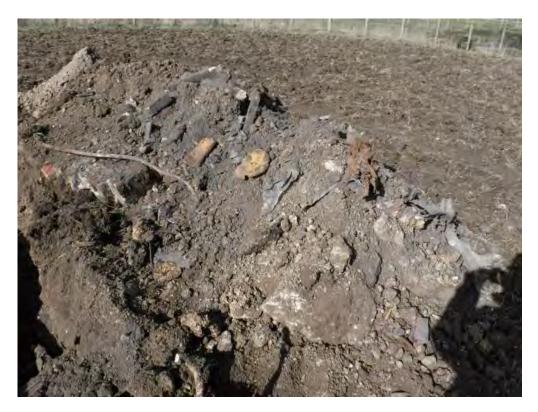
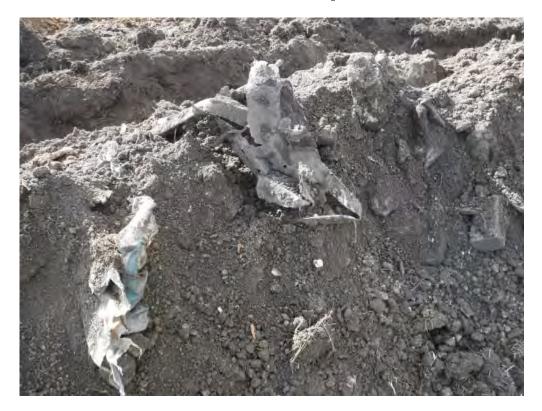
Trial Trench TP16 arisings

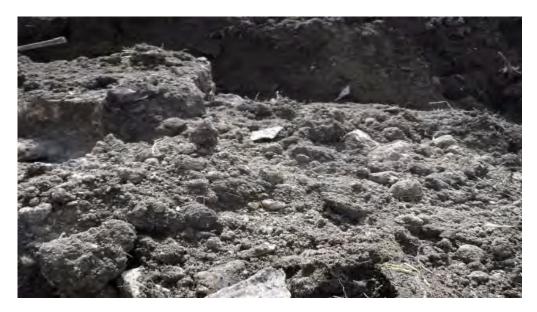
Similarly, in trial trench TP16, rare fragments of ACM were observed yet 3No. tubs of soil matrix did not recorded asbestos at depths of 0.50m, 0.80m and 0.80 - 0.90m bgl from various lengths along the pit extending in a south-easterly direction.

Similarly, in trial trench TP16, rare fragments of ACM were observed yet 3No. tubs of soil matrix did not recorded asbestos at depths of 0.50m, 0.80m and 0.80 - 0.90m bgl from various lengths along the trench. Asbestos was not observed in TP17.

Suspected ACM - Trial Trench TP16

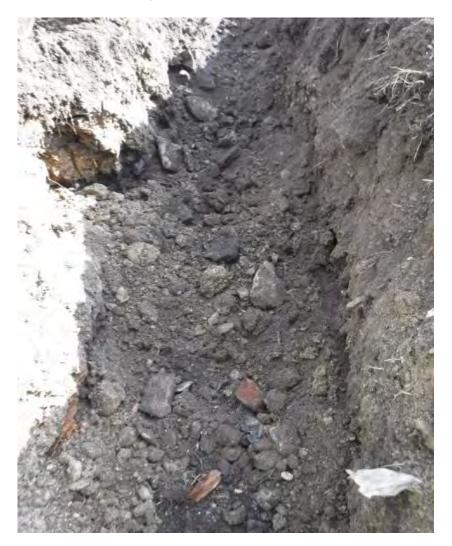
Trial Trench TP16

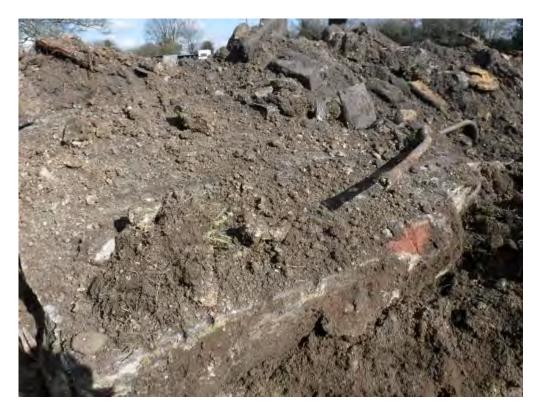
Trial Trench TP16 – large piece of masonry

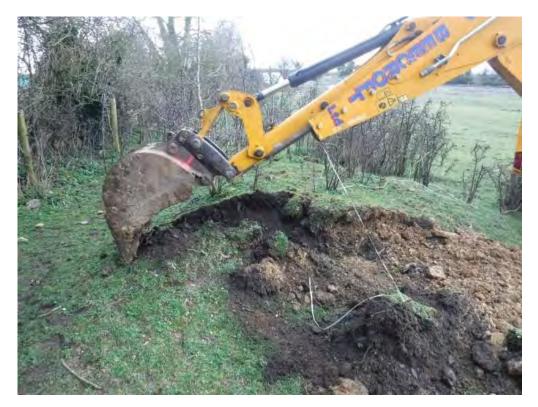
Asbestos was recorded in TP27 as 'Chrysotile - Hard Cement Type Material and Loose Fibres'. TP27 was excavated into a small 1m high stockpile of soil in the north western corner of the site. Numerous pieces of suspected asbestos sheeting were visually confirmed at this location.

TP27 – Stockpile in North-West Corner

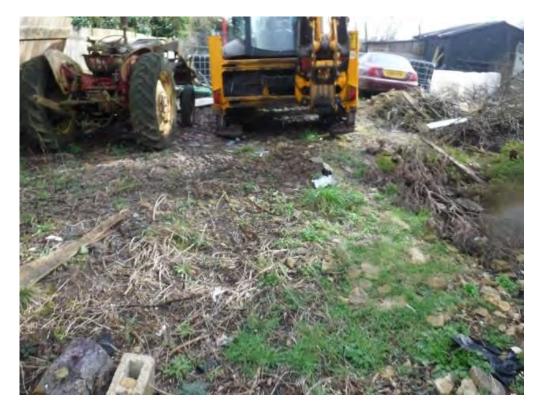
Location of TP28

TP28 and TP29 were excavated into a small triangular part of the site in the far northern corner, directly west of the site entrance, which has been used as storage for a roofing company. Made Ground was encountered to a maximum depth of 0.30m in TP29. Materials comprised loose black and grey slightly clayey very sandy gravel of tile, brick and concrete. Rare wire and a plastic bag was also recorded. Visible asbestos was not recorded in this area.
