**Land South of South Side, Steeple Aston,
Oxfordshire**

**Construction Environmental Management Plan
(Biodiversity)**

June 2021

on behalf of Rectory Homes Ltd

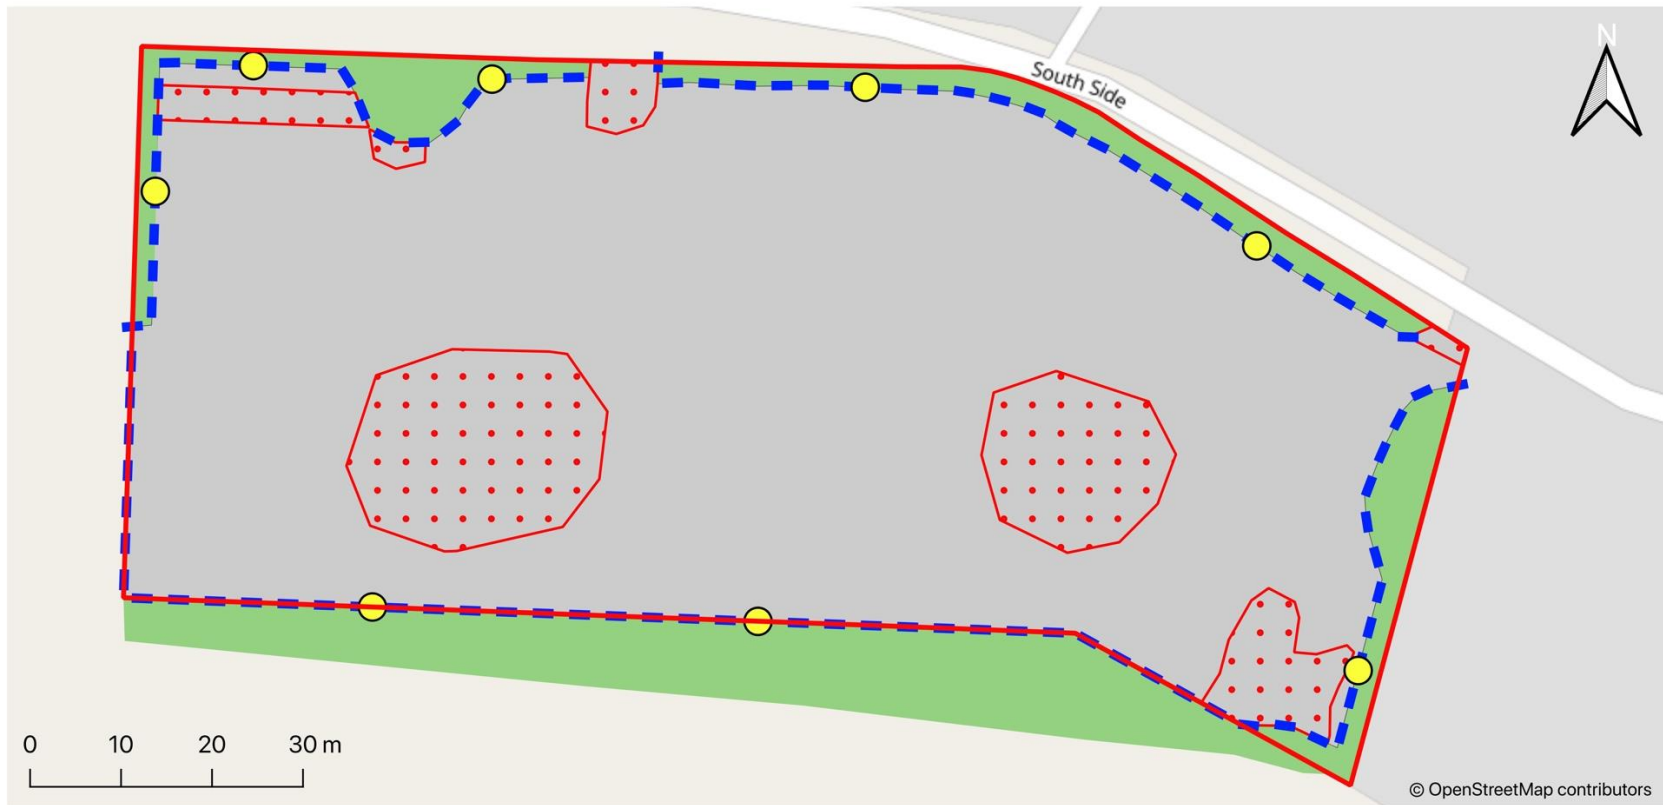
10 Appendix 4. Ecological Mitigation Plan

Table 3. Mitigation strategy. Please refer to Appendix 4 for a plan to show retained habitats and Biodiversity Protection Zones.

Ecological feature identified as at risk	Purpose of mitigation measures	Mitigation measures to be implemented/ECOW requirements	Timing of works	Location	Responsibility
Hedgerows	<p>To protect retained hedgerows</p> <p>Short sections of the northern boundary hedgerow will be cleared to accommodate the new access road visibility splay and footpath</p> <p>Some areas of hedgerow will be reduced in width where hedgerow shrubs have encroached into the site</p>	<p>Retained hedgerows will be fenced within the Biodiversity Protection Zones (Appendix 4), and protected in accordance with British Standard 5837:2012, with the establishment of appropriate root protection areas. In the long-term, retained areas will be managed and enhanced with supplementary hedgerow planting.</p> <p>Prior to the installation of the protective fencing, the hedgerows will be managed to ensure safe working and to facilitate the erection of the protective fencing.</p> <p>Protective fencing will be installed to provide a physical and visual barrier. This fencing will also encircle those semi-mature trees adjacent to the northern hedgerow that are to be retained (see Appendix 3 for a plan). This will create an overall 'biodiversity protection zone' for all retained habitats.</p> <p>The fencing will have all weather notices attached, marked as 'Construction Exclusion Zone – KEEP OUT'.</p> <p>No materials will be stored within the 'Construction Exclusion Zone' areas and no activity is to take place within these areas.</p> <p>If any roots over 25mm diameter are found outside the root protection area an arboriculturist should be contacted for advice.</p>	<p>Protective fencing will be put in place prior to the commencement of construction works.</p> <p>The fencing will remain in place throughout the construction period.</p>	Northern, eastern, southern and western hedgerows	Contractor
