Arboricultural Impact Assessment & Preliminary Method Statement

Land to the north-east of Junction 11
of the M40,
Banbury,
Oxfordshire.

21st January 2019

PJC ref: 5092/19/01

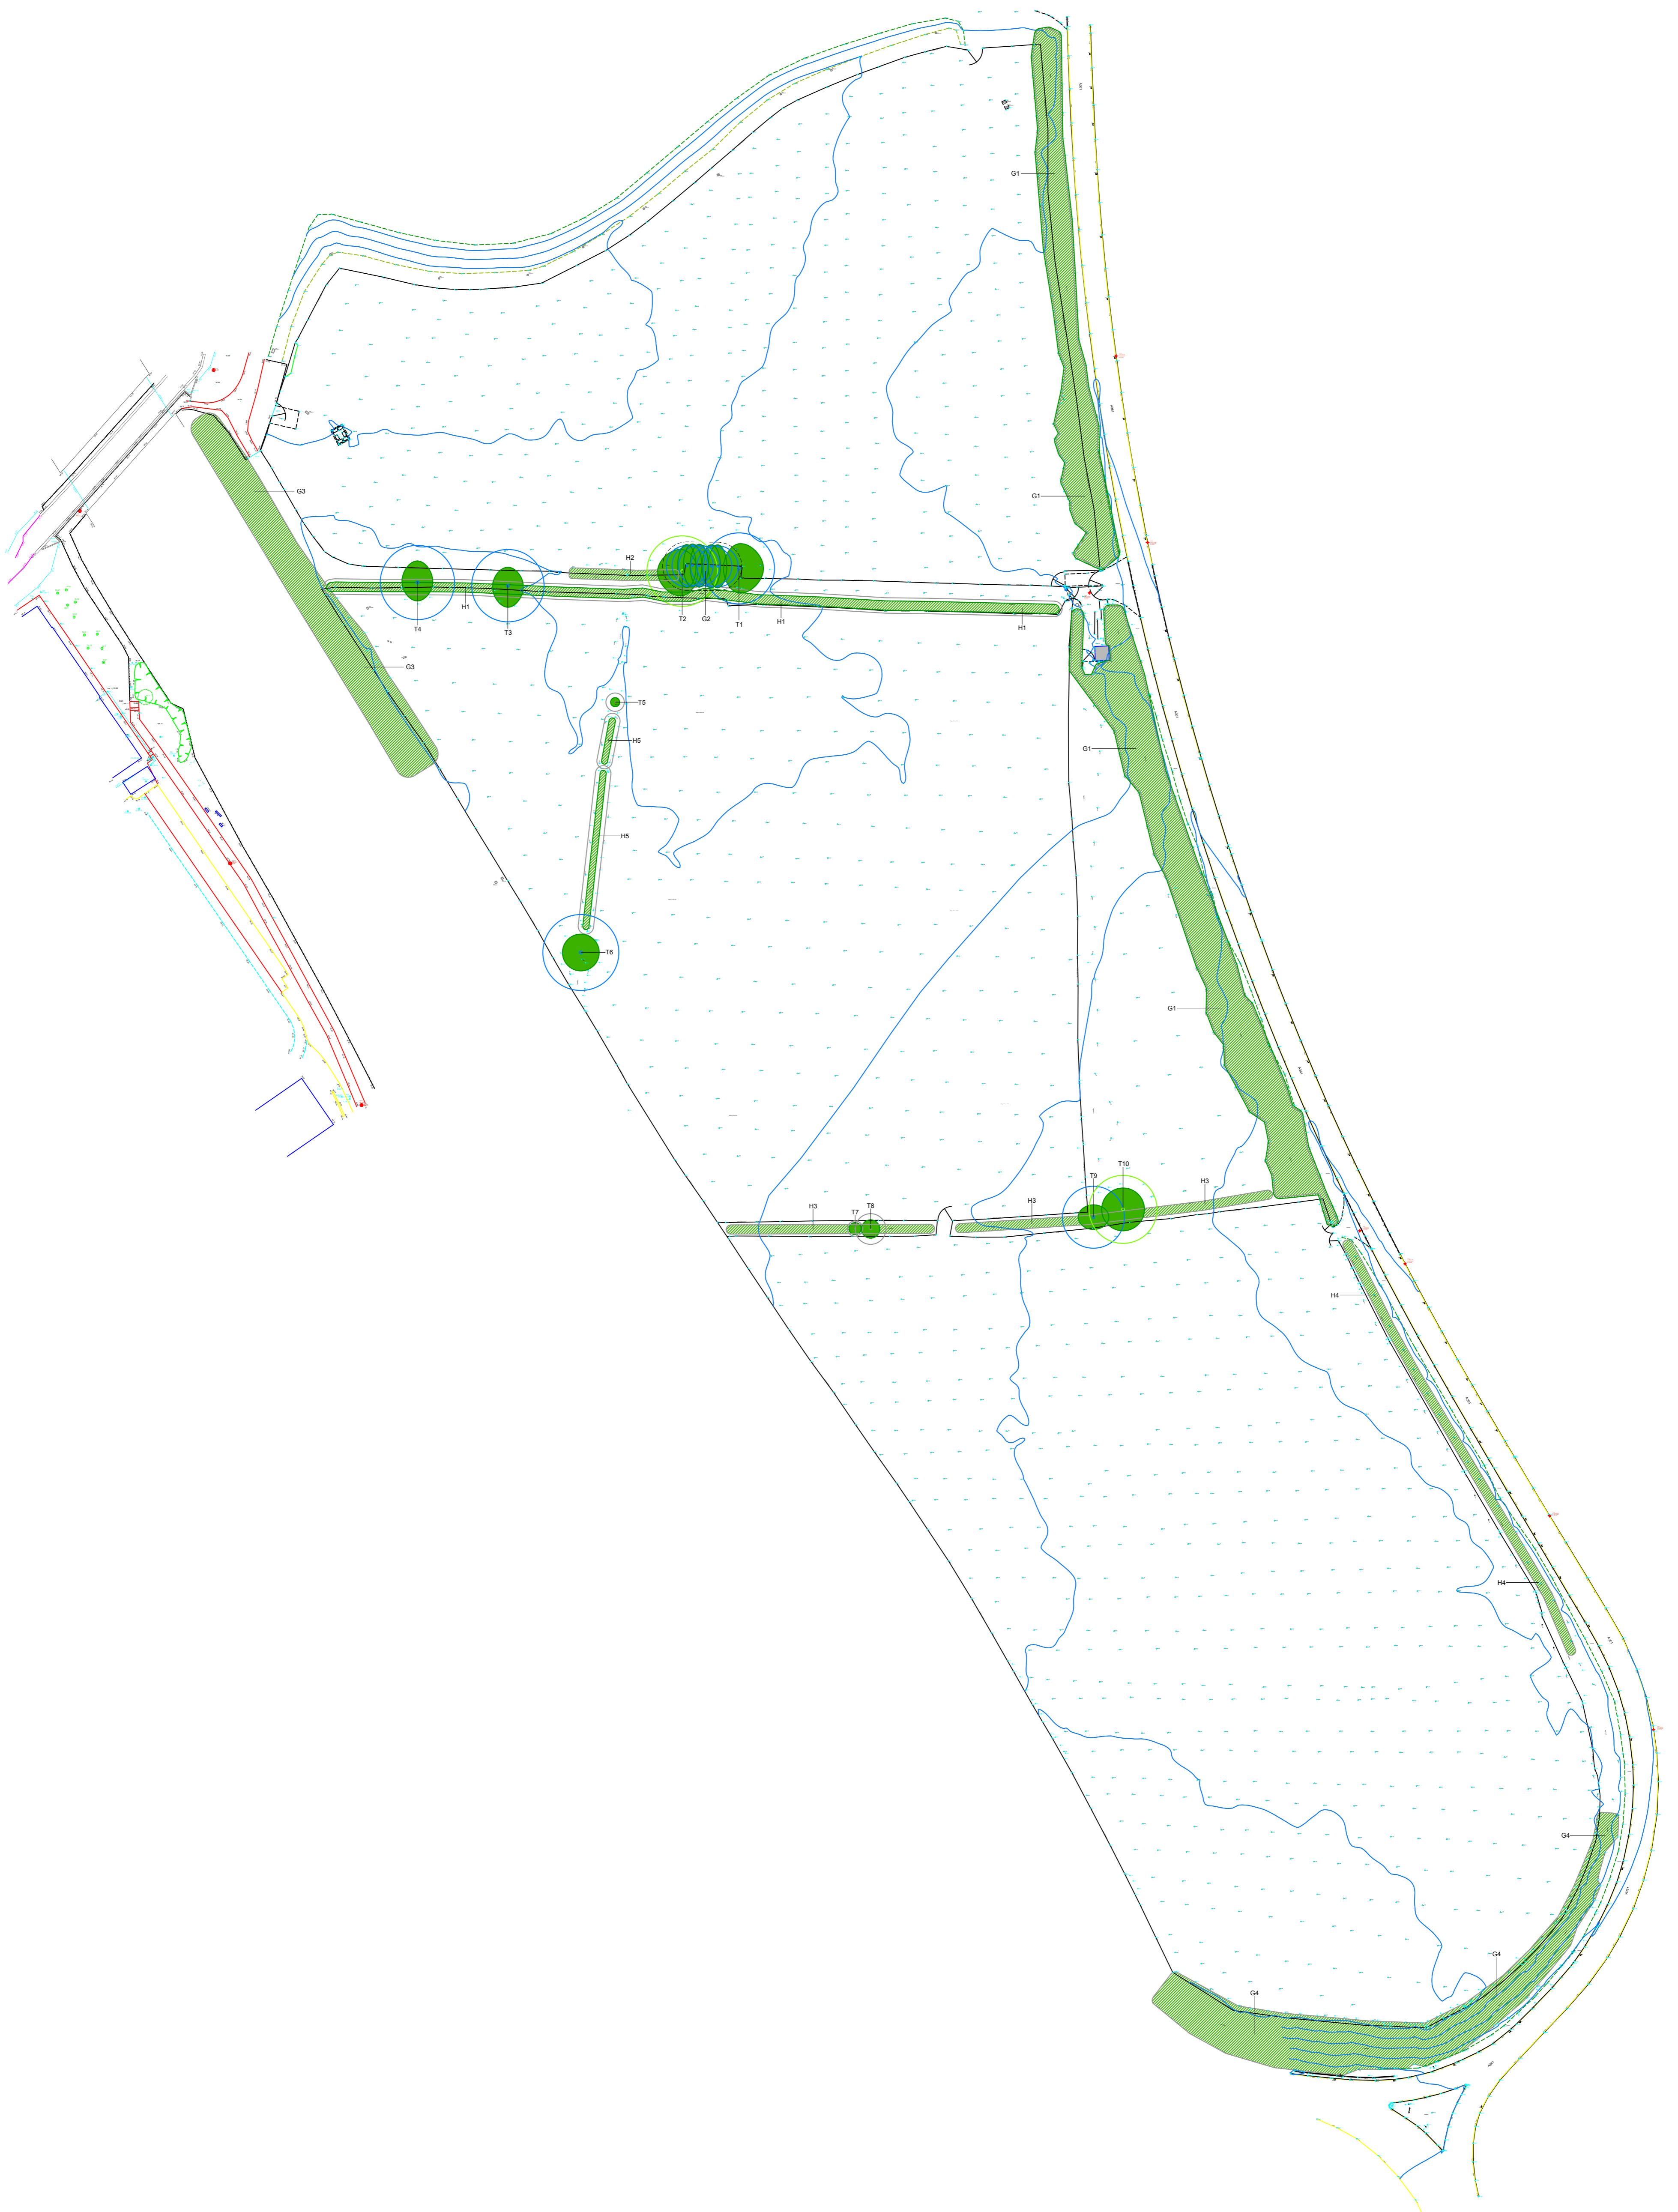
Drawing no: PJC/3627AO/17/A Rev: 01 Sheet number: 1 of 3

Drawing title: Tree Constraints Plan

* Tree categorised in accordance with BS 5837:2012 'Trees in relation to design, demolition and construction - Recommendations'.

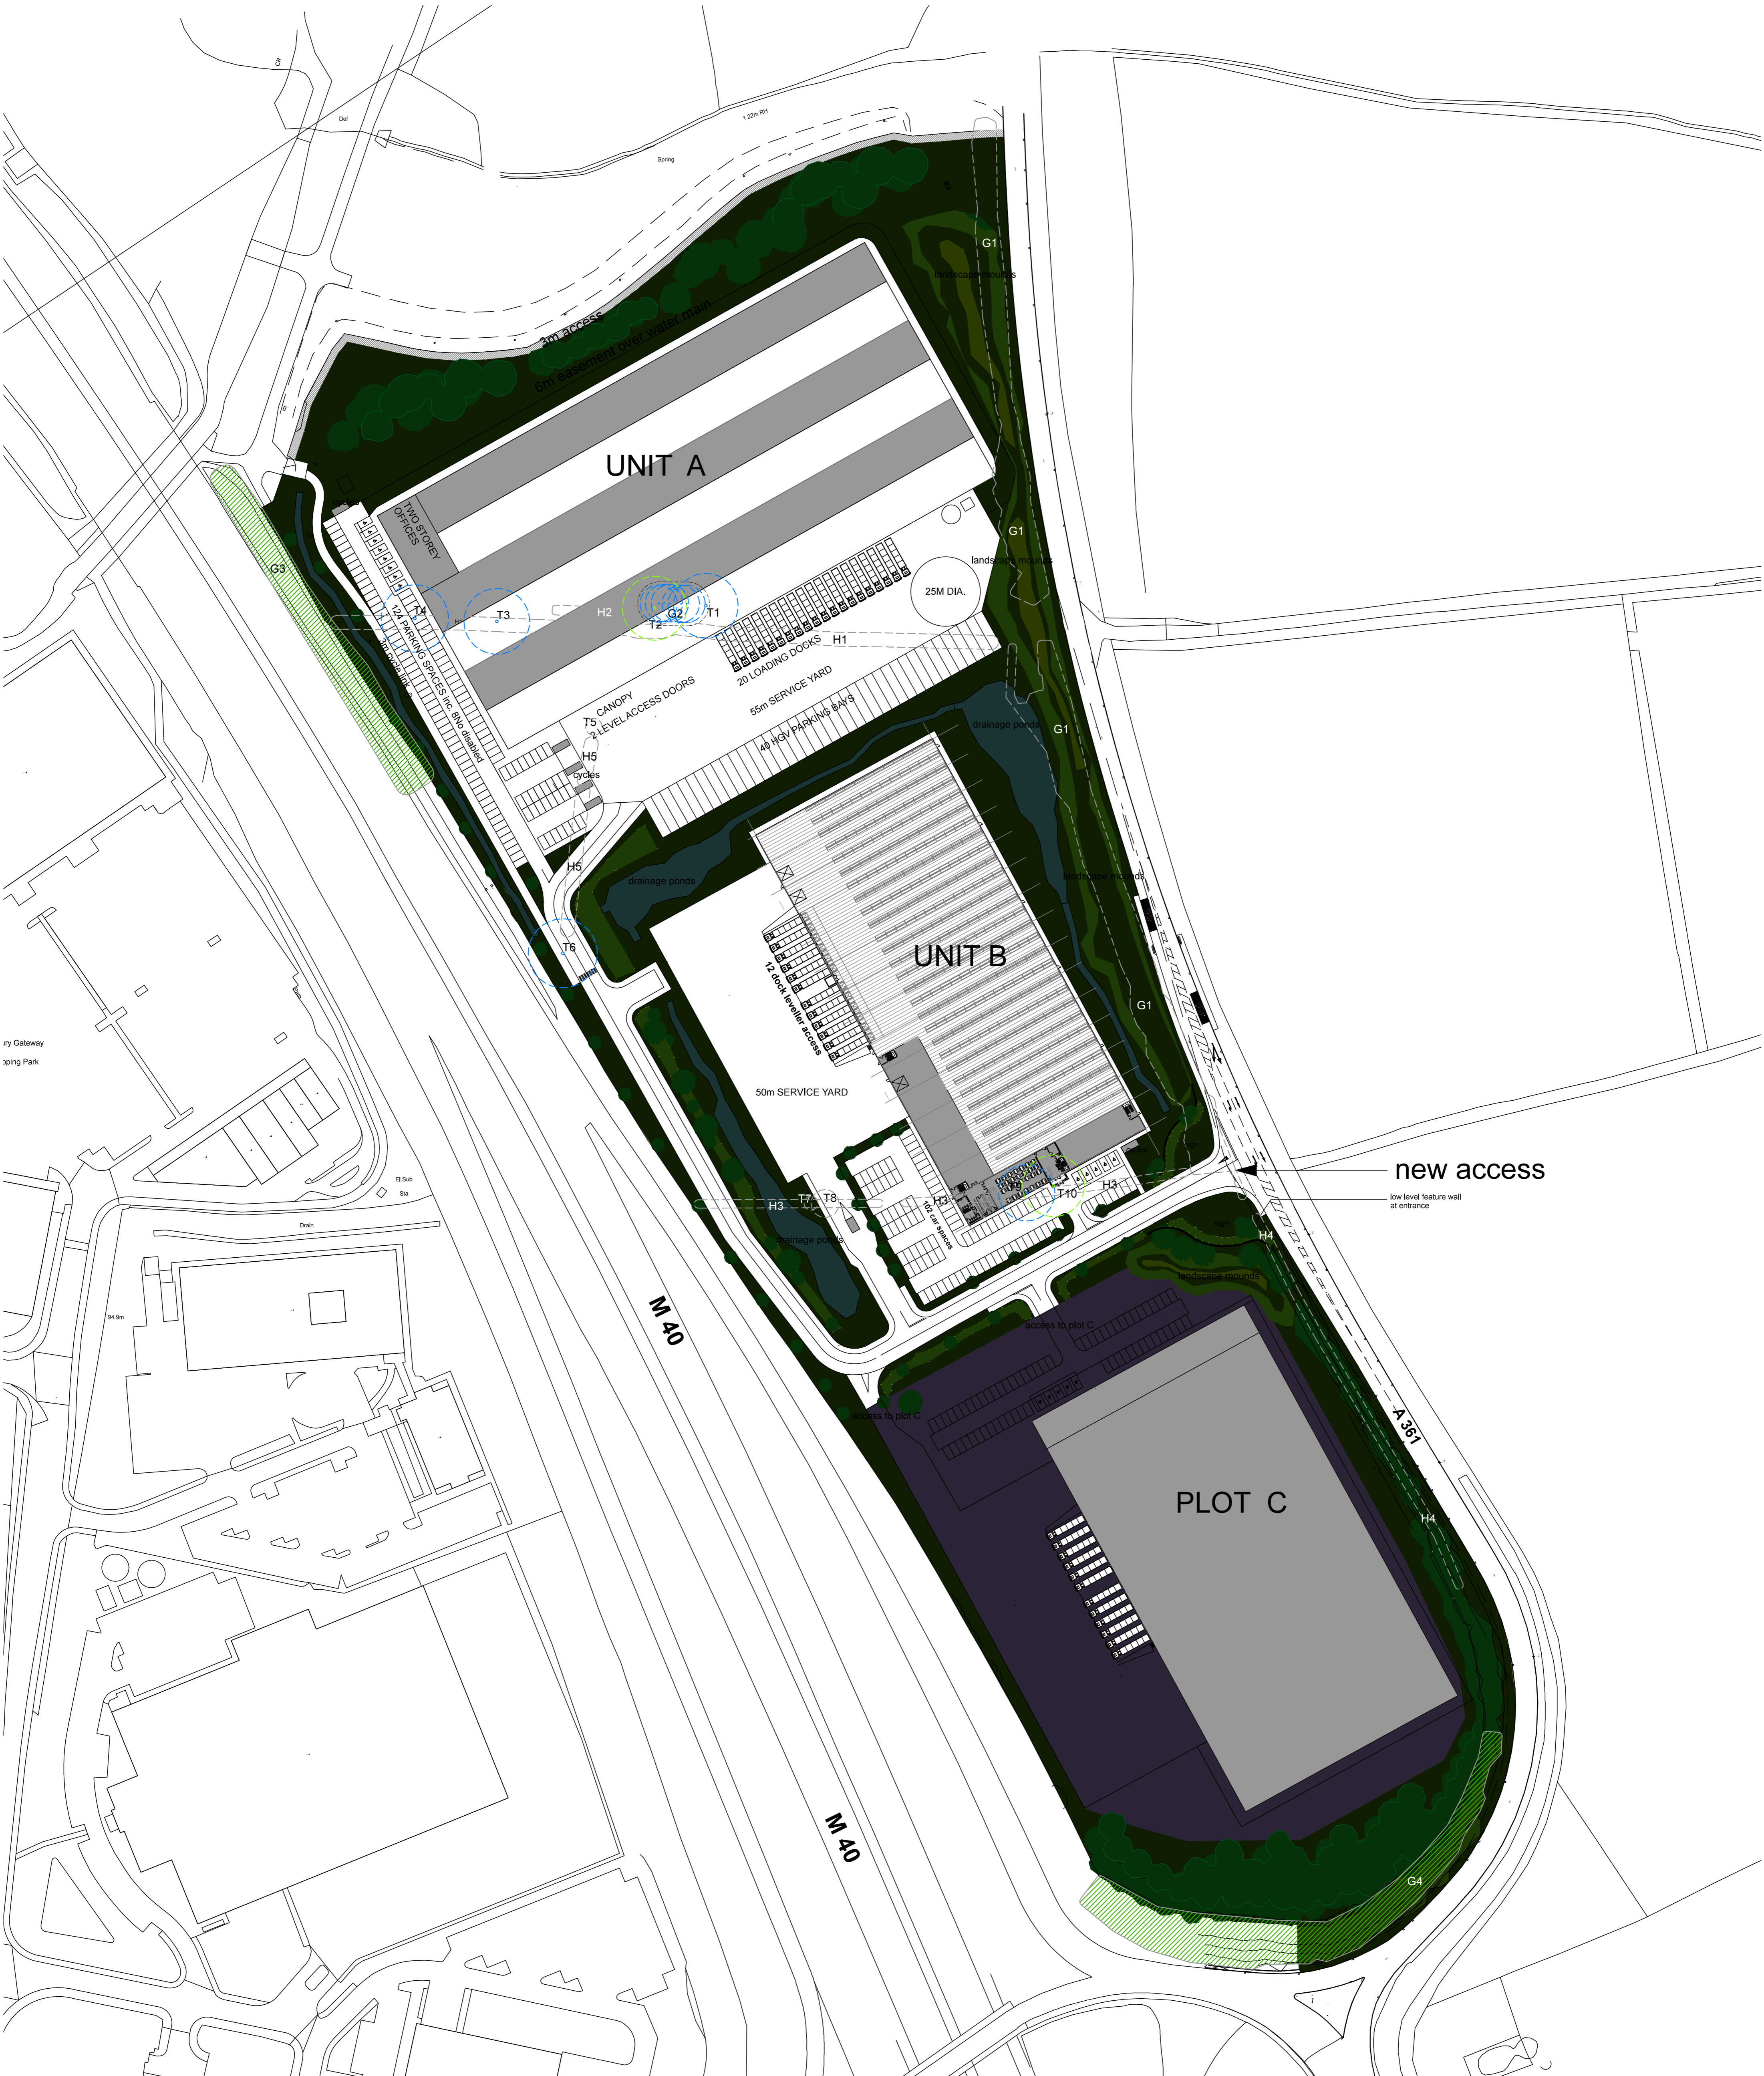
Drawing no: PJC/5092/19/A Rev: 01 Sheet number: 1 of 1

Drawing title: Tree Retention / Removal Plan

1.3 **Tree removals:** With the exception of category C tree groups G3 and G4, all arboricultural features will require removal in order to facilitate the proposed construction works. The loss of trees as a direct result of the proposals will be mitigated through a robust tree and shrub planting strategy to be implemented during the soft landscaping phase of development.

4.1 **Tree removals:** Trees to be removed for the proposed development are shown with coloured dashed outlines on the Tree Protection Plan in Appendix 1. These include two individual category A trees, five individual category B trees, three individual category C trees, one category B tree group, one category C tree group and five category C hedgerows.

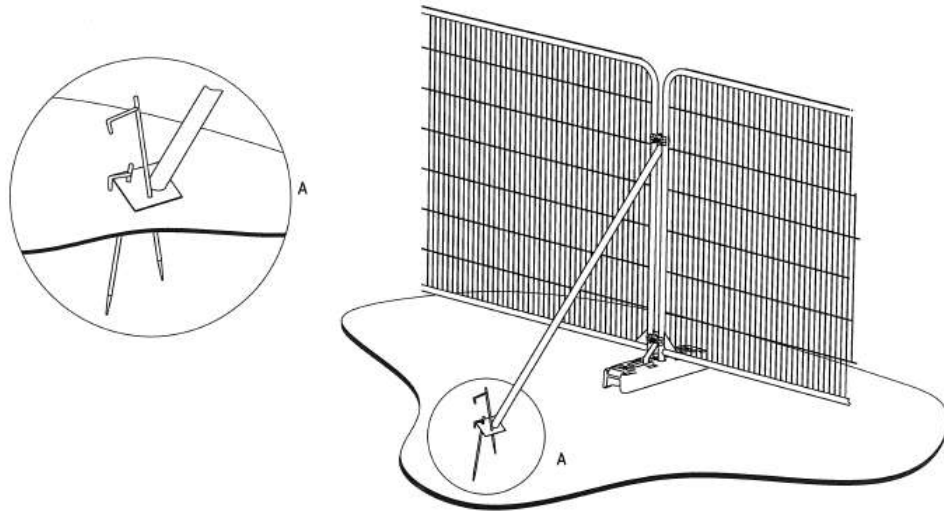
a) Stabilizer strut with base plate secured with ground pins

5.10 Tree protection fencing shall be installed in the locations shown on the Tree Protection Plan. The specification for tree protection fencing shall be metal welded mesh panels (e.g. Heras panels), in concrete or rubber feet. The panels shall be supported by metal stabiliser struts mounted on either a base plate secured by ground pins, or in a block tray (refer to Appendix 5). Any variation from this specification for tree protection fencing shall be discussed with the project arboriculturist and agreed in writing with the local authority arboricultural officer.

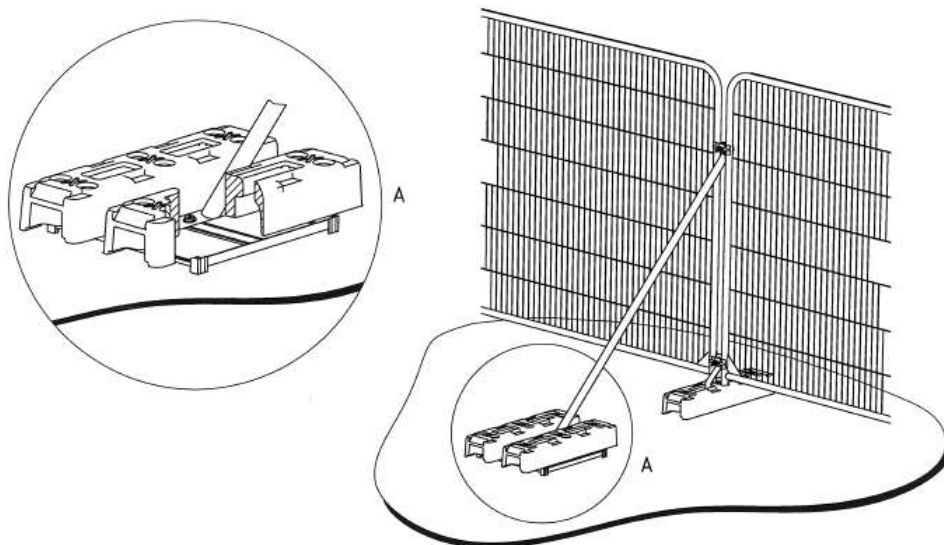
b) Stabilizer strut mounted on block tray
