Bat Survey Report for Cricket Pavilion at Sibford School, Sibford Ferris, Banbury OX15 5QL

The Cricket Pavilion, Sibford School, Banbury – Bat Survey Report

Report Number: 4077-CWS-01

Date: 9th August 2021

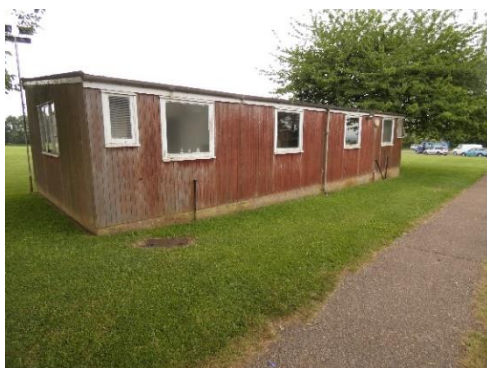
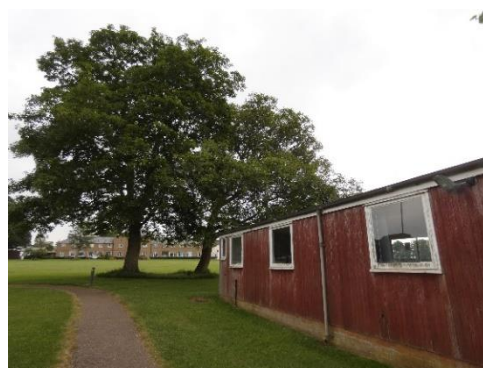
The survey site comprised a stand-alone pavilion with a mono-pitch felted roof over timber clad walls on a brick plinth (Figs. 1 and 2).

Figs. 1 & 2 Pavilion – front (L) and rear (R)

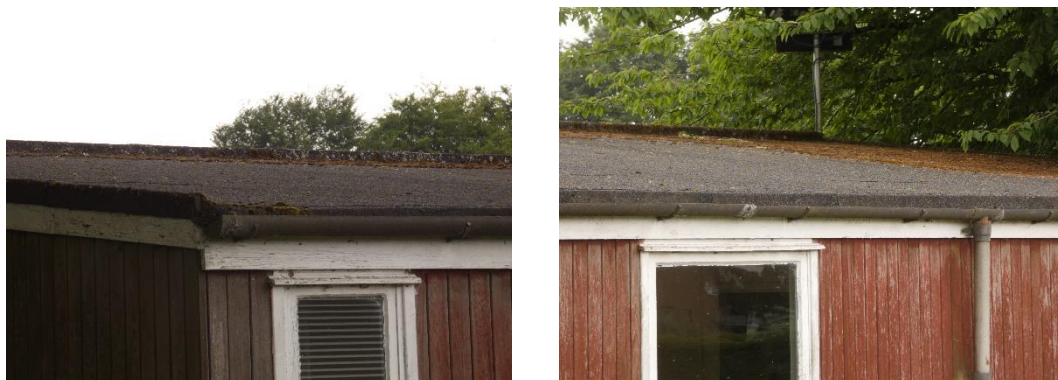
The roof was a gently sloping mono-pitch that was covered with 1F type traditional felt, this intact and un-torn (Figs. 3 and 4).

Figs. 3 & 4 Roof felt un-torn

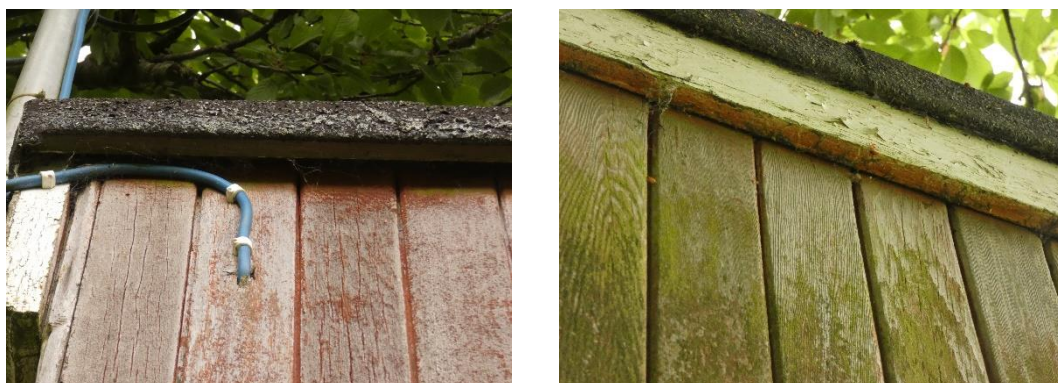
At the eaves the roof overhung a wide gap (Fig. 5). At the end the felt was folded over a tightly fitting end rafter (Fig. 6). The walls of timber cladding were sound throughout, whilst all the window casements and door frames were tightly fitting with no gaps or crevices.

Figs. 3 & 4 Roof eaves and roof end

This was considered to be negligible, as the only gaps were much too wide and open for bat roosting.

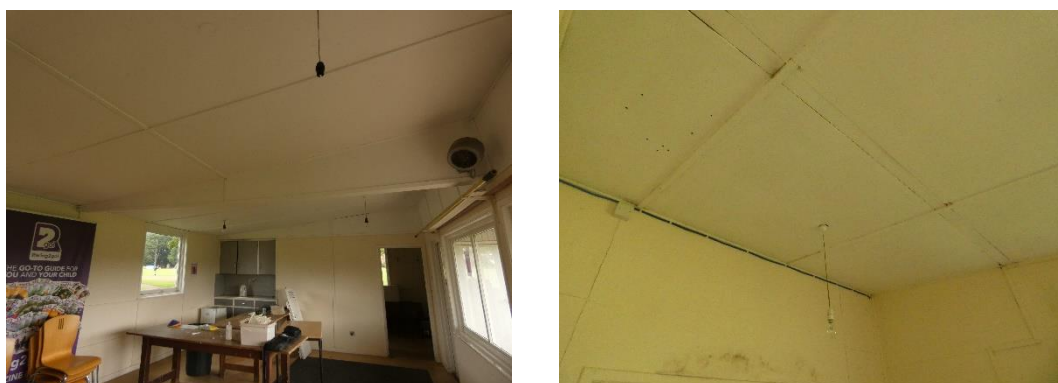
Internally the roof was lined with hardboard, and there was no void (Figs. 7 and 8).

Figs. 7 & 8 Roof lining

No signs of Brown Long-eared Bat activity were found, nor indeed signs of other species which are commonly found in roof spaces, and the interior of the building was both unsuitable and inaccessible to bats.

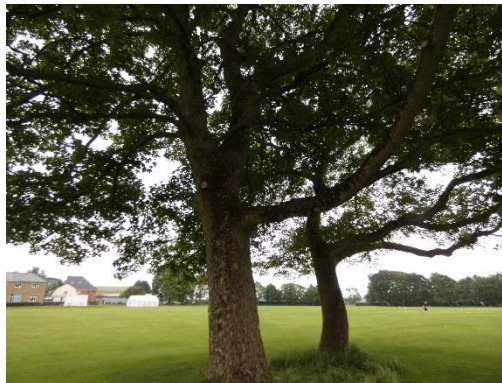
The surrounding habitat consisted of close mown amenity grass and three trees, all of which are being retained (Fig. 9).

Fig. 9 Trees and close mown grass
