- 1.1 This document sets out the design office response to a Road Safety Audit (RSA) Stage 1 undertaken by Mott MacDonald in relation to a Toucan crossing on Howes Lane in relation to Axis J9 Phase 3 proposals. The full RSA report is attached as **Appendix A**.

Howes Lane, Bicester

Road Safety Audit
Stage 1

23 March 2022

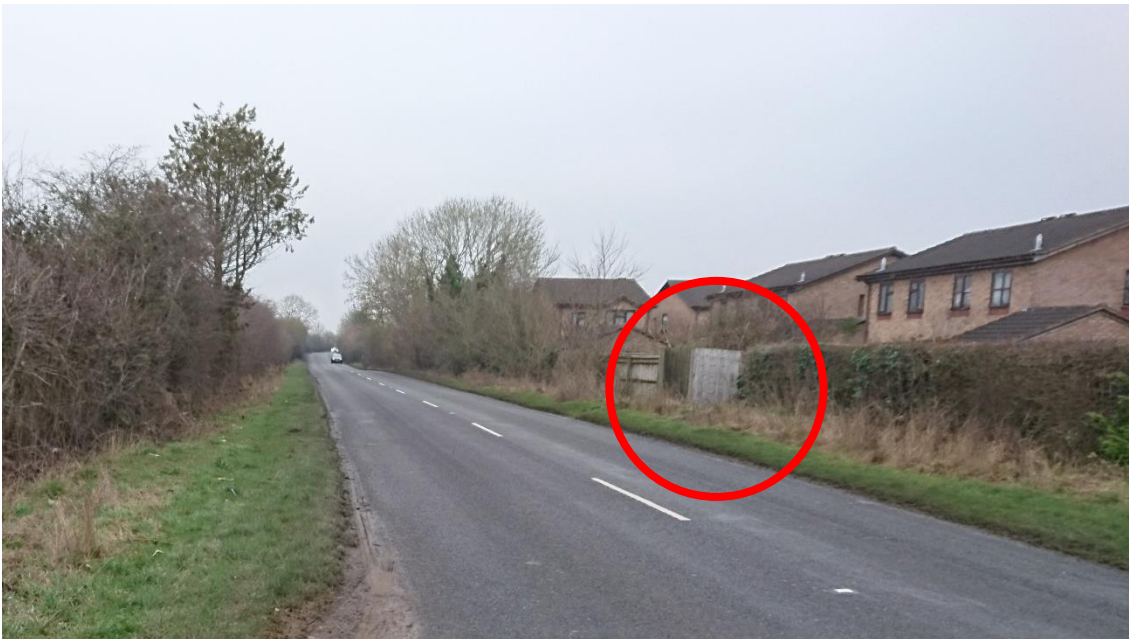
Summary: Crossing facility in line with NMU approach may lead to conflicts.

The proposed Toucan Crossing is shown 'in line' with the existing footway link to Wansbeck Drive and the proposed footway / cycleway into the residential development. As such, pedestrians or cyclists approaching the crossing facility may do so at inappropriate speed increasing the likelihood of NMUs failing to stop before entering the carriageway. This may increase the risk of collisions with approaching vehicles. A guardrail 'chicane' is present at the western end of the existing footway link to Wansbeck Drive to mitigate against this, but a similar arrangement is not proposed on the western side of Howes Lane.

Figure 1: Point at which existing footway joins Howes Lane on the east.

Recommendation

It is recommended that either the Toucan Crossing is 'offset' from the footway / cycleway approaches on both sides of Howes Lane, or a guardrail 'chicane' is installed on the new

footway / cycleway on the western side of Howes Lane. The existing 'chicane' on the eastern side should be retained.

The Toucan Crossing is still proposed 'in line' with the existing footway link and the proposed footway / cycleway has no guardrail 'chicane' proposed. Therefore, this issue is considered to remain outstanding and has been raised again in **Section 3** of this report.

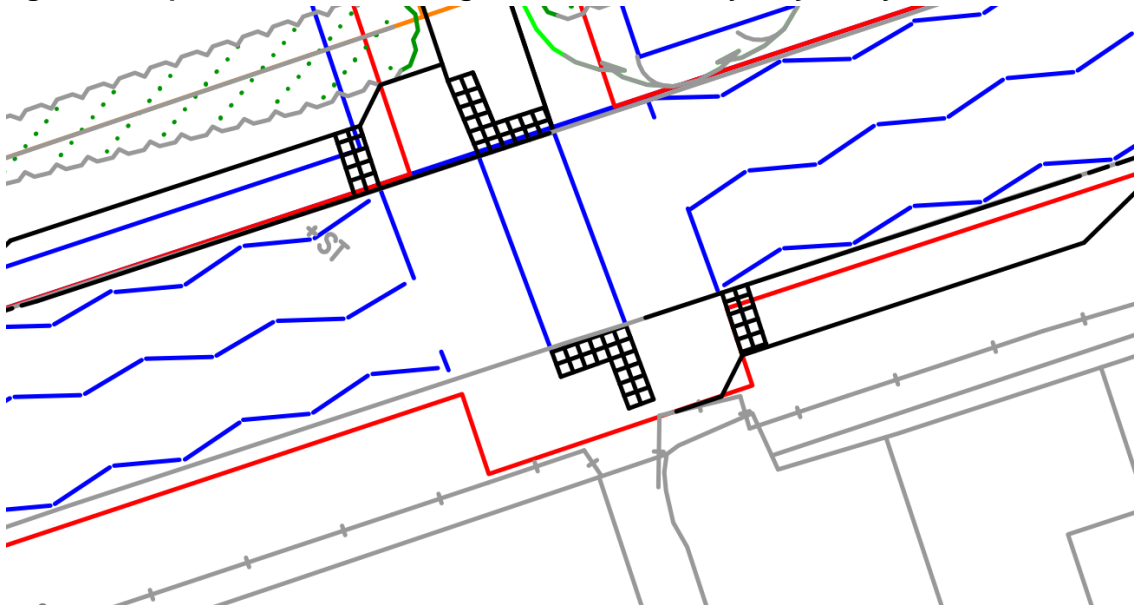
Summary: Crossing facility in line with NMU approach may lead to conflicts.

The proposed Toucan Crossing is shown 'in line' with the existing footway link to Wansbeck Drive and the proposed footway / cycleway into the development. As such, pedestrians or cyclists approaching the crossing facility may do so at inappropriate speed increasing the likelihood of NMUs failing to stop before entering the carriageway. This may increase the risk of collisions with approaching vehicles. A guardrail 'chicane' is present at the western end of the existing footway link to Wansbeck Drive to mitigate against this, but a similar arrangement is not proposed on the new footway / cycleway.

Figure 2: Proposed Toucan Crossing 'in line' with footways / cycleways.

This recommendation is accepted and the recommendation to introduce a guardrail chicane on the new footway / cycleway on the western side of Howes Lane would be addressed at the detailed design stage.

It is recommended that either the Toucan Crossing is 'offset' from the footway / cycleway approaches on both sides of the Howes Lane, or a guardrail 'chicane' is installed on the new footway / cycleway on the western side of Howes Lane. The existing 'chicane' on the eastern side should be retained.

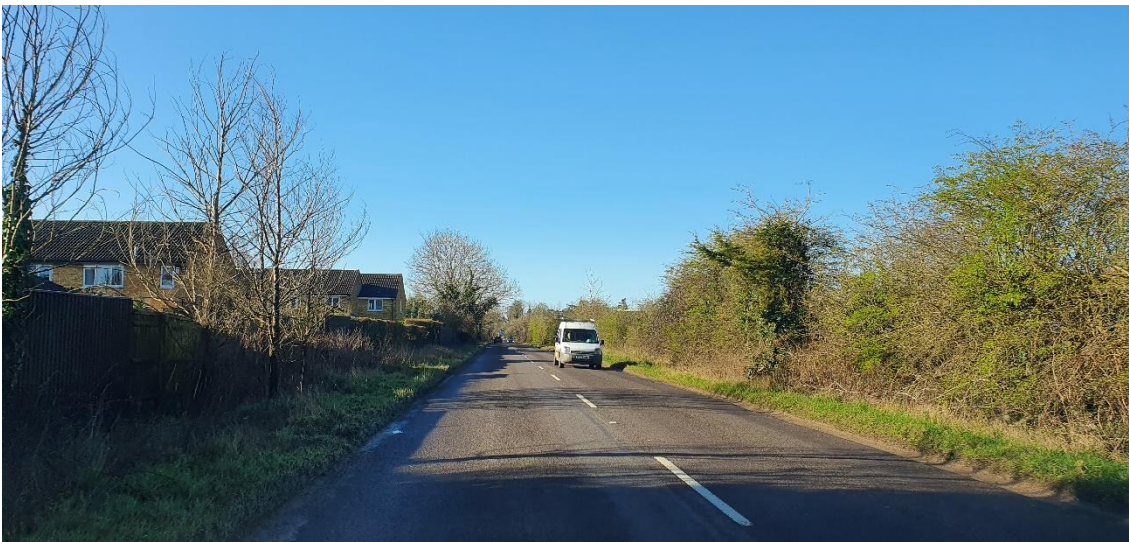
Summary: Lack of lighting provision.

It is unclear whether street lighting is to be provided at the Toucan Crossing. A lack of street lighting may result in approaching motorists failing to observe a pedestrian / cyclist waiting to, or starting to, cross the carriageway. This may lead to an increased risk of collisions between crossing pedestrians / cyclists and approaching vehicles. This may be exacerbated by approaching motorists focussing on the traffic signals rather than pedestrians / cyclists who might cross contrary to the red crossing indicator.

Figure 3: Lack of street lighting at location of proposed Toucan Crossing.

This recommendation is accepted and would be address through the detailed design as part of the S278 works.

It is recommended that appropriate levels of street lighting are provided at the Toucan Crossing.
