**Bat Survey Report for  
Lane Head, Sibford Gower,  
Oxfordshire, OX15 5RT**

**Cotswold Wildlife Surveys**

**3<sup>rd</sup> June 2021**

Report Number: 4047-CWS-01

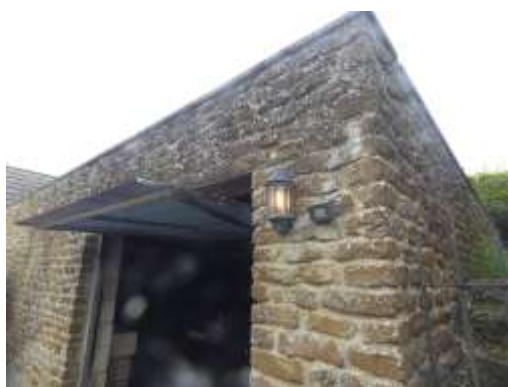
**Figs. 1 & 2 Garage (L) and store (R)**

The survey site comprised a large, flat roofed garage (Fig. 1) and an adjacent flat roofed store. Part of the latter included a short section of mono-pitched roof covered by stone tiles.

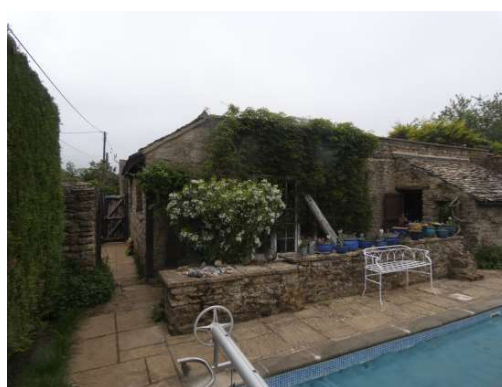
A small, stone lean-to with a mono-pitched stone tiled roof adjoined the east elevation of the store (Fig. 2).

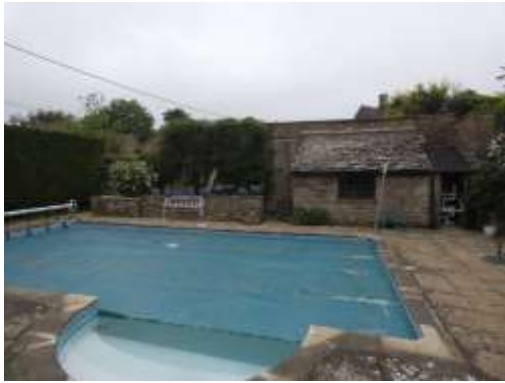
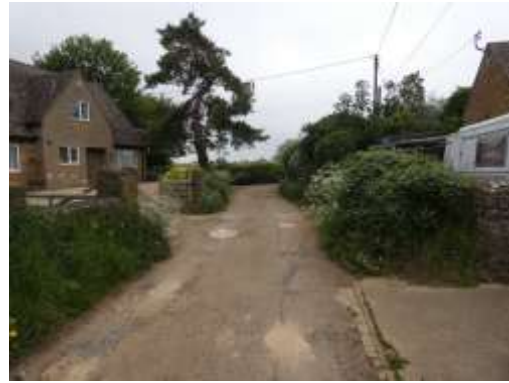
**Figs. 3 & 4 Adjacent dwelling (L) and barn to the south (R)**

The buildings lay in the grounds to the west of Lane Head, this consisting of formally landscaped garden with swimming pool (Fig. 3).

In front of the garage was a small lane leading off Main Street (Fig. 4). There were other dwellings nearby.

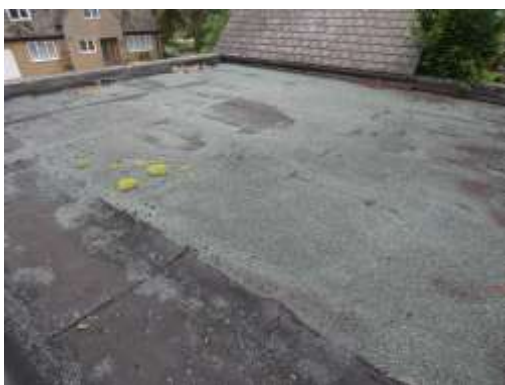
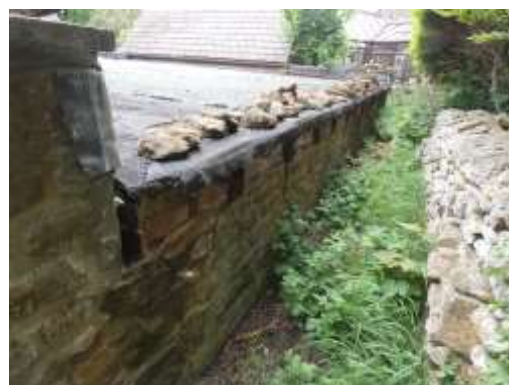
**Figs. 5 & 6 Felt covered roof of garage**

The flat roof of the garage was covered by tarred felt (Fig. 5). This was in poor condition, with a hole in one corner and various tears across the rest.

The rear edge of the felt was held down by a row of stones (Fig. 6), whilst the rest was sealed to a small parapet

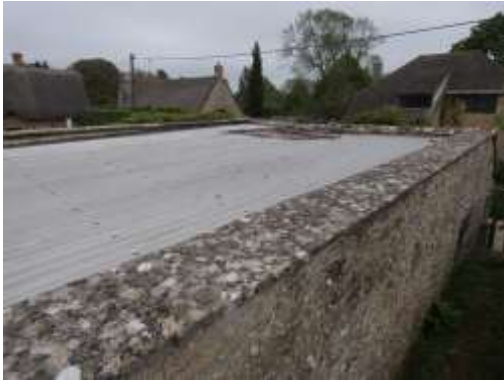
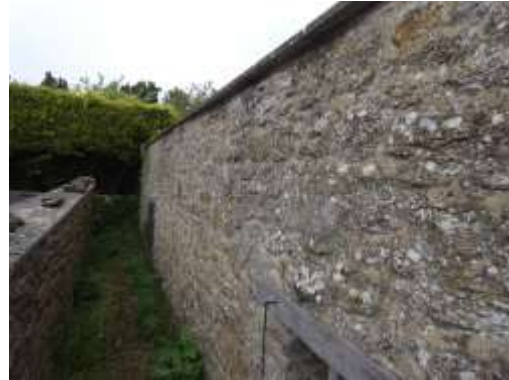
**Figs. 7 & 8 Flat roof of store and gap between the buildings**

The flat roof of the store consisted of corrugated metal sheets sealed to a concrete parapet (Fig. 7). There were capping slabs on top of the parapet, these overhanging at the eaves (Fig. 8). The two structures were separated by a narrow gap, with both buildings built into the ground such that they were partially subterranean.

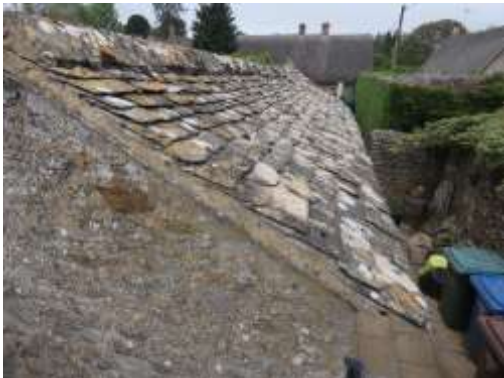
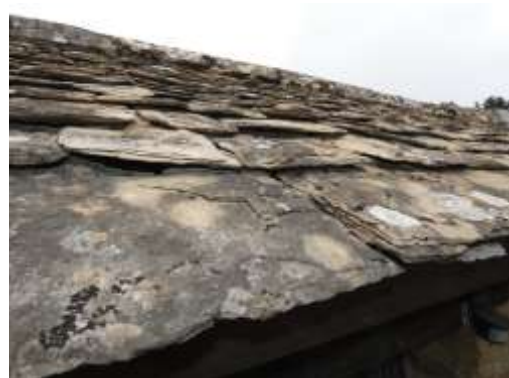
**Figs. 9 & 10 Stone tiled section at front of store**

At the front of the store (south elevation) there was a short section of mono-pitched roof covered by stone tiles (Figs. 9 and 10). The fronts of the tiles were slightly raised, but the back edges were touching, so there was no bat access into the roof structure itself.

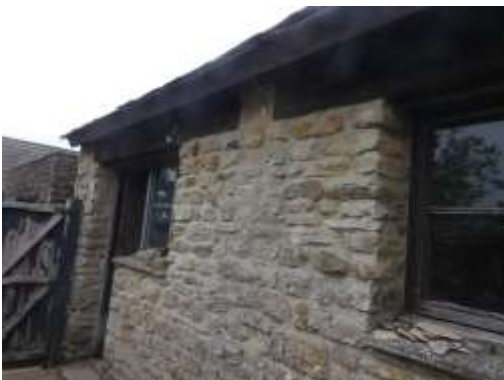
**Figs. 11 & 12 Front section (L) and stone lean-to (R)**

The eaves at the front were closed (Fig. 11), and there were no side or rear eaves.

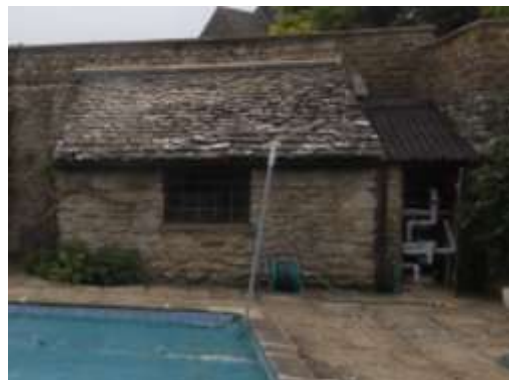
Adjoining the east elevation of the store was a small, stone lean-to (Fig. 12). This had a mono-pitched roof of stone tiles, these generally tightly overlapping. This structure is being retained as part of the scheme.

The stonework was sound throughout, whilst the window casements and door frames were all tightly fitting.

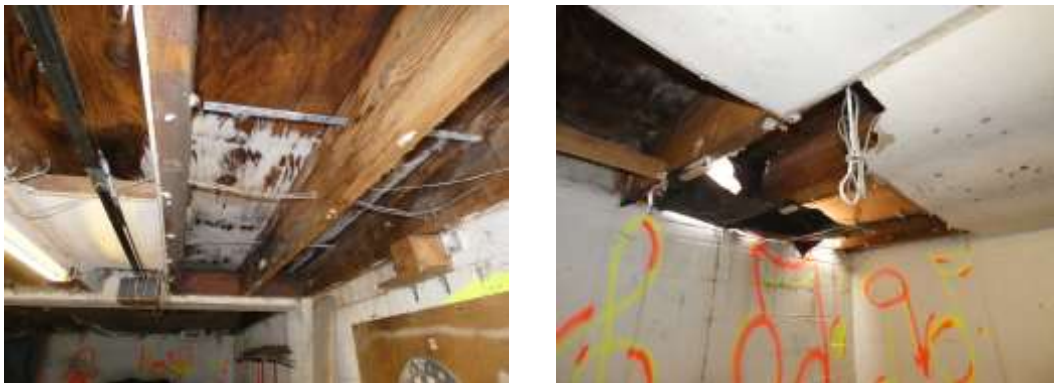
**Figs. 13 & 14 Interior of garage**

Internally the garage roof was in poor condition, with holes in the ceiling where the dryboard had become waterlogged and dropped off (Figs. 13 and 14). The whole structure was damp and cobwebbed and not suitable for bat roosting.

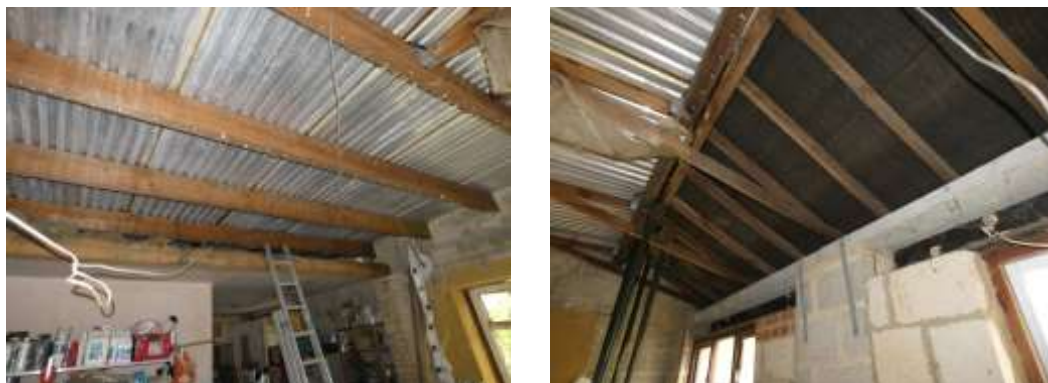
**Figs. 15 & 16 Interior of store**

Except for the stone tiled section at the front, which was lined with tarred felt, the roof of the store was unlined and open to the underside of the corrugated metal sheets (Figs. 15 and 16).

Despite a thorough search, no evidence of bat activity was found, and the building was considered to be unsuitable for bat roosting.

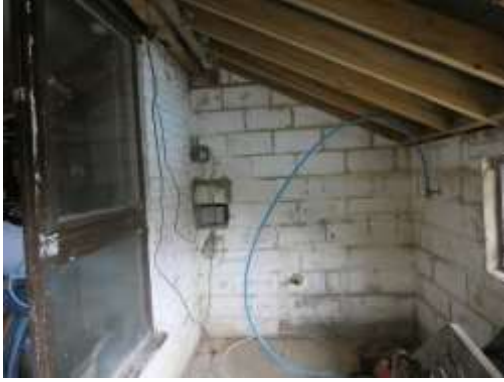
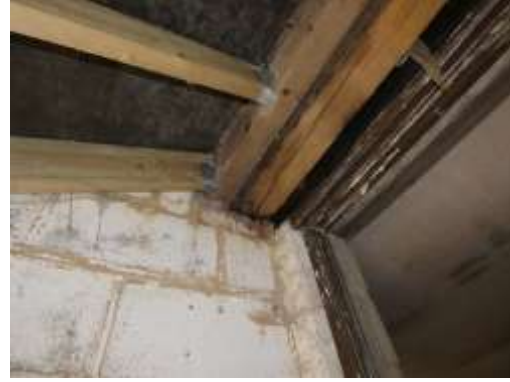
**Figs. 17 & 18 Interior of stone lean-to**

The adjoining lean-to was open to the tarred felt lined roof, this intact and un-torn and quite heavily cobwebbed (Figs. 17 and 18). The eaves were closed and the window casements and door frame were tightly fitting. There was no bat access to the interior of the lean-to, and no evidence of bat use was found.
