**Heyford Park
Dorchester Living: Phase 9 – Baseball Pitch
Remediation Earthworks Completion Report
For Urban Regen Ltd.
June 2021**

Report Title: Heyford Park, Dorchester Phase 9 – Baseball Pitch
Remediation Earthworks Completion Report

Client: Urban Regen Ltd

Report Date: 21 June 2021

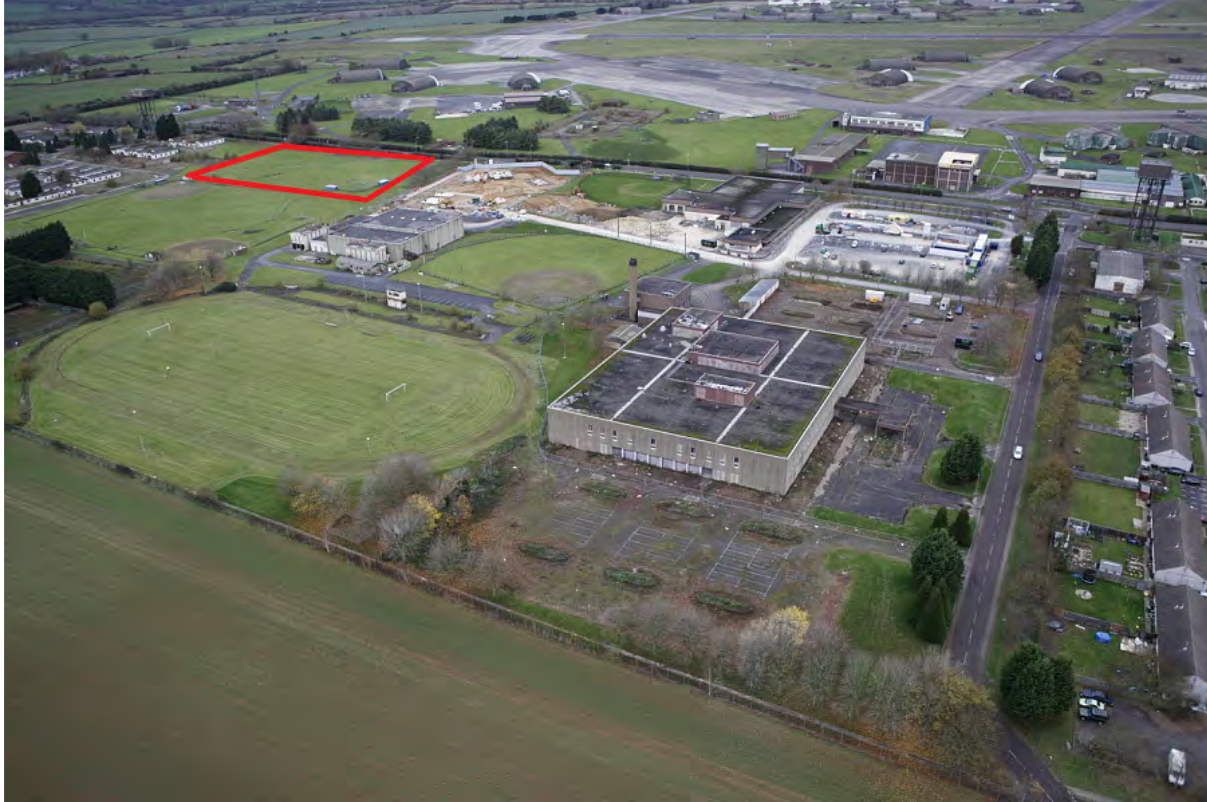
Figure 1.1 Approximate boundary of Phase 9 – Baseball Pitch

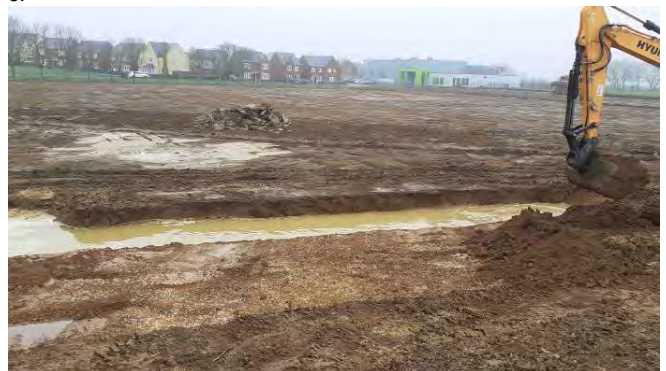
6.

14.01.21 – Stripping and recovery of topsoil complete. Trenching to delineate extent of impacted area to allow initial recover of clean overburden soils

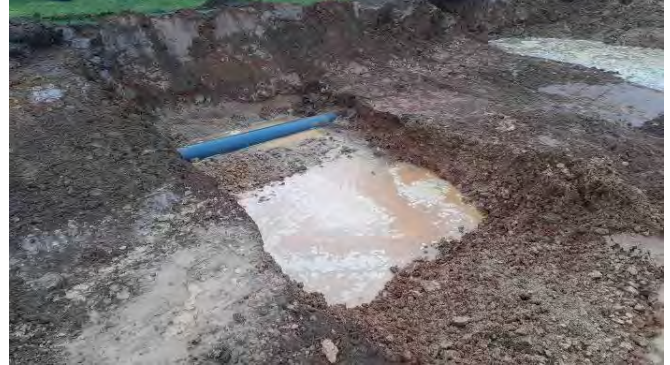
8.

14.01.21 – Exposure of POL pipeline in the north. Shallow ingress of groundwater, no sheen, floating product or globules observed.

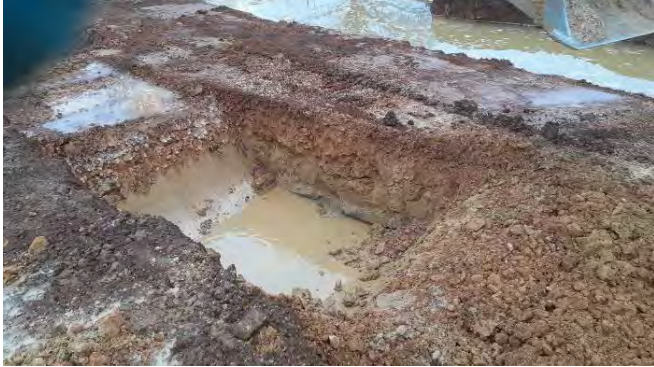
9.

14.01.21 – Excavation of a series of shallow trial-pits to delineate extent of impacted soils

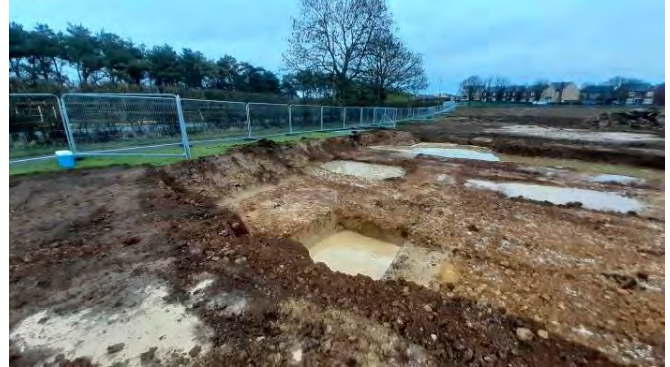
10.

14.01.21 – Eastern view across the hotspot area with partial recovery of clean surface soils and a series of trial-pits / trenches to delineate extent

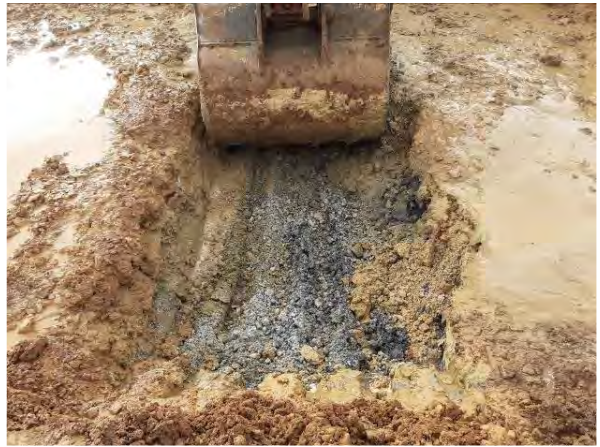
14.

02.02.21 – Hydrocarbon impacted soils present as dark grey to black gravel beneath clean light brown soils/gravels.

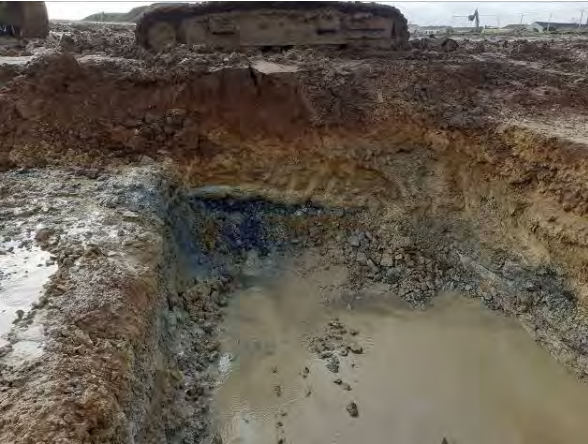
15.

02.02.21 – Horizon of impacted soils visible approximately 1-1.5m below ground level

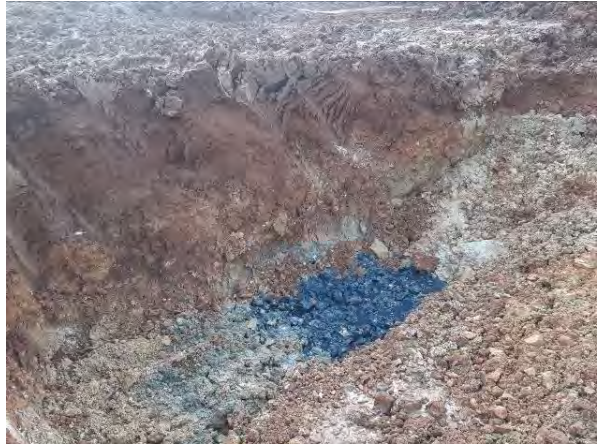
16.

03.02.21 – Hydrocarbon impacted gravel evident by black colouration

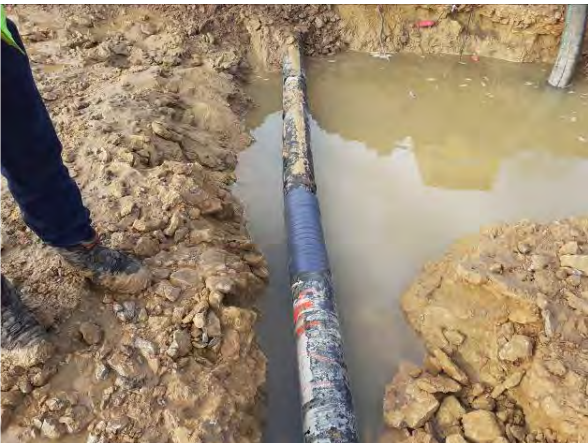
17.

03.02.21 – POL pipeline exposed in the northwest. Wrapping around pipework suggests possible historical repair work

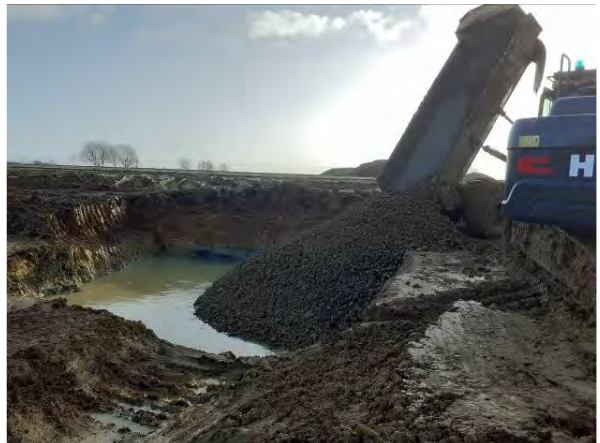
18.

03.02.21 – Backfill of remediation excavation with aggregates

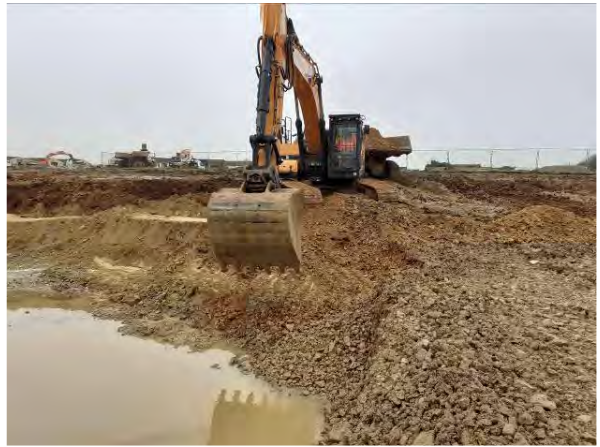
20.

04.02.21 – Western extent of contamination following delineation works

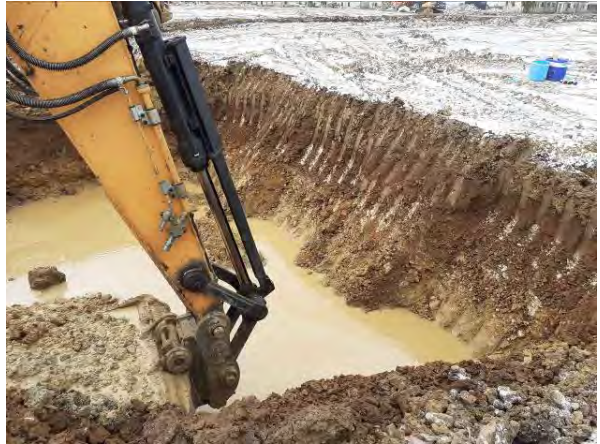
22.

08.02.21 – Recovery of clean overlying soils from hotspot area. Ingress of shallow groundwater, no sheen, globules or floating product observed.

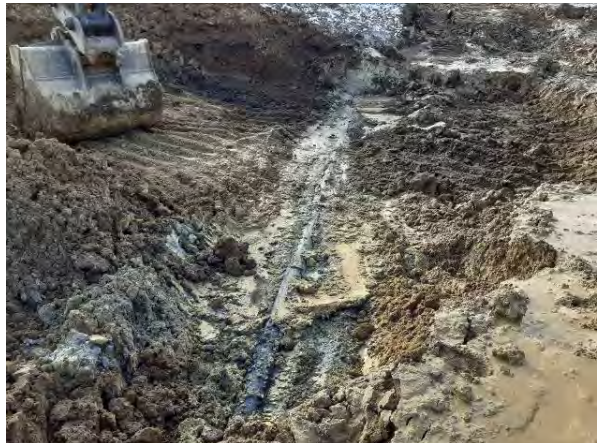
24.

09.02.21 – Exposure of POL pipeline which ran north to south through the centre of the baseball pitch

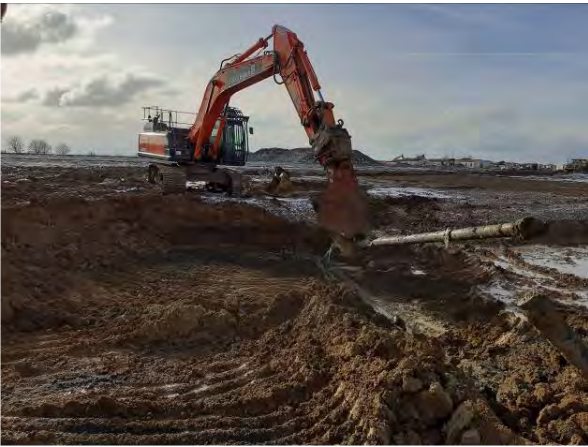
25.

09.02.21 – Removal of pipeline from remediation excavation

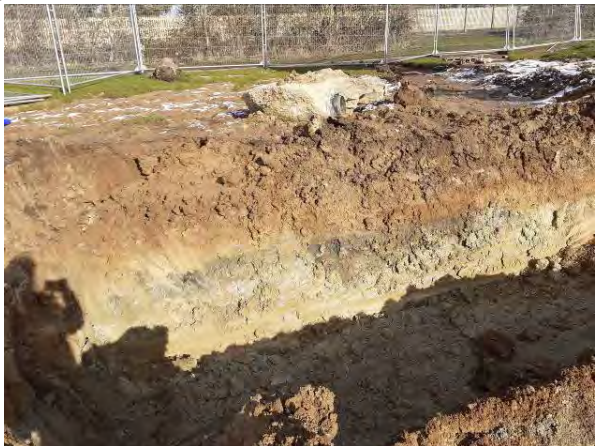
28.

09.02.21 – Northern sidewall of remediation excavation absent of any significant contamination indicators suggesting sufficient removal of impacted soils

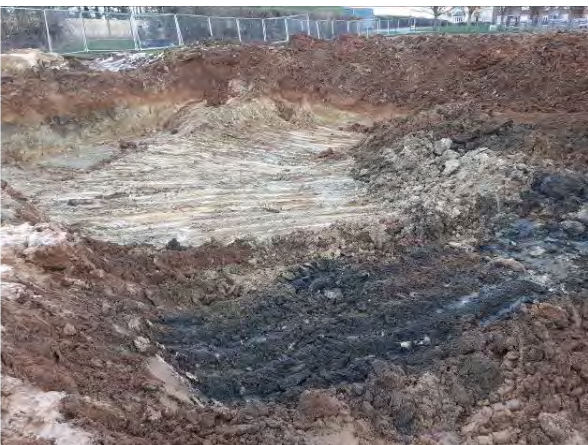
29.

09.02.21 – Area of contamination (black soils)

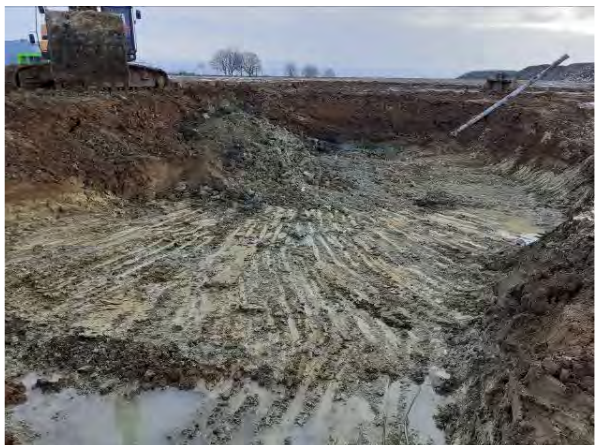
30.

09.02.21 – Removal of impacted soils until visual, olfactory indicators absent and low (<10ppm) readings recorded on PID. Base of excavation in northeast onto clay.

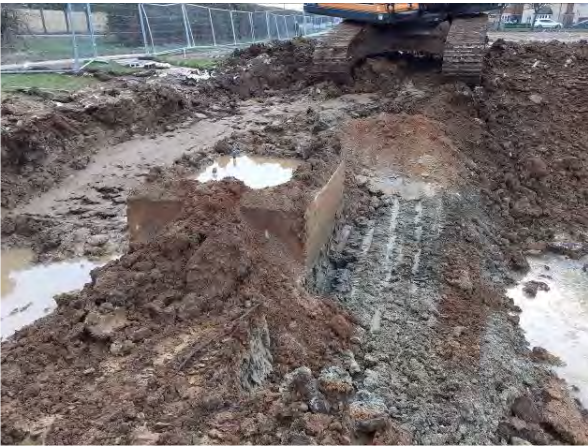
31.

10.02.21 – Relict manhole chamber within northeast where impacted soils thin out.

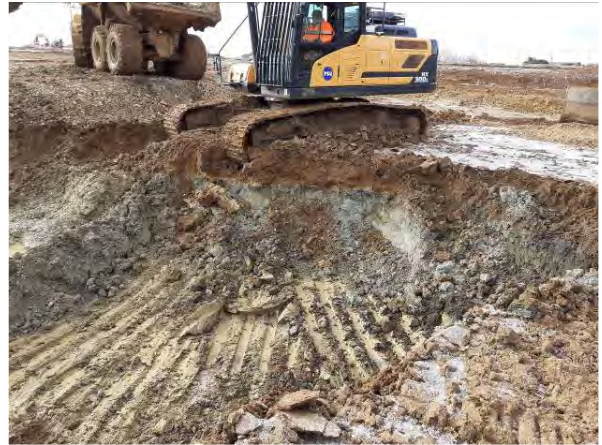
34.

10.02.21 – Light grey soils below light brown visible denote fuel impacted soils.

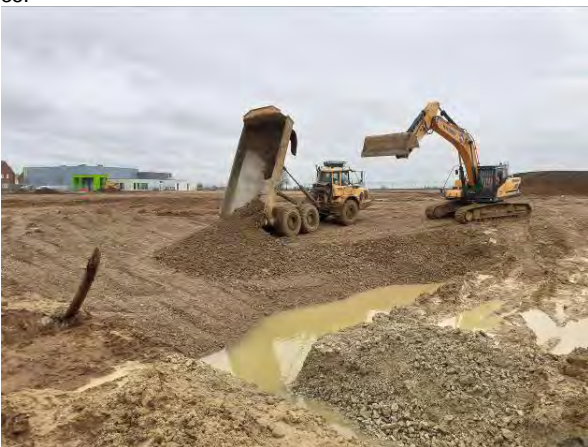
35.

16.02.21 – Backfilling of remediation excavation with aggregate concurrently with removal of impacted soils

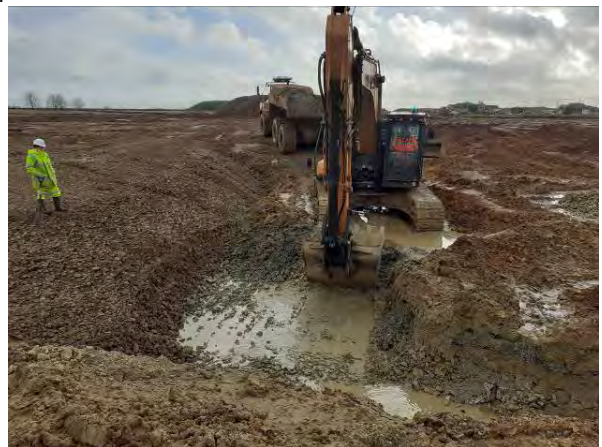
36.

16.02.21 – Removal of impacted soils down to bedrock. Ingress of groundwater at surface of bedrock, no sheens observed.

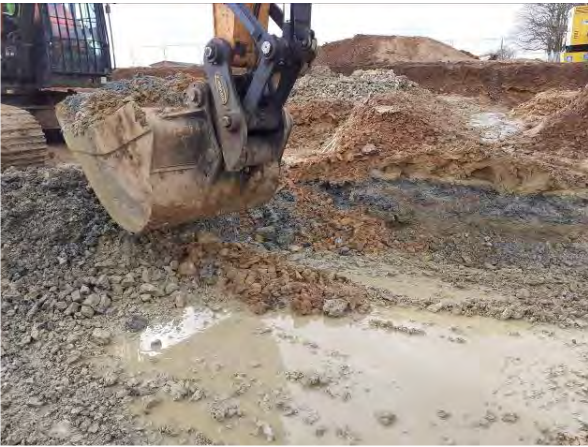
37.

16.02.21 – Black / dark grey soils above bedrock shown thickness of impacted soil horizon

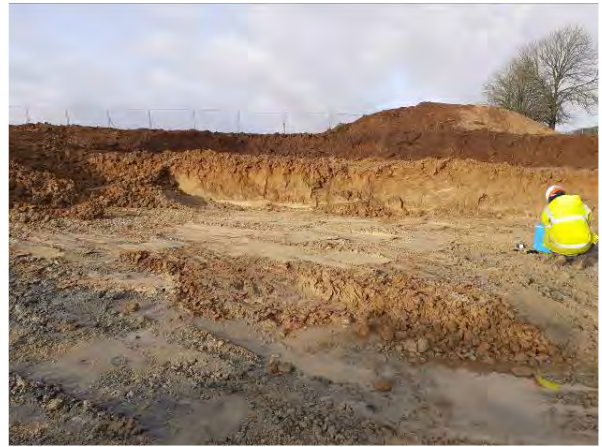
38.

17.02.21 – Collection of validation samples at the base of the remediation excavation

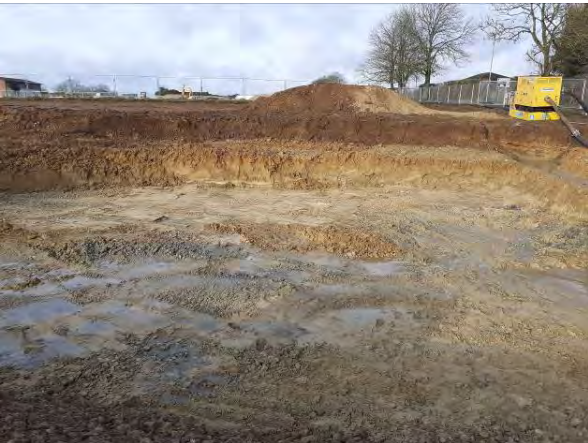
39.

17.02.21 -. Completed extent of remediation excavation in the north / northwest. Base and sidewalls ready for validation samples to be collected

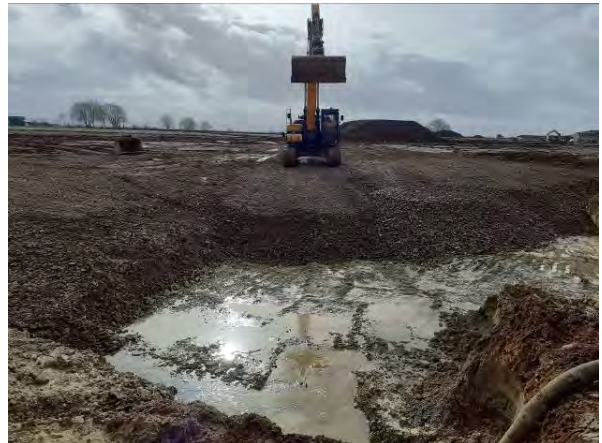
40.

17.02.21 - Backfill of remediation excavation immediately following the collection of samples due to the ingress of groundwater

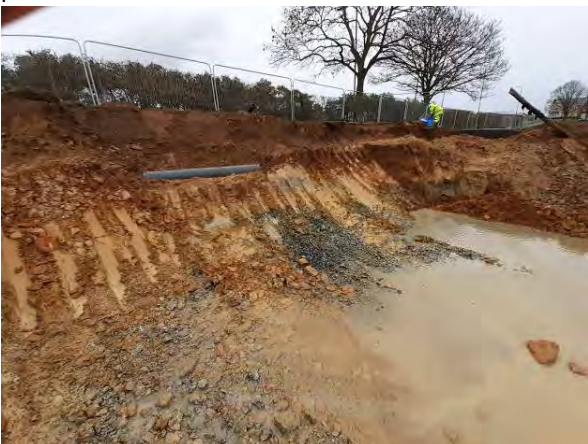
41.

17.02.21 - Residual pocket of impacted soil awaiting removal

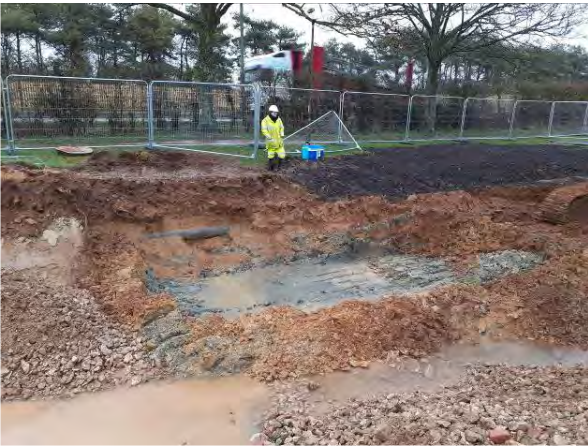
43.

18.02.21 – Grey impacted soils awaiting removal following removal of clean overburden. Pipework in sidewall drainage pipe and not POL pipeline

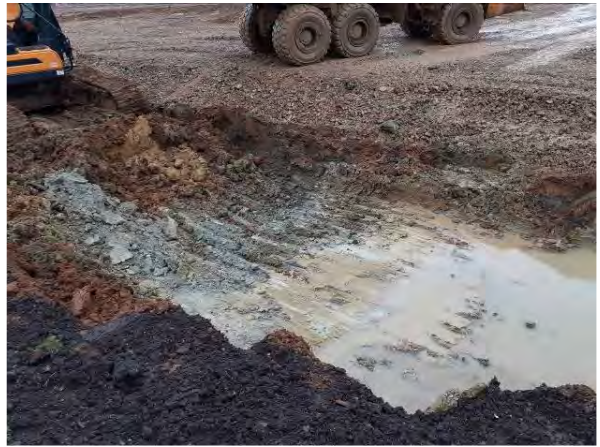
44.

18.02.21 – Removal of impacted soils down to layer of clean clay above shallow bedrock

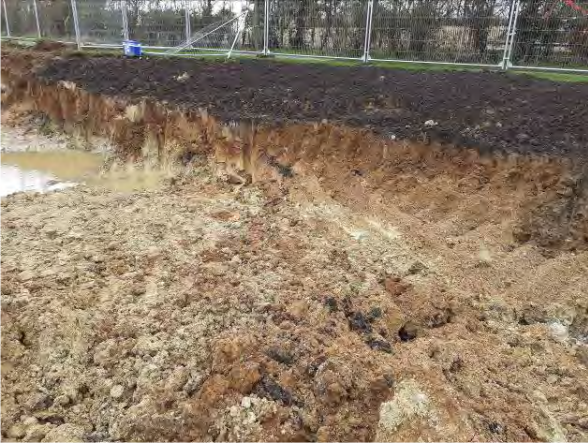
45.

18.02.21 – Northern extent of remediation excavation due to the presence of trees with protection orders

4.3.2. Excavations north towards Camp Road were limited due to the presence of an existing footpath and the two trees which have Tree Protection Orders applied to them. As such, an appropriate stand-off was adopted so as not to undermine the footpath or damage the tree roots. There were no further limitations to the remediation works.

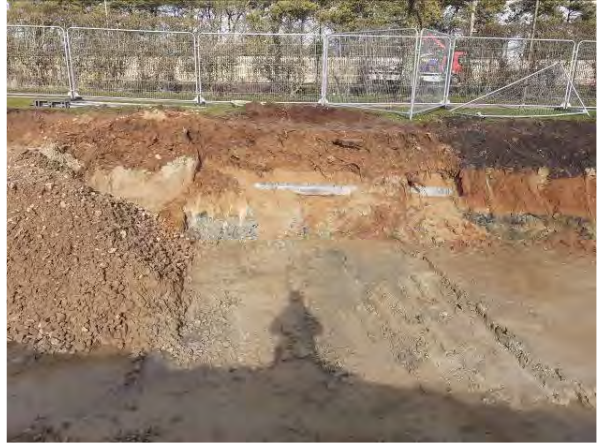
46.

18.02.21 – Impacted soils appear to extend north towards Camp Road beyond the accessible extent of remediation

- 3.5.1 Constraints to the remediation earthworks within the baseball pitch were limited to the presence of several trees along the northern boundary which have Tree Preservation Orders placed on them. An appropriate stand-off had to be adopted to ensure no damage to the roots during the removal of impacted soils. This is not considered to significantly impact the effectiveness of the remediation, however the area where soils could not be fully removed due to this constraint was subject to post-vapour monitoring.

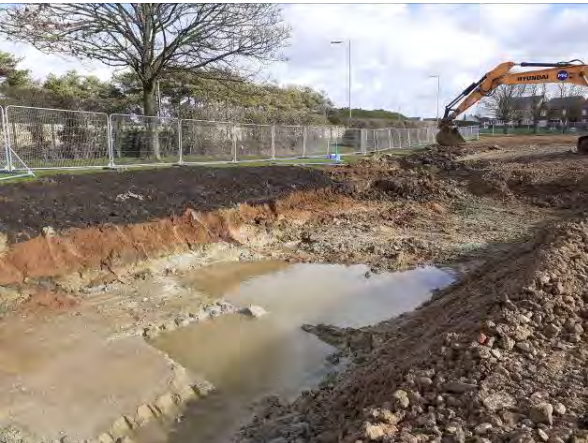
47.

18.02.21 – Northern extent of hotspot remediation prior to backfill

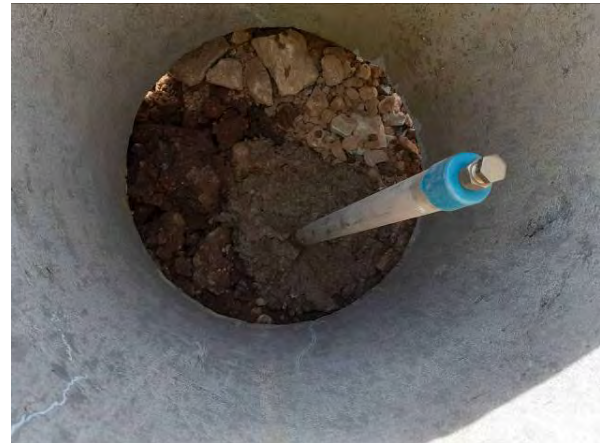
48.

06.04.21 – Vapour probe installed within footprint of remediation excavation

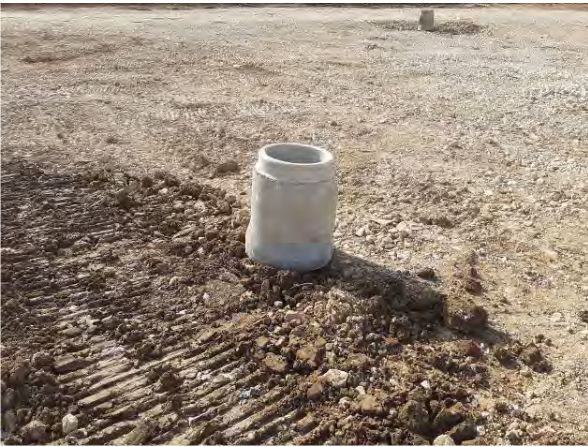
49.

06.04.21 – Concrete collars placed over monitoring probes to protect during monitoring period
