Further to your instruction of the 18th May 2015 to carry out a Phase 1 geotechnical and geoenvironmental desk study, we have pleasure in presenting a summary of our findings. This report has been prepared on behalf of Albion Land to assess the potential for hazardous substances or conditions to exist on, at or near the site at levels or in a situation likely to warrant mitigation or consideration appropriate to the intended end use proposed by the Client and to establish likely geological conditions for use in preliminary development appraisal.

Site: **Ardley, Junction 10, M40**
Title: **Taken from Ordnance Survey (1:50,000) Map 164, Oxford, Chipping Norton and Bicester**

NGR: **SP 547 289** Project No: **AG2255-15**

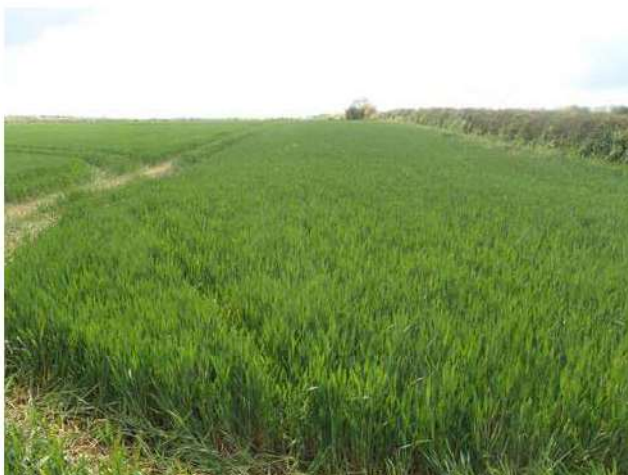
The eastern part of the site comprised cropped fields with a drainage ditch running along the hedge forming the northern site boundary and an approximately 0.5m deep depression just north of the centre filled with nettles and surrounded by trees. The depression may represent a former pond.

View of eastern part of site, looking southwest from B4100

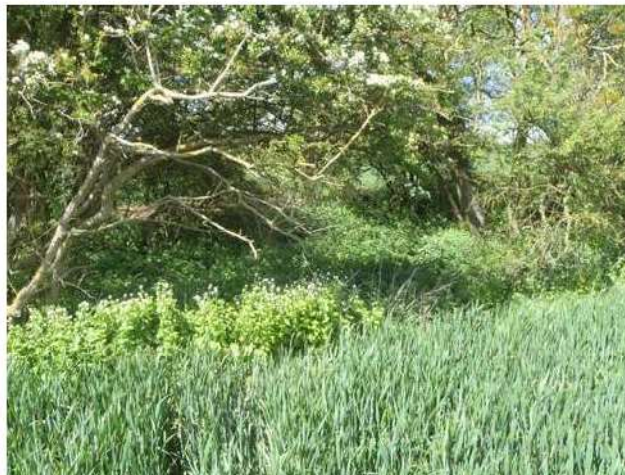
Depression in ground in eastern part of site

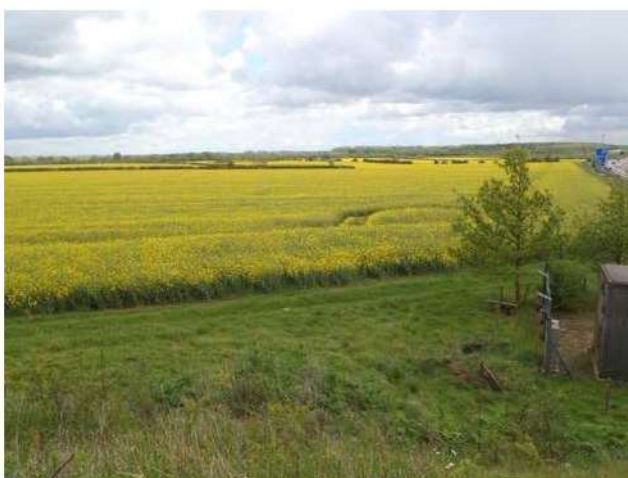
The western part of the site comprised fields cropped with oil seed rape with a drainage ditch running along part of the southwestern site boundary and two buildings and a possible pump/hydrant near the centre. The smaller of the buildings comprised a barn with stone walls and a pitched roof. It was mostly empty except for some hay bales. The larger of the buildings comprised a barn with stone walls and a steel frame with a sloping roof of possible corrugated asbestos sheeting. This barn was full of hay bales. A line of deciduous trees ran through the east of this part of the site and a mobile phone mast and possible electricity substation in the southwestern corner.

View of western part of site, looking east from southwestern corner

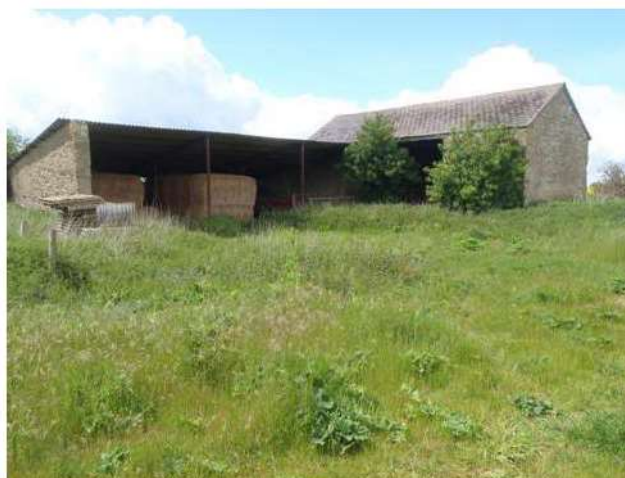
Barns in western part of site
