**Bat Assessment**  
Preliminary Roost Assessment and  
Roost Characterisation Surveys

**Barn at The Leys**  
**Adderbury**  
**Banbury**  
**OX17 3ER**

(29<sup>th</sup> March 2019)

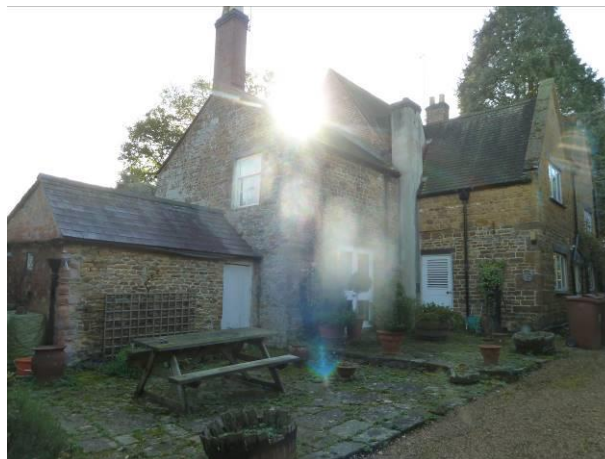
*Western elevation*

This was an occupied three storey dwelling, known as The Leys. It was constructed in solid stonework and had a series of gabled roofs finished with clay tiles. Potential access points for bats were recorded via spalled mortar at gable verges, behind the fascia board, as well as under lifted tiles. There was also a large crack in the stone wall of the single storey element on its western elevation which could provide access for bats and potential hibernation opportunities within the walls.

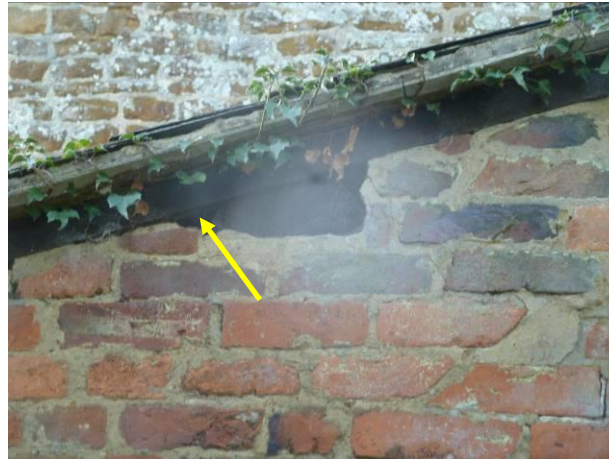
*Potential access into single storey element*

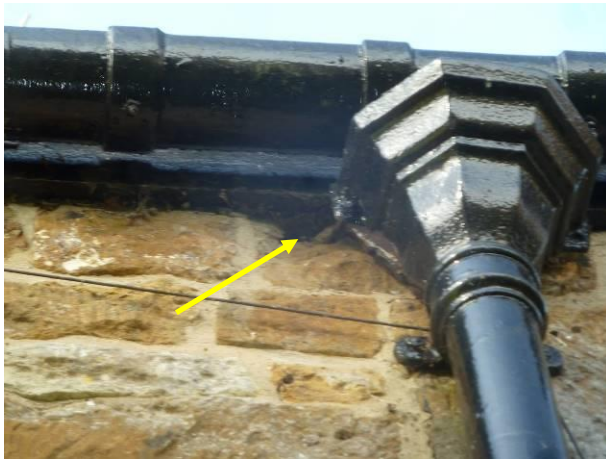
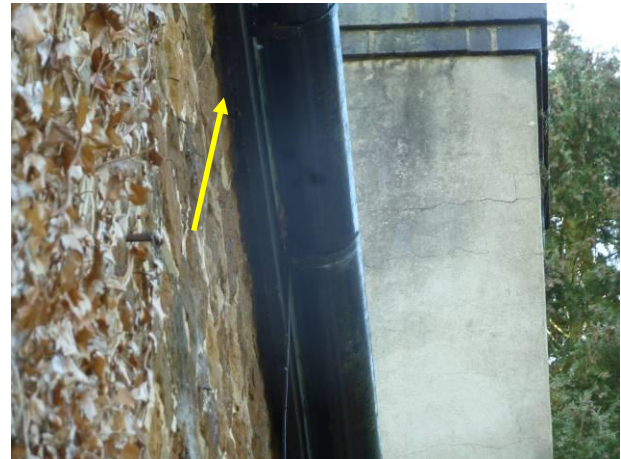
*Potential bat access at eaves*

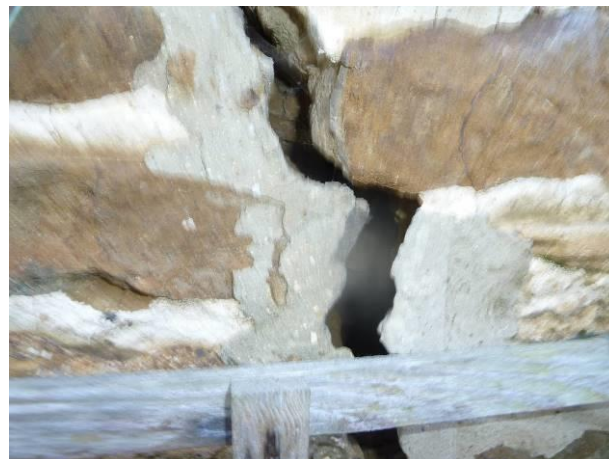
*Crack in stone wall of single storey element*

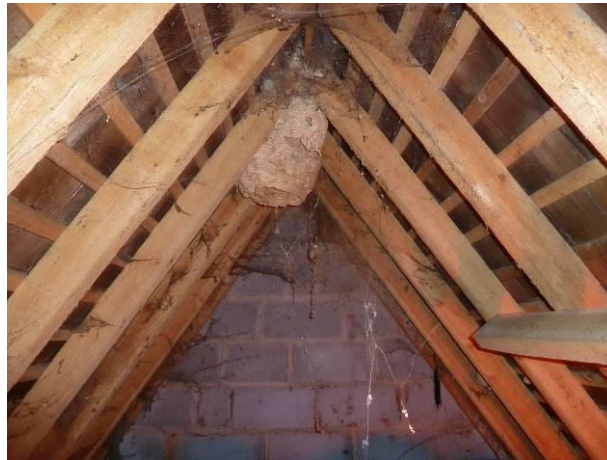
Void A was a traditional cut roof constructed with purlins and rafters but without the benefit of any lining or underfelt. A thin layer of mineral wool insulation was present at ceiling level between the joists. Small sections of daylight were visible via lifted tiles and the maximum headroom was estimated to be 1.4m.

*Void A*

Roosting opportunities for bats were present on top of the walls, behind the fascia boarding, and against the ridgeboard and rafters. As the roof was unlined, it was easily accessible to most bat species, except horseshoe bats which would need free-flighted access.

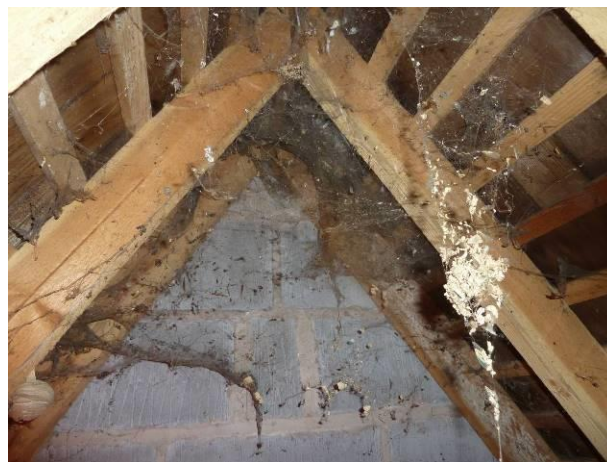
The void was full of cobwebs hanging from the ridgeboard and at the gable ends. A large inactive wasps' nest was also recorded together with c50 mouse droppings. No evidence of bats was recorded in Void A.

*Cobwebs in Void A*

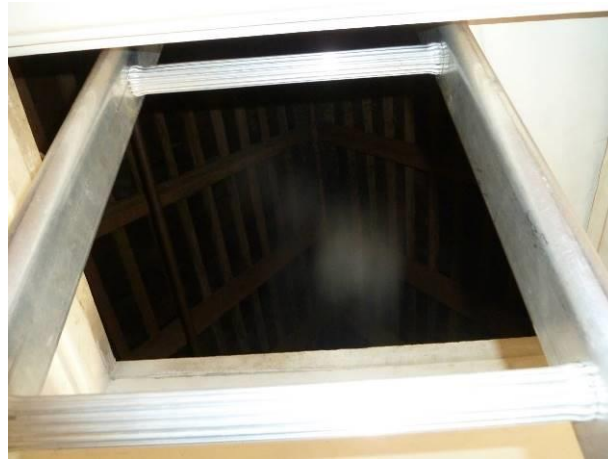
Void B was only viewed from the loft hatch as when the loft hatch was opened, many wasps came flying out of the void and around the surveyor. More buzzing was heard in the roof void and therefore for health and safety reasons, this void was not accessed at the time of survey. What could be viewed from the loft hatch indicated a maximum headroom of around 1.2m (the ceilings were heavily raked in the third floor) with the same construction as Void A.

*Void B*

The ridgeline visible above the loft hatch in Void B was covered in dense cobwebs and the void clearly supported an active wasps' nest. No bat evidence was found but approximately 90% of this void could not be surveyed properly due to the presence of wasps, as such it could not be confirmed whether there was any evidence of bats in this Void B.

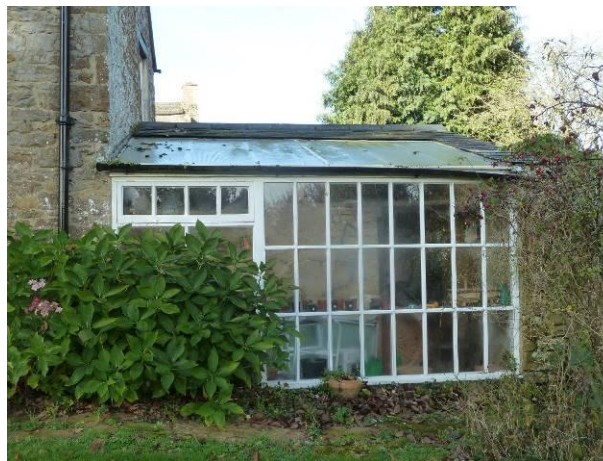
*Glazed roof of single storey element*

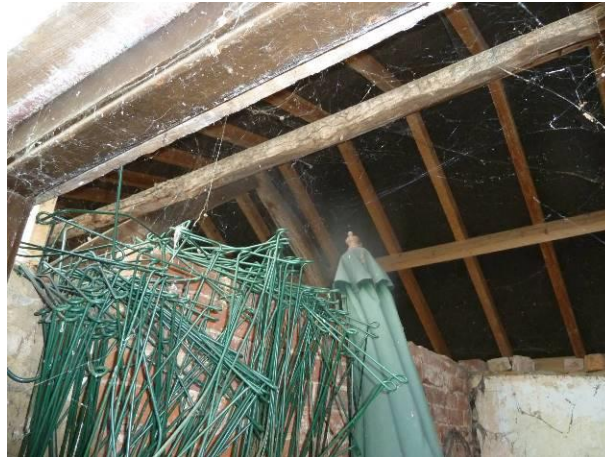
Internally, the single storey element was vaulted and benefited from a bitumen lining to its underside. Potential access points for bats were noted at the gable verge and via gaps above the wooden door. Roosting opportunities were therefore considered possible between the slates and the lining, on top of the solid walls and inside against the ridgeboard, although this latter area did suffer from a fair amount of light ingress due to the glazed lean-to. Again, the internal roof area was densely cobwebbed and with so many stored items in the building it made searching for evidence of bats a little difficult, nevertheless, as thorough search as possible was made and no evidence of bats was recorded.

*Light ingress in single storey element*

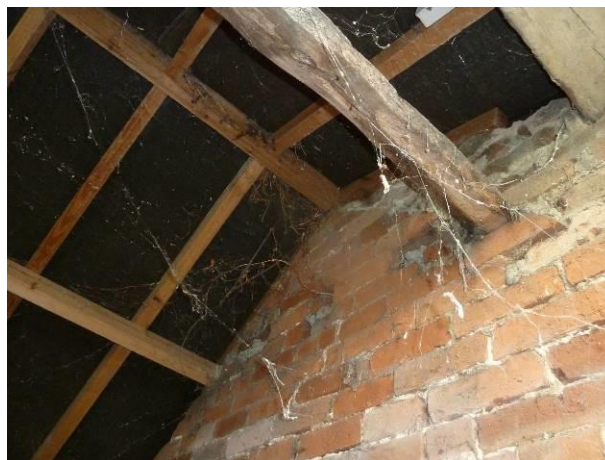
*Cobwebs in single storey element*

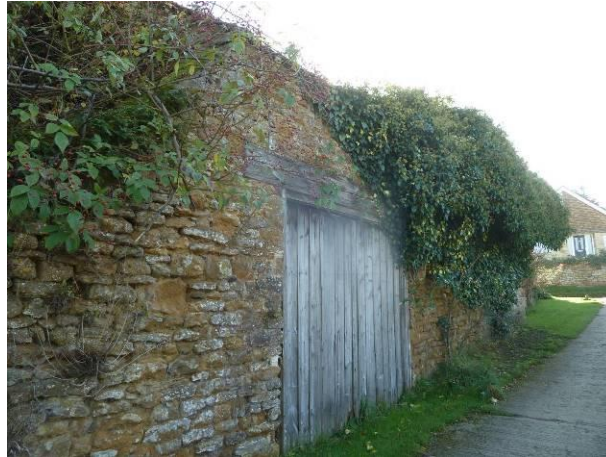
*Western elevation*

Potential access points for bats were noted at the south-east corner of the barn where flighted access for bats was possible directly into the barn via a large gap between the top of the wall and the start of the roof. There was

also potential bat access above the wooden door on the western elevation. Once inside the barn, potential roosting opportunities for bats were noted on top of the southern blockwork wall as well as inside the wall as there may be gaps in the blocks themselves that could support roosting bats (the surveyor has witnessed common pipistrelle, Natterer's and brown long-eared roosting in this manner at sites across the Midlands). The tops of the stone walls on all elevations, except the southern gable, were sealed. Bats may alternatively roost on top of the central purlins. The internal area of the barn was very dark with little light ingress, also, close to the north-west flighted access point was a mature conifer that would provide sufficient shelter for bats accessing any possible roost in the barn.

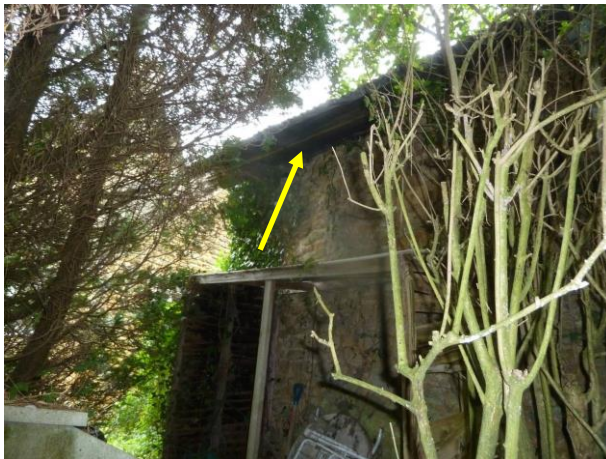
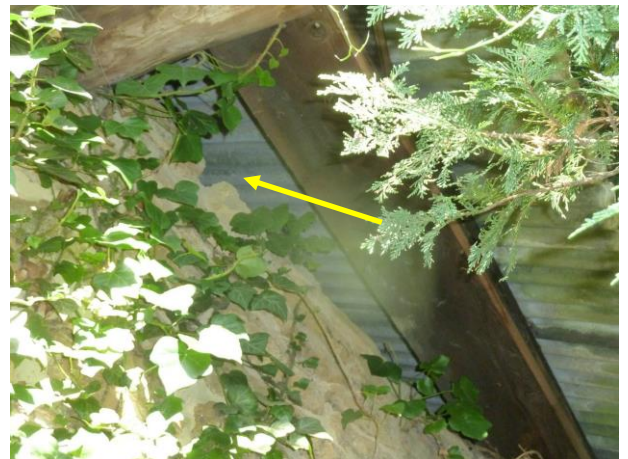
*Bat access at the south-east corner*

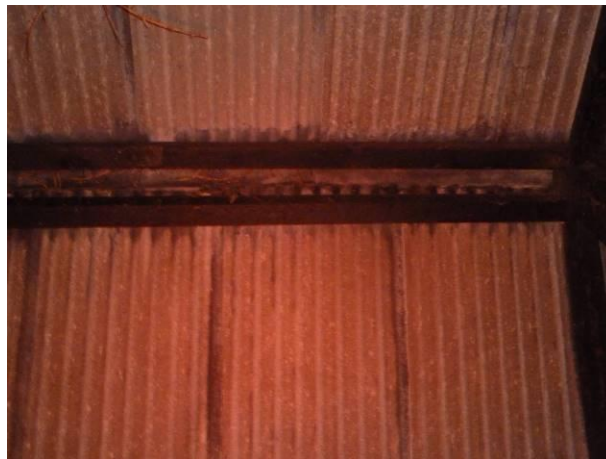
*Two central purlins*

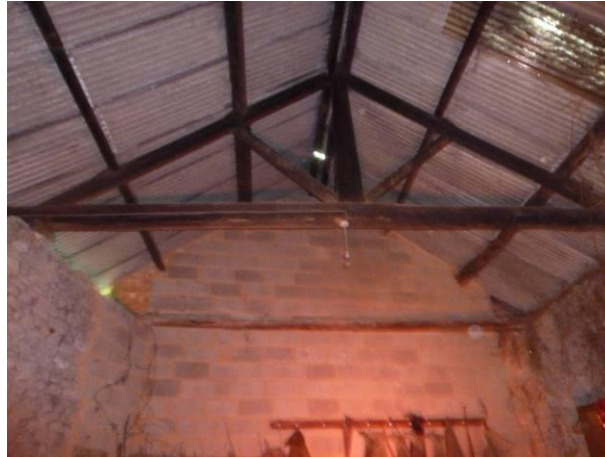
The barn was used for storing garden machinery and paraphernalia, with a small, lean-to log store at its northern elevation, as such some areas of the barn were difficult to search for bat droppings. Nevertheless, evidence of bats was found by way of tens of discarded noctuid wings caught in cobwebs against the southern gable with a general scattering of these throughout the barn. Additionally, two piles of medium-sized bat droppings were recorded with a pile of 10 droppings observed on the floor close to the northern gable and a pile of 20 droppings noted on the floor and on stored items in the centre of the barn below the two central purlins. At least half of these droppings appeared to be relatively fresh and likely deposited in the most recent active season (May-August).

*Internal area of barn*

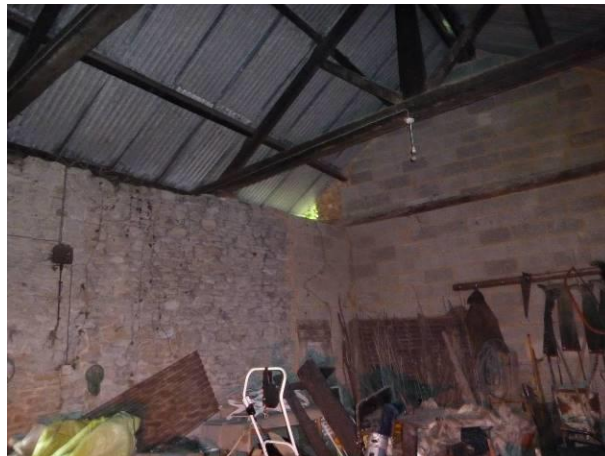
*Light ingress at south-east corner*

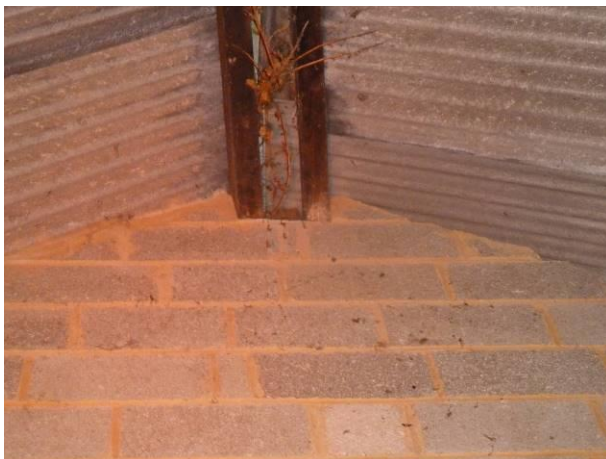
*Noctuid wings stuck to southern gable*

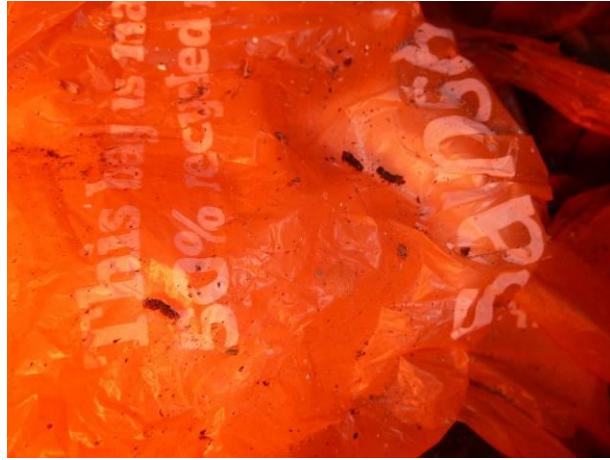
*Bat droppings on stored items under central purlins*

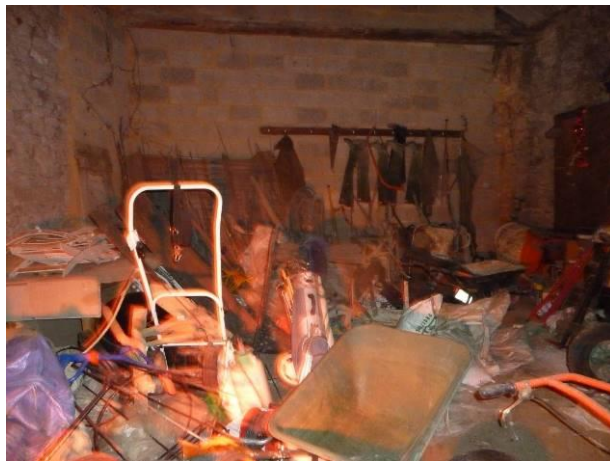
*Stored items in barn*

It is not clear whether the roost was a non-breeding day roost or potentially a nursery roost as it is possible that some bat droppings may not have been recorded as some areas of the barn were difficult to view due to the number of stored items. It is also possible that the barn could be used by roosts of crevice-dwelling bats such as whiskered, Brandt's, Natterer's or pipistrelle sp. as evidence of these species could be concealed in area inaccessible to the surveyor.

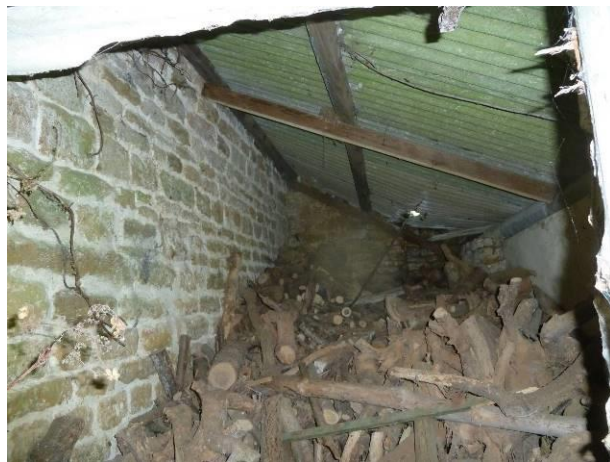
*Log store lean to at northern elevation*

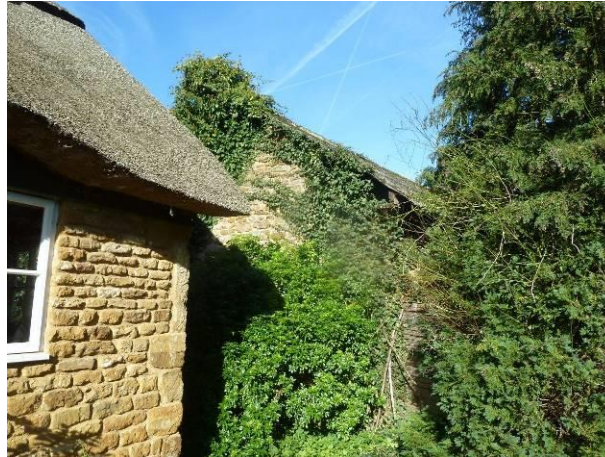
As the barn was made of stone, such buildings can offer suitable hibernation opportunities for bats within the walls and, given the presence of the mature conifer at the south-east corner and ivy at its southern and northern elevations, this could provide suitable humidity levels to support hibernating bats.

*Mature conifer and ivy on the barn*

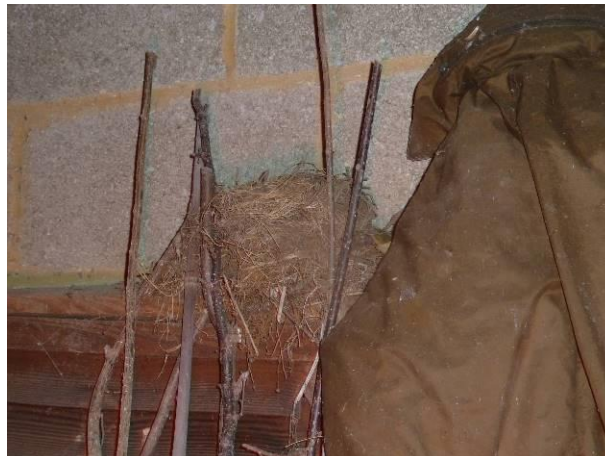
Incidental evidence of an inactive nest from a blackbird/thrush or wagtail sp. was recorded at the southern gable wall at the time of survey.

*Thrush/wagtail nest at southern gable*

### 5.1.2 Nesting bird check of barn

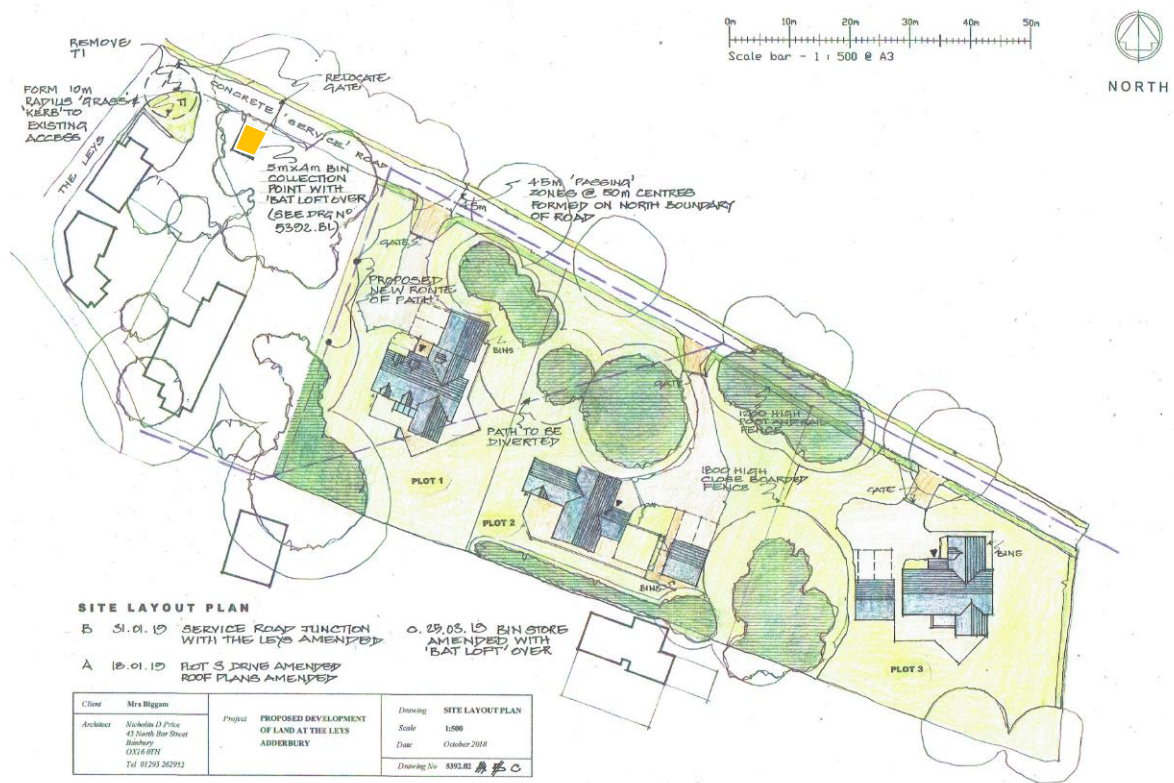
Figure 5 – Permanent replacement bat loft (in orange) for BLE located in loft above bin store

In advance of any disturbing works to the barn, the permanent replacement loft space for bats above the bin store should be completed and available for use by brown long-eared bats.

- bat access to include 1x standard access slate close to the eaves on the south-east or south-west elevation, close to cover;
- have an access hatch of 500mm x 500mm which would permit access for people for either maintenance reasons or for a licensed person to check on the status of roosting bats

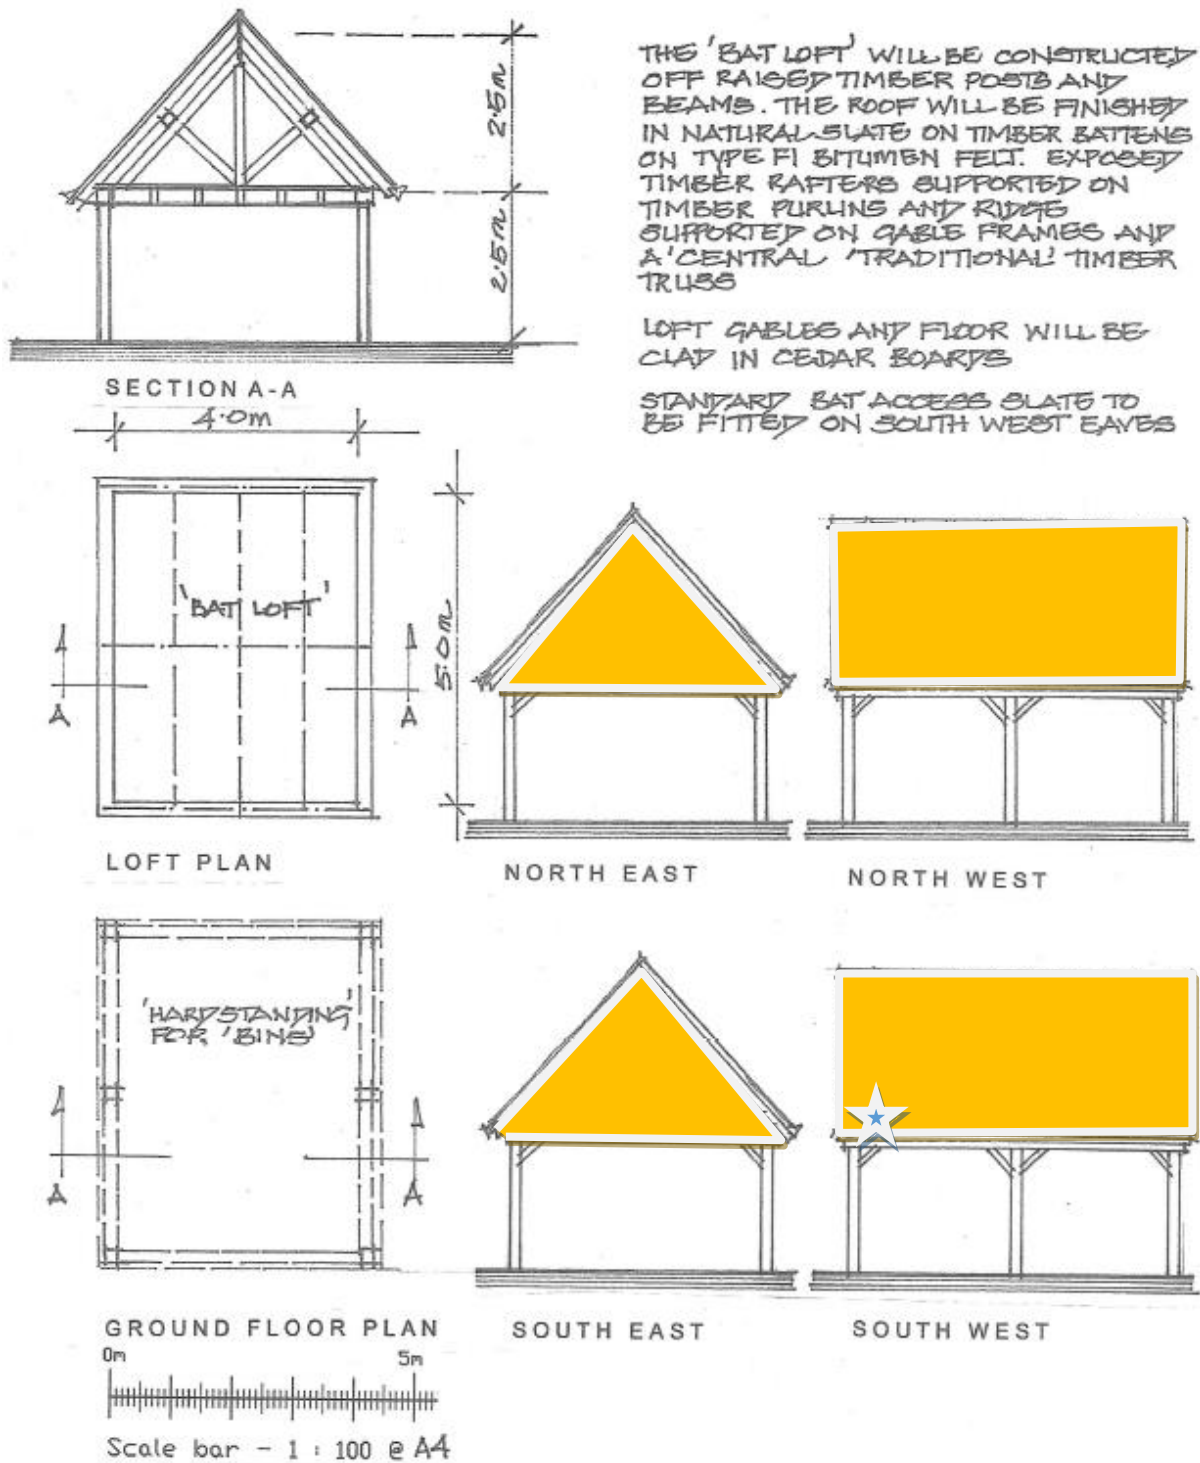
Figure 6 – Permanent replacement bat loft (in orange) for BLE located in loft above bin store with bat access indicated by blue star
